**THURBER ENGINEERING LTD.**

December 11, 2006

File: 15-85-38

**PEACE REGION (SWAN HILLS AREA) GEOHAZARD ASSESSMENT  
HWY 2A:54 (SH 17, SITES #1 & #1A, WEST OF GUNN'S CREEK)  
2006 ANNUAL INSPECTION REPORT**

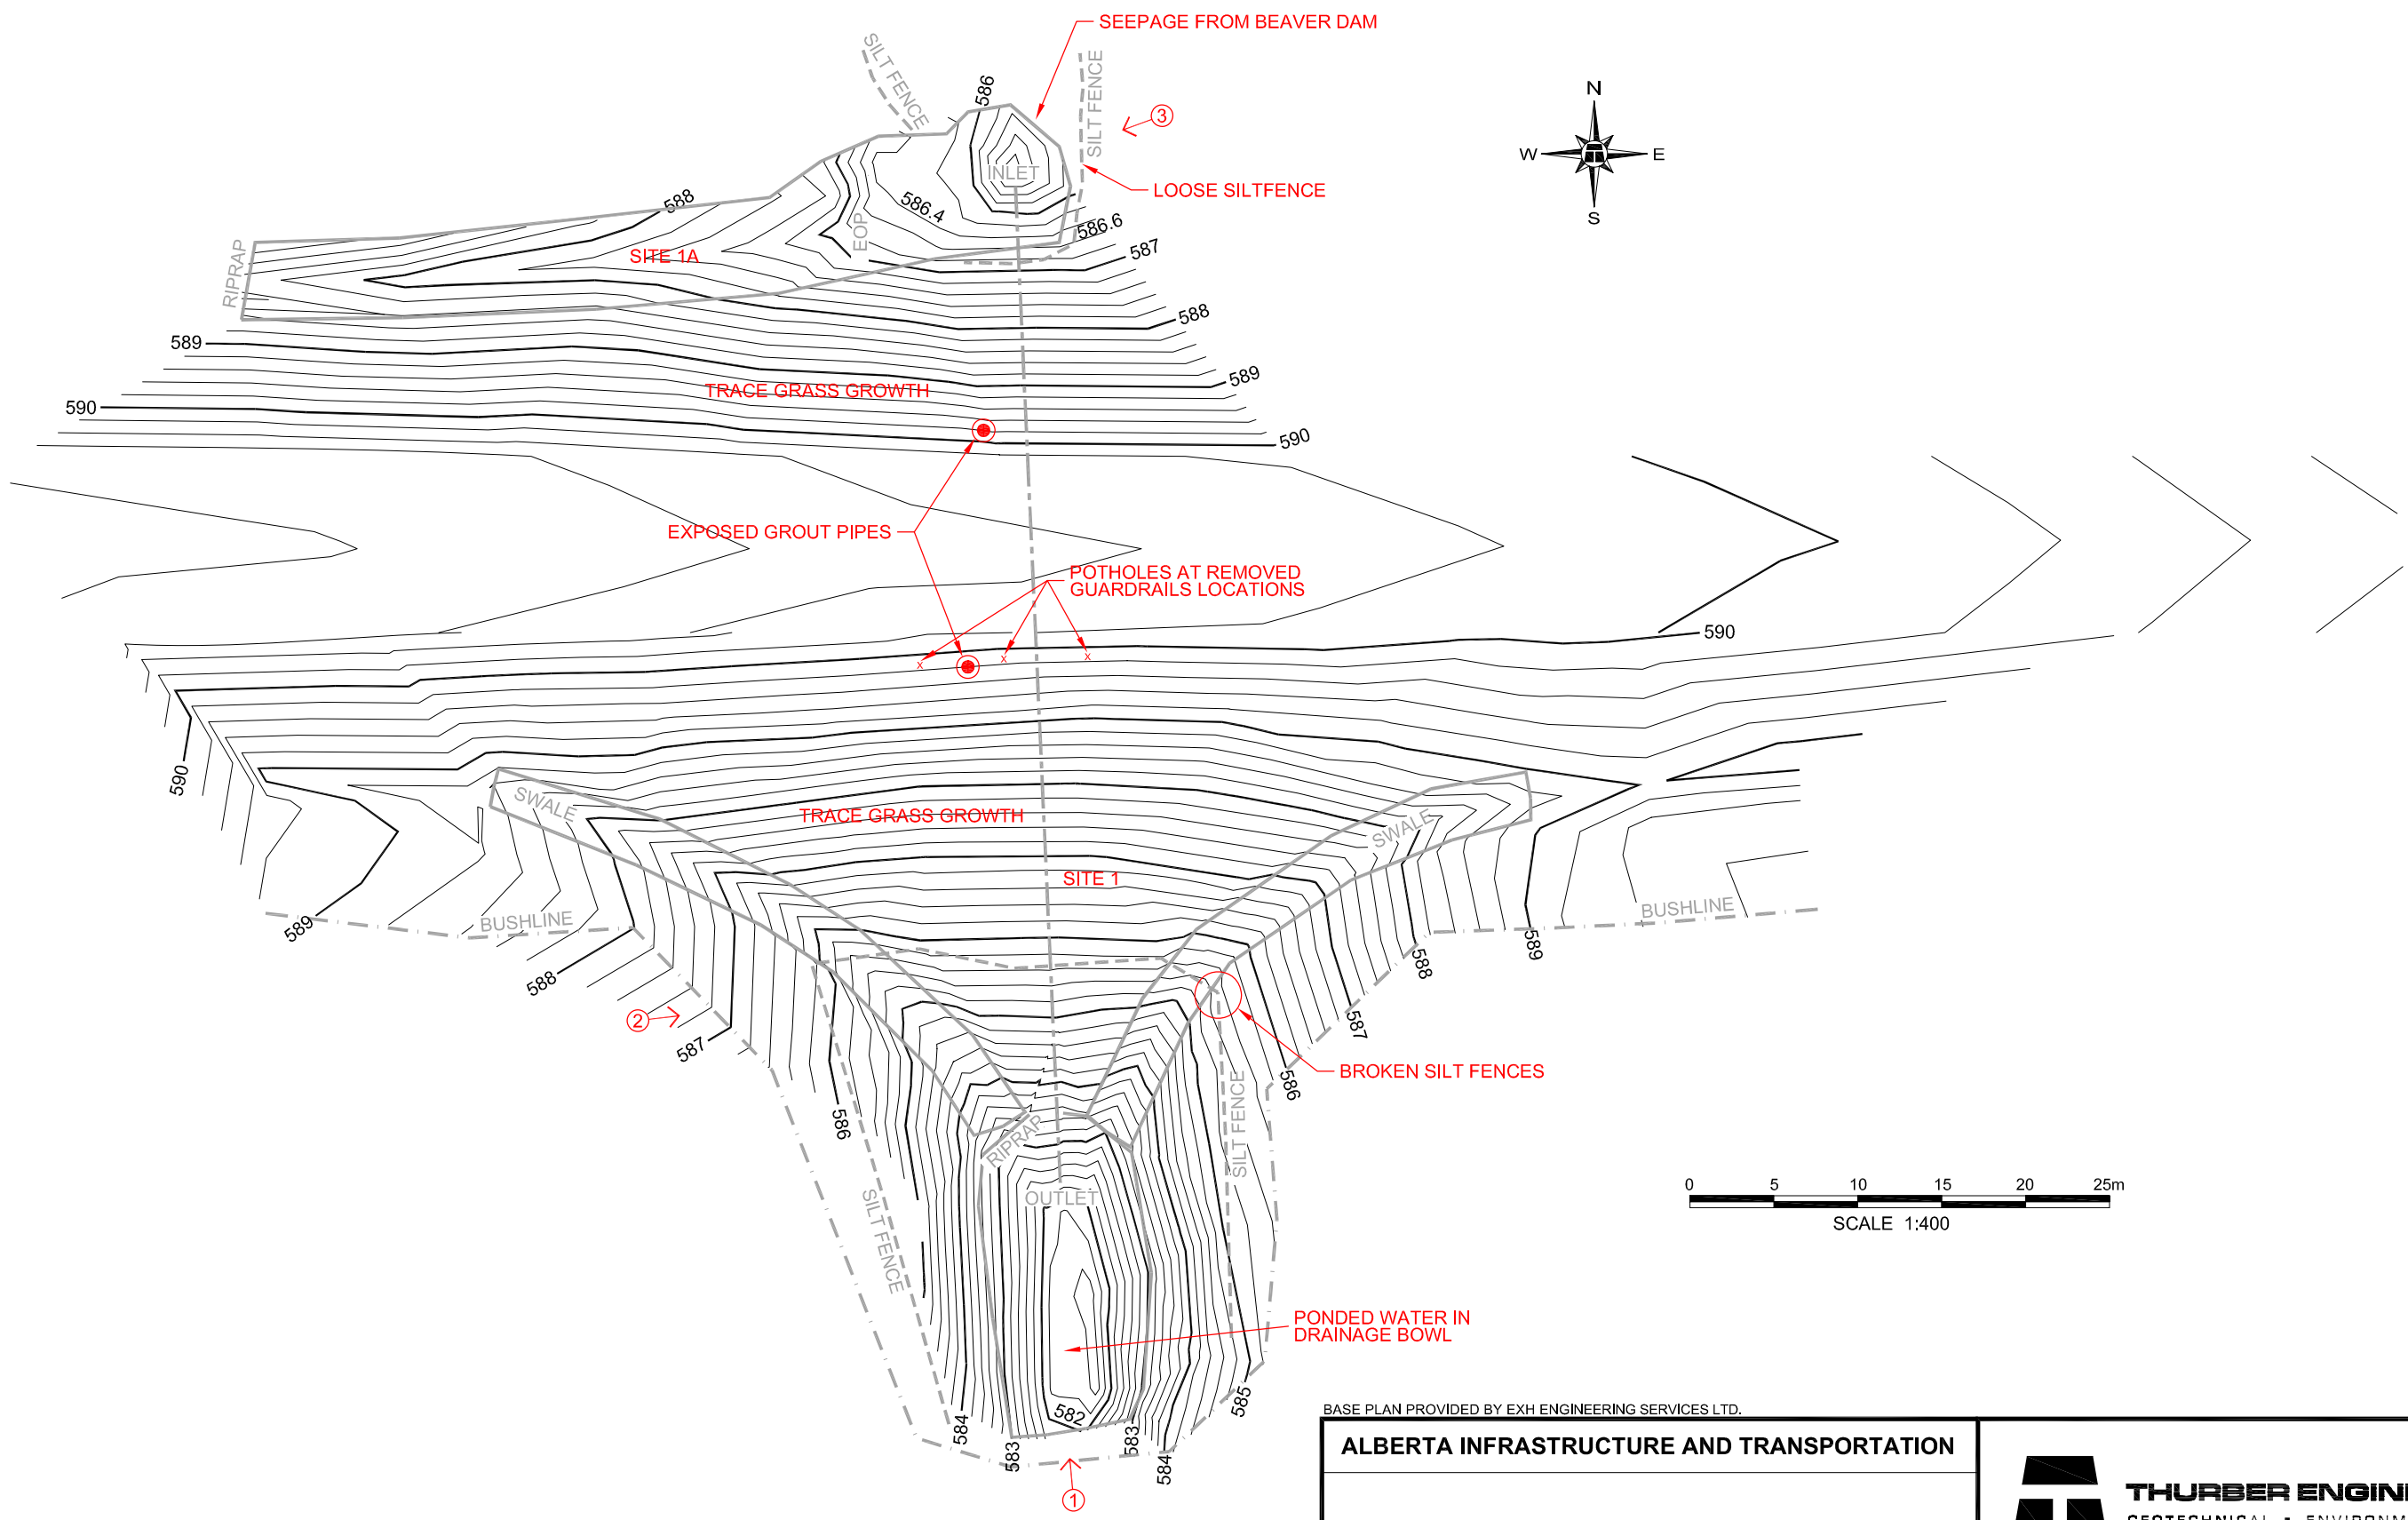
ENGINEER: GSB/BHM	DRAWN: HH	APPROVED:
DATE: DECEMBER 2006	SCALE: 1:400	DRAWING No. <b>15-85-38-SH17-1</b>

The reconstructed slope and erosion control work undertaken at both Sites #1 and #1A are shown on the attached as built site sketch plan and cross-sections which was recently surveyed by EXH Engineering Services Ltd. as part of the construction repair work. Selected photographs taken during the visit are also attached.

**NOTE**  
 2006 OBSERVATIONS ARE SHOWN IN RED

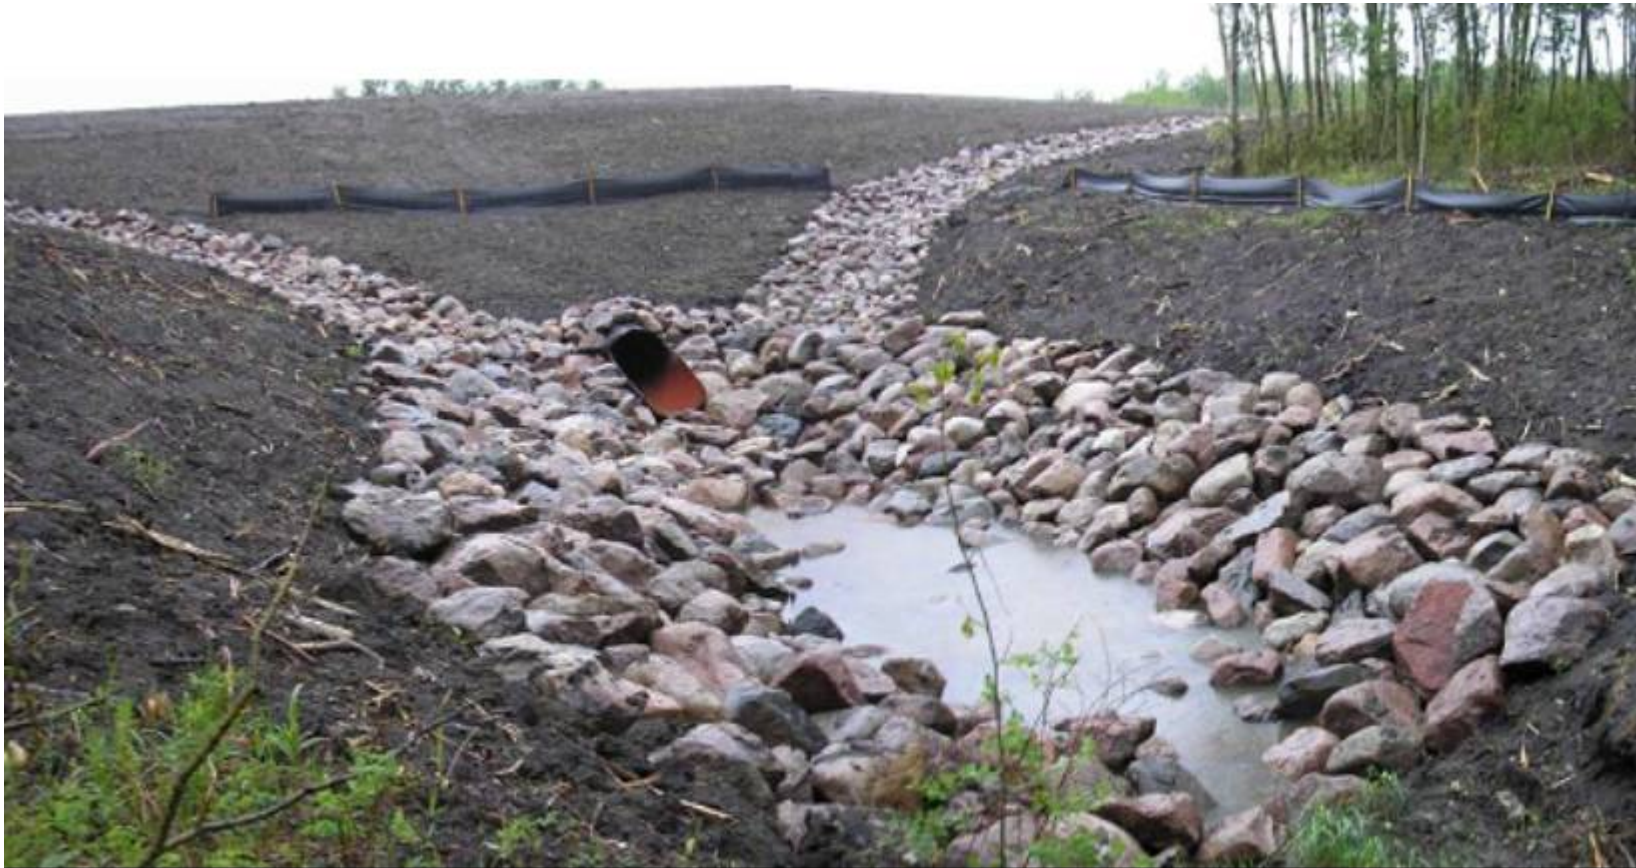
Slight seepage was observed to be coming out of the beaver dam on the north side of the highway. There was trace amount of flow from the sub-drain installed at Site 1A. The drainage bowl at the culvert outlet had ponded water and was performing as anticipated. No significant flow was however observed along the swale.

The reconstructed slope and erosion repairs appeared to be working satisfactorily where the riprap has been placed to check erosion.

Photo 1 - Looking north at the culvert outlet, swale and reconstructed slope, May 25, 2006.

Since repairs have been only recently carried out it is recommended that periodic visual inspections of the site be carried out by AIT's Maintenance Contract Inspector to gauge how well they are working and to quickly identify if any further maintenance items arise.

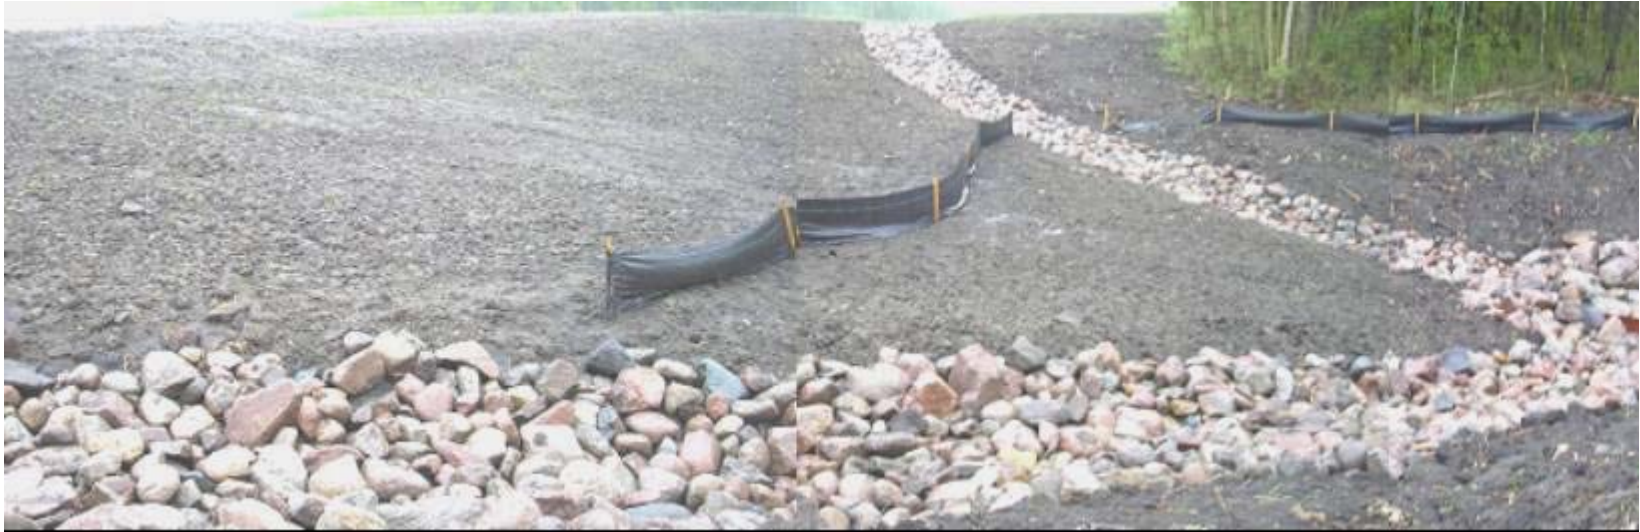
Photo 2 - Looking east at the highway embankment and swale, May 25, 2006.

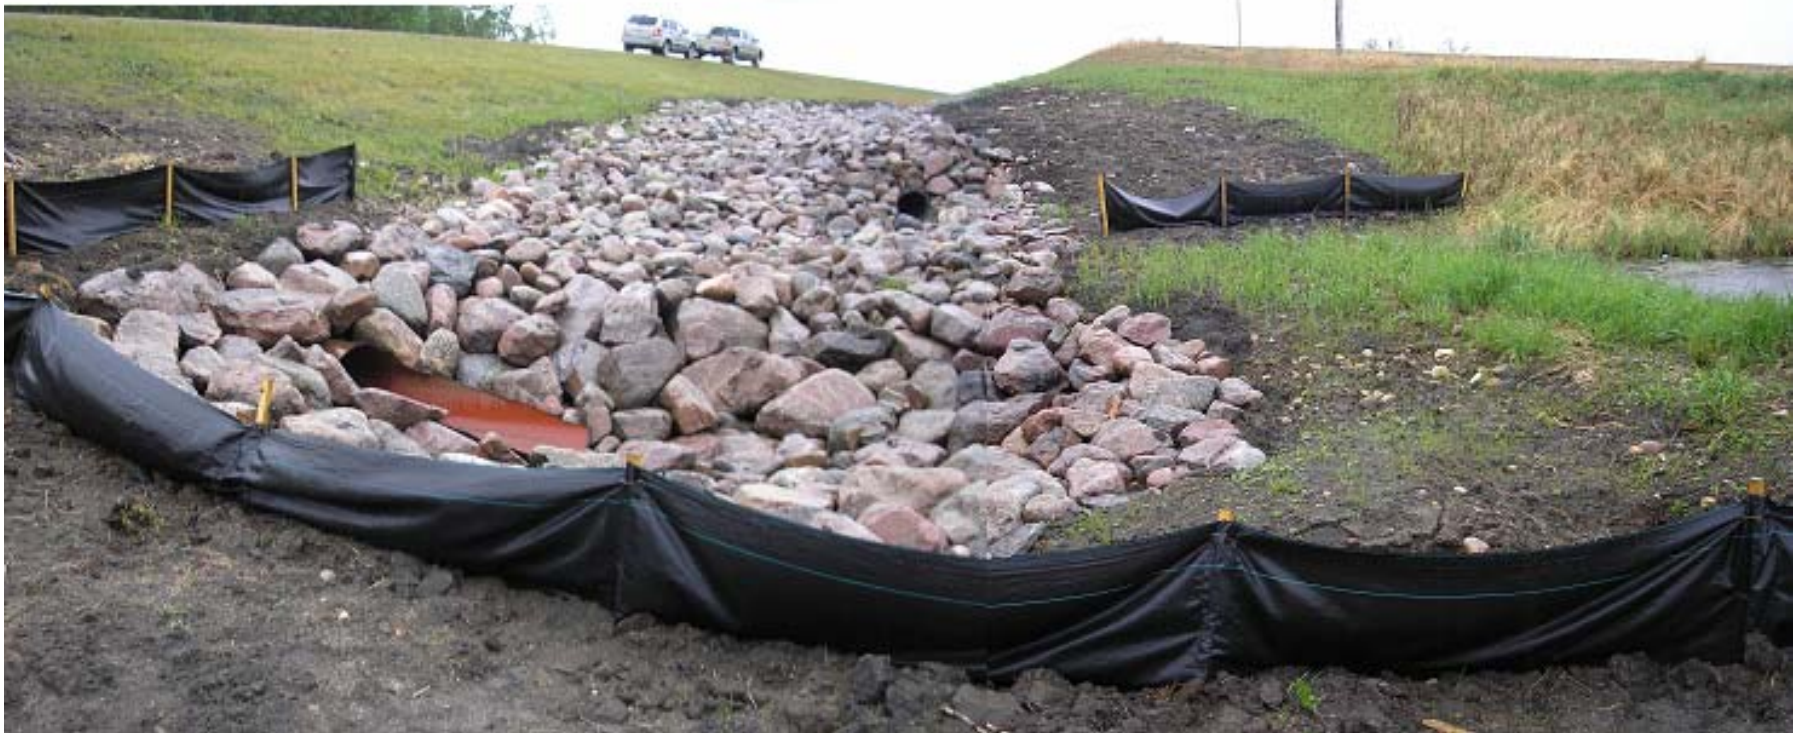
Photo 3 - Looking southwest towards culvert inlet, sub-drain outlet and swale riprap of Site #1A, May 25, 2006.
