**PEACE REGION (SWAN HILLS AREA) GEOHAZARD ASSESSMENT
HWY 2A:54 (SH 17, SITES #1 & #1A, WEST OF GUNN'S CREEK)
2007 ANNUAL INSPECTION REPORT**

ENGINEER: GSB/BHM	DRAWN: PS	APPROVED:
DATE: JANUARY 2008	SCALE: 1:400	DRAWING No. 15-85-73-SH17-1

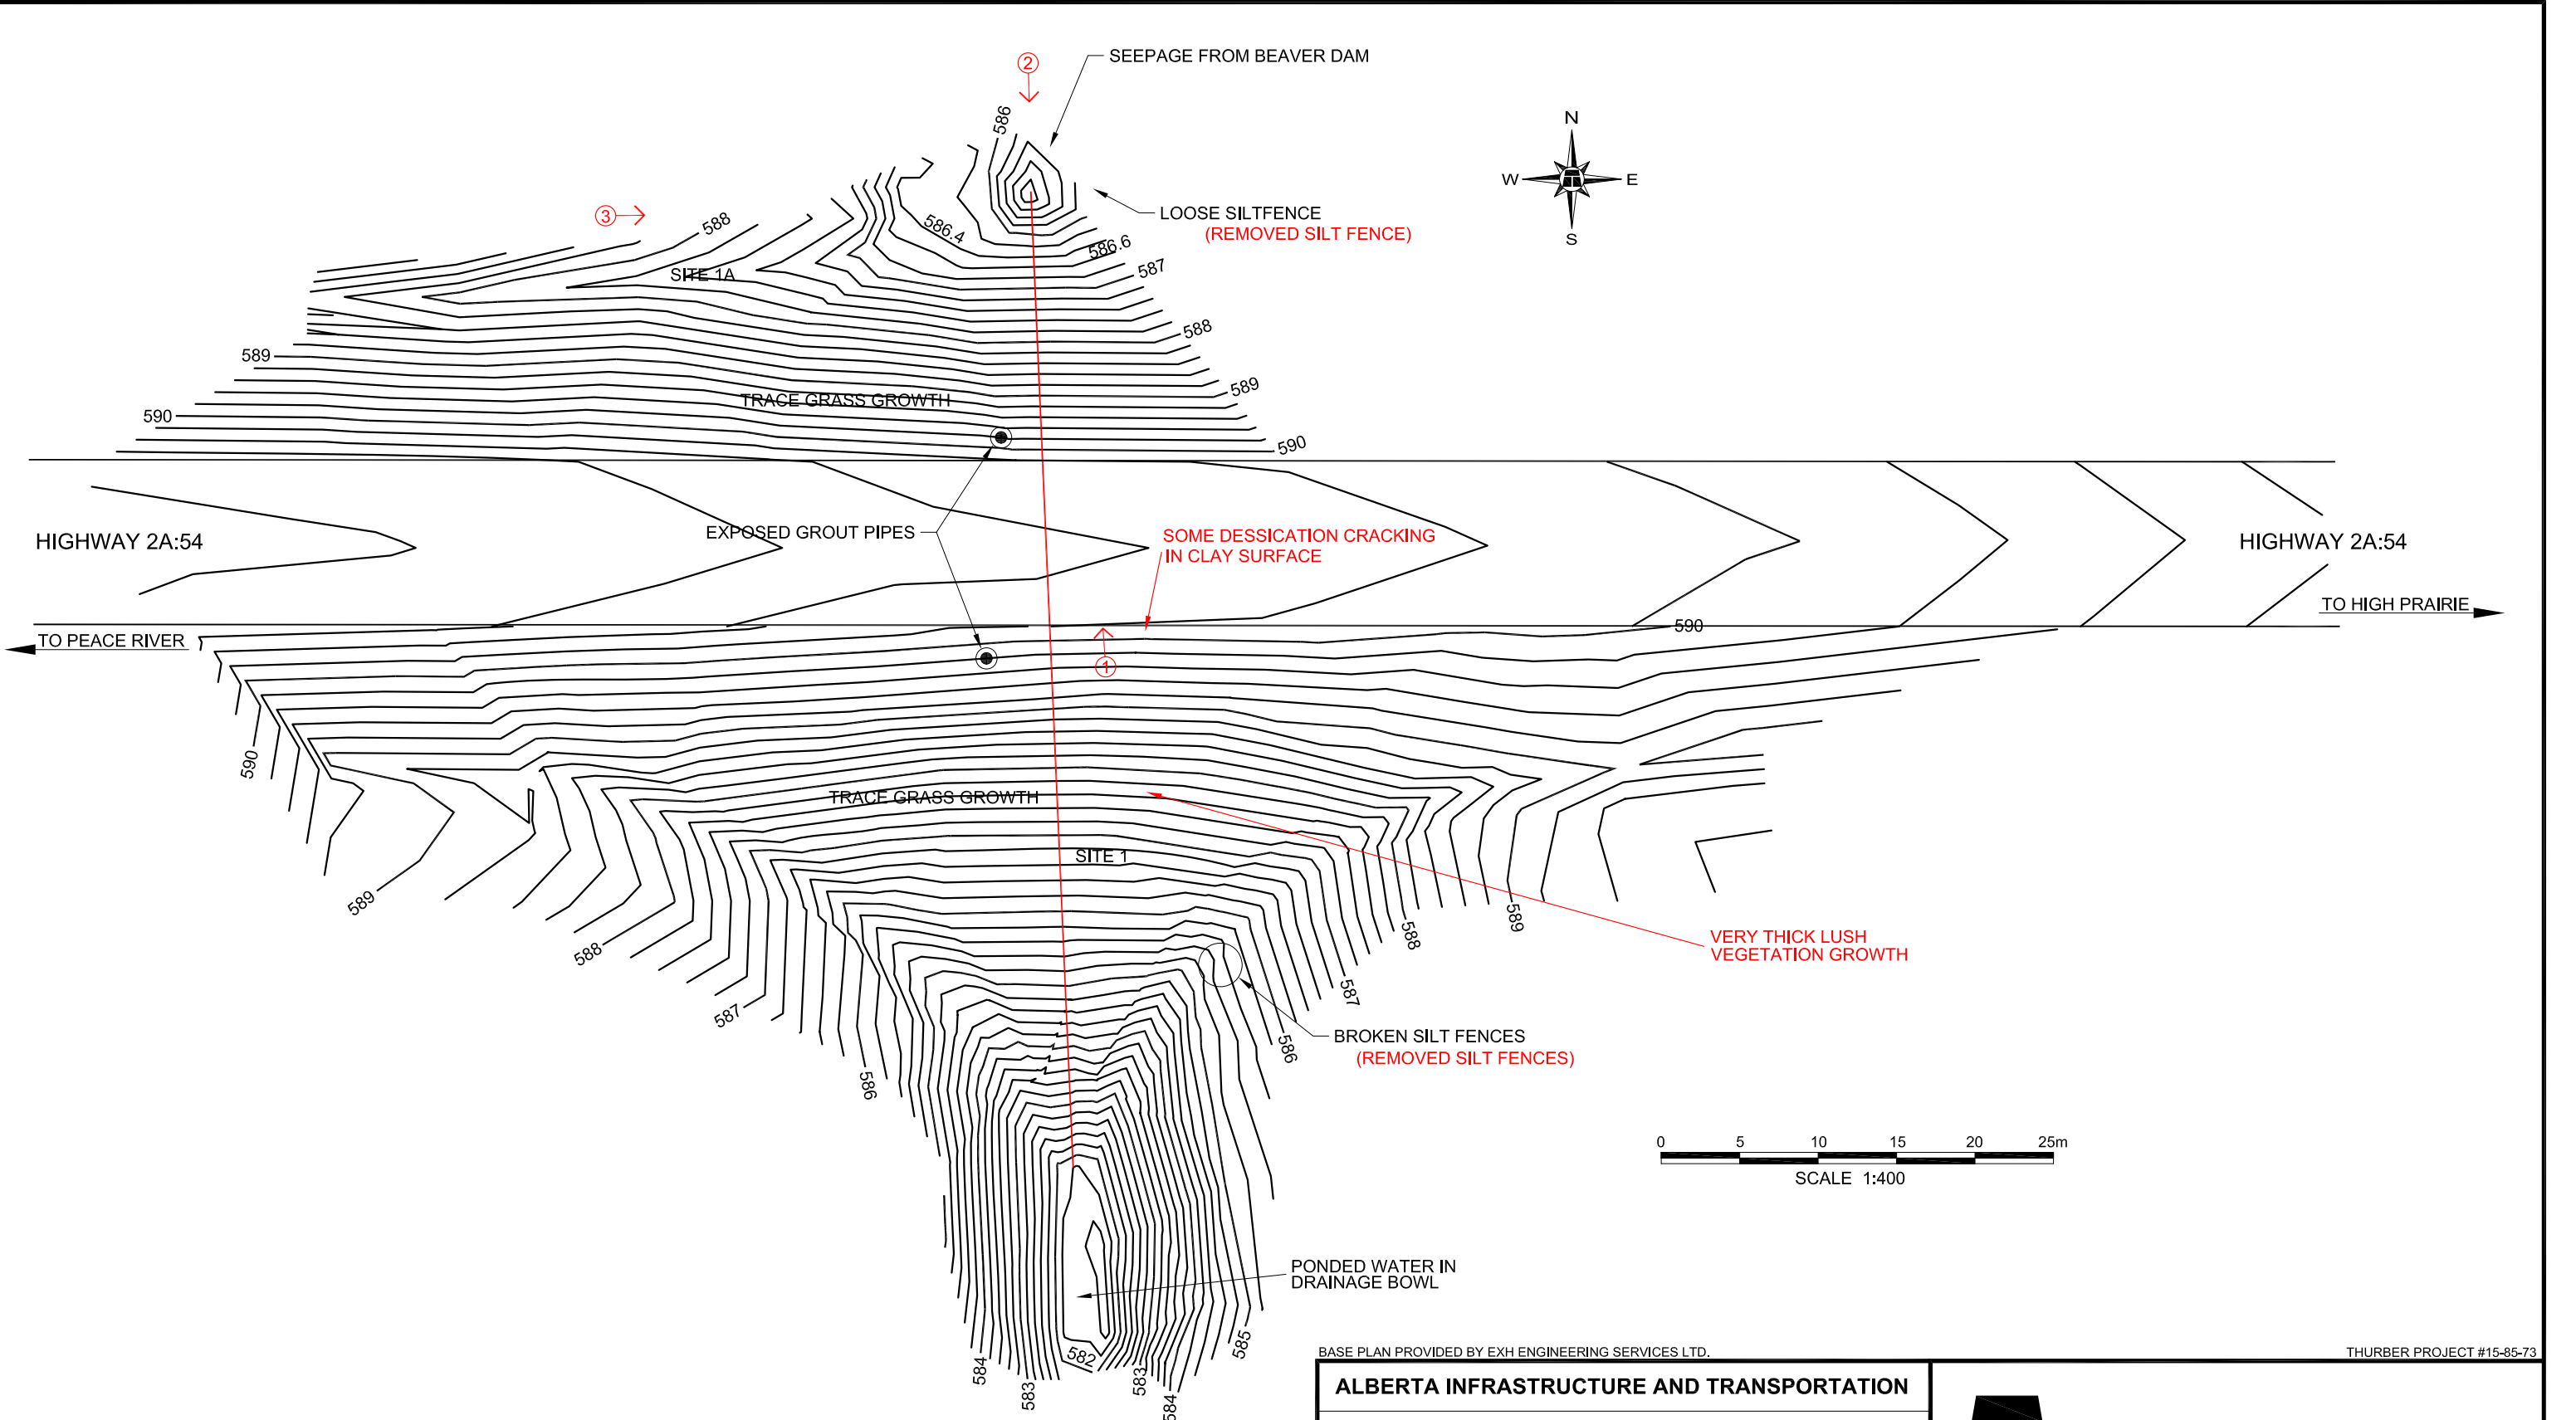
**AS-BUILT SITE PLAN SHOWING
 VARIOUS CONSTRUCTED FEATURES**

The reconstructed slope was performing to satisfaction. The grass growth was very thick and lush green with primarily clover growing through the entire site. The silt fences were sitting loose at couple of spots and were torn at other spots.

Slight seepage was observed to be coming out of the beaver dam on the north side of the highway. There was trace amount of flow from the sub-drain installed at Site 1A. The drainage bowl at the culvert outlet had ponded water and was performing as anticipated. No significant flow was however observed along the swale.

The silt fences can now be removed from all the locations.

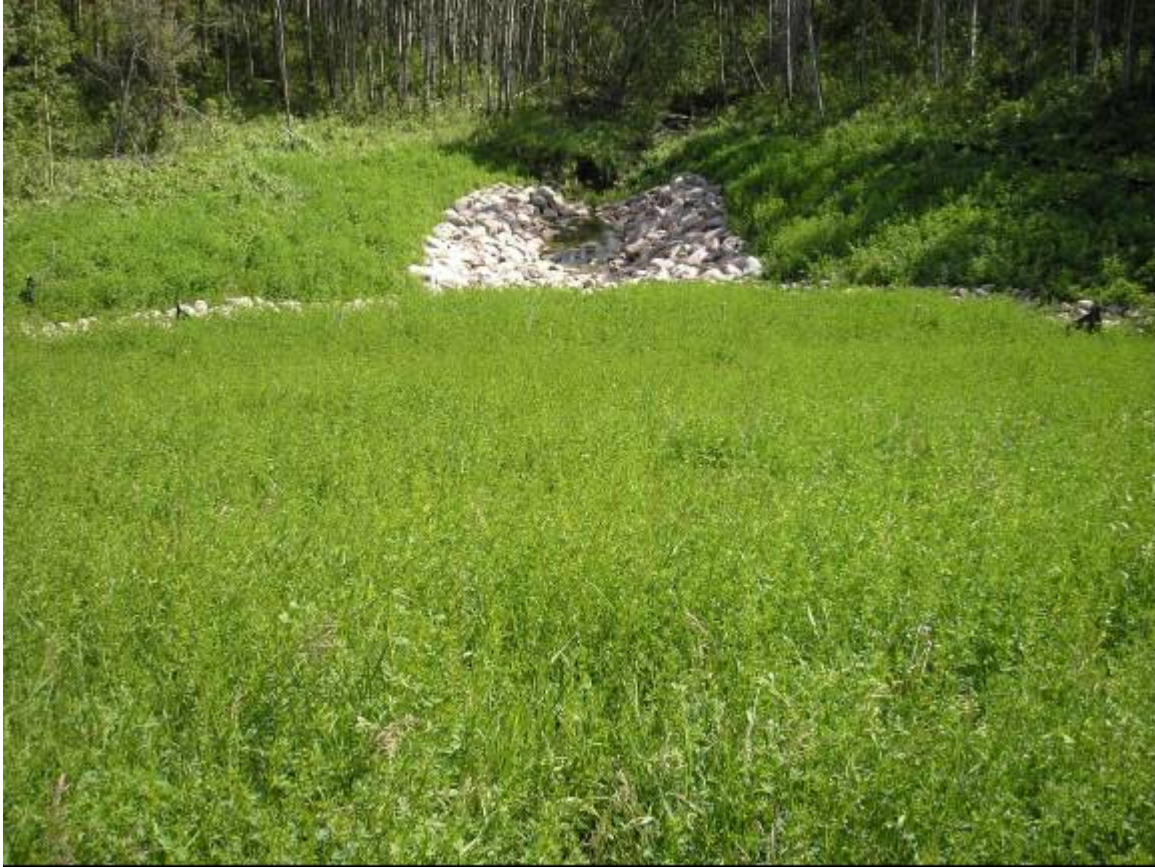
Photo 1 - Looking south at the culvert outlet, swale and reconstructed slope,
June 13, 2007.

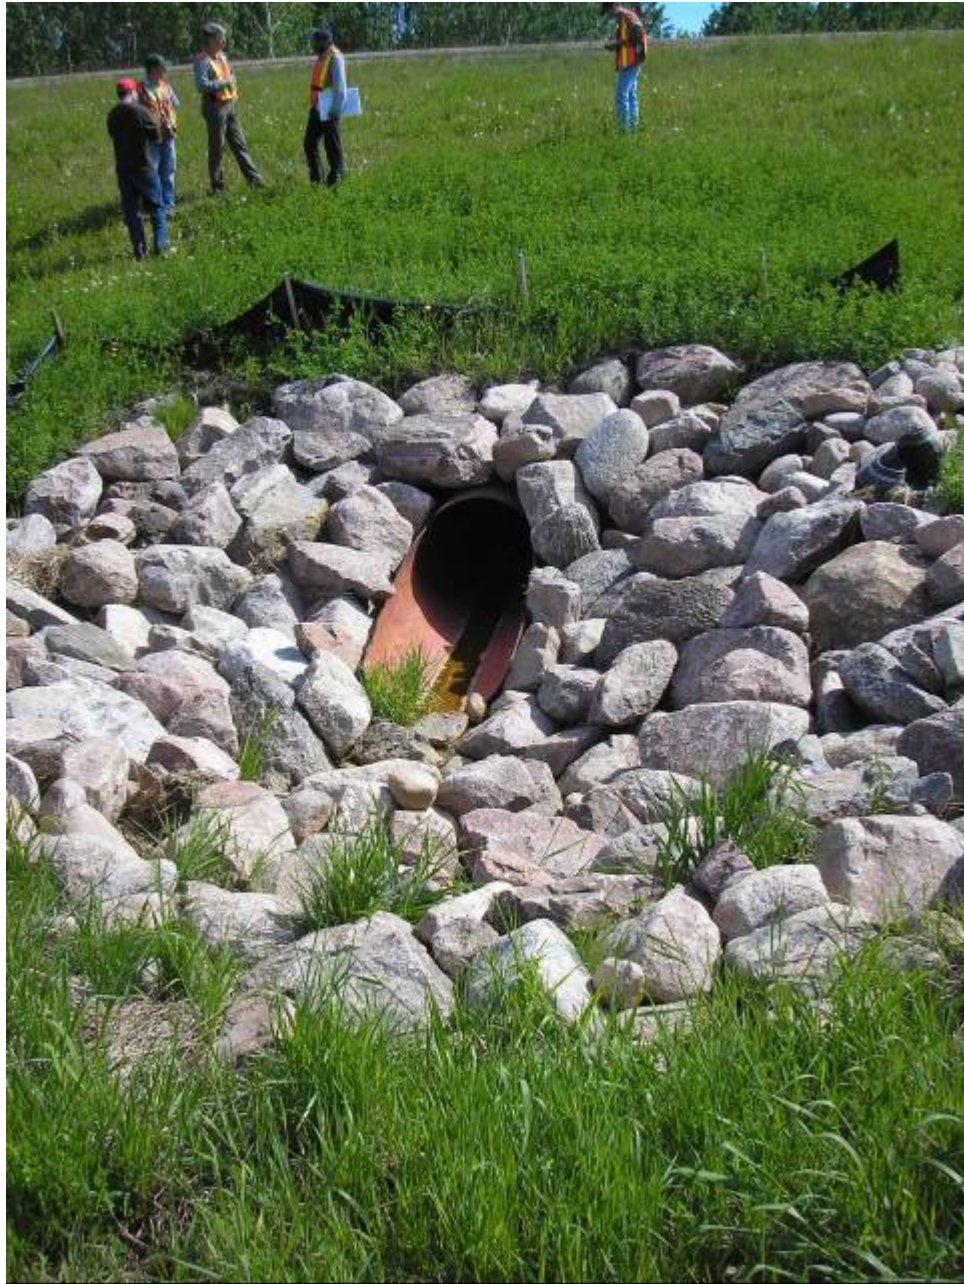
Photo 2 - Looking south at the culvert inlet, June 13, 2007.

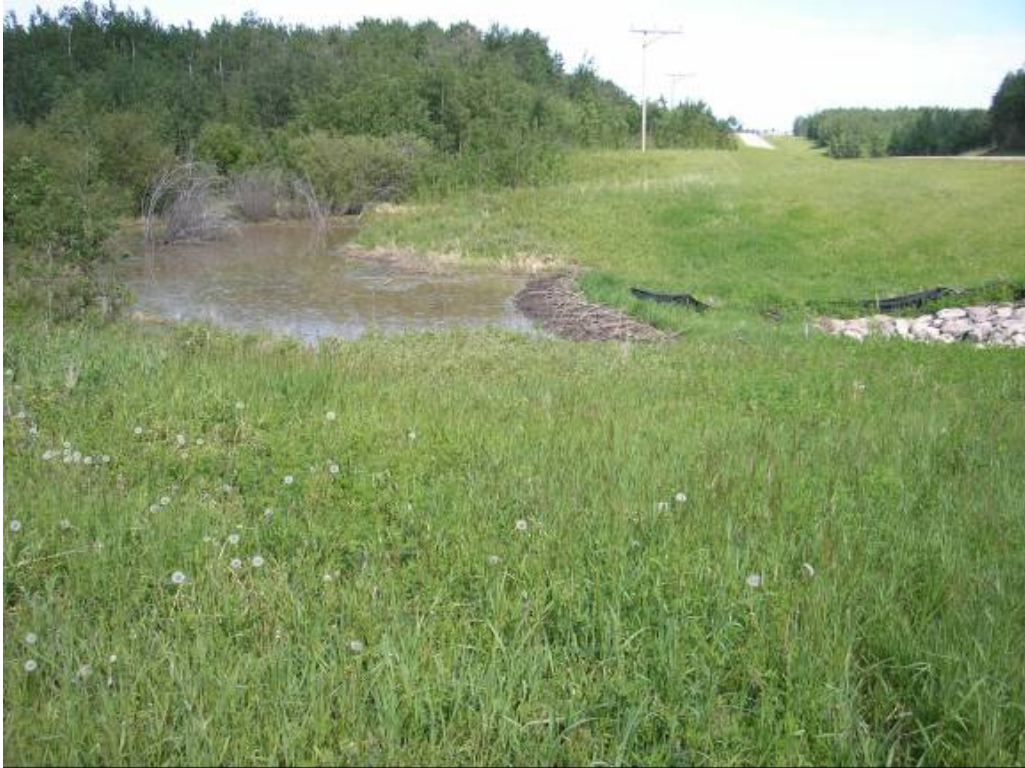
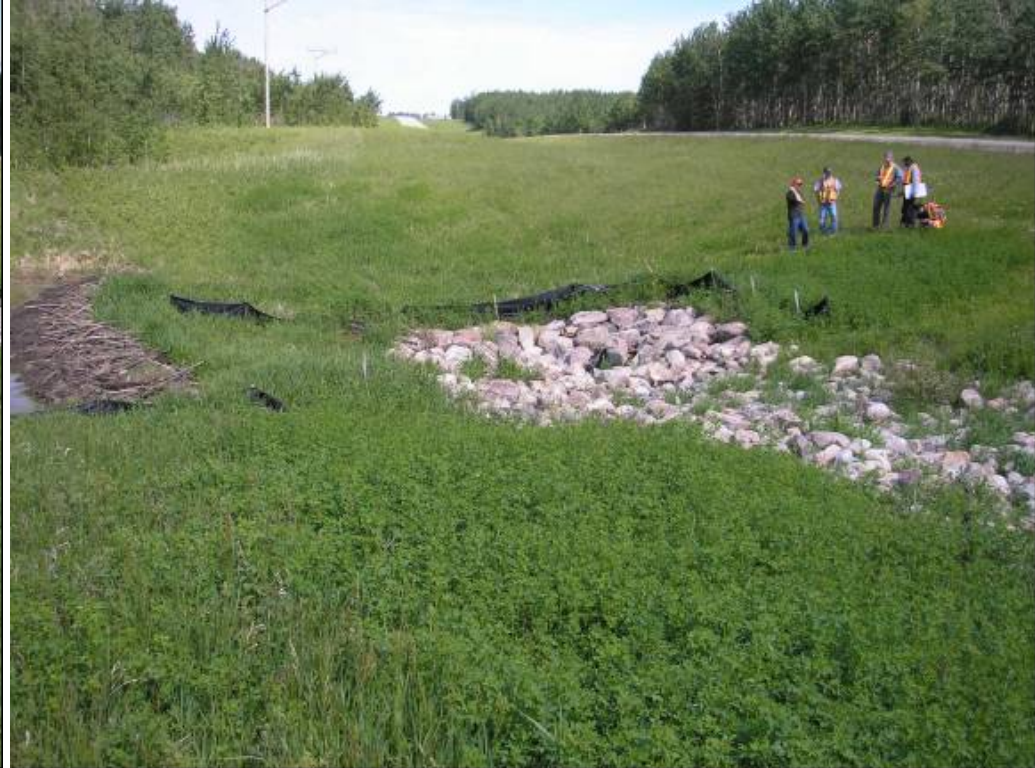
Photo 3 - Looking east towards culvert inlet, sub-drain outlet and swale riprap of Site #1A, June 13, 2007.
