**ALBERTA TRANSPORTATION  
GEOHAZARD ASSESSMENT PROGRAM  
PEACE REGION – SWAN HILLS  
2018 INSPECTION**

Site Number	Location	Name	Hwy	km
SH026	West of High Prairie	Gunns Creek North Embankment	2A:54	18.2 – 18.3
Legal Description		UTM Co-ordinates		
SW2-75-20-W5M		11U E 500,382	N	6,146,164

**SH026: HWY 2A:54 GUNN'S CREEK  
2018 SITE INSPECTION PLAN**

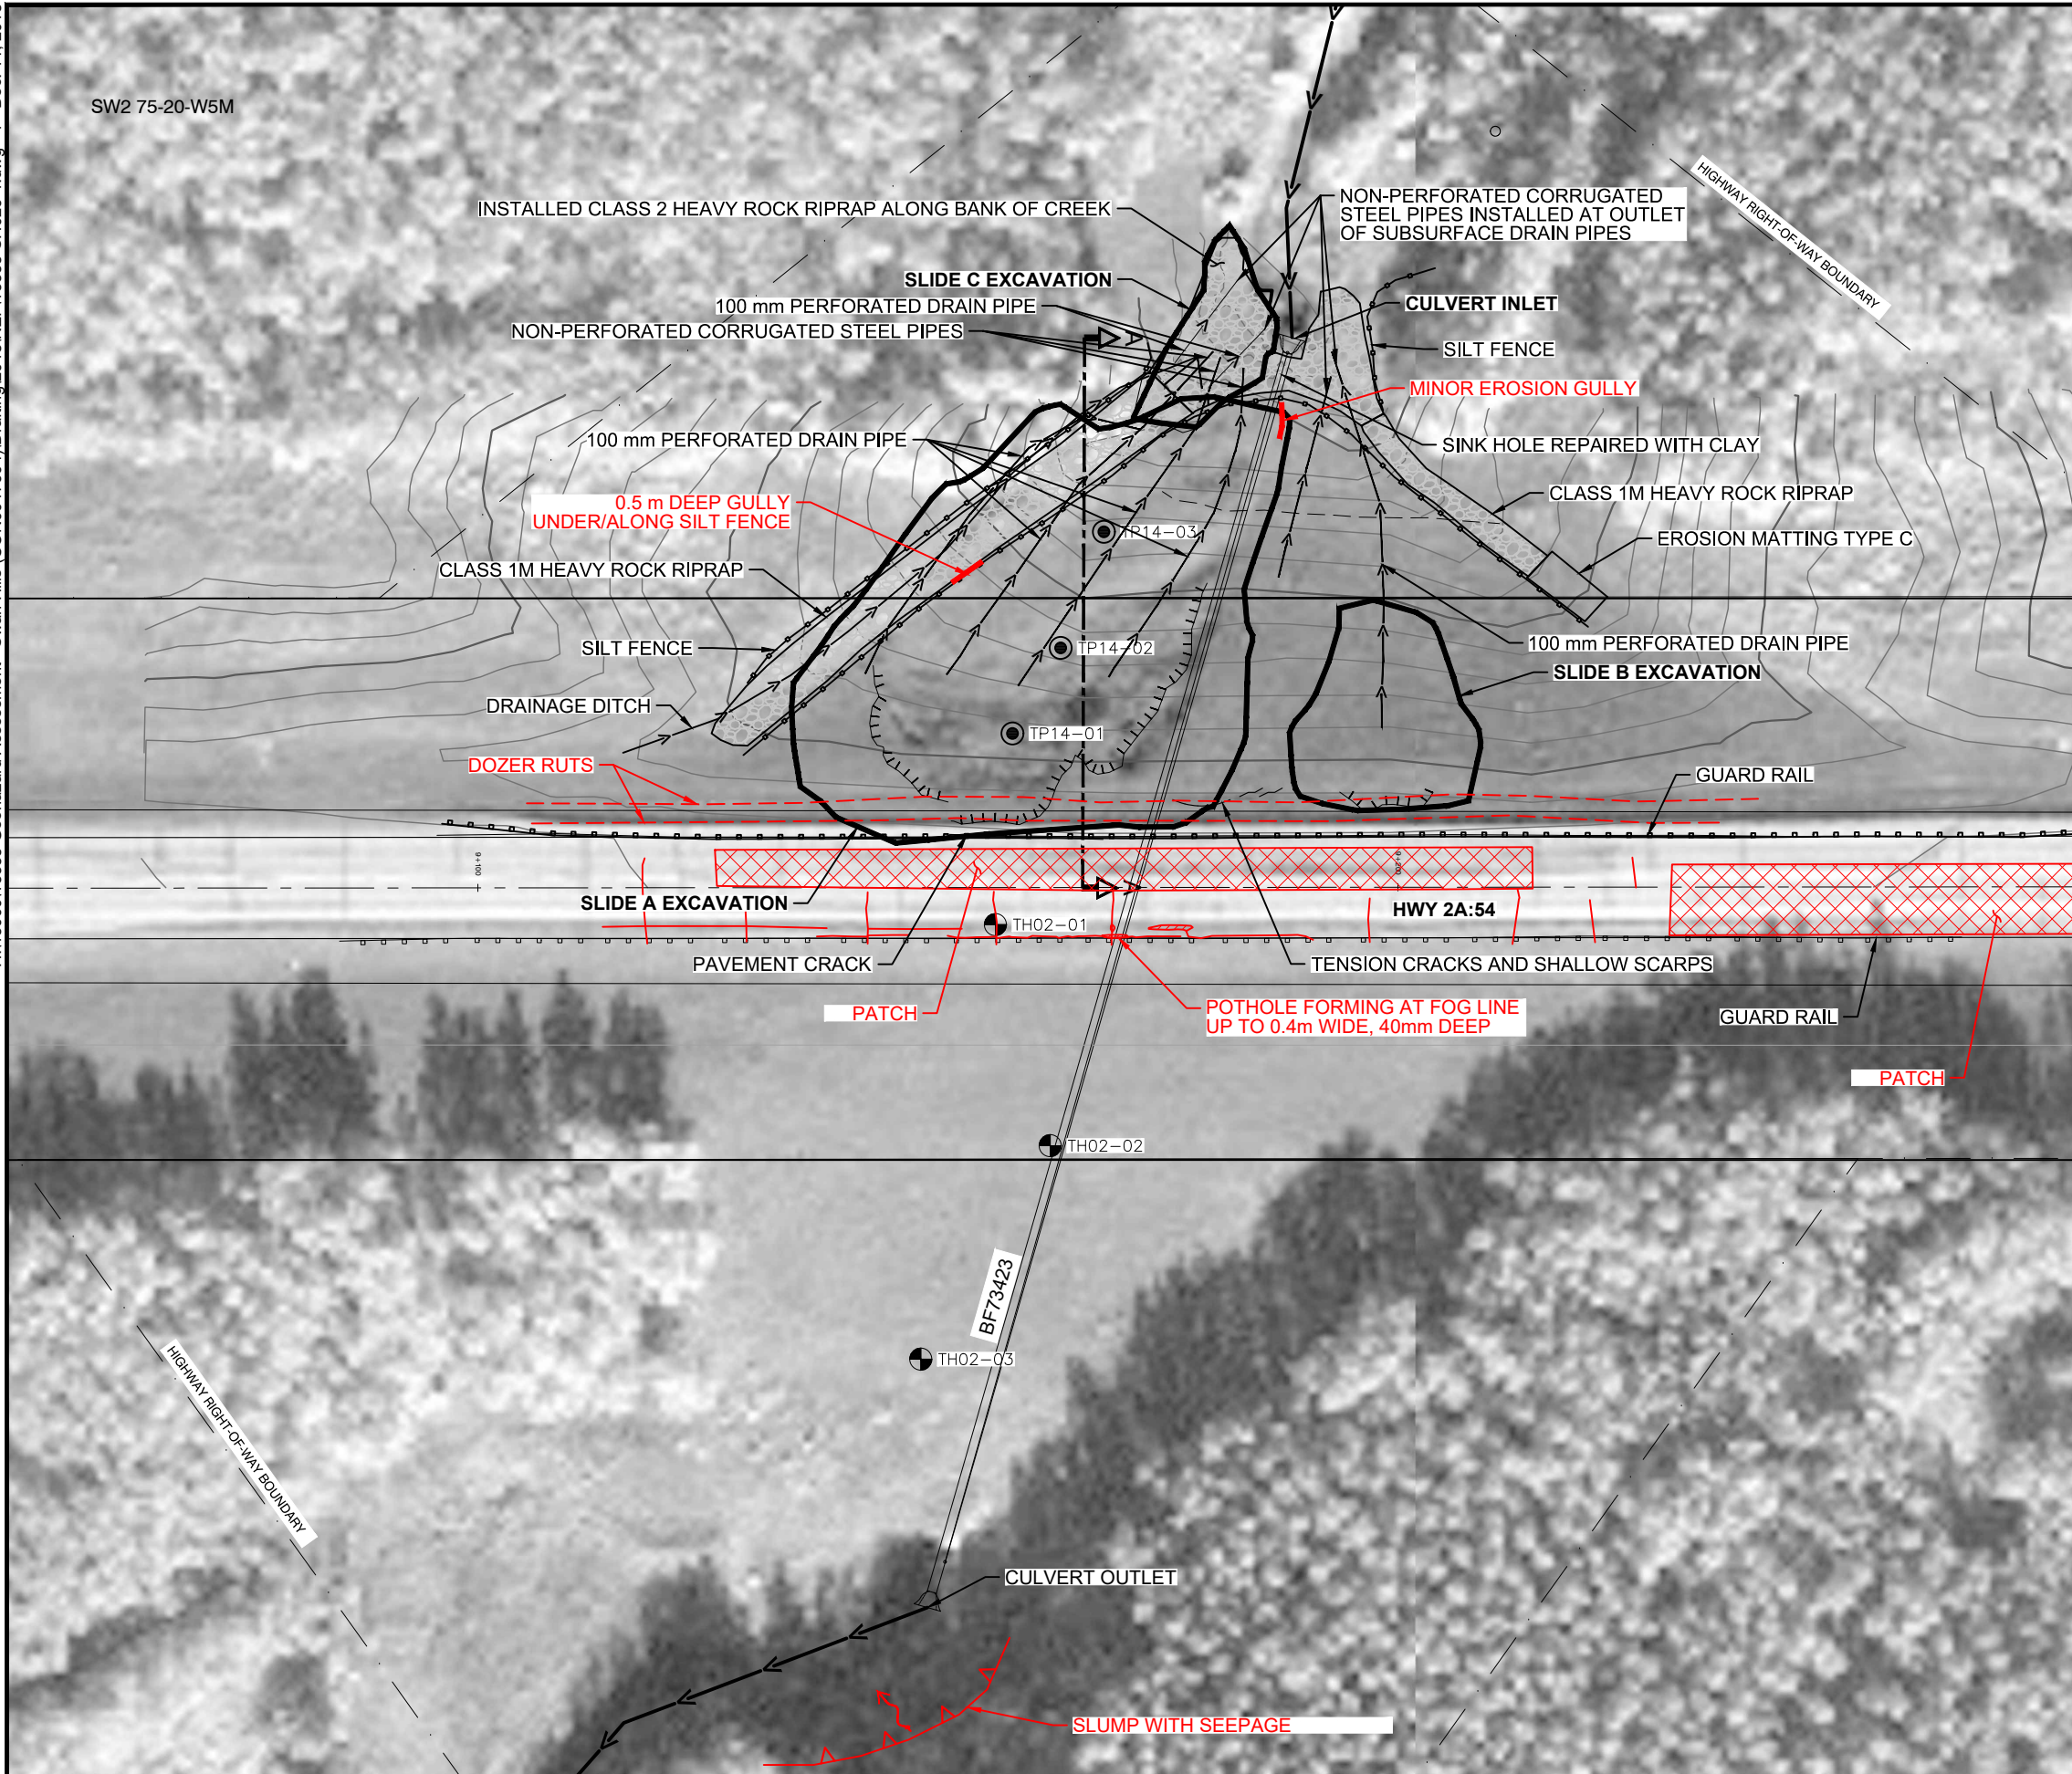
**DWG No. 13355-SH026-1-1**

- 1. JUNE 2018 OBSERVATIONS SHOWN IN RED.

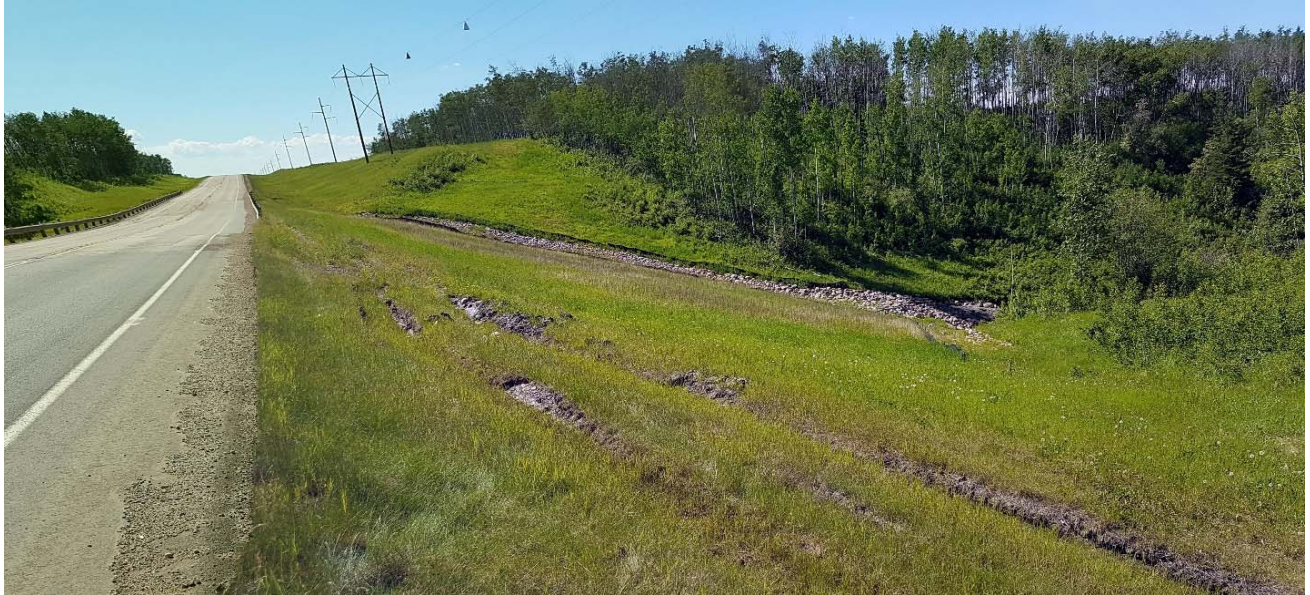
Photo 1 – Looking west at crest of repaired north embankment.

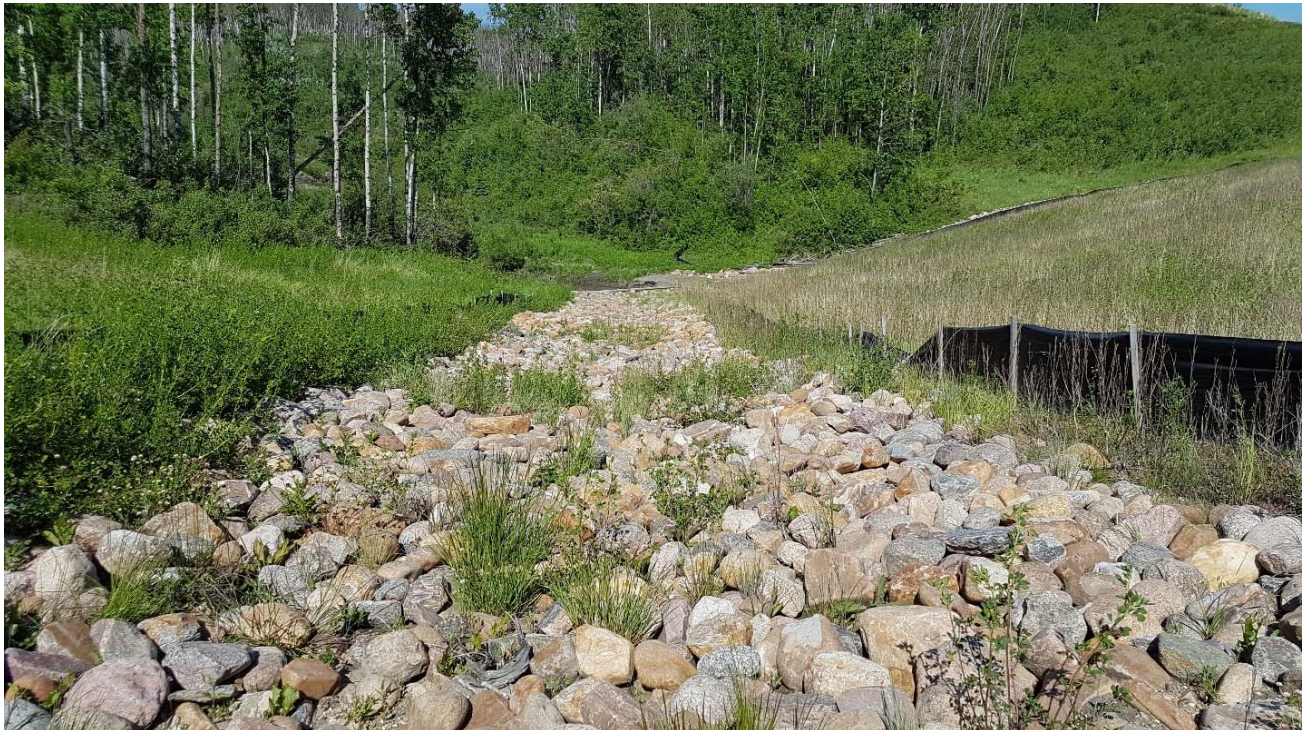
Photo 2 – Looking northeast at riprap-lined ditch channel.

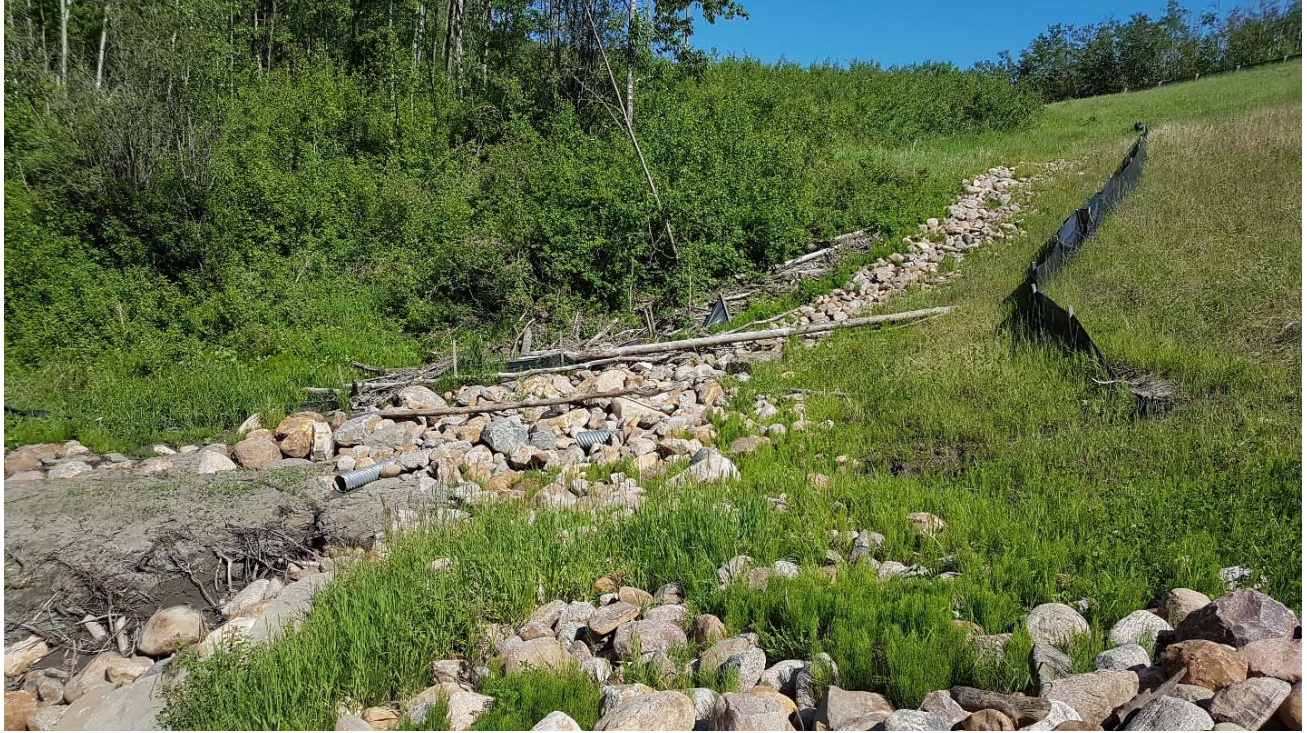
Photo 3 – Looking southeast at riprap-lined ditch channel with two subdrains visible at the toe.

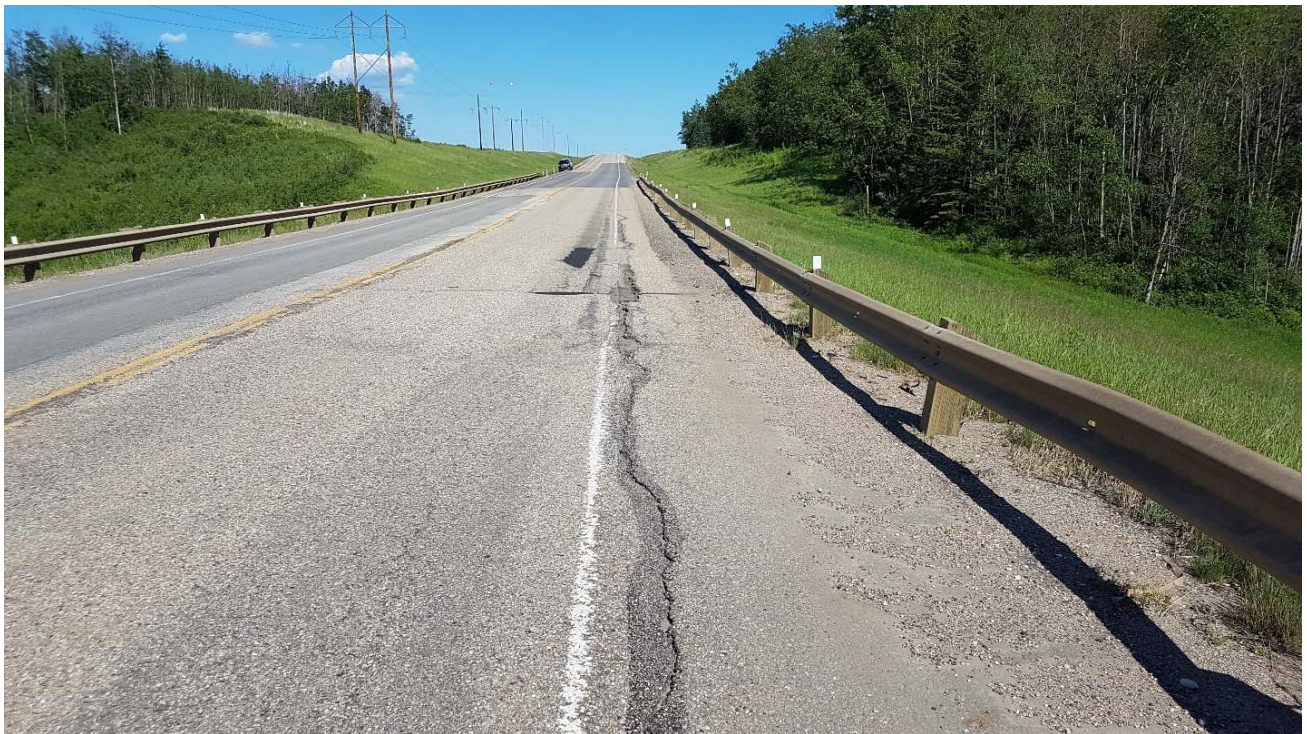
Photo 4 – Looking east at un-overlaid portion of the pavement at this site.

- Consideration should be given to completing the pavement overlay through the remainder of the site.

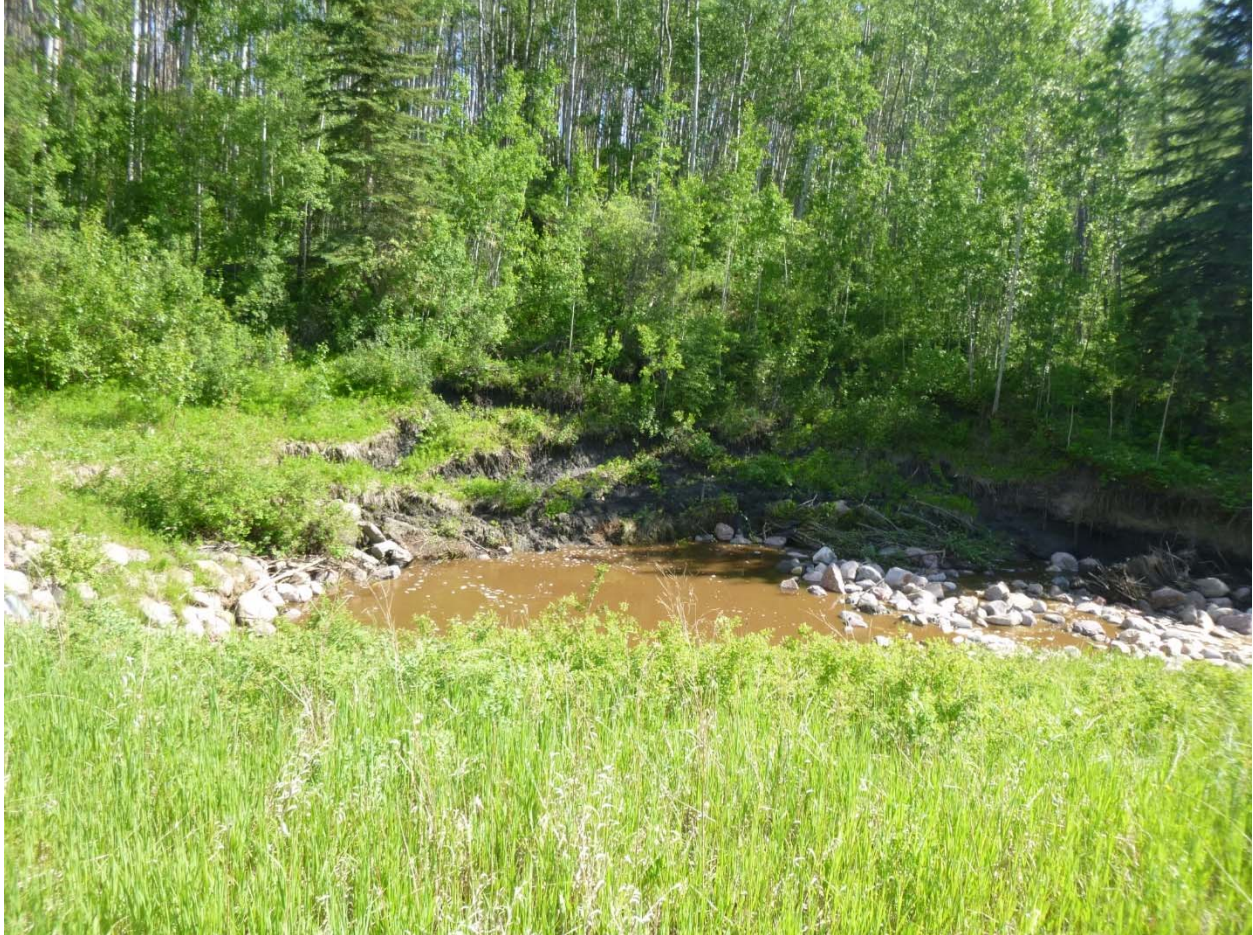
At the time of the 2018 inspection, the repairs appeared to be performing well. There was some minor items noted: a gully forming below a silt fence, minor cracking above Slide B (which could be settlement-related), and equipment ruts adjacent to the guardrail. It was noted that the asphalt pavement in the vicinity of the site is fairly worn with a few popouts/shallow potholes. A slump was observed south of the embankment where the culvert outlet flow may be impacting on the bank of Gunns Creek.

Photo 5 – Looking southeast at eroding bank immediately south of the culvert outlet.

- If future work is being undertaken in this area, consideration should be given to bank protection beyond the culvert outlet to minimize erosion and sedimentation downstream.
- If it is understood that this site is currently programmed for a culvert replacement. Given the recent investment in stabilization of the embankment, it is recommended that in-place repair methods be considered for the culvert such as a liner.
