**PEACE REGION – SWAN HILLS
GEOHAZARD RISK ASSESSMENT
SITE INSPECTION FORM**

SITE NUMBER SH 29	SITE NAME Driftpile Bank Erosion	HIGHWAY & KM HWY 2:50	PREVIOUS INSPECTION DATE July 4, 2012	INSPECTION DATE June 17, 2013
LEGAL DESCRIPTION LSD 16-20-73-12-W5M	NAD 83 COORDINATES N 6,133,779 E 575,973	PREVIOUS RISK ASSESSMENT		
		PF: 9	CF: 2	TOTAL: 18
		CURRENT RISK ASSESSMENT		
		PF: 9	CF: 2	TOTAL: 18

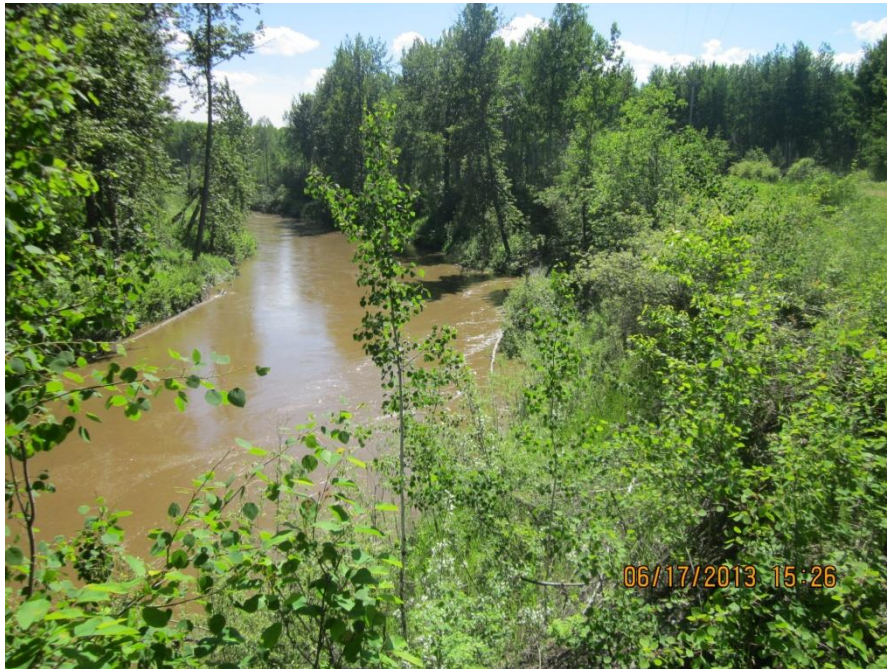
Photo 1: Location where Driftpile River bank is encroaching on local road looking south west

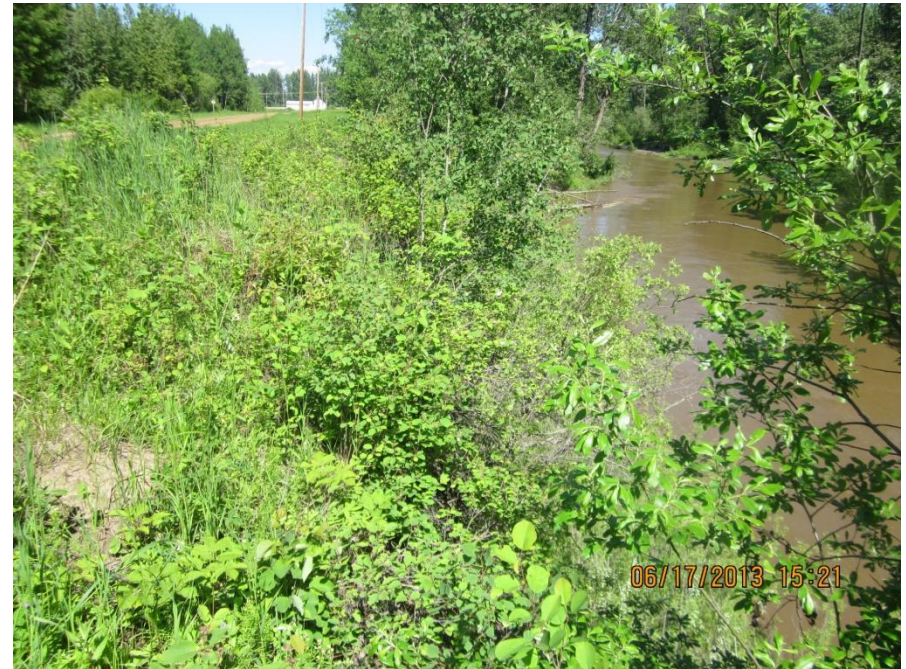
Photo 2: Looking north east from top of scarp
