**PEACE REGION – SWAN HILLS
GEOHAZARD RISK ASSESSMENT
SITE INSPECTION FORM**

SITE NUMBER SH 29	SITE NAME Driftpile River Bank Erosion	HIGHWAY & KM HWY 2:50	PREVIOUS INSPECTION DATE June 17, 2013	INSPECTION DATE July 2, 2014
LEGAL DESCRIPTION LSD 16-20-73-12-W5M	NAD 83 COORDINATES N 6,133,779 E 575,973	PREVIOUS RISK ASSESSMENT		
		PF: 9	CF: 2	TOTAL: 18
		CURRENT RISK ASSESSMENT		
		PF: 9	CF: 2	TOTAL: 18

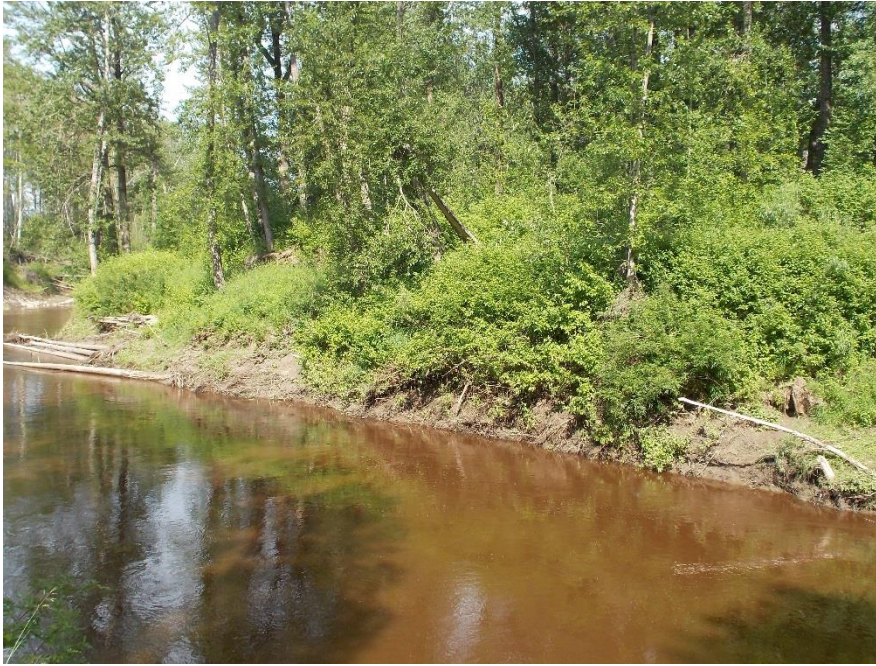
Photo 1 (left): Looking west at the inside (east) bank of the river directly across from the site location. River level at the time of inspection was lower than the 2013 inspection, exposing river banks.

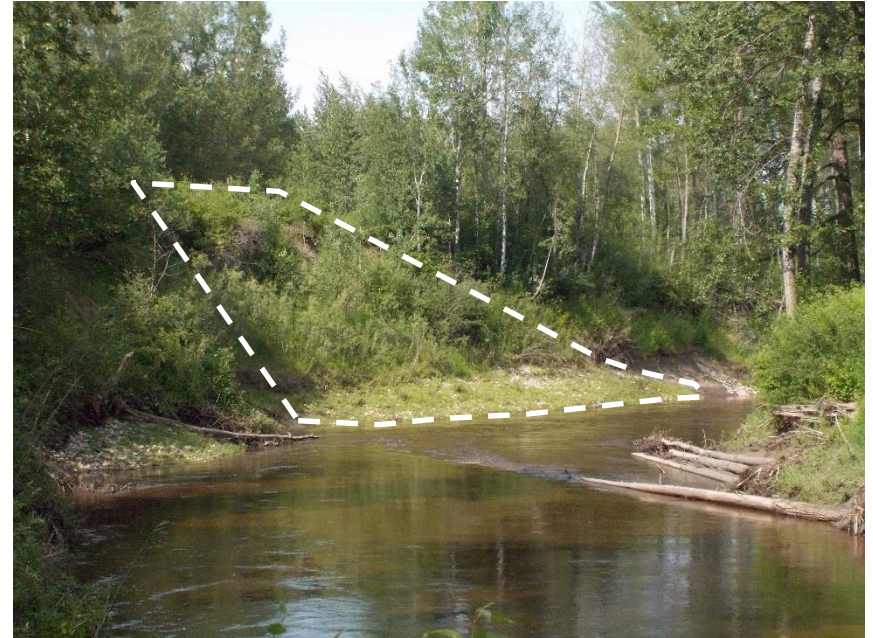
Photo 2 (right): Looking northeast from the top of the scarp. Slumping has occurred and debris was observed in the river.
