September 8, 2009

File: 15-16-229

**PEACE REGION (PEACE RIVER/HIGH LEVEL) GEOHAZARD ASSESSMENT
HWY 2:60 EMBANKMENT SLIDE AREA (PH 13), NAMPA
2009 ANNUAL INSPECTION REPORT**

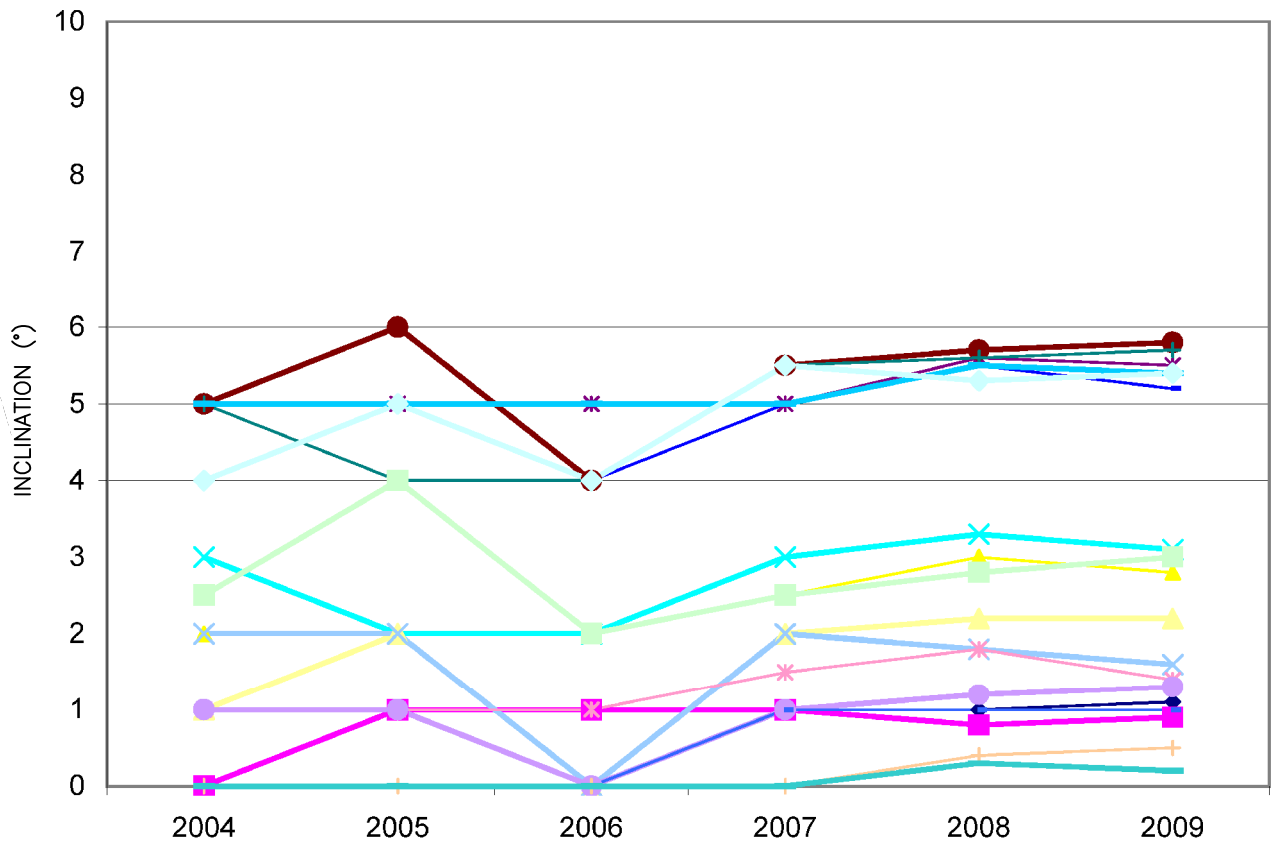
PH13-2

The slide area below the lagging wall appeared to be in a similar condition as noted in previous inspections (Photo 13-04). The retaining wall itself also appeared to be in a similar condition to that reported in previous assessments as shown in Photos 13-05 and 13-06 and 8 from 2009 and 2008, respectively. As in previous years, measurements were taken on the inclination of the piles using a hand held clinometer. The results are shown in Figure 13-2 and show no discernible increase in pile inclination since measurements began in 2004.

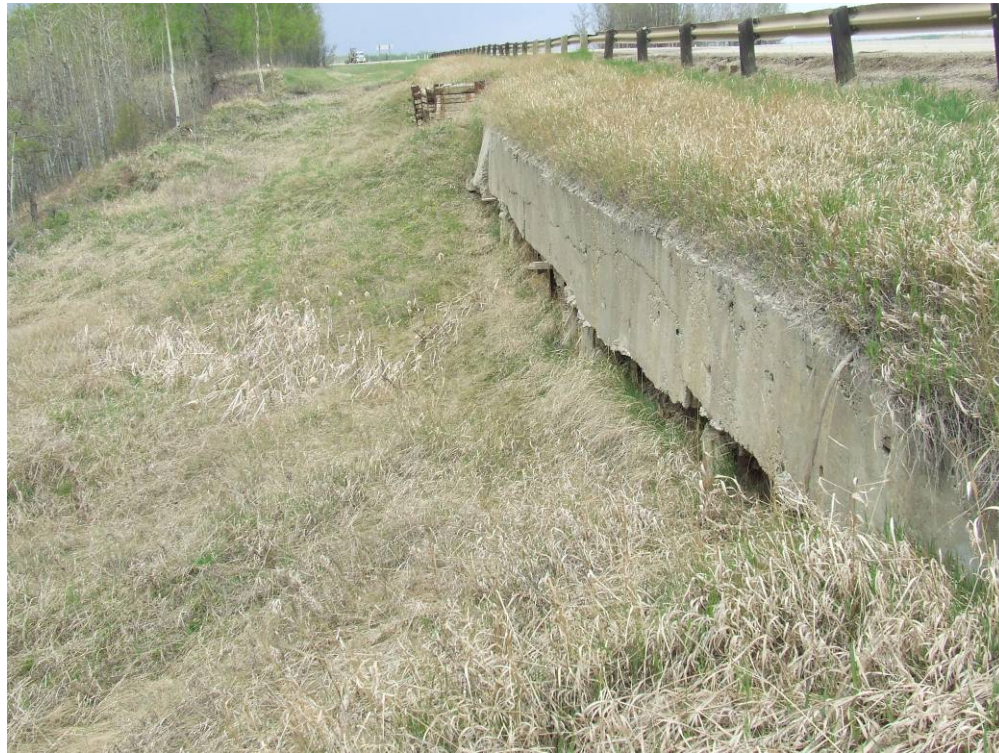
Photo 13-01

The condition of the concrete retaining wall and piles appeared similar to that reported in previous assessments as can be seen in Photos 13-01 and 13-02 from 2009 and 2008, respectively. The graben area forming as the slide mass creeps downslope below the wall appeared to be similar to that observed in 2008 (Photo 13-03).

Looking north at concrete retaining wall in South Slide area.

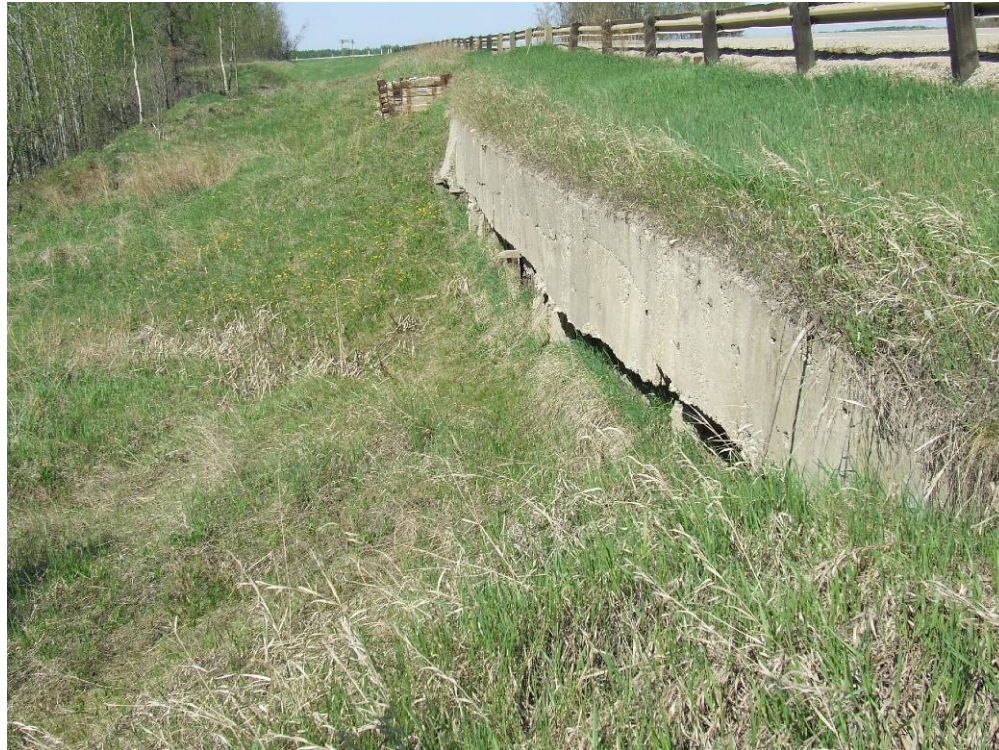
Photo 13-02

Similar view as Photo 13-01 above taken in 2008.

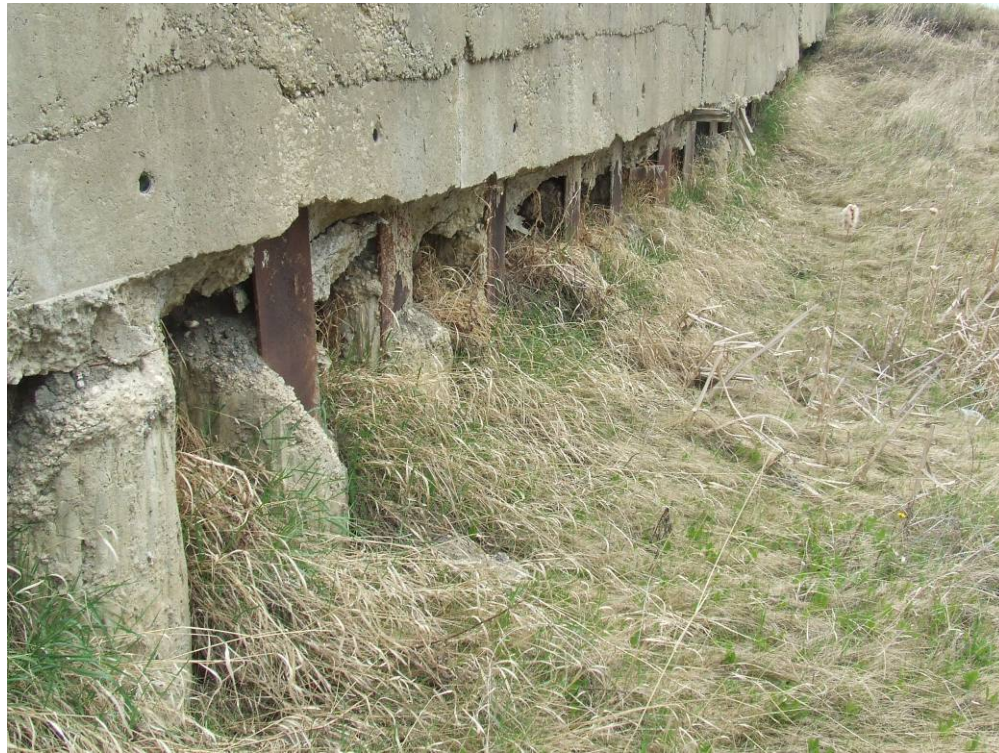
Photo 13-03

Some ongoing downslope movement is likely occurring below the concrete retaining wall at the South Slide, evidenced by the formation of a graben between the piles and the slide mass. This movement is not believed to have affected the functionality of the retaining wall at this time, although the slope should be regularly monitored.

Close-up looking south at concrete retaining wall in South Slide area. Note development of a graben (sunken area) immediately downslope of piles.

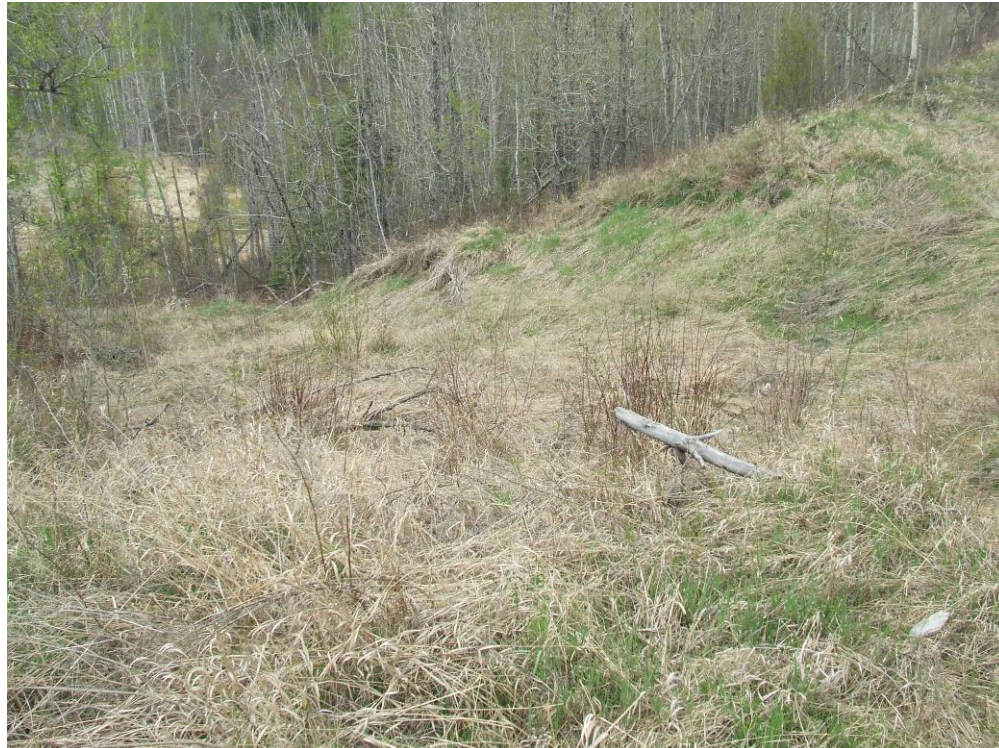
Photo 13-04

Looking downslope at Central Slide area below lagging retaining wall.

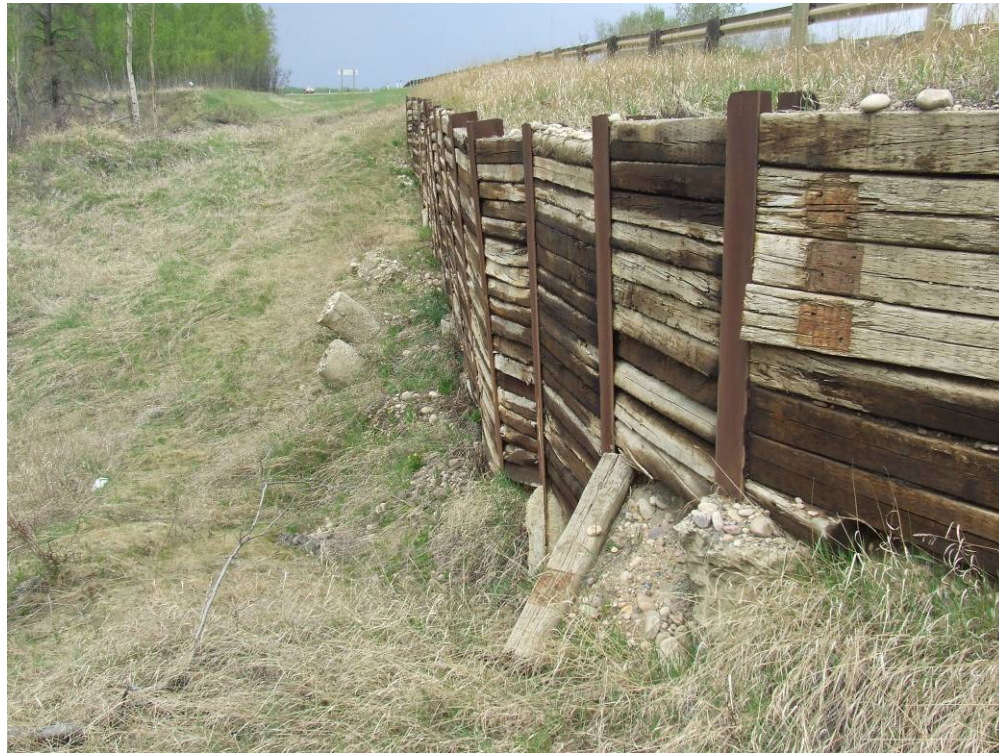
Photo 13-05

As noted in previous assessments, some of the lagging has become dislodged in the southern portion of the wall (Photo 13-05).

Looking north along lagging retaining wall in Central Slide area.

- Cracks in the pavement should be sealed.
- A wedge of clean (<5% fines) granular material should be placed at the base of the southern 5 panels of the timber lagging wall (Central Slide). The intent of this is to reduce loss of ground due to the dislodged lagging. The granular material can be dumped from the top of the wall and should extend 0.3 m above the dislodged lagging. The estimated size of the wedge is 10 m long by 1.2 m high, with a 2H:1V slope out from the retaining wall.

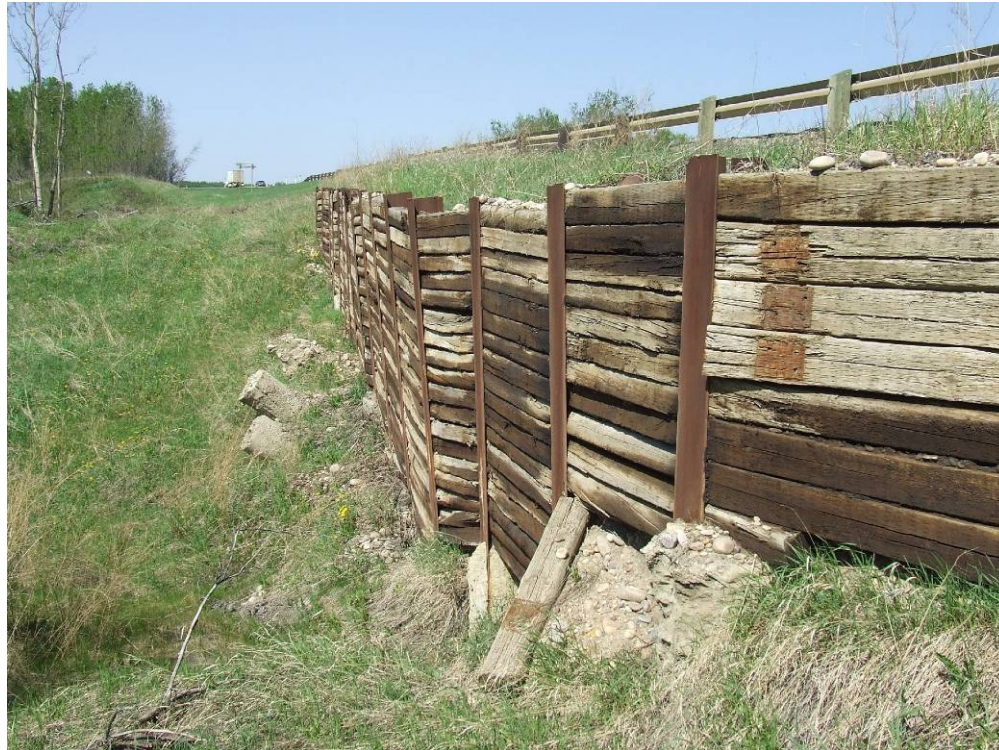
Photo 13-06

Similar view to Photo 13-05 from 2008. No discernible changes to conditions of retaining wall or immediate downslope.

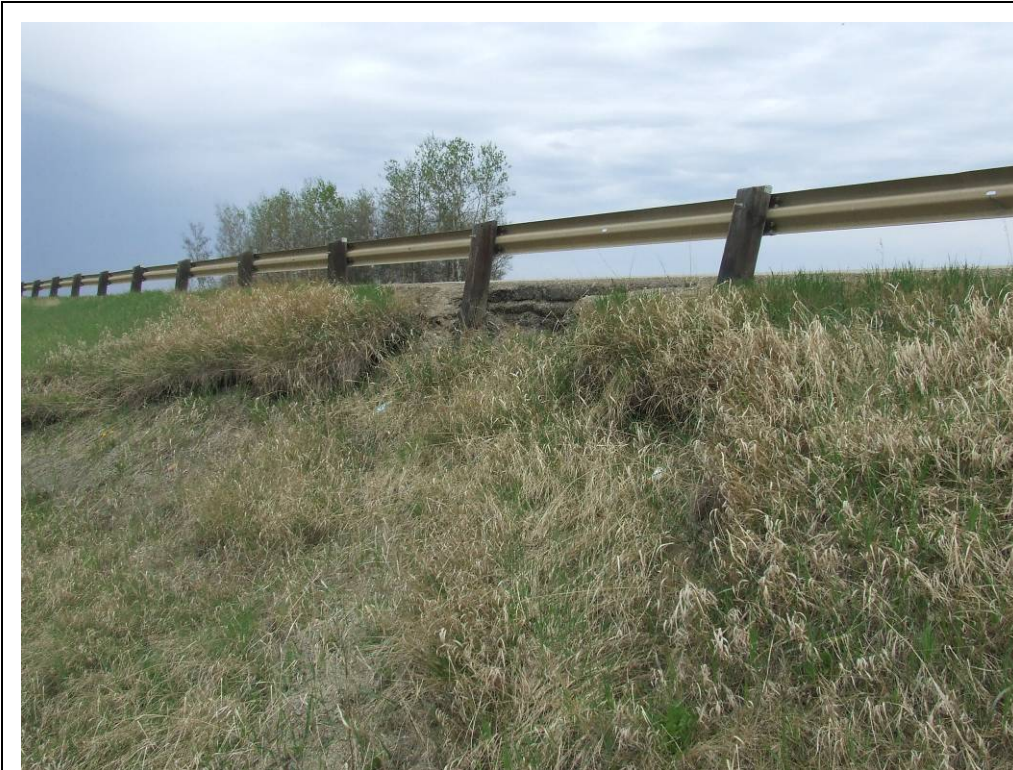
Photo 13-07

The north slide area is the most active of the three areas within PH13 and is the only one of the three that has not been remediated to date. Photos 13-07 and 13-08 show the headscarp area of the slide encroaching into the edge of the roadway and guardrails. The slide is considered to be shallow, with an estimated maximum depth of 2 m.

No remedial measures have been conducted for the North Slide, and the headscarp is presently located at the guardrail. As discussed earlier, the slide appears to be shallow and is likely being exacerbated by a possible leak in the water line located north of the site.

At this time, the slide is not affecting the road surface, but if mitigation measures are not undertaken soon, it is likely that the slide will begin to affect the paved surface.

View of headscarp of North Slide at edge of guardrail.

In the short term, the site should be regularly inspected by the MCI to assess if the highway becomes affected, and implement any traffic safety requirements.

Potential long term stabilization measures at this site include construction of a third pile wall at the north site, replacement of the slide mass with a free-draining granular material (gravel) and slope flattening. These options could be combined depending on costs and final configurations. A variation on the slope flattening option would include a toe berm. Based on similar previous projects it is expected that the costs of remedial measures to fix the north slide will be in the order of \$280,000.

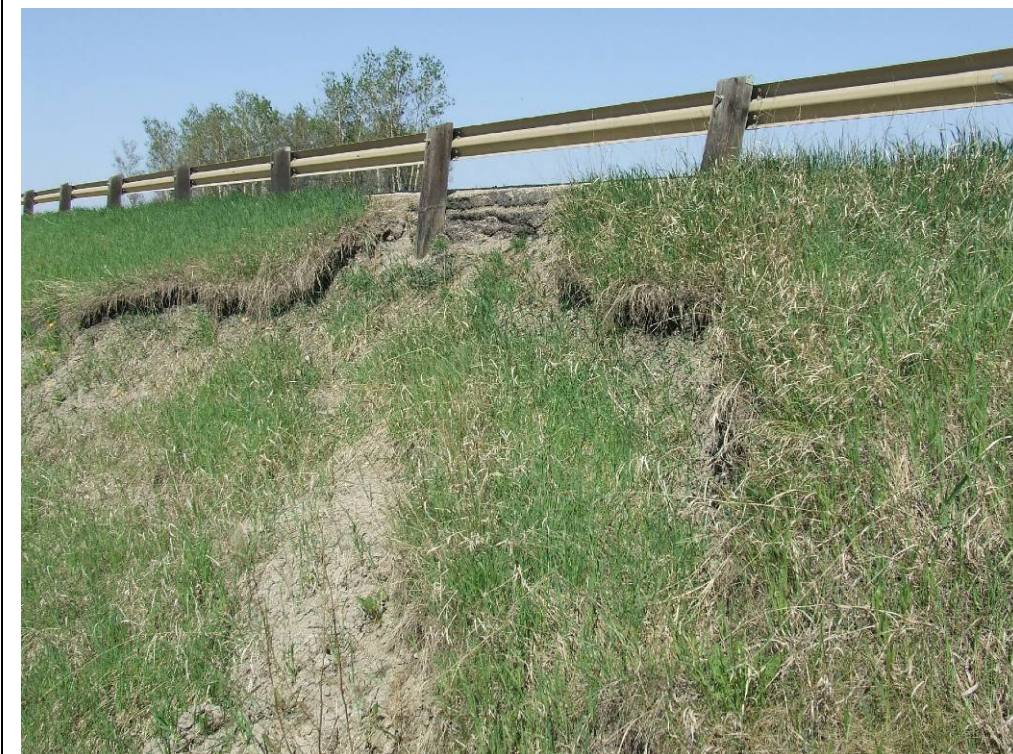
Photo 13-08

Similar view as Photo 13-07 taken in 2008. No discernible change since 2008.

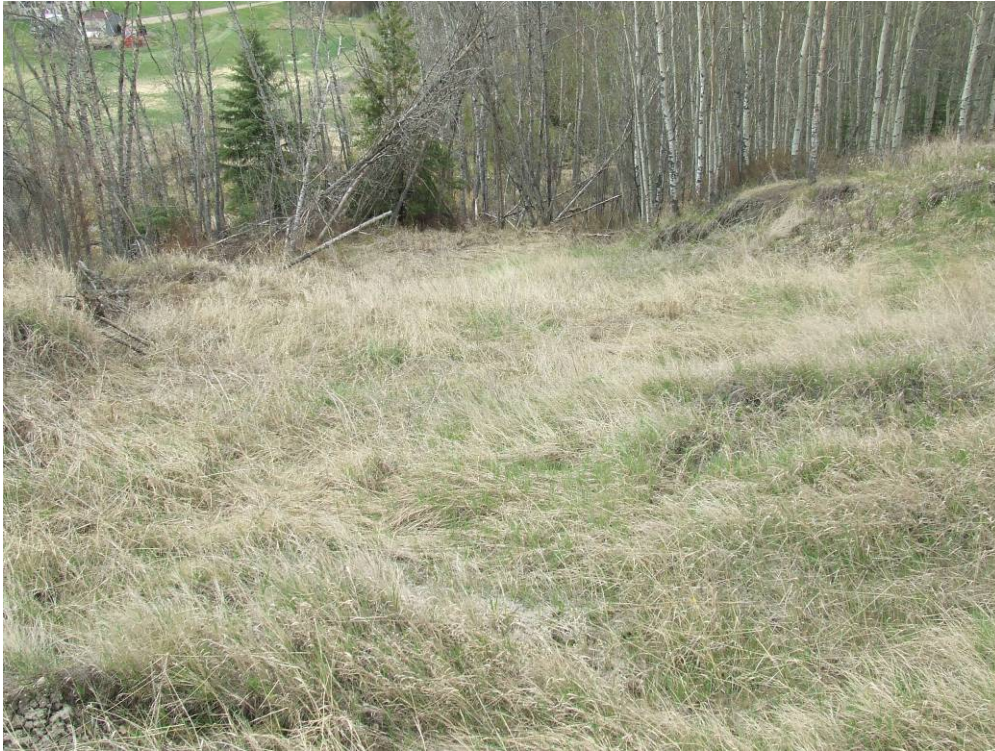
Photo 13-09

View looking downslope At North Slide area below roadway.

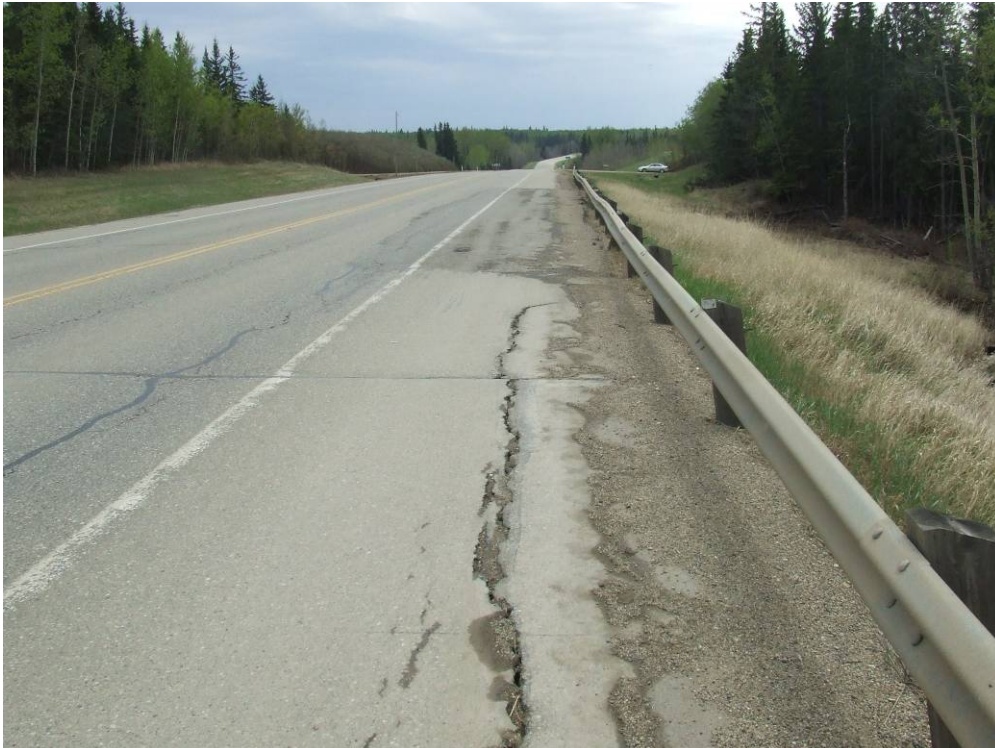
Photo 13-10

The roadway adjacent to this area was patched in 2006 to address the local settlement around the piles/cracking that previously existed and has not changed since 2008 (Photo 13-10).

Cracking in the roadway upslope of this slide appears to have increased since 2008 and are now slightly open (Photo 13-10).

View looking south at cracking parallel to the roadway in the vicinity of the North Slide. Cracks are open and slightly wider than in 2008. Patched asphalt adjacent to lagging wall in Central Slide area shown in the distance.
