November 2, 2010

File: 15-16-229

**PEACE REGION (PEACE RIVER/HIGH LEVEL) GEOHAZARD ASSESSMENT  
HWY 2:60 EMBANKMENT SLIDE AREA (PH 13), NAMPA  
2010 ANNUAL INSPECTION REPORT**

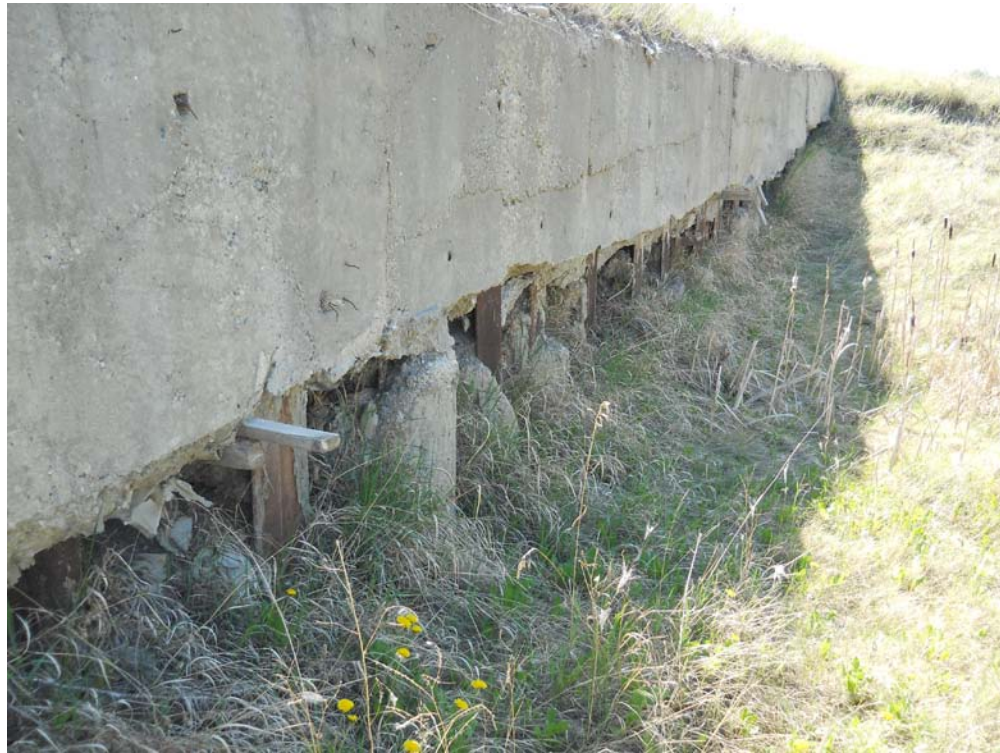
**Photo 13-01**

The condition of the concrete retaining wall and piles appeared similar to that reported in previous assessments as shown in Photo 13-01. The graben area forming as the slide mass moves downslope below the wall appeared to be similar to that observed in previous years. However, there did appear to be a widening of cracking in the soil south of the concrete wall as shown in Photo 13-02 which was more evident this inspection.

Some ongoing downslope movement is likely occurring below the concrete retaining wall at the South Slide, evidenced by the formation of a graben between the piles and the slide mass. This movement is not believed to have affected the functionality of the retaining wall at this time, although the slope should be regularly monitored. The development of a crack on the south side of the wall suggests the slide may have recently become more active.

Looking south at concrete retaining wall in South Slide area. Note graben developing in front of wall and poor condition of concrete showing exposed H-piles.

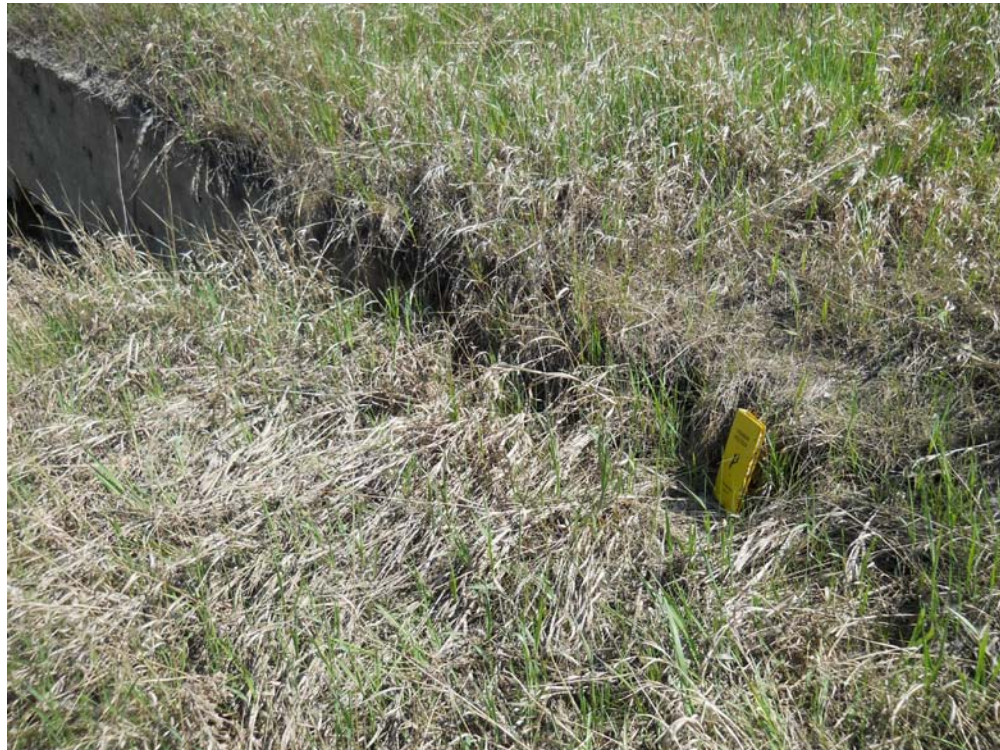
**Photo 13-02**

Crack developing on south side of concrete wall at South Slide.

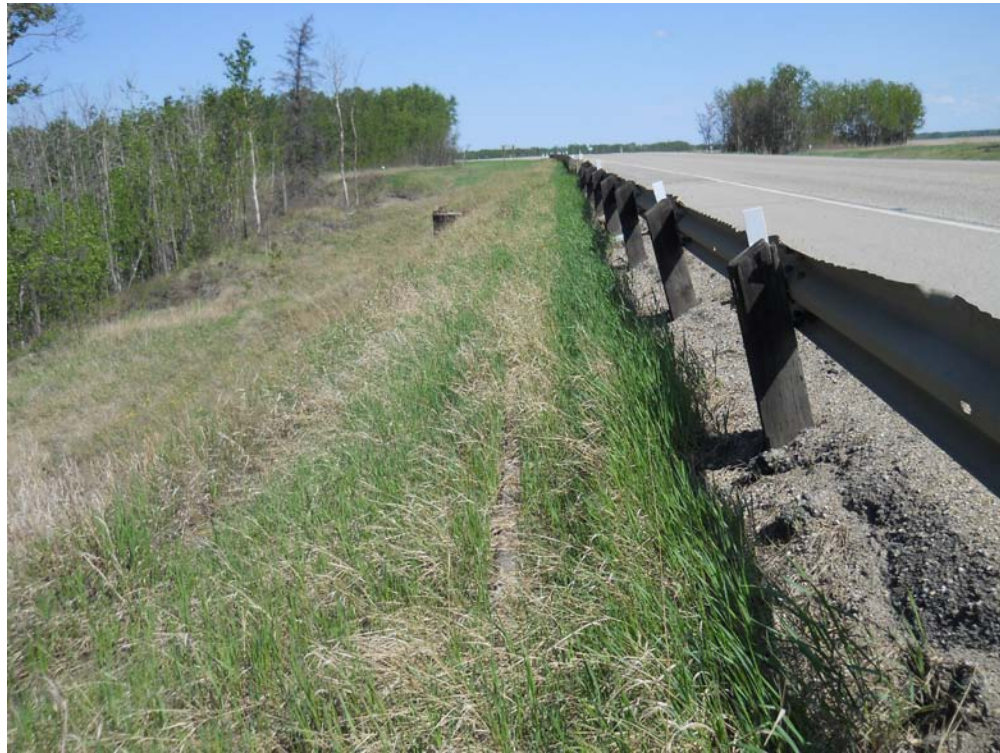
**Photo 13-03**

The row of pipe piles along the edge of the road contained water at a depth of 0.1 m to 0.2 m, similar to the previous assessments. The guardrail was observed to be deflected outwardly at the top in this area, but this could have been due to vehicle impact.

Minor subsidence/creep of the slope below the guardrail in this area was also observed to be more pronounced this year compared to previous inspections (Photo 13-03).

Guardrail leaning outward in vicinity of South Slide, possibly from vehicle impact. Note ground subsidence/creep behind asphalt layer.

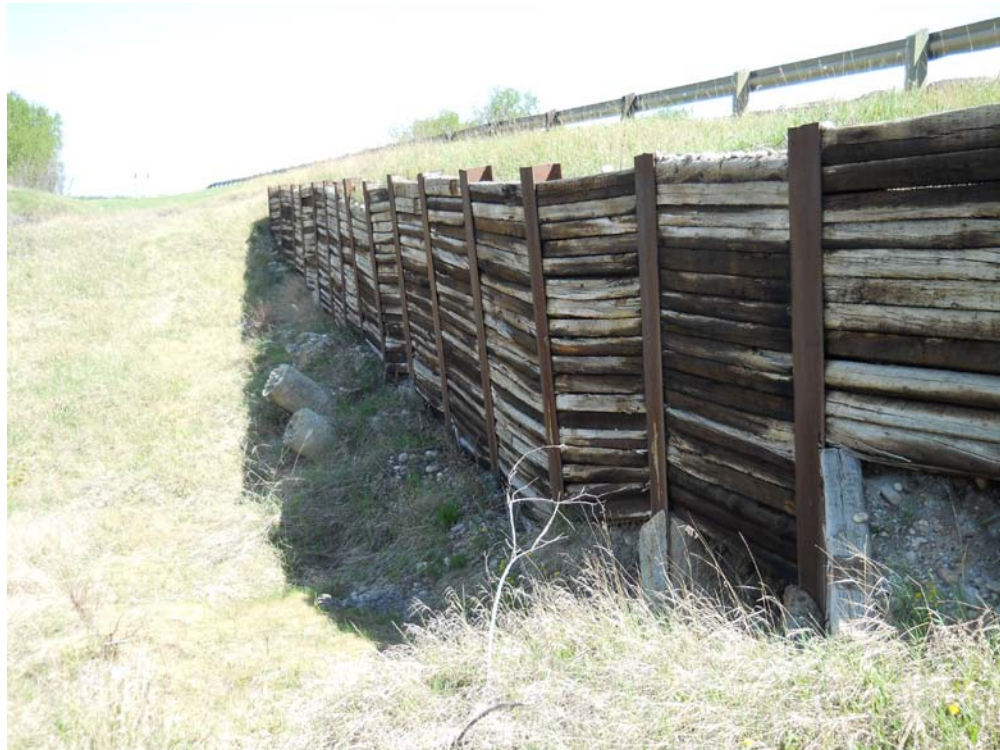
**Photo 13-04**

The slide area below the lagging wall appeared to be in a similar condition as noted in previous inspections (Photo 13-04). The retaining wall itself also appeared to be in a similar condition to that reported in previous assessments. As in previous years, measurements were taken on the inclination of the piles using a hand held clinometer. The results are shown in Figure 13-2 and show no discernible increase in pile inclination since measurements began in 2004.

Looking north at wooden lagging wall in Central Slide area in similar condition to previous years.

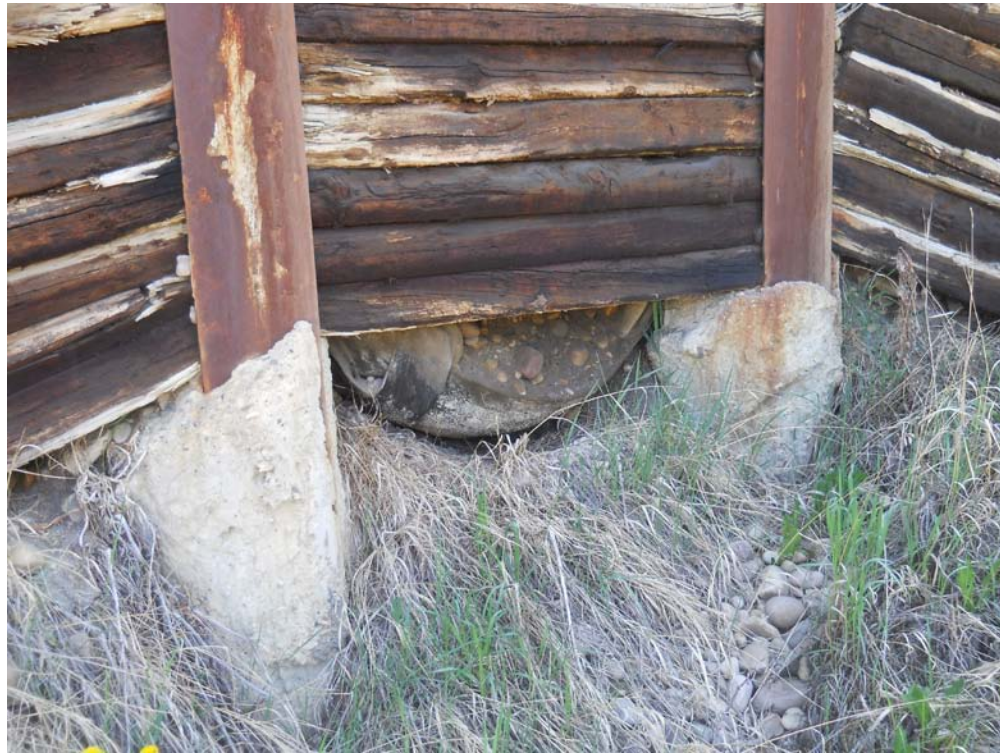
**Photo 13-05**

As noted in previous assessments, some of the lagging has become dislodged in the southern portion of the wall. Geotextile supporting the backfill behind the wall is also exposed locally (Photo 13-05) as the ground continues to subside within the graben feature below the wall.

Close-up of subsidence in front of lagging wall and exposed geotextile similar to that observed in previous years.

In previous years it was suggested a wedge of clean (<5% fines) granular material be placed at the base of the southern 5 panels of the timber lagging wall (Central Slide) to reduce loss of ground due to the dislodged lagging. However, based on the performance of the North and South Slides, we believe this form of remediation/maintenance could potentially load the slope and result in further movement. Hence no immediate action in this area is recommended unless additional material loss occurs through the retaining wall.

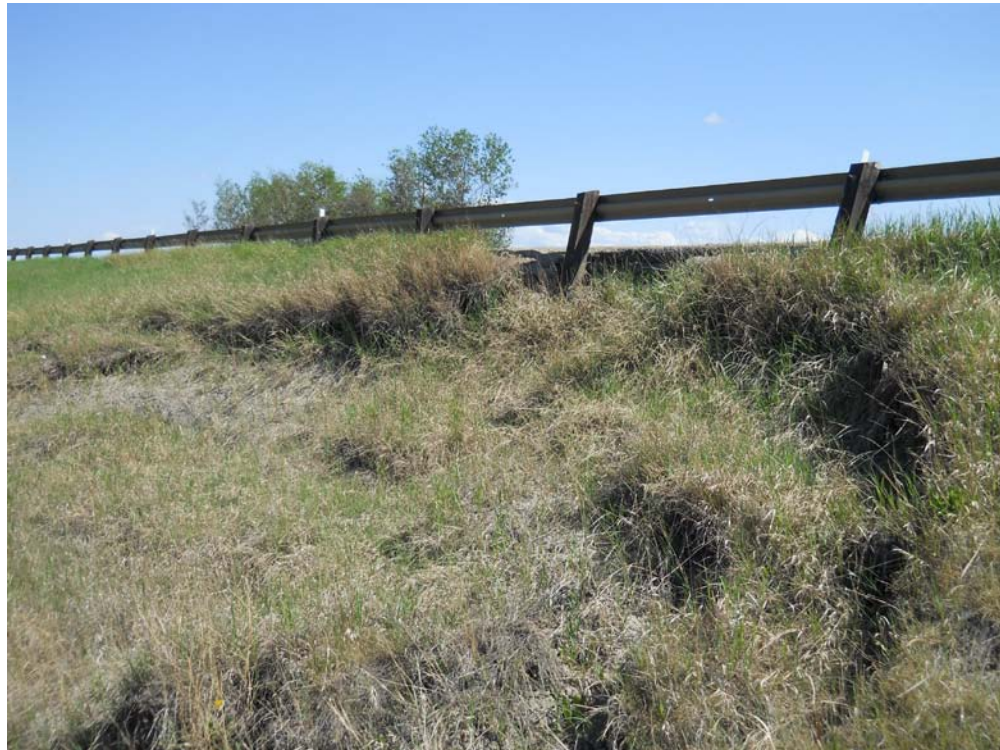
**Photo 13-06**

The north slide area is the most active of the three areas within PH13 and is the only one of the three that has not been remediated to date. Photos 13-06 and 13-07 show the headscarp area of the slide encroaching into the edge of the roadway and guardrails. The slide is considered to be shallow, with an estimated maximum depth of 2 m.

No remedial measures have been implemented at the North Slide, and the headscarp is presently located at the guardrail. As discussed earlier, the slide appears to be shallow and may be exacerbated by a possible leak in the water line located north of the site.

Looking upslope at shallow slide in upper portion of North Slide area. Condition is similar to previous years although guardrail has moved out slightly at bottom from 2009.

Potential long term stabilization measures at this site include construction of a third pile wall at the north site, replacement of the slide mass with a free-draining granular material (gravel) and slope flattening. These options could be combined depending on costs and final configurations. A variation on the slope flattening option would include a toe berm. Based on similar previous projects it is expected that the costs of remedial measures to fix the north slide will be in the order of \$280,000.

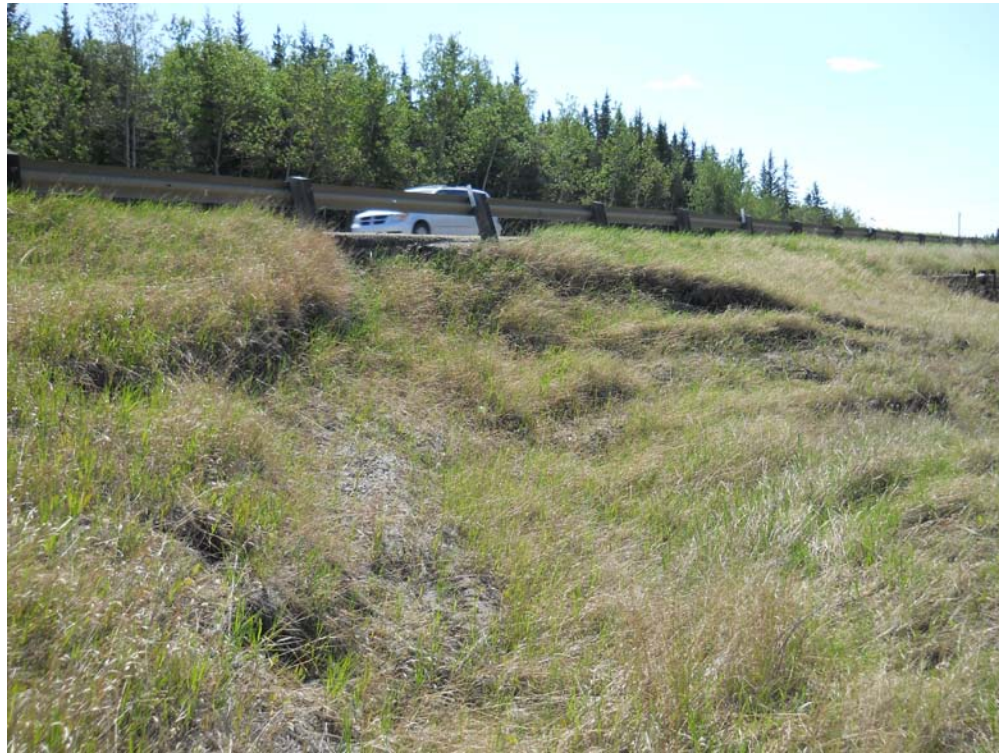
**Photo 13-07**

Looking southeast at upper portion of North Slide .

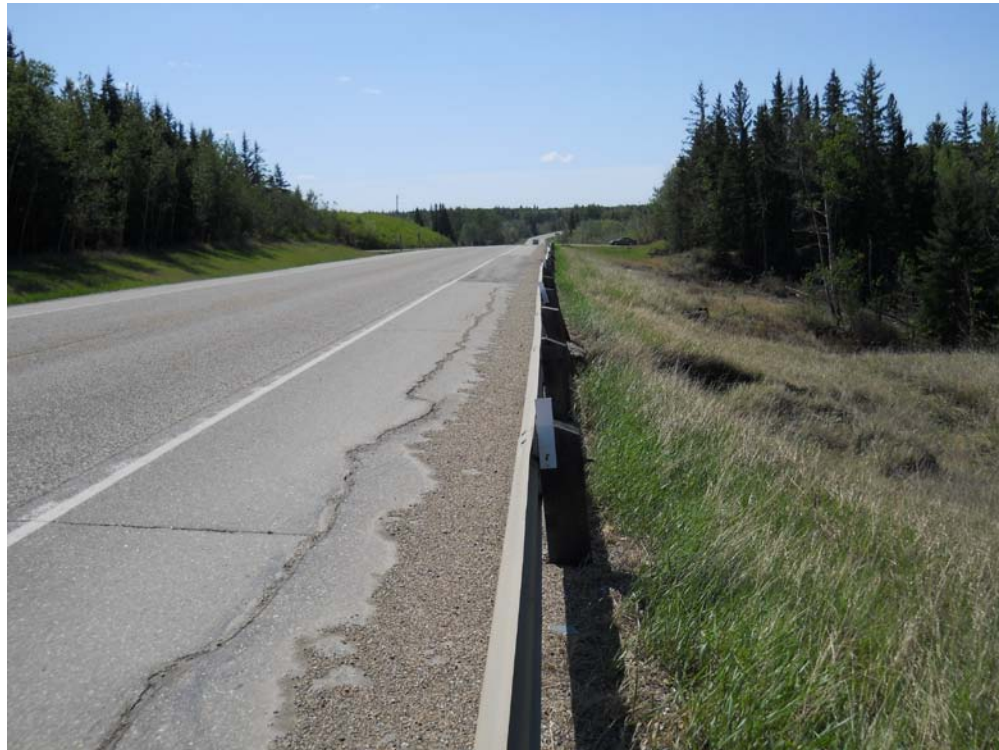
**Photo 13-08**

Cracking in the roadway upslope of this slide is slightly open but has not changed significantly from 2009 (Photo 13-08).

Looking south at cracking parallel to the roadway in the vicinity of the North Slide. Cracks are open and slightly wider than in 2008/9. Patched asphalt adjacent to lagging wall in Central Slide area shown in the distance.

Cracks in the pavement through the slide area(s) should be sealed.
