**ALBERTA TRANSPORTATION
GEOHAZARD ASSESSMENT PROGRAM
PEACE REGION – PEACE-HIGH LEVEL
2017 CALL OUT**

Site Number	Location	Name	Hwy	km
	Peace River East Hill	98 Street Intersection Slide	2:60	38.4
Legal Description		UTM Co-ordinates		
NW¼ 31-083-021 W5M		11U E 481671	N 6233044

Date	PF	CF	Total
Previous Inspection:				
Current Inspection:	6-June-2017	9	4	36
Road AADT:	2220		Year:	2016
Inspected By:	Rocky Wang, TRANS Ed Szmata, TRANS		Don Proudfoot, Thurber Shawn Russell, Thurber	
Report Attachments:	<input checked="" type="checkbox"/> Photographs <input checked="" type="checkbox"/> Plans <input checked="" type="checkbox"/> Maintenance Items

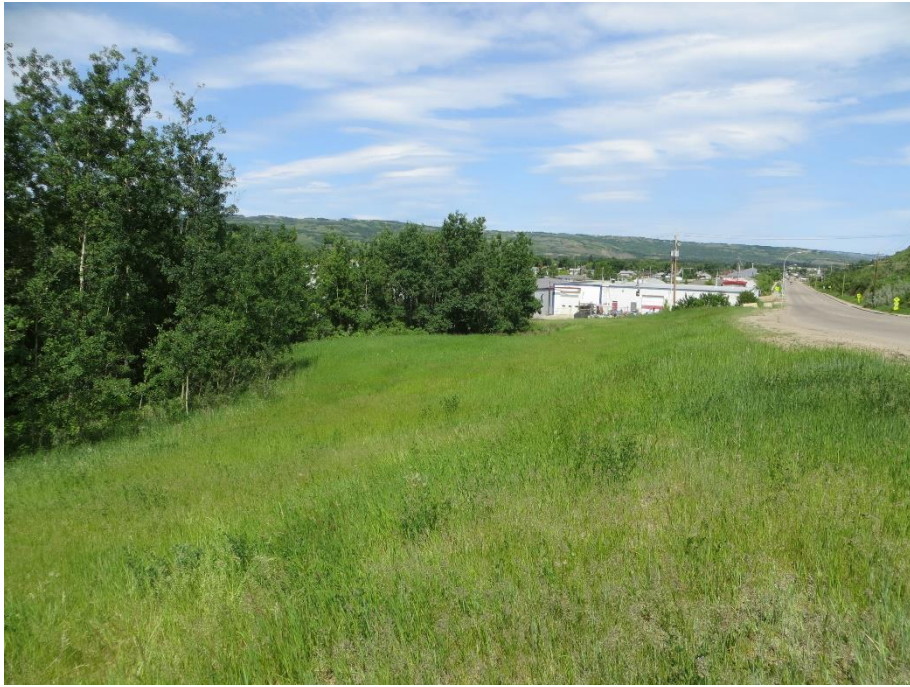
Photo 1.
Looking north along the top of bank west of 98 Street north of the Hwy 2:60 on-ramp. There is a distinct dip in the sideslope at the top of bank.

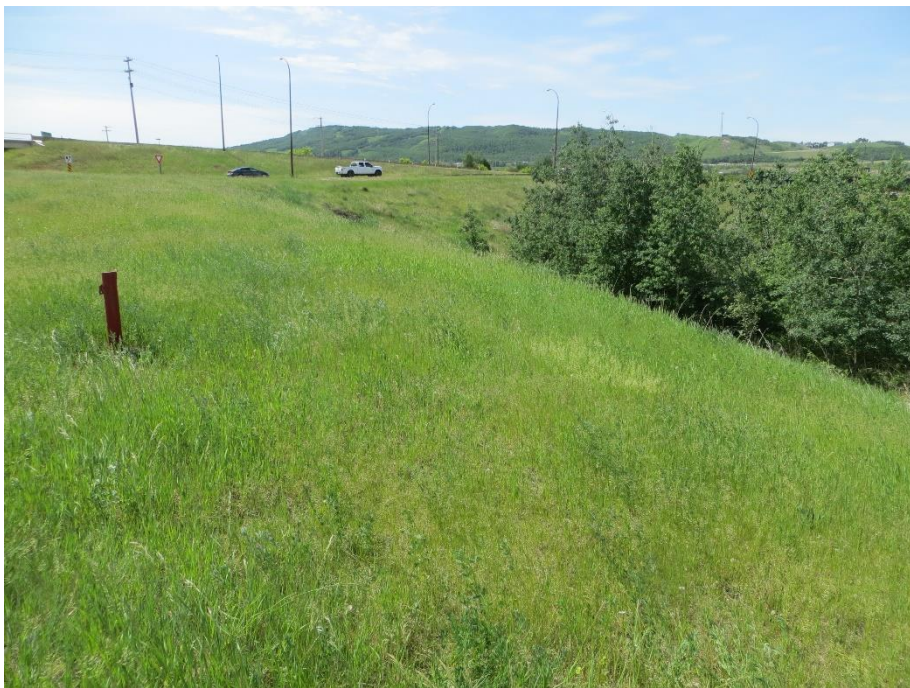
A standpipe believed to be TH11-15, of the geotechnical investigation completed in 2011 for the twinning of Hwy 2 was found at the crest on the slope to the west 98 Street. No recent reading data for the standpipe was available. The test hole logs from the 2011 report indicated a water level of 7.78 m below ground surface on January 20, 2012.

Photo 2.
Looking south along the sideslope at the standpipe at the top of bank downslope of 98 Street. The standpipe is likely from test hole No. TH11-15 that was drilled as part of the geotechnical investigation by AECOM performed for the twinning in 2011.

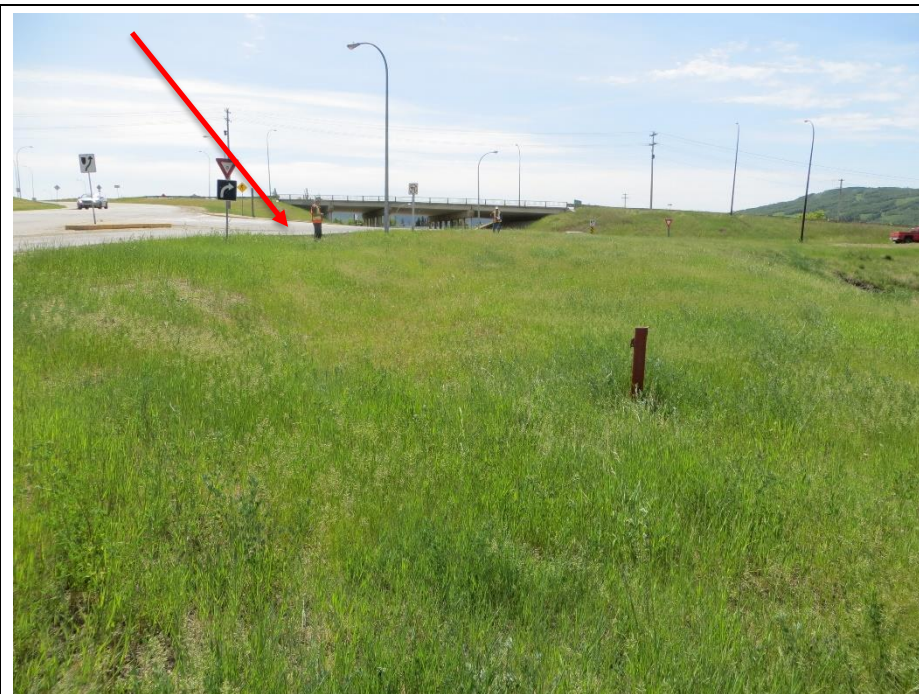
Primary Site Issue:	<p>A landslide in the sideslope of the 98 Street/Hwy 2:60 on-ramp (Photos 3, 5, 6, 7, 8 and 9). Cracks have developed along the backscarp of the landslide in the pavement of 98 Street at the intersection with the Hwy 2:60 on-ramp.</p> <p>The outlet of a 460mm diameter concrete drain pipe has become disconnected along the flank of the landslide with water now pouring onto the slope and a scour is forming below (Photos 17 and 18).</p>	
Dimensions:	The landslide is estimated to be about 30 m wide along the backscarp in the ACP on 98 Street and as wide as 70 m on the slope. It is estimated that the slip plane of the landslide could be as deep as 8 m based on the lateral extent of the landslide.	
Maintenance:	No maintenance has been performed recently at the site. The property belonging to Alberta Transportation at the toe of the slope was recently regraded with some environmental excavation work done to remediate some salt contamination.

Photo 3.
Looking southeast towards the 98 Street/Hwy 2 on-ramp intersection. There is a distinct dip in the curb along the projection of the cracks observed in the pavement on 98 Street.

Pending the beginning of the construction work for the twinning of Hwy 2, the maintenance Contractor and the MCI should regularly inspect the road to check for cracks and possible backscarp retrogression and patch the pavement when necessary to maintain a safe surface. If aggressive slide movements occur, the connecting road between 98 Street and the ramp might need to be closed.

The embankment fill for the new bridge alignment should adequately buttress the slide area, once constructed, and stop the sliding. The fill for the new highway embankment will should be placed first over the flat-lying graded area at the base of the slope and built gradually upwards in flat layers butting against the existing slope. Subdrains should be installed prior to placing the fill to drain the toe area of the slope. The separated drain pipe will also need to be extended through the new embankment fill. The outlet channel should be armoured with rip rap down to flat ground level. It is understood that a new roundabout will be built in the new WBL at the crest of the new fill slope. It is understood that the highway twinning and remedial measures will be designed by AECOM.

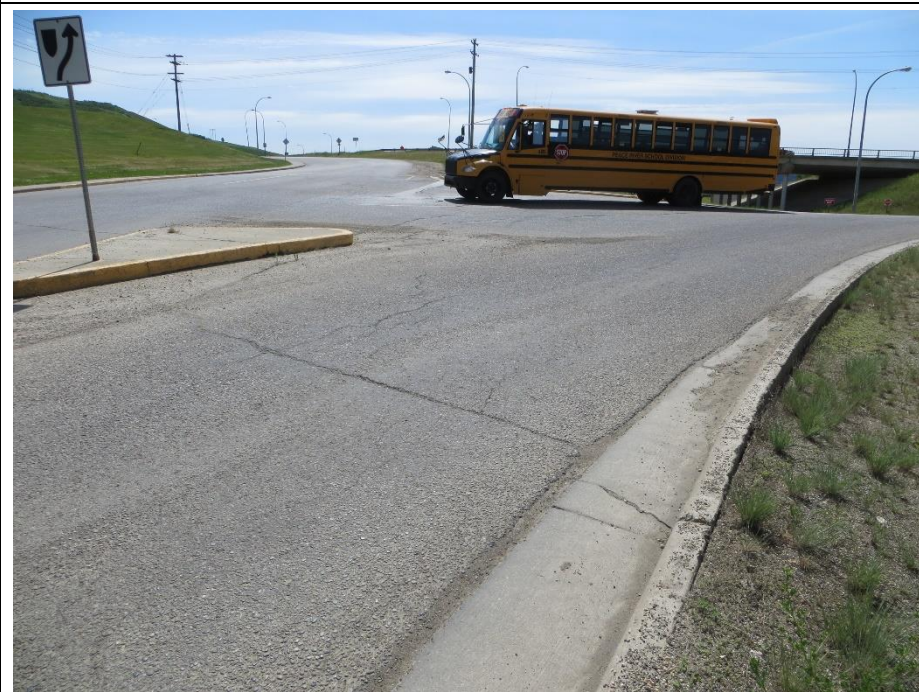
Observations:	Description	Worsened?
<input checked="" type="checkbox"/> Pavement Distress	Cracks have formed in the ACP at about 9.5 m from the west side concrete curb at the island of the 98 Street and Hwy 2 on-ramp intersection (Photos 4, 5, 6). The cracks are open from 50 mm to 80 mm in width and a dip has formed	<input checked="" type="checkbox"/>
<input checked="" type="checkbox"/> Slope Movement	A landslide has developed at the intersection of the roadway embankment sideslopes of 98 Street and the Hwy 2:60 on-ramp. Cracks have recently developed in the ACP of 99 street above. Trees along the toe of the slope have distinct bends in the lower portions of their trunks (Photo 19).	<input checked="" type="checkbox"/>
<input checked="" type="checkbox"/> Erosion	An erosion gully has formed at the based of a dislocated 460mm concrete pipe, which is likely the outlet pipe for the catch basins in the roadway above (Photo 17).	<input checked="" type="checkbox"/>

Photo 4.
Looking southeast along the cracks in the pavement at the 98 Street/Hwy 2 on-ramp intersection.

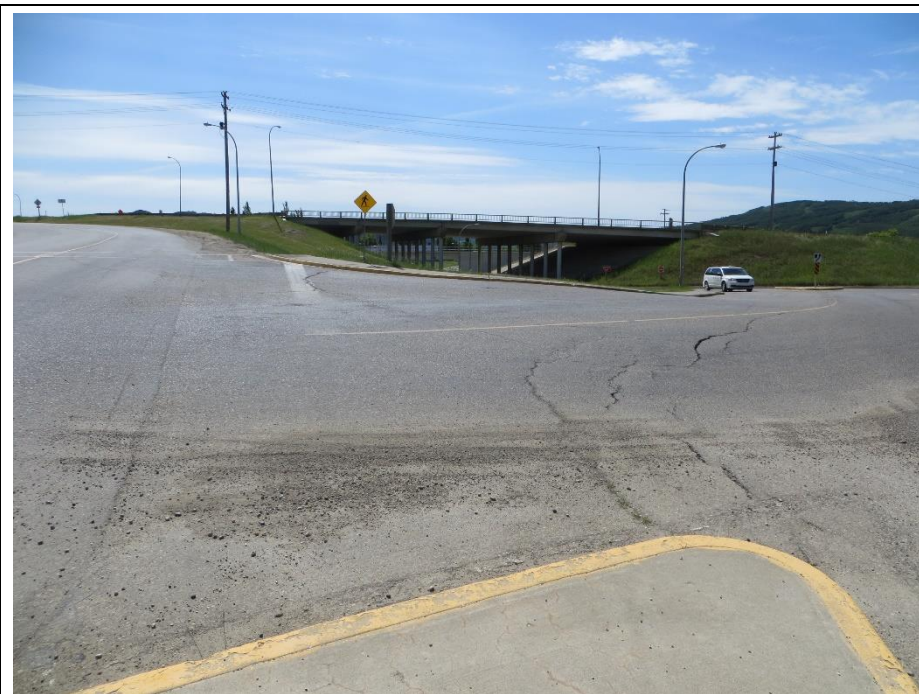
Photo 5.
Looking south from the median at the 98 Street/Hwy 2 on-ramp intersection. The cracks in the pavement (ACP) are open from 50mm to 80mm and there is a distinct dip in the pavement about 9.5m from the edge of the curb on the west side of 98 Street.

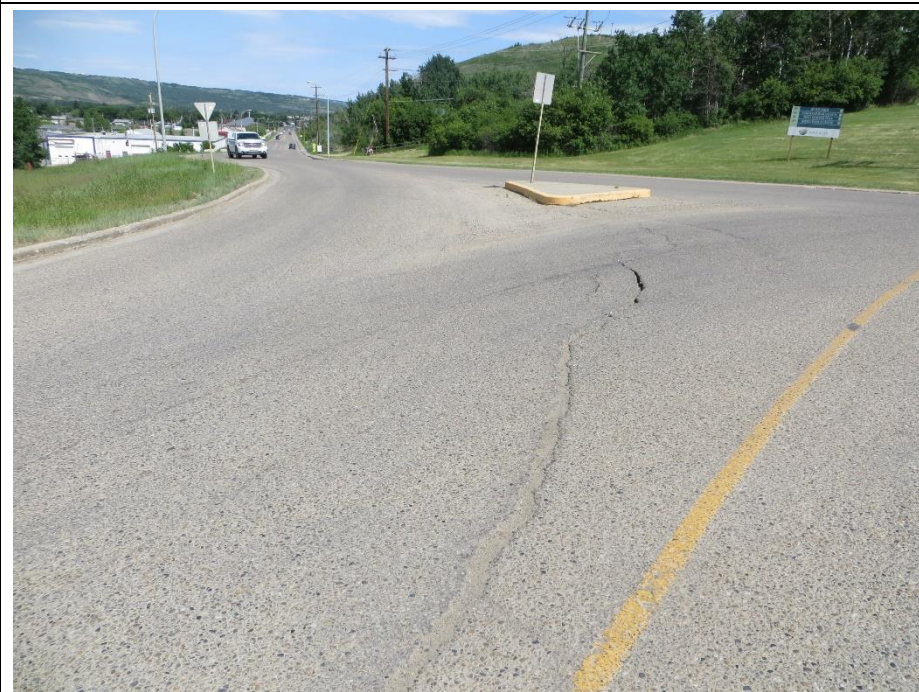
Photo 6.
Looking northeast towards the median at the 98 Street/Hwy 2 on-ramp intersection. The cracks in the ACP are open from 50mm to 80mm and there is a distinct dip in the ACP about 9.5m from the edge of the curb on the west side of 98 Street.

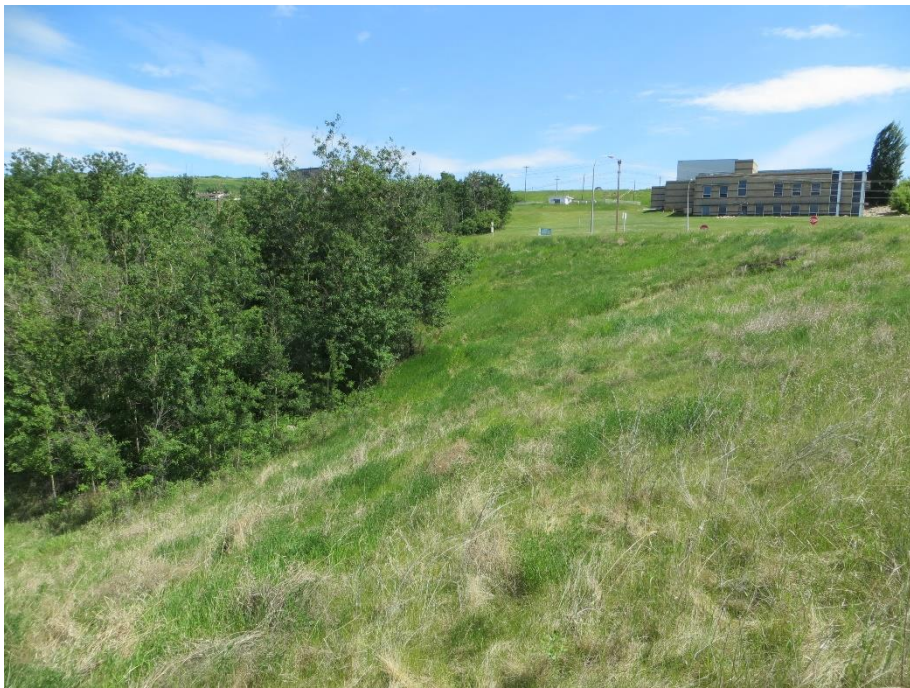
It is likely that the landslide was triggered by a combination of the overall slope steepness (from 2.5H:1V to 3H:1V), slope height (8 m to 12 m), saturation of the material in the toe of the slope and a loss of some of buttressing material at the toe of the slope during the remediation excavation work. The soil conditions encountered in Test Holes TH11-15 and TH11-17, drilled by AECOM as part of the 2011 investigation of the twinning of Hwy 2:60, are shown on DWG. No. 13351-2:60-CALLOUT-3. It appears that the slip surface is located near or below the contact between the clay embankment fill and the underlying native high plastic clay. Silt, sand and gravel layers are present in the clay, which is underlain by sandstone and clay shale bedrock. The groundwater table is about 8 m to 10 m below the existing ground surface which corresponds to slightly above the toe of the highway embankment sideslopes. The standpipe in TH17-11 at the toe of the slope has a water level of 1m above ground surface, which could explain the seepage noted at the toe of the slope. The 2.6H:1V embankment slope is likely too steep for the relatively weak high plastic clay underlying it especially given the relatively high groundwater table in the area.

Photo 7.
Looking east from the Hwy 2 on-ramp sideslope about 120m to the west of 98 Street. There is a slump in the backslope immediately below the cracks in the ACP in the median.

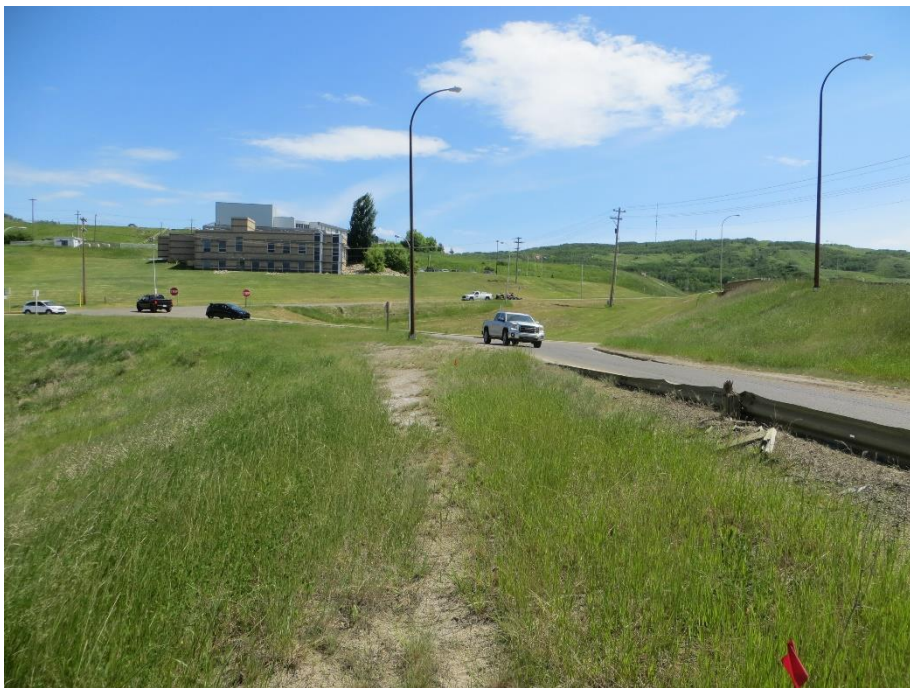
Photo 8.
Looking east along the top of bank of the Hwy 2 on-ramp about 120m to the west of 98 Street. There is a slump in the backslope immediately below the cracks in the ACP in the median.

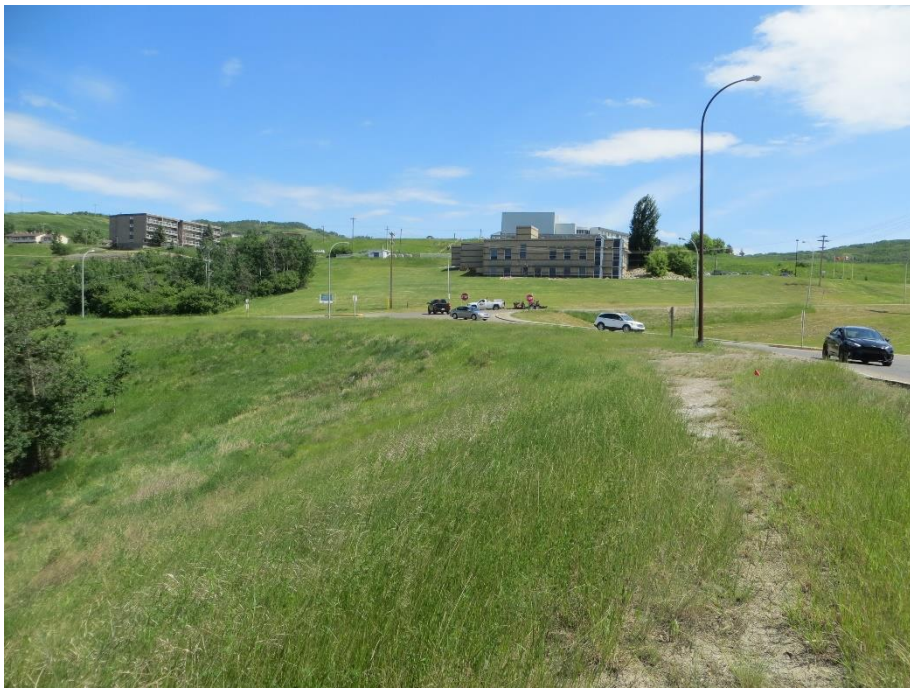
Photo 9.
Looking east along the top of bank of the Hwy 2 on-ramp about 90m west of 98 Street. There is a slump in the backslope immediately below the cracks in the ACP in the median.

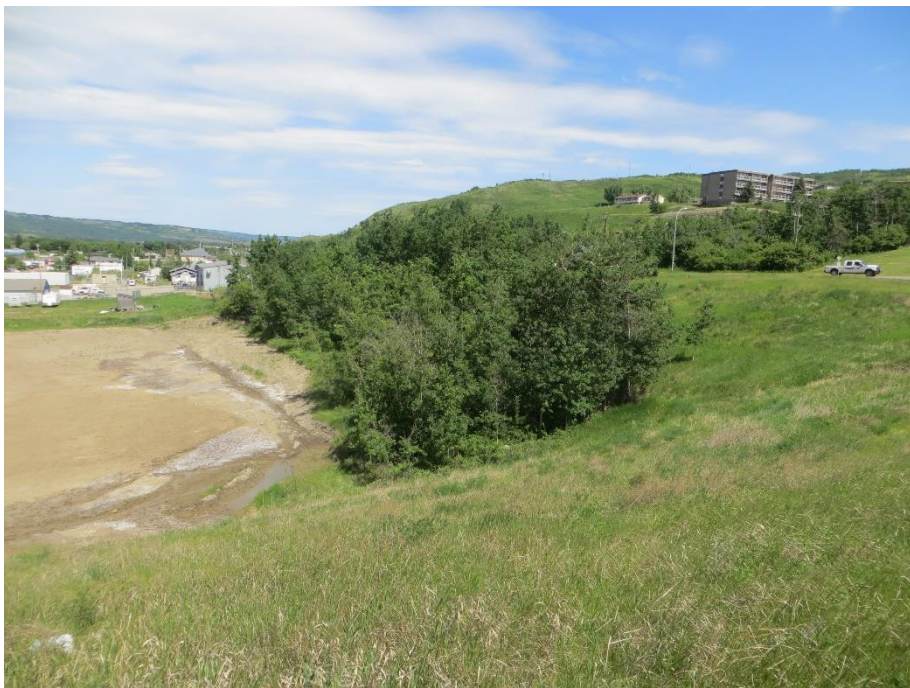
<input checked="" type="checkbox"/> Seepage	Seepage, with water ponding, was noted at the toe of the slope below the landslide (Photos 10 to 16).	<input checked="" type="checkbox"/>

Photo 10.
Looking north along the slope below 98 Street.

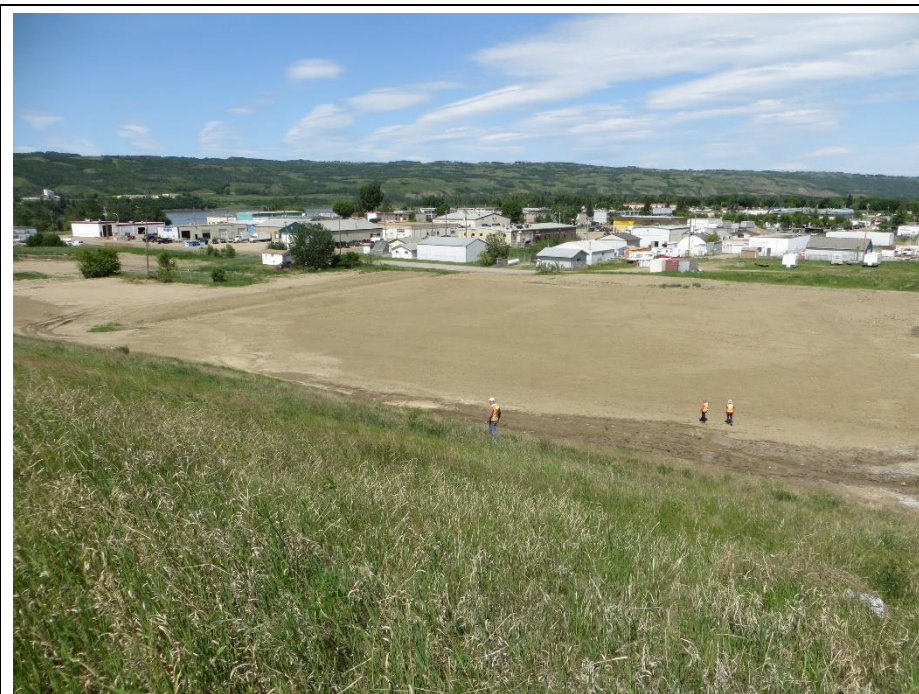
Photo 11.
Looking northwest from the 98 Street/Hwy 2:60 on-ramp shoulder towards the former Alberta Transportation yard that has been regraded as part of the salt contamination remediation in the spring of 2017.

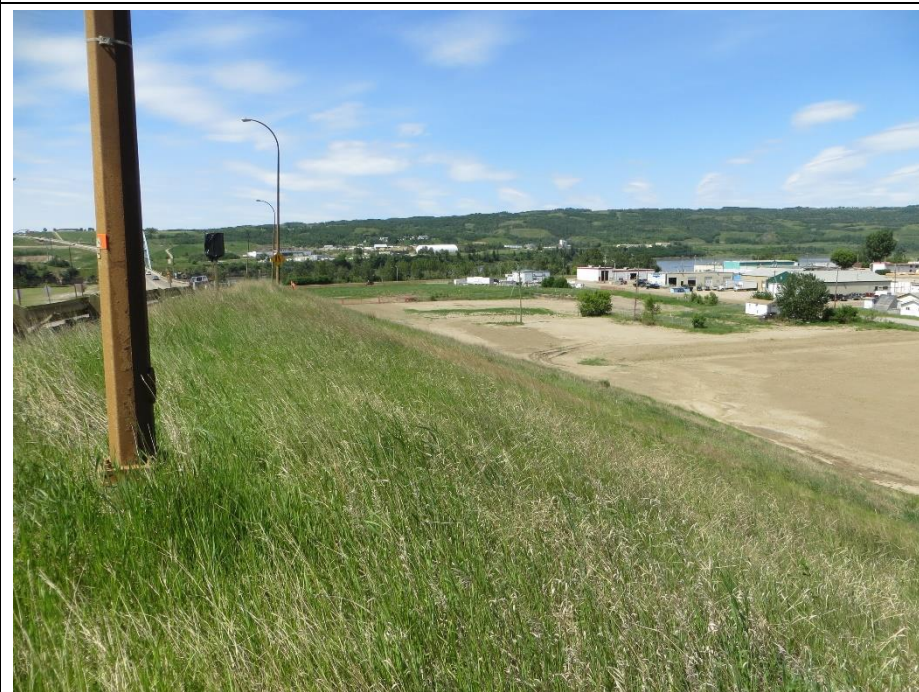
Photo 12.
Looking northwest from the 98 Street/Hwy 2:60 on-ramp shoulder towards the former Alberta Transportation yard that has been regraded as part of the salt contamination remediation in the spring of 2017.

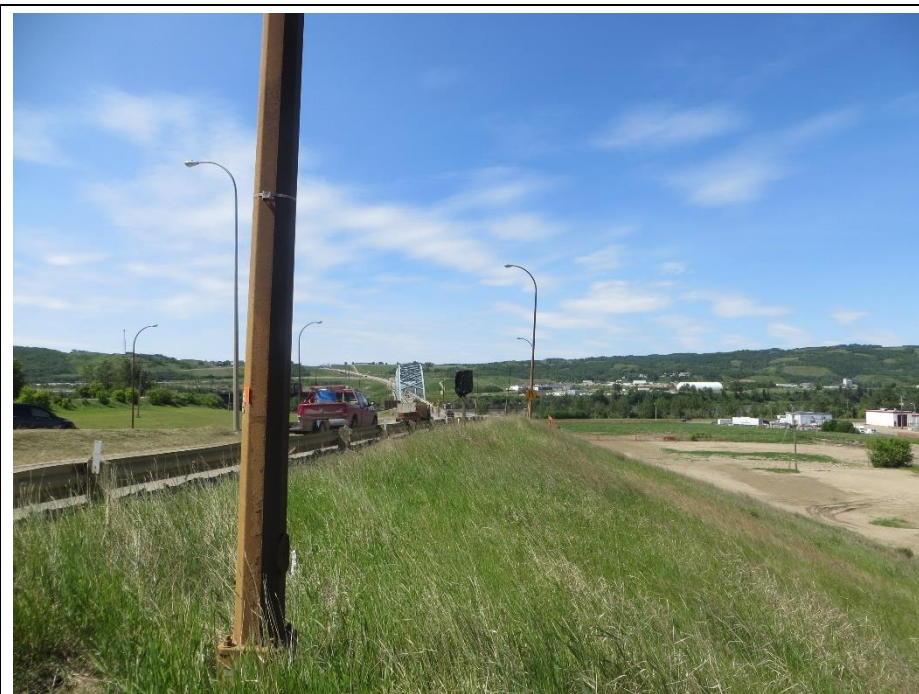
Photo 13.
Looking west along the sideslope of the 98 Street/Hwy 2:60 on-ramp. The embankment is about 13m in height

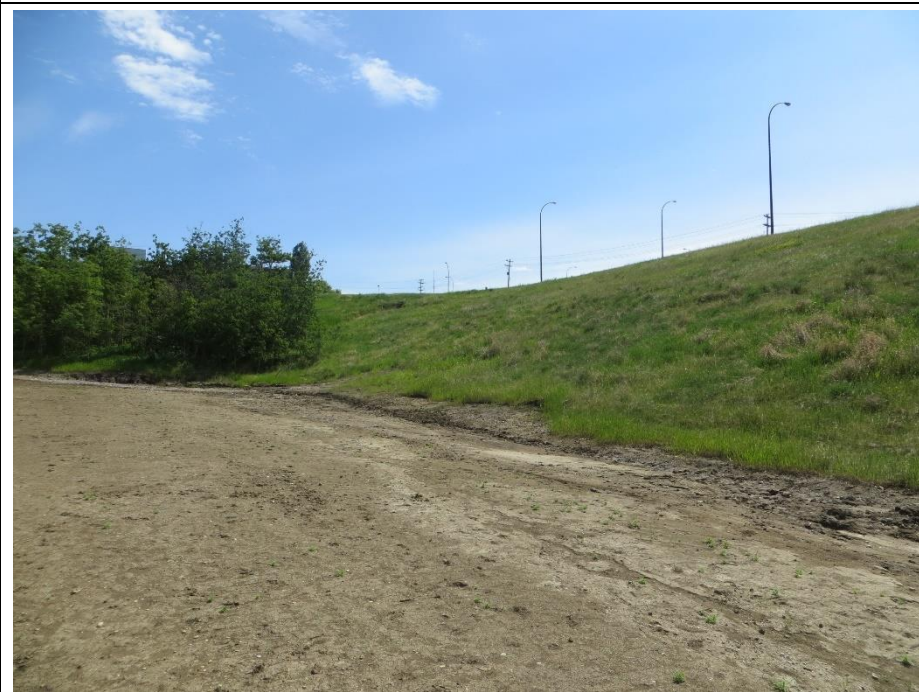
Photo 14.
Looking east along the toe of the slope of the Hwy 2:60 on-ramp. The slope is about 13m in height. There are signs of seeping, flowing and ponding water along the toe of the slope. This area was regraded as part of the salt contamination remediation in the spring of 2017.

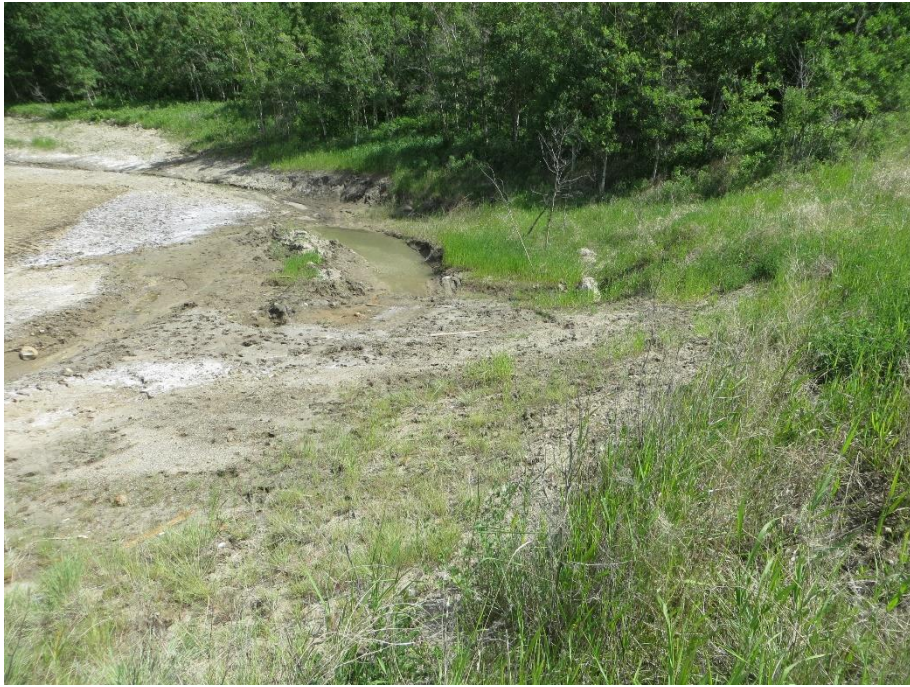
Photo 15.
Looking northeast along the toe of the slope below the 98 Street/Hwy 2:60 on-ramp intersection. Some water has ponded at the toe possibly from the culvert discharge immediately upslope of the toe, as well as the seepage from the toe of the slope.

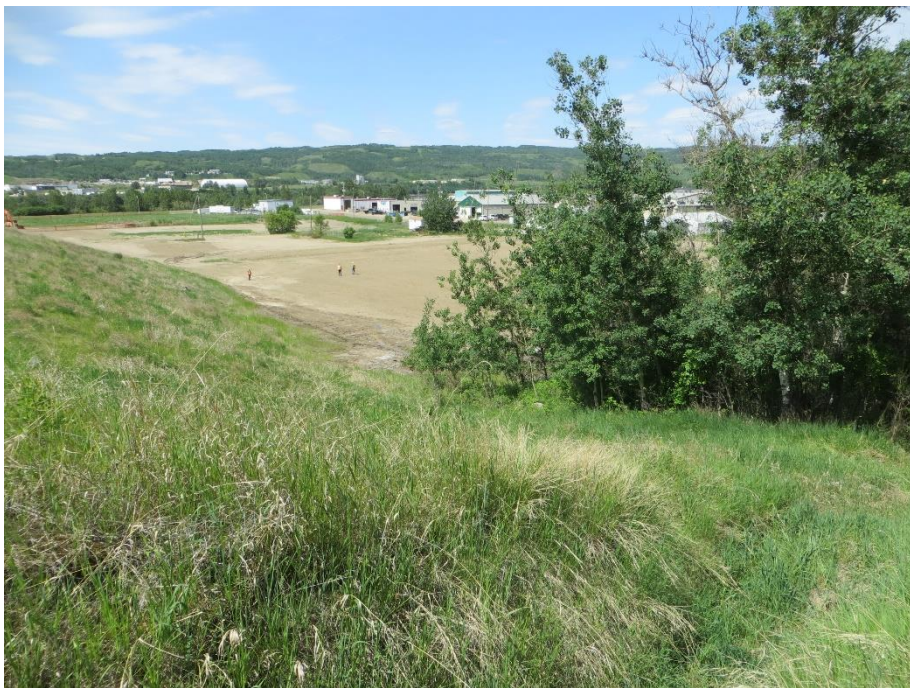
Photo 16.
Looking northwest from the crest of the slope above the slump in the sideslope.

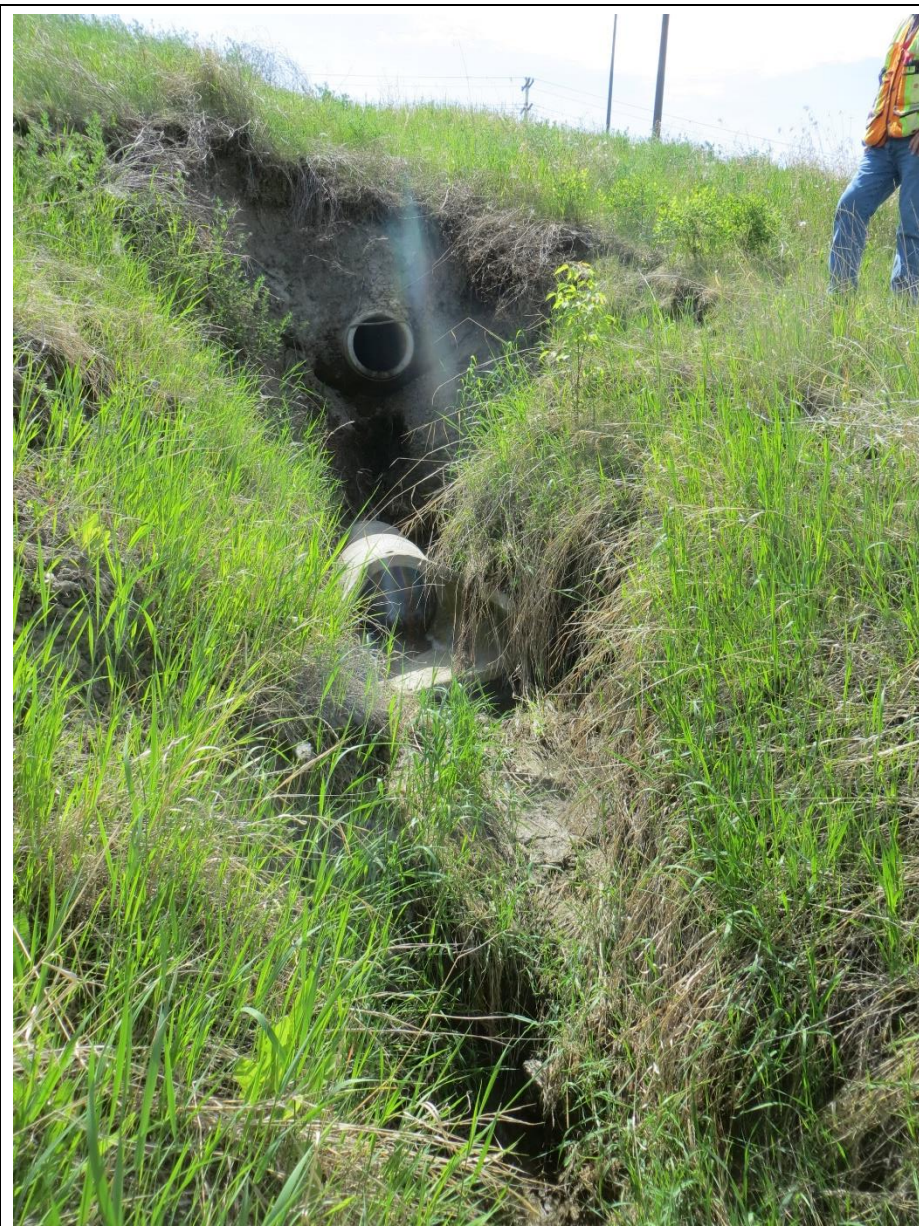
<input checked="" type="checkbox"/> Bridge/Culvert Distress	A 460 mm diameter concrete drain pipe is disconnected at about the mid-slope height along the west flank of the landslide (Photos 17 and 18).	<input checked="" type="checkbox"/>
<input type="checkbox"/> Other		<input type="checkbox"/>

Photo 17.
Looking south at the disconnected 460 mm OD drain pipe in the backslope below the 98 Street/Hwy 2:60 on-ramp intersection and the scour channel that has developed below.

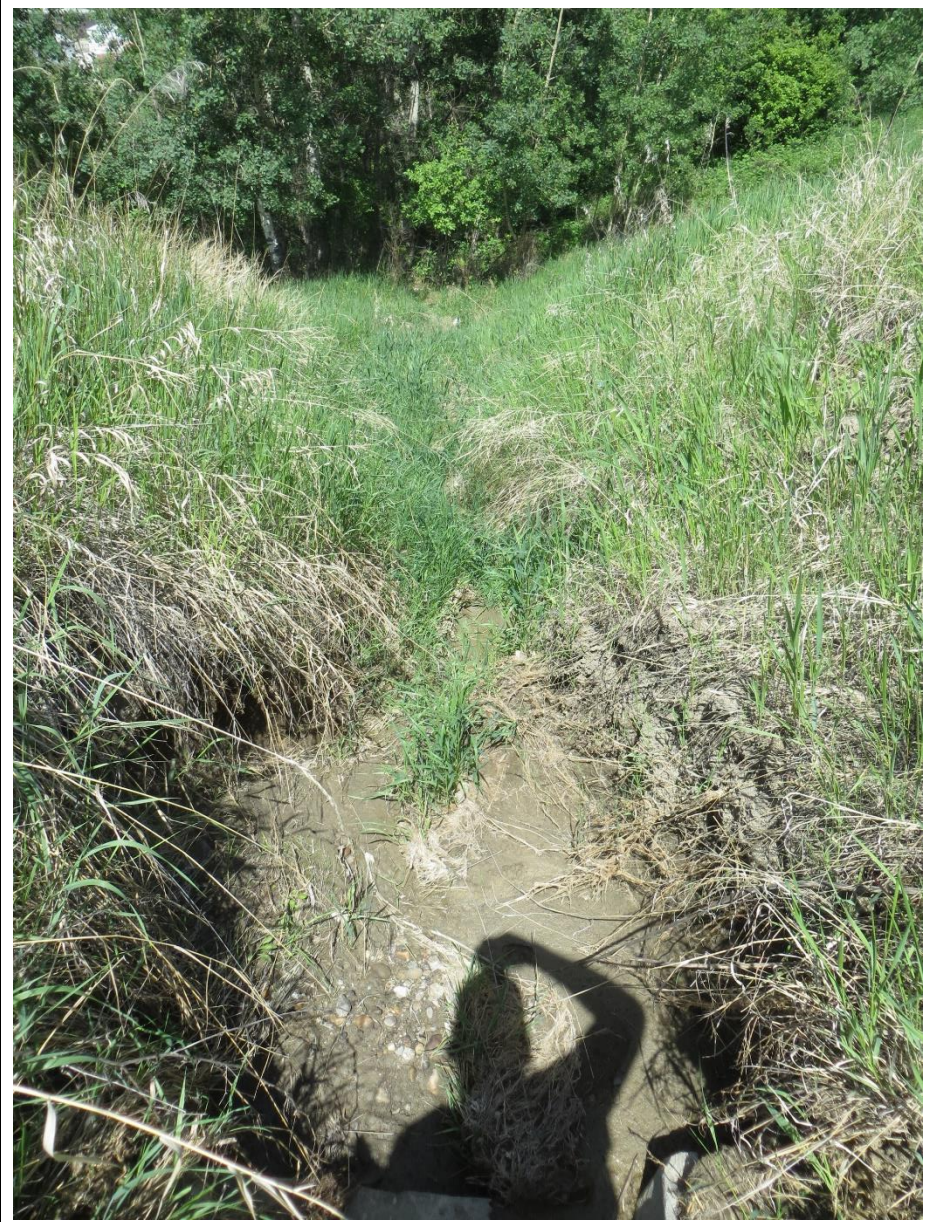
Photo 18.

Looking northwest at the scour channel that has developed below the disconnected 460 mm OD concrete drain pipe in the backslope below the 98 Street/Hwy 2:60 on-ramp intersection.

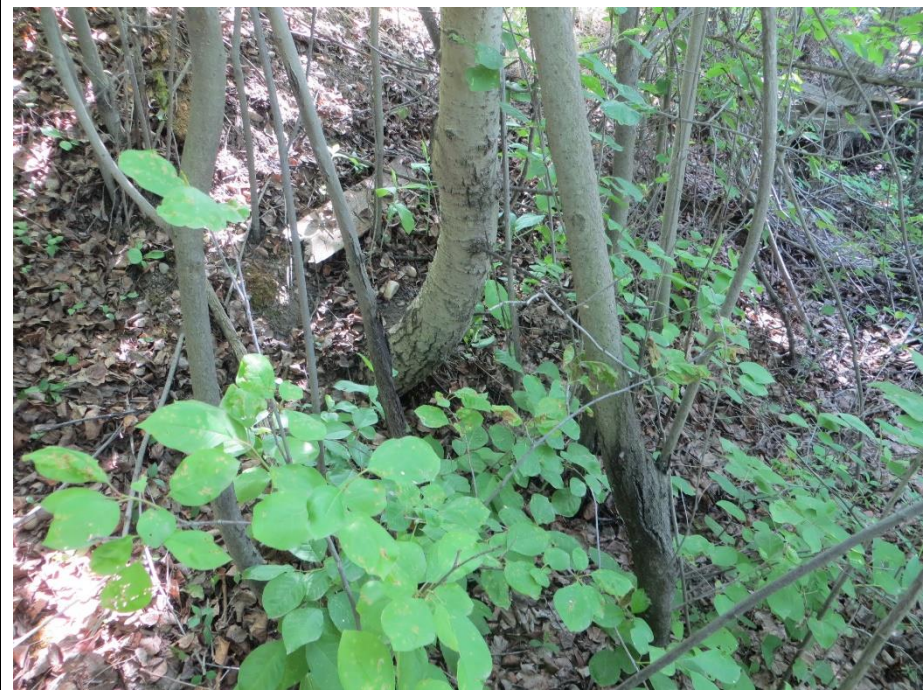
Photo 19.
Looking at a bent tree trunk at the lower mid-slope in the area assessed to be within the landslide.
