**ALBERTA TRANSPORTATION  
GEOHAZARD ASSESSMENT PROGRAM  
PEACE REGION – SWAN HILLS  
2018 INSPECTION**

Site Number	Location	Name	Hwy	km
SH027 SH027A	South of Swan Hills	Judy Creek Erosion	32:12	48.2 – 48.5 48.1
Legal Description		UTM Co-ordinates		
NW15-64-10-W5M		11U E 601,654	N	6,044,517

SH027: HWY 32:12 JUDY CREEK  
2018 SITE INSPECTION PLAN

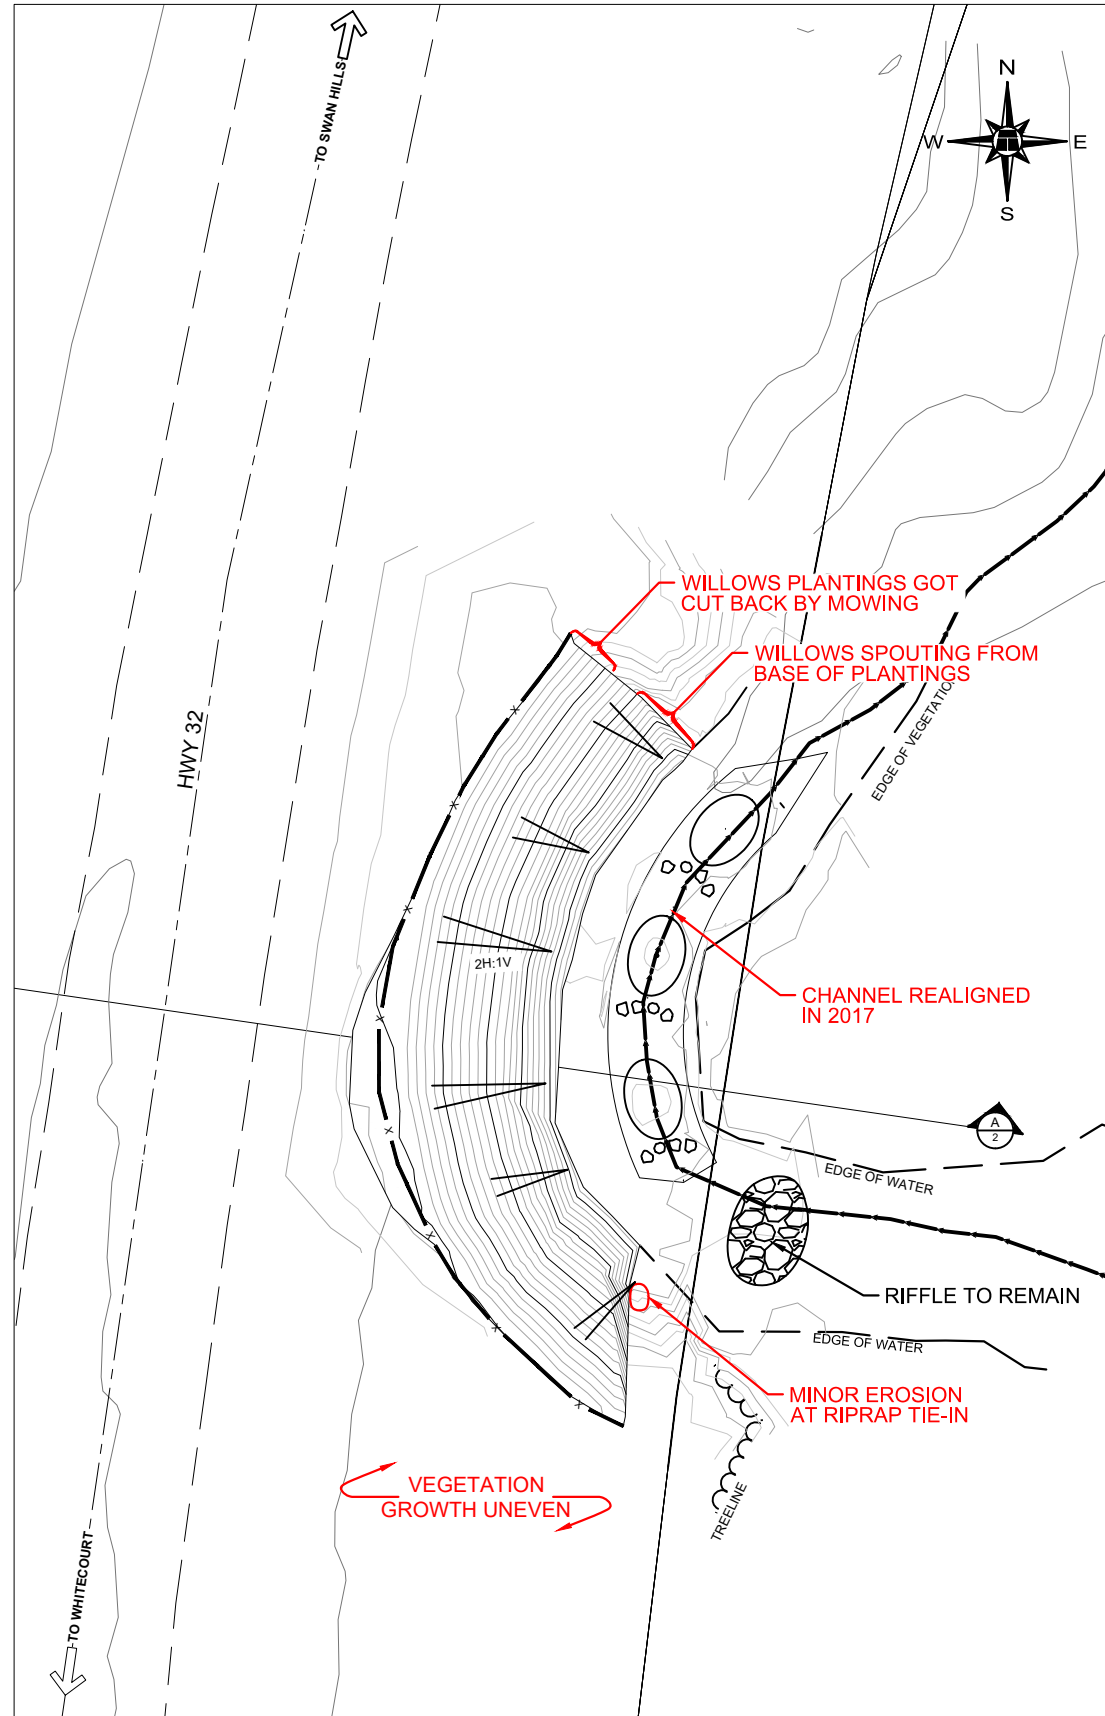
**SH27 - STREAM BANK REPAIR**  
SCALE 1:400

<b>Primary Site Issue:</b>	An outside bend of Judy Creek (flow toward the north) was eroding the slope with the slumping encroaching on the highway embankment.  SH027A: Erosion gully was in the west ditch of highway with the potential to extend and undermine the highway.	
<b>Dimensions:</b>	25 m length adjacent to the highway. SH027A: 40 m of highway adjacent to erosion gully.	
<b>Date of Remediation:</b>	2017: Creek channel was realigned further away from the highway and the bank reconstructed and protected with riprap. SH027A gully was infilled with gravel and covered with riprap.	
<b>Maintenance:</b>	None	
<b>Observations (SH027):</b>	<b>Description</b>	<b>Worsened?</b>
<input type="checkbox"/> Pavement Distress		<input type="checkbox"/>
<input checked="" type="checkbox"/> Slope Movement	Retrogression of eroding creek banks had been encroaching on the highway.	<input type="checkbox"/>
<input checked="" type="checkbox"/> Erosion	Creek had been eroding left bank adjacent to the highway.	<input type="checkbox"/>

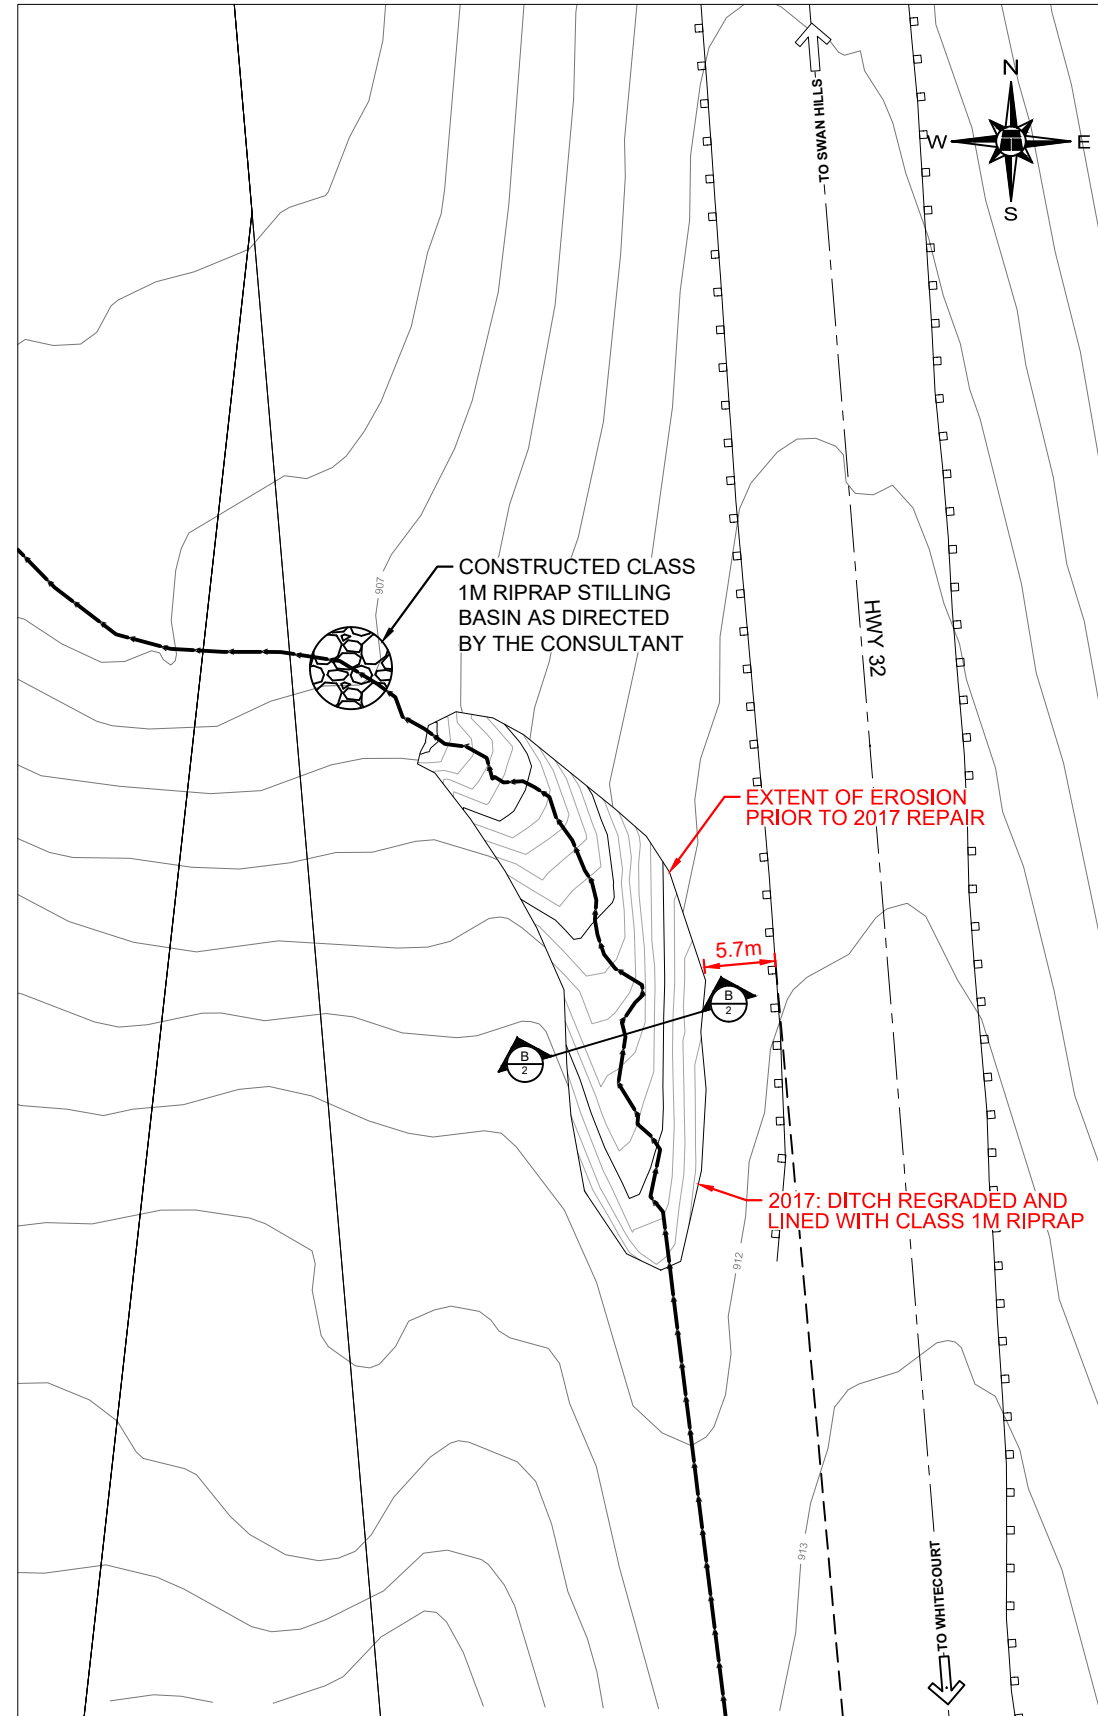
**SH27A - DITCH EROSION REPAIR**  
SCALE 1:400

<input checked="" type="checkbox"/> Seepage	Seepage had been observed in the scarp near the top of the bank.	<input type="checkbox"/>
<input checked="" type="checkbox"/> Bridge/Culvert Distress	Some minor slumping at the inlet of the 3.9 m dia. culvert at the south end of the site noted in 2015.	<input type="checkbox"/>
<input type="checkbox"/> Other		<input type="checkbox"/>
<b>Observations (SH027A):</b>	<b>Description</b>	<b>Worsened?</b>
<input type="checkbox"/> Pavement Distress		<input type="checkbox"/>
<input type="checkbox"/> Slope Movement		<input type="checkbox"/>
<input checked="" type="checkbox"/> Erosion	Gully in west ditch was widening and deepening to about 2.5m and 5.7m from hwy in 2016.	<input type="checkbox"/>

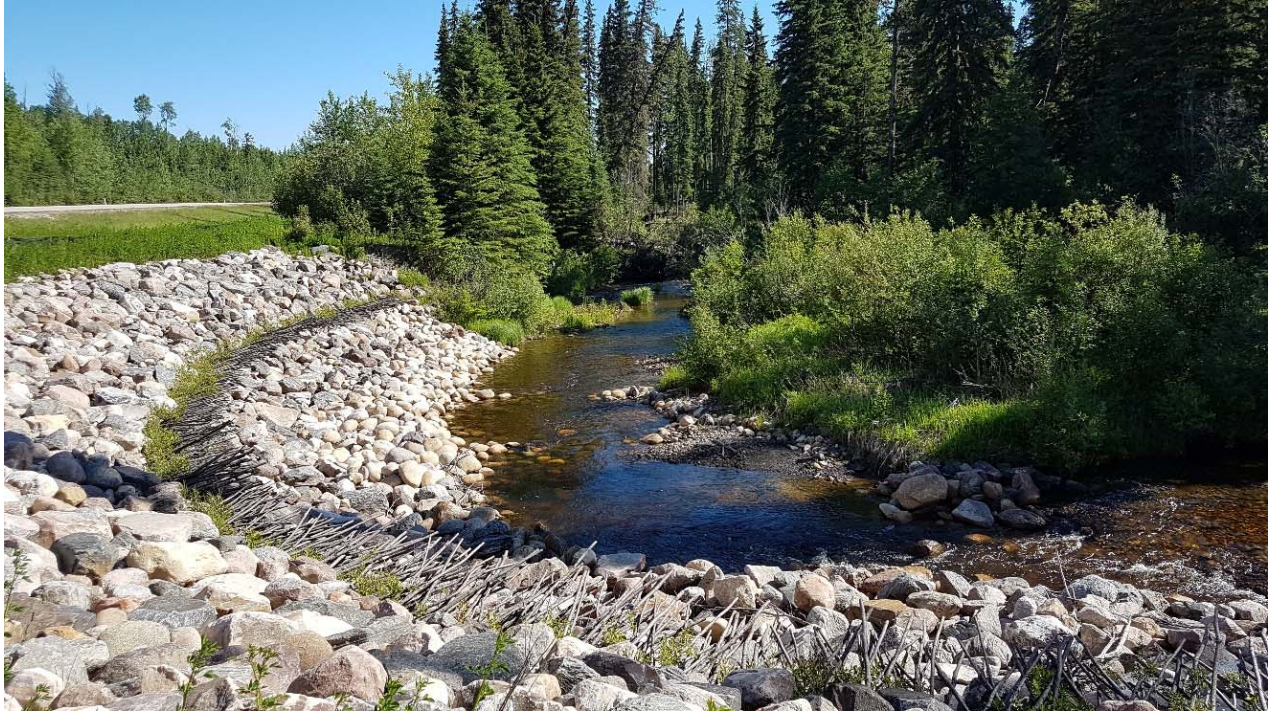
Photo 1 – Looking north at realigned channel.

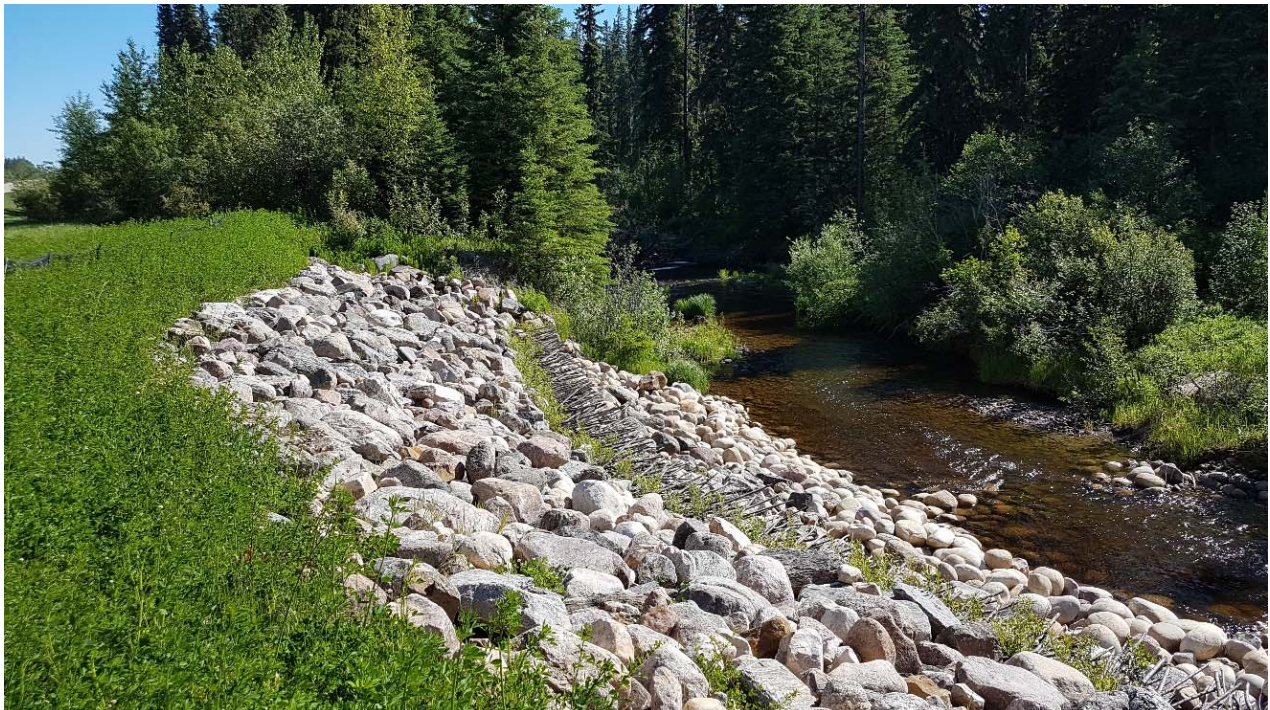
Photo 2 – Looking north at rebuilt left creek bank. Note willow growth from base of plantings in the brush layering at midslope.

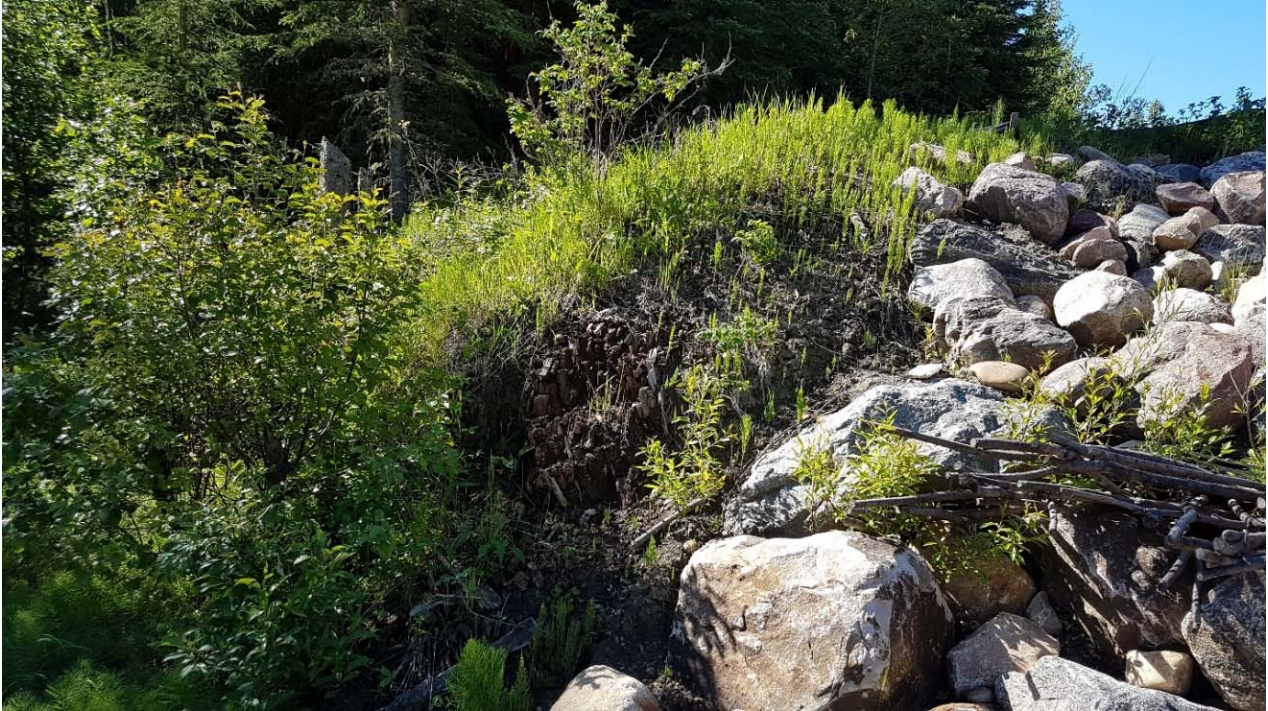
Photo 3 – Looking at minor erosion at south tie-in of riprap protection.

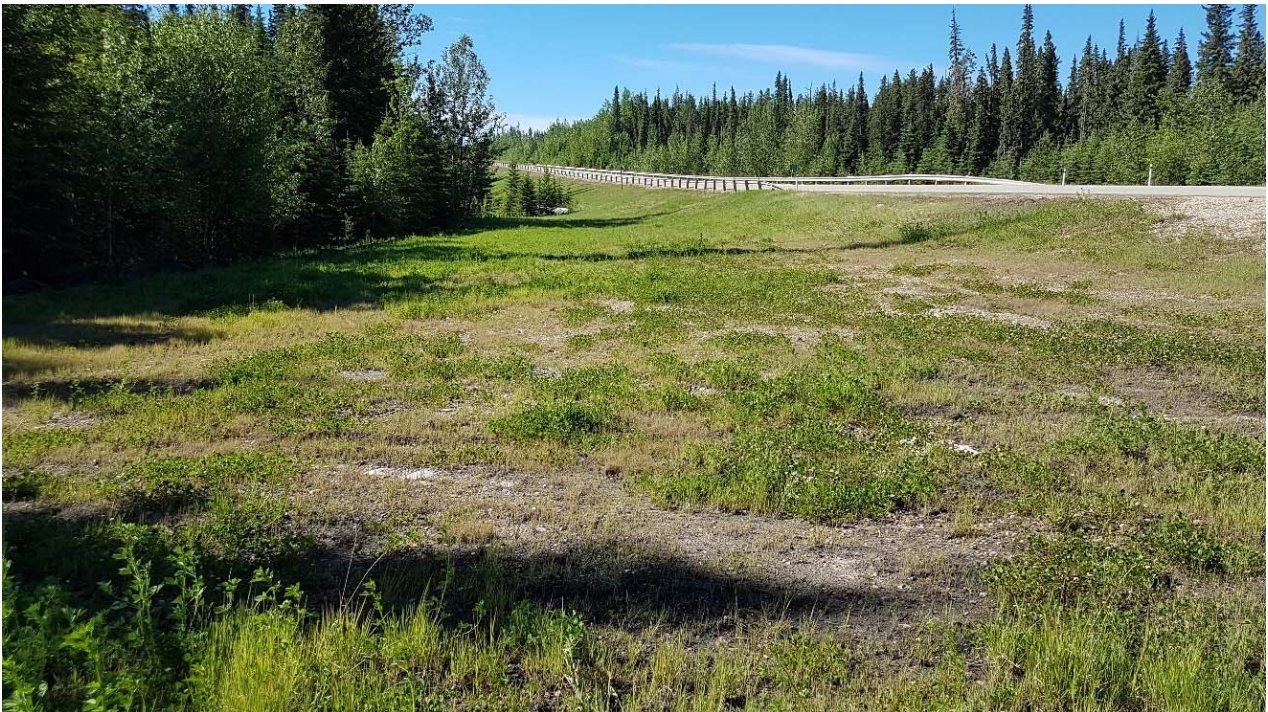
Photo 4 – Looking south at sparser growth in construction laydown area south of realigned channel area.

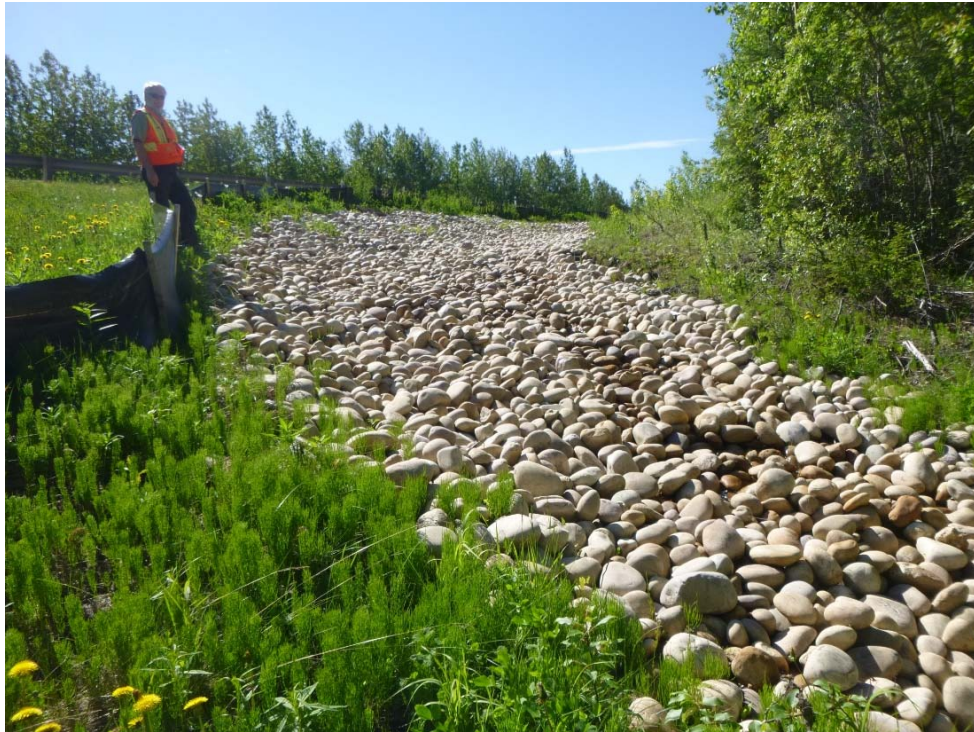
Photo 5 – Looking south at regraded and lined SH027A gully area.

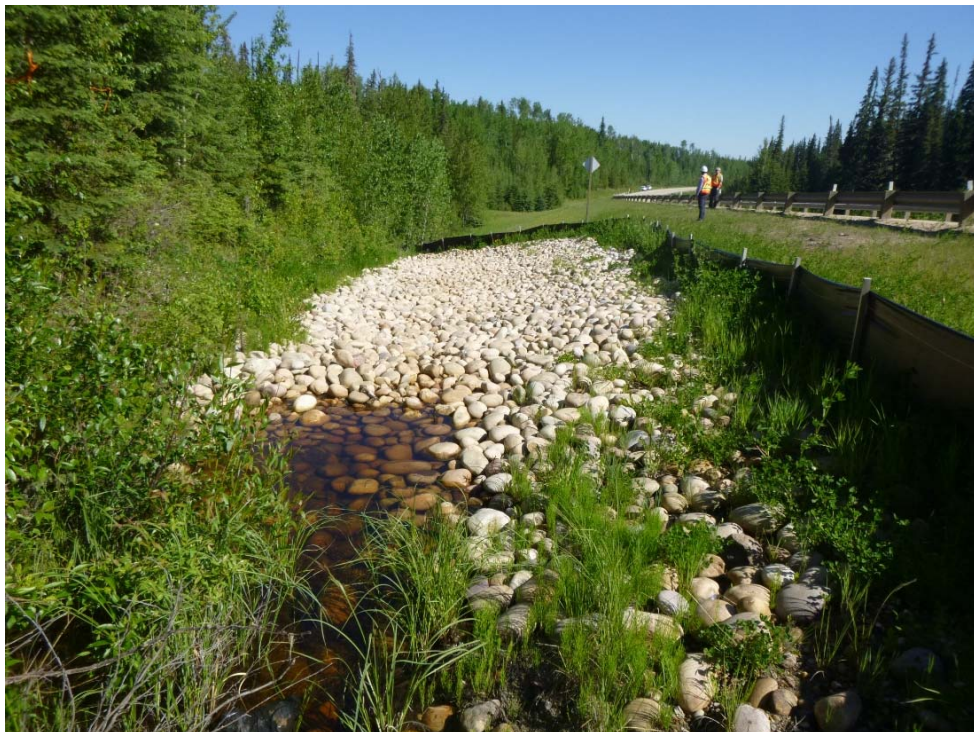
Photo 6 – Looking north at regraded and lined SH027A gully area.
