August 4, 2000

File: 15-76-20

**HWY33:10 MORSE RIVER SLIDE
EMERGENCY CALL-OUT FOR EMBANKMENT SLIDE AND DITCH EROSION
LOCATED APPROXIMATELY 27 KM NORTH OF Ft. ASSINIBOINE**

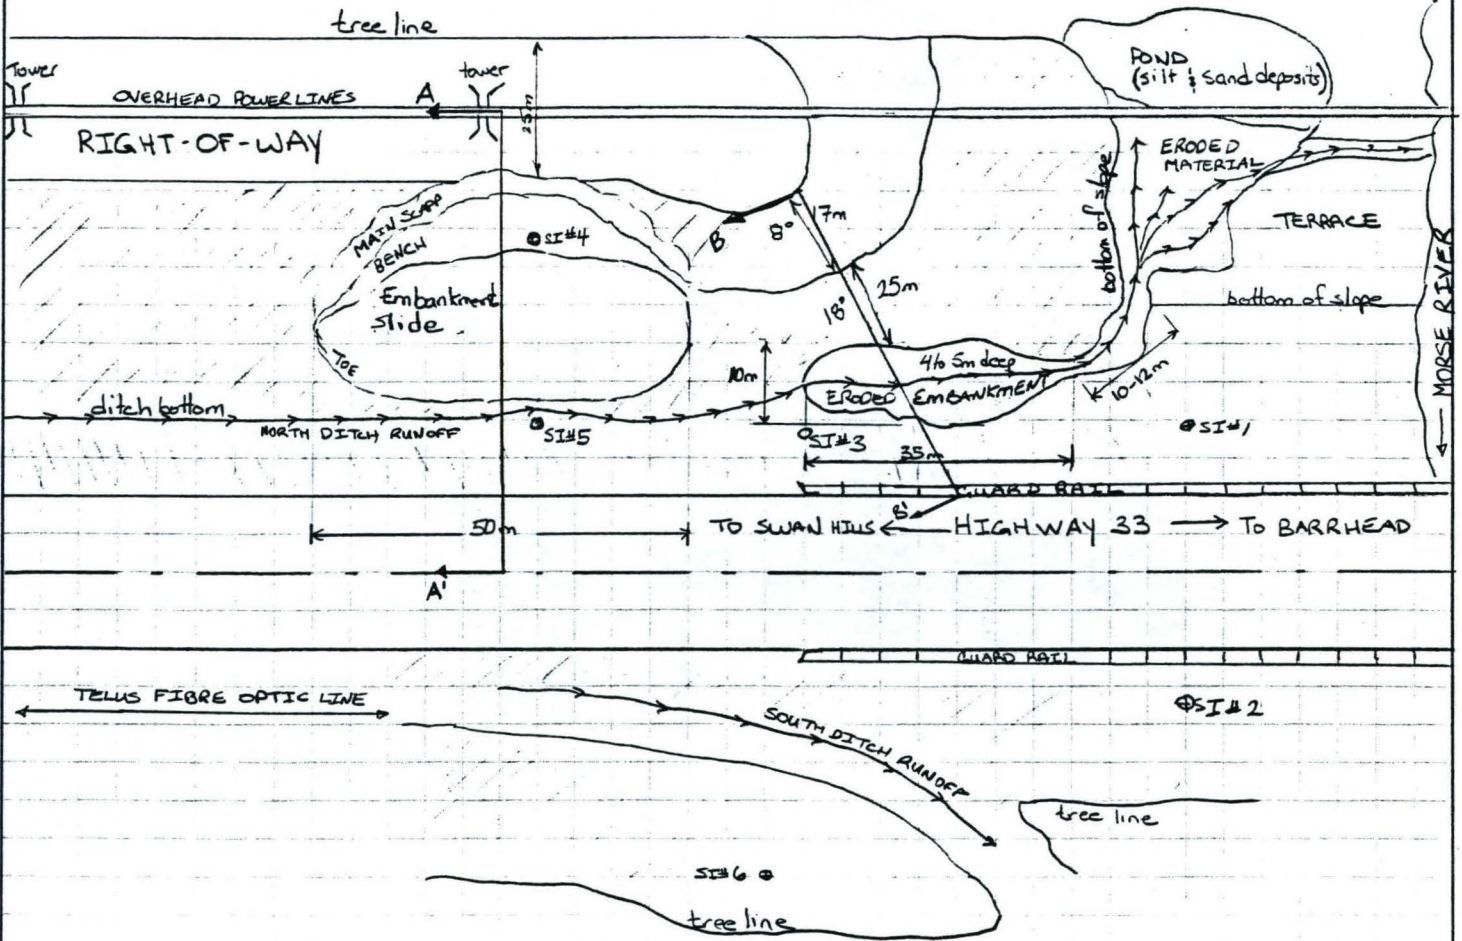
PLAN VIEW OF SLIDE AREA
FIGURE 1 N.T.S.

Upon arrival to the site an embankment slide and severe ditch erosion were observed along the north side of the highway. Observations of the side slope indicate that the embankment slide is not deep seated. A sketch of the site in plan showing the approximate location and extent of the embankment slide and ditch erosion is provided on Figure 1, while sketches of cross-sections A-A' through the slide area and B-B' through the eroded area are provided on Figure 2. Also, Plate 1, 2, and 3 provide photos of the slide and erosion areas under investigation.

In addition, observed utilities at the site include: overhead powerlines and power poles located along the right-of-way just above the crest of the north side embankment; and a Telus fiber optic cable which runs parallel to highway in the south ditch, as shown in Figure 1. However, the location of the Telus line has not been confirmed.

For the embankment slide we recommend to continue observing by MCI and under the Swan Hills Instrumentation Program until the slide poses a danger to either the highway or power pole located near the crest of the slope. At present, there is one slope inclinometer (SI#4) located within the slide area near the crest, and one SI (SI#5) located at the base of the slide near the toe, as illustrated in Figure 1. Both SI's had shown no movement in the Spring 2000 readings.

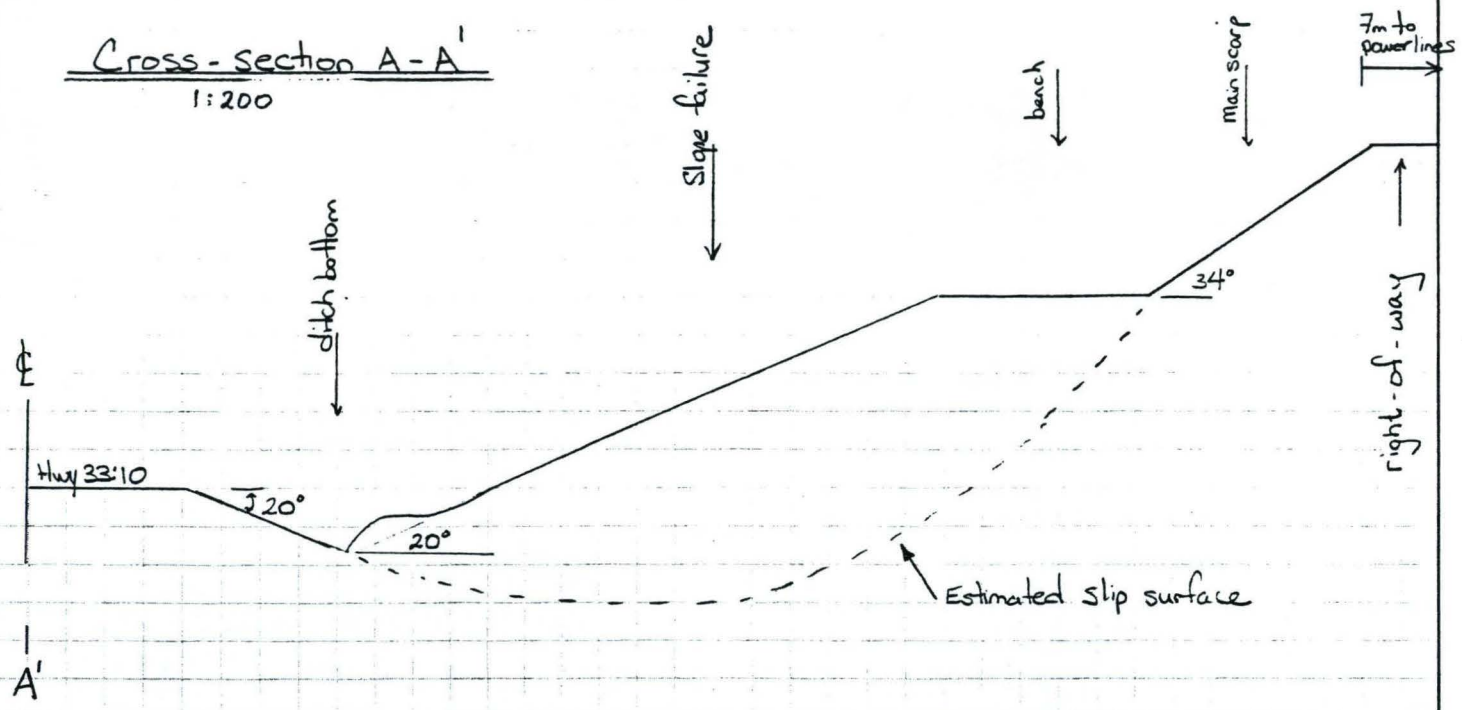
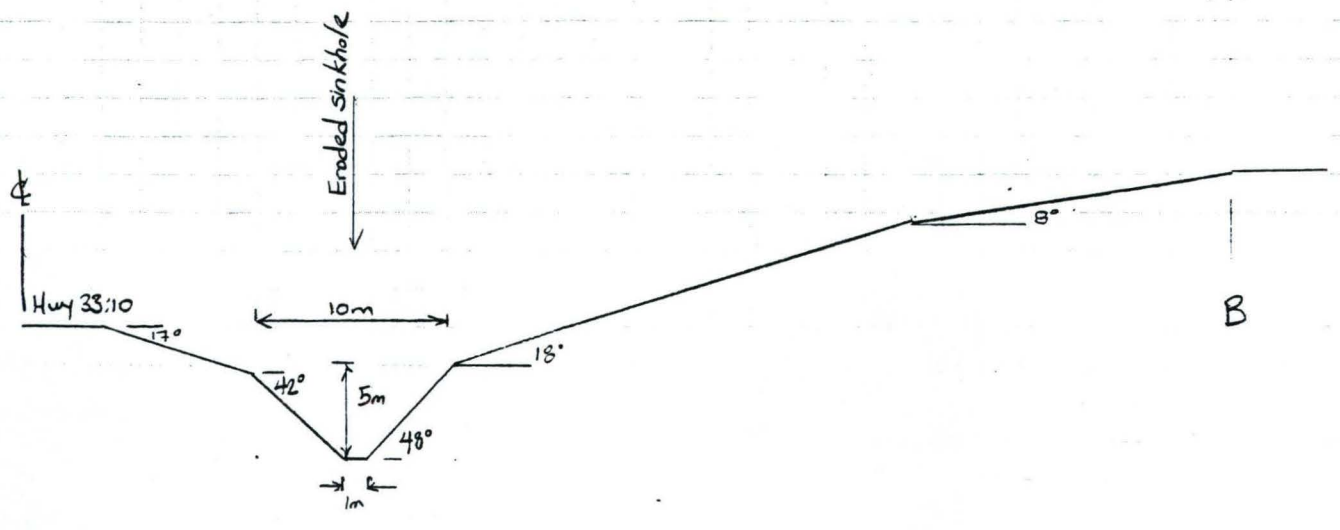
Cross-section sketches
Figure 2 N.T.S

The dimensions on the site plan and cross-sections were obtained by pacing and by the use of a hand held inclinometer, and thus should be taken as approximate.

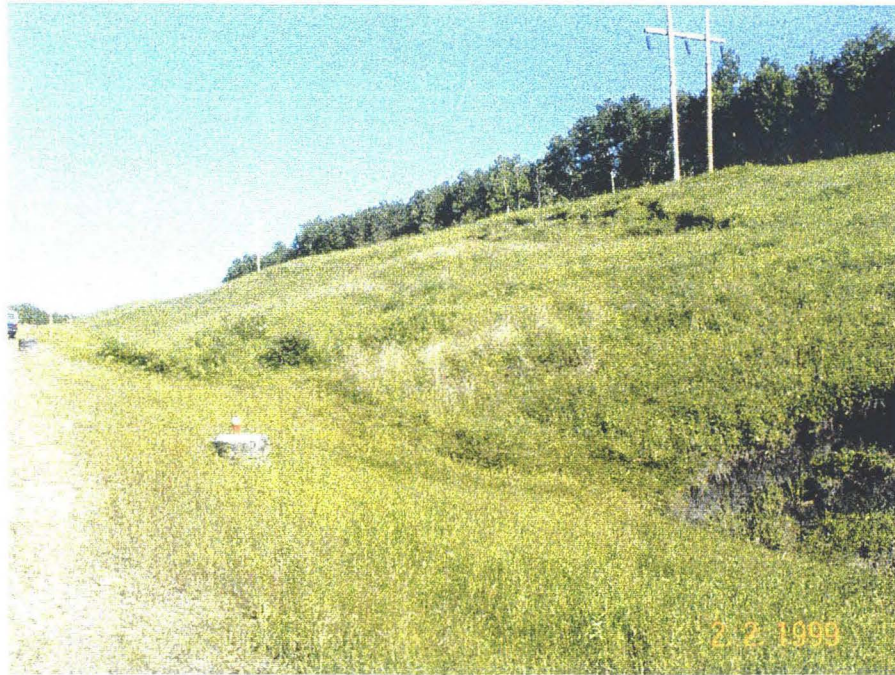
PLATE 1

The reason for leaving the slide area alone is to avoid causing any further disturbance, which may create movements. Currently, the sloughed material at the base of the embankment slide (toe of the slide) is acting as a type of berm that is helping to stabilize the slope and also to prevent any potential movement of the power pole located at the top of the slope.

VIEW OF NORTH EMBANKMENT SLIDE AREA LOOKING WEST

Our immediate recommendation is to fix the eroded section of embankment while doing nothing to the slide area.

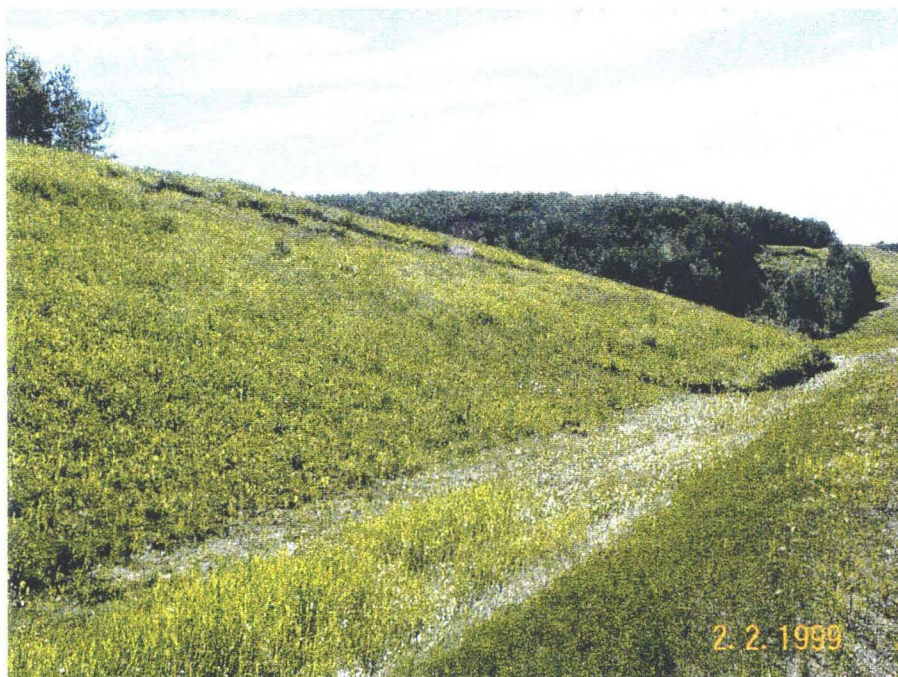
It was observed, during the site inspection that the toe of the slide appeared to be encroaching somewhat into the north ditch, however this does not appear to impede runoff flow or posing any immediate threat to the highway. Should the toe of the slide become a concern, a culvert maybe installed along the toe to better facilitate the flow of water through the ditch, and backfilled at the top in order to help stabilize the slope.

VIEW OF NORTH EMBANKMENT SLIDE AREA LOOKING EAST

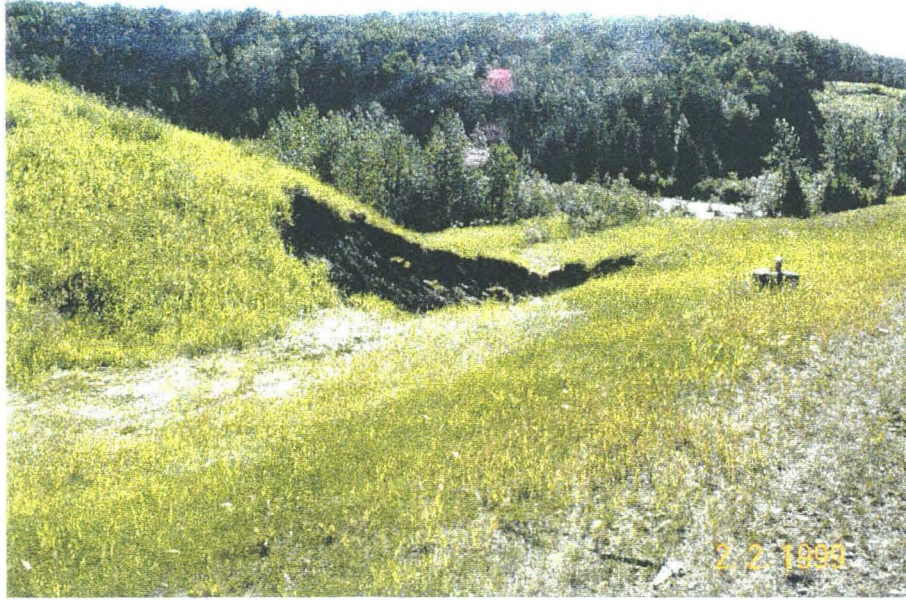
<p>THURBER</p>
<p>PLATE 2</p>

Due to the recent amount of high rainfall in the area over the past two months, of which have caused high runoff flows to occur along the ditches of the highway, severe erosion of the north ditch has occurred.

VIEW OF ERODED EMBANKMENT SECTION LOOKING EAST

To fix the eroded section of highway we recommend using inorganic clay or gravel fill compacted to a minimum 95% Standard Proctor placed in 300-mm lifts to fill the eroded section. Fill material can be obtained from the slope surface above the eroded section provided that the embankment slide area remains undisturbed, a minimum slope angle of 3H:1V should be maintained for the borrow area, and the topsoil layer be stripped off prior to fill placement. In addition, a topographic survey of the slope surface should be conducted.

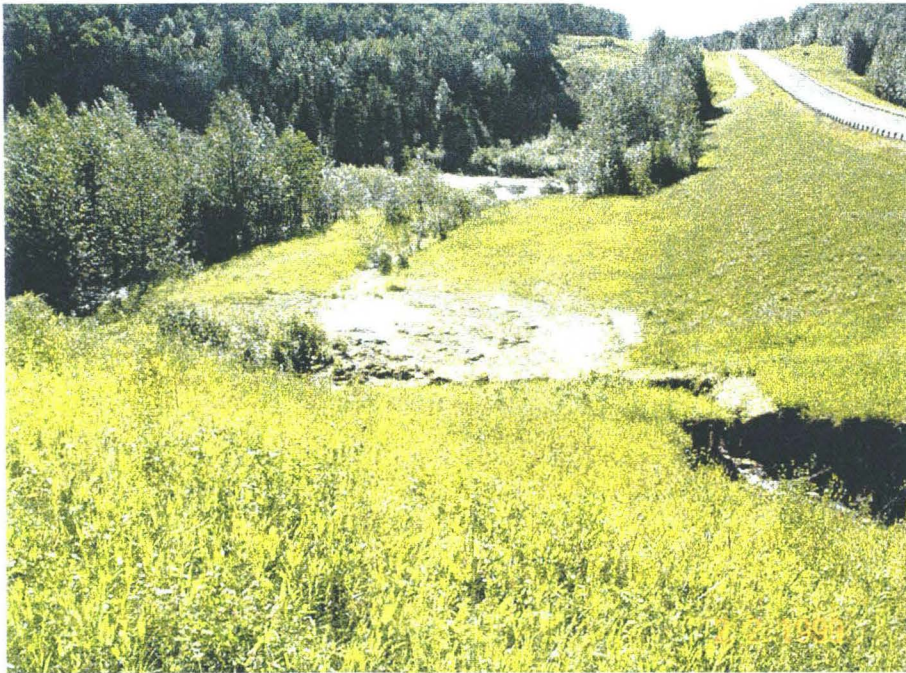
VIEW OF MATERIAL ERODED FROM EMBANKMENT AT
BASE OF SLOPE LOOKING EAST

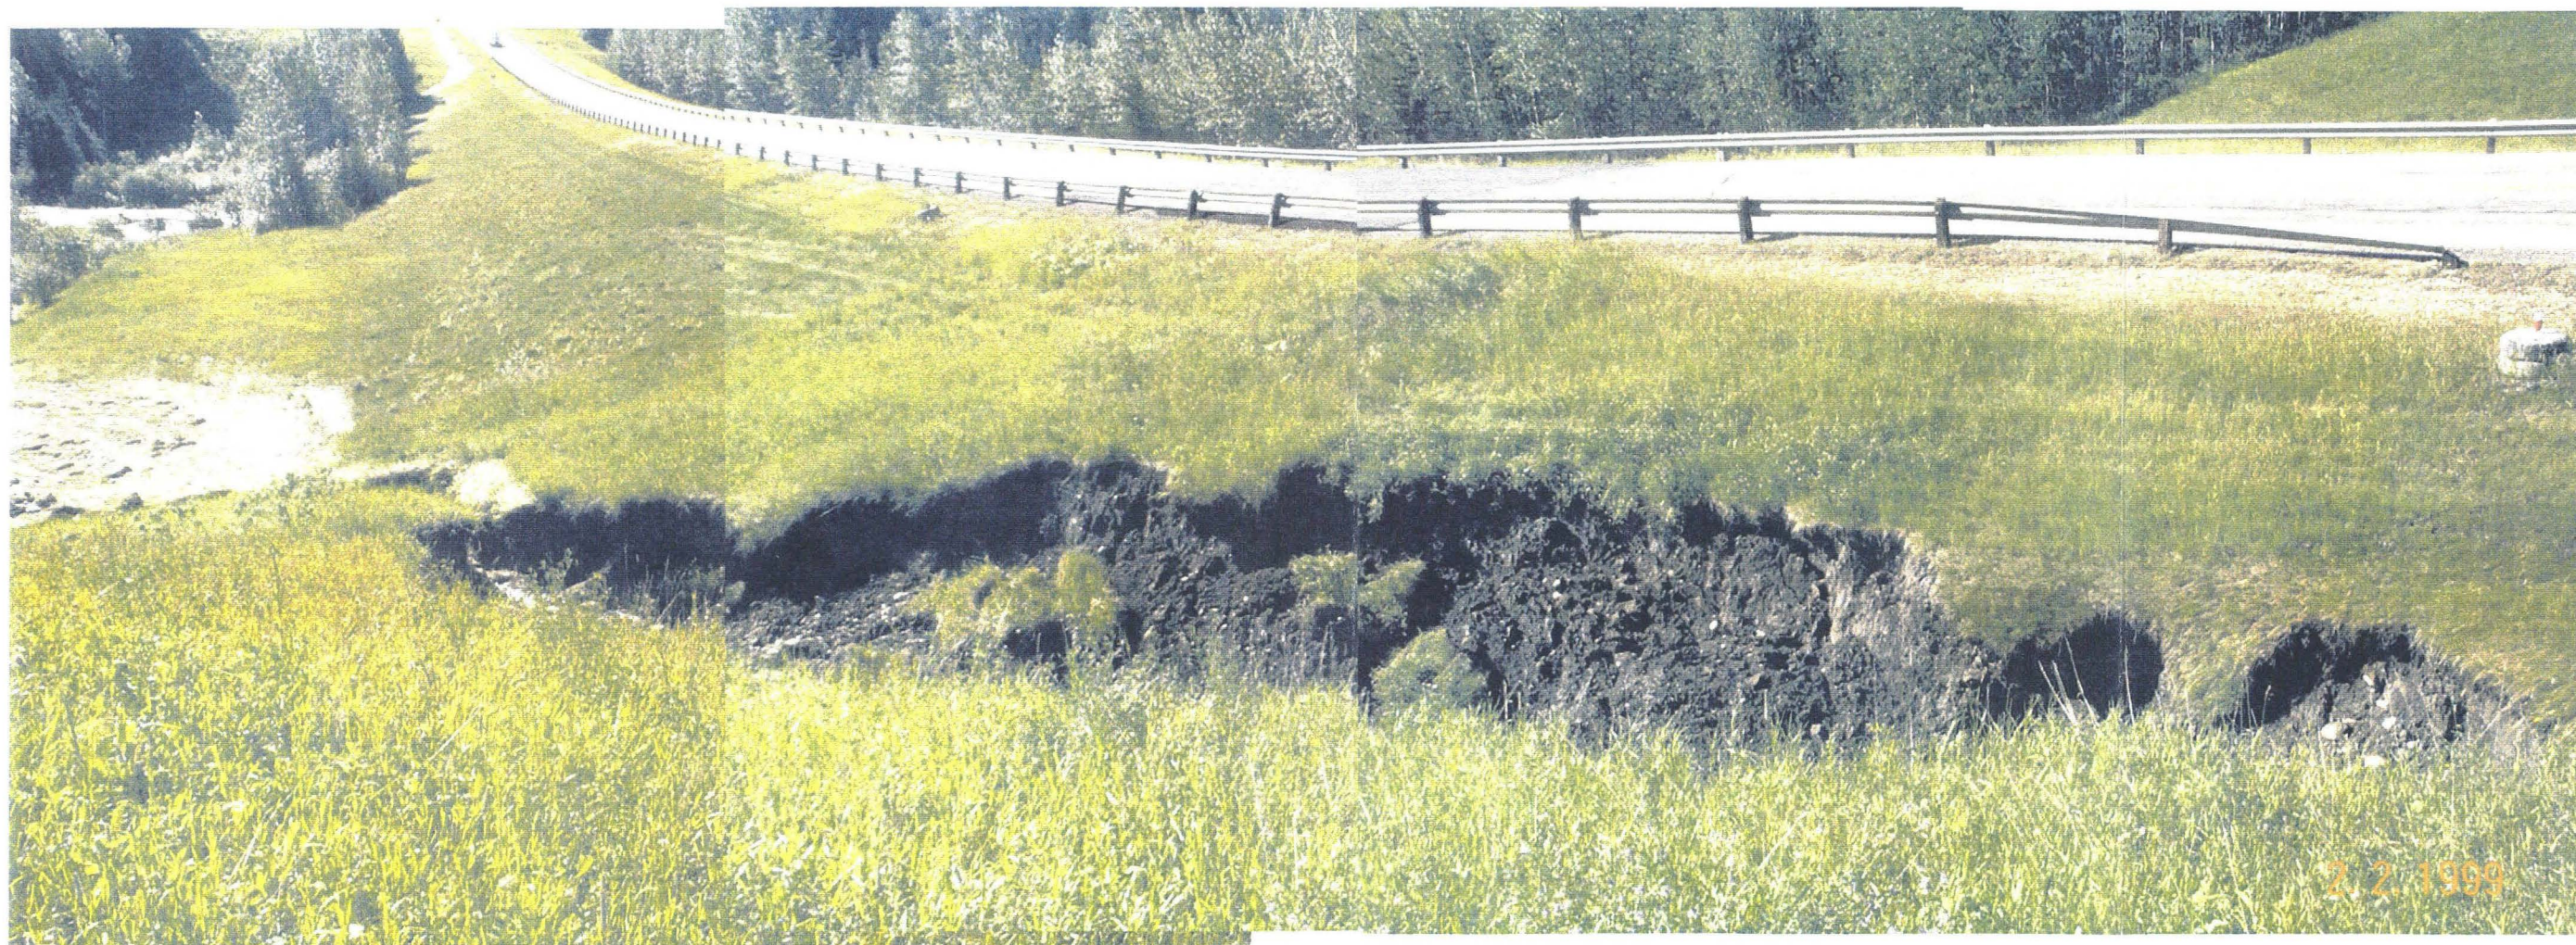
PLATE 3

The erosion has created an open hole approximately 35 to 45 m long, 8 to 10 m wide, and 4 to 5 m deep, as can be seen in Plate 3 at the end of this report.

VIEW OF ERODED SECTION OF EMBANKMENT ON NORTH SIDE OF HIGHWAY 33

Short-term remedial solutions should consist of providing erosion protection for the backfilled area of the north ditch along the area where the severe ditch erosion exists. A topographic survey of the area the area will be required.

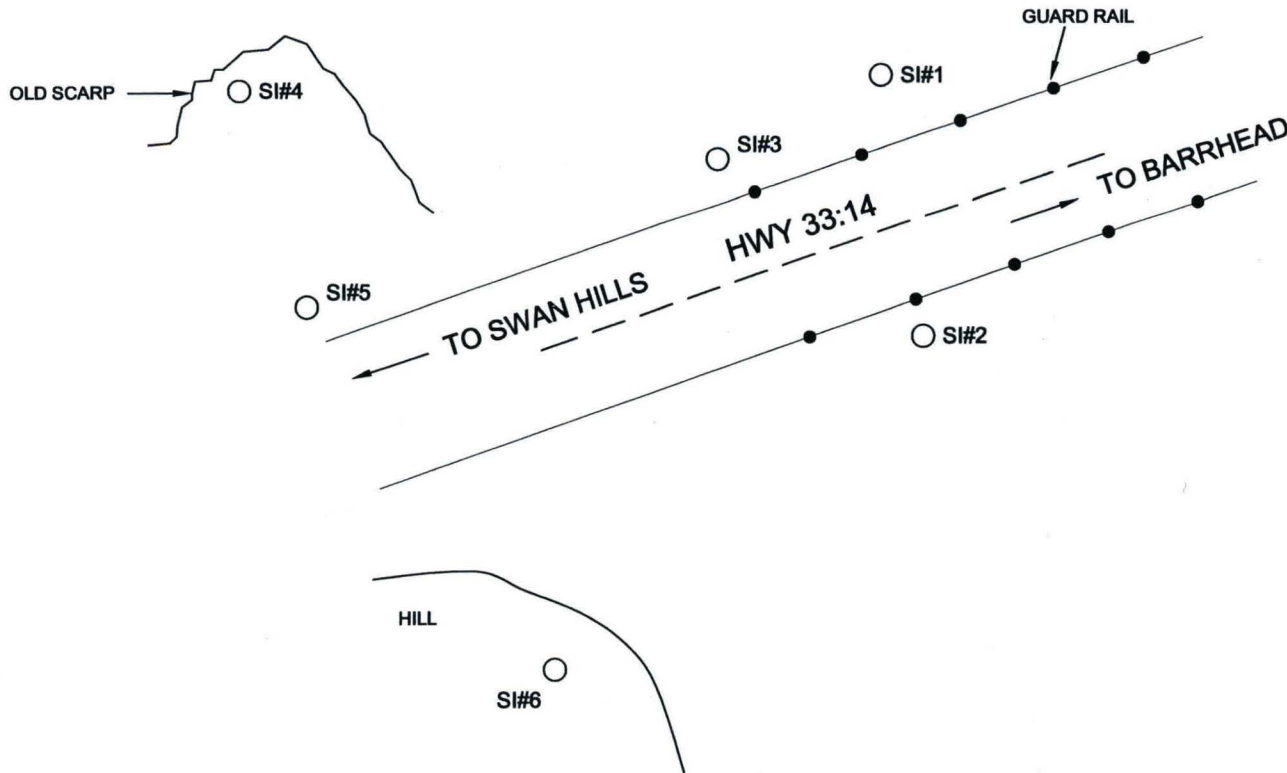
FIGURE SH5 (NC) - 1

SH5 (NC) : HWY 33:10
MORSE RIVER SLIDE
SITE PLAN N.T.S
