**PEACE REGION (SWAN HILLS AREA) GEOHAZARD ASSESSMENT
HWY 33:12 EMBANKMENT SLUMP (SH9)
2005 ANNUAL INSPECTION REPORT**

This letter documents the 2005 annual site inspection of an area of former slope instability located along Hwy 33:12 about 23 km north of Swan Hills, Alberta. Thurber Engineering Ltd. (Thurber) undertook this inspection in partial fulfillment of our Geotechnical Services for Geohazard Assessment, Instrumentation Monitoring and Related Work contract (CE047/2004) with Alberta Infrastructure and Transportation (AIT).

**HWY 33:12 EMBANKMENT SLUMP
23 km NORTH OF SWAN HILLS (SH9)
UPDATED SITE SKETCH PLAN (JUNE 7, 2005)**

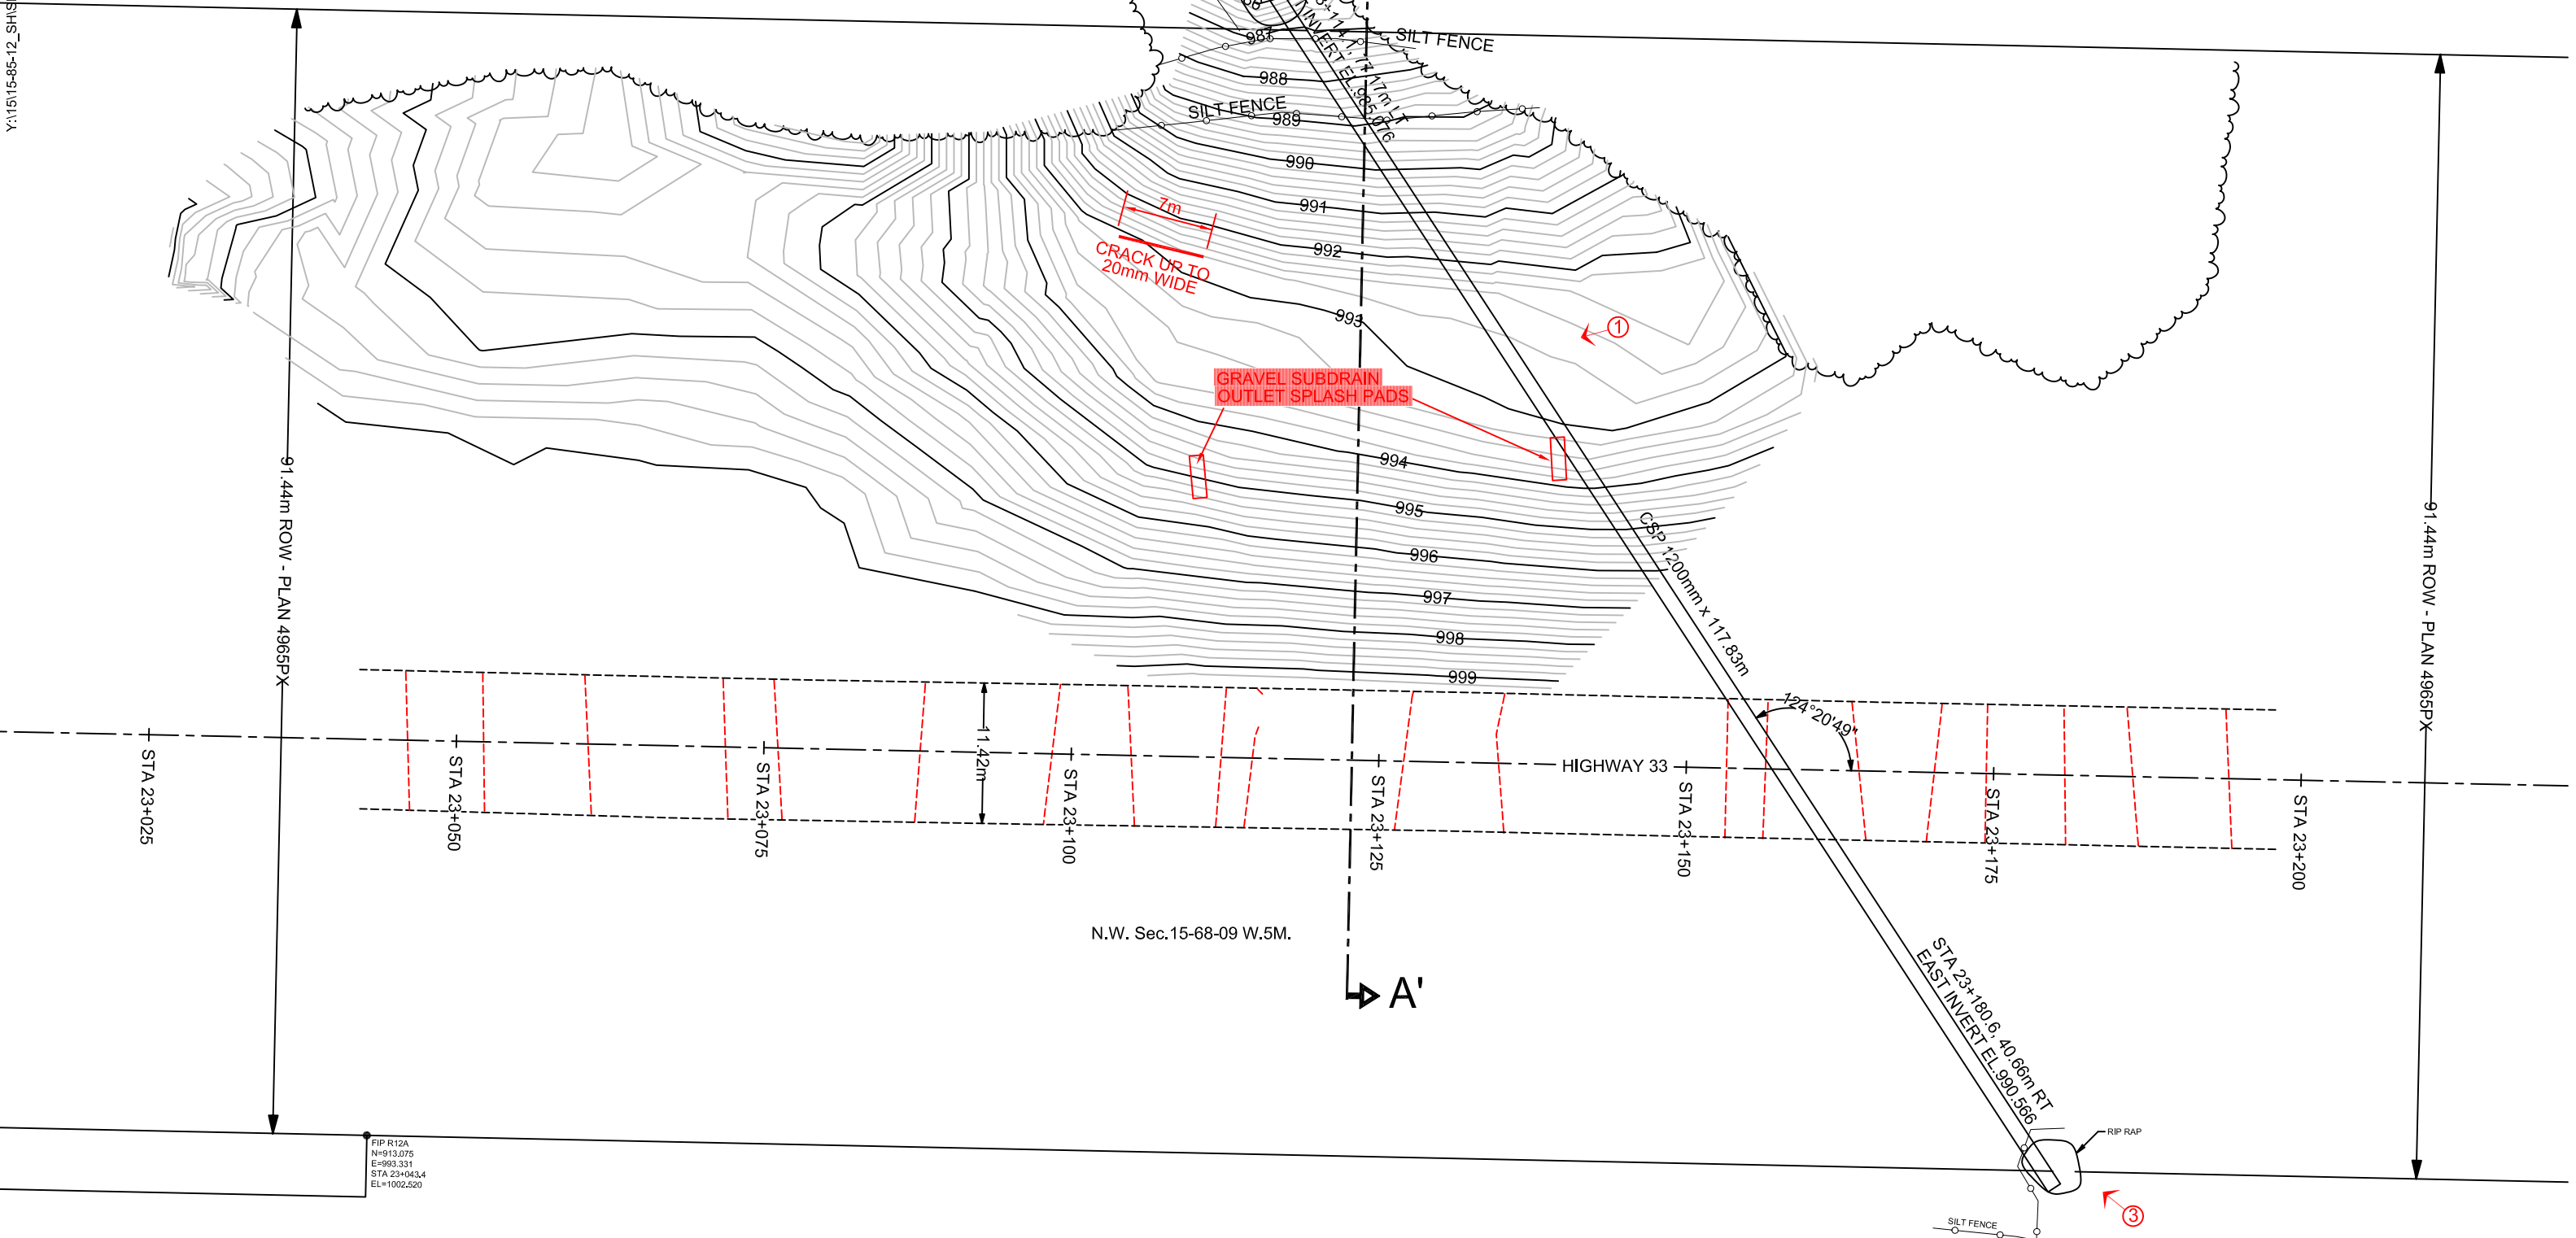
The changes in condition since repairs were completed last fall are shown on the attached site sketch plan and cross-section, which shows the updated remediation measures. Selected photographs taken during the visit are also attached.

Grass was just beginning to sprout on the recently rehabilitated west sideslope. Two silt fences were installed across the slope in a north-south fashion above the culvert outlet, and were functioning well but had a couple of loose spots. An additional silt fence located lower down the slope along the south edge of the creek was loose. A 7 m long crack up to 20 mm wide was observed right at the grade change of the flatter upper slope and lower steeper slope nearer the south side of the old slump (see attached drawing).

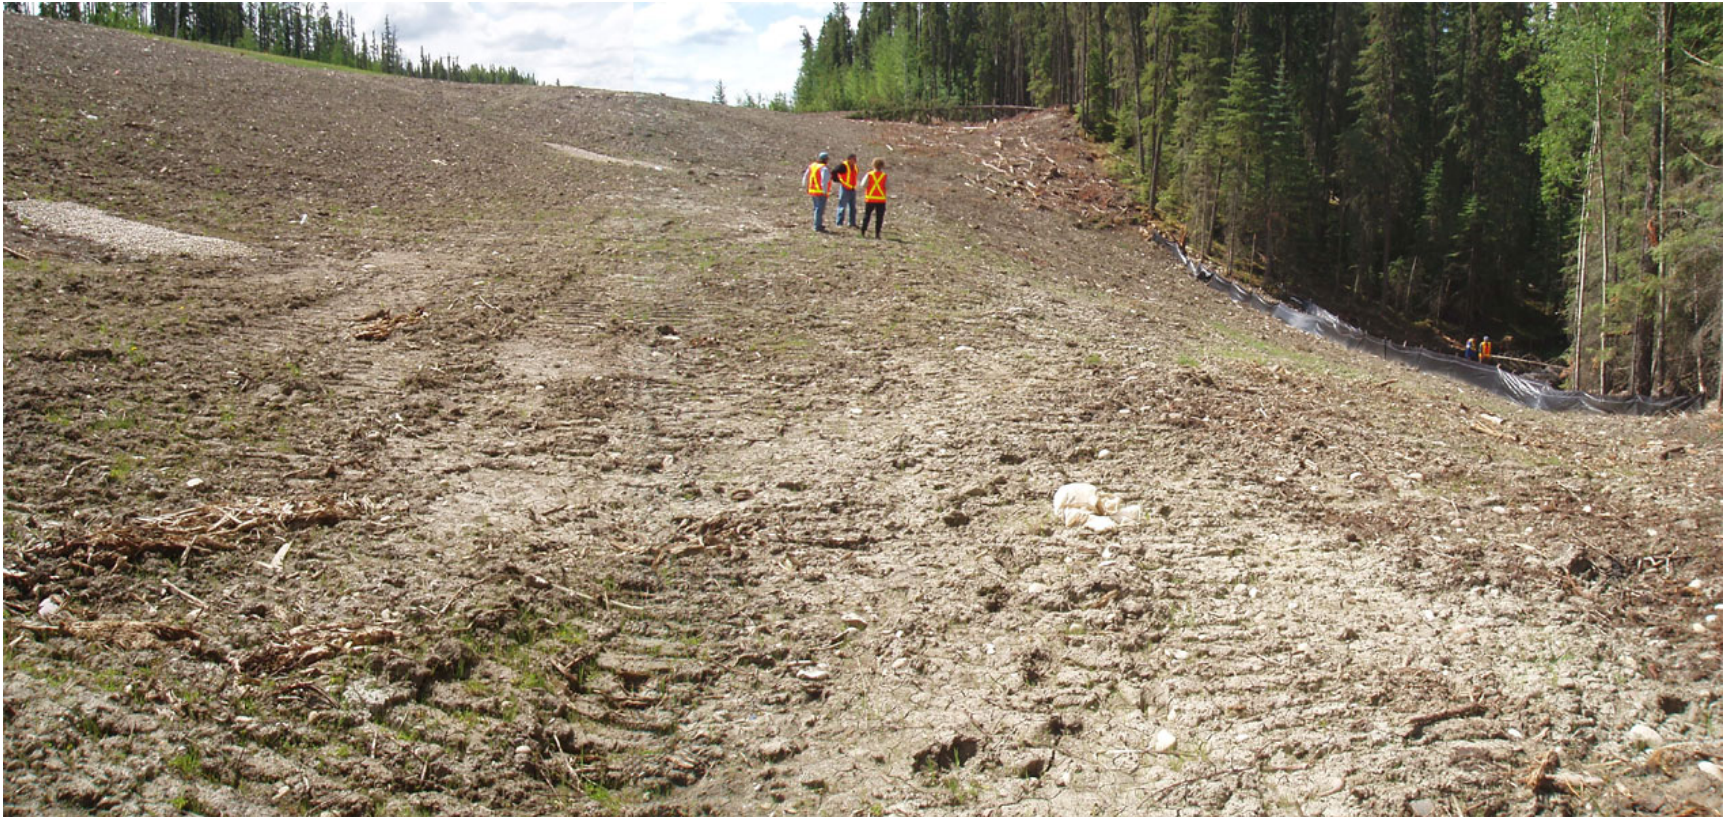
Photo 1: Looking south to southwest along slope at gravel drains and culvert outlet.

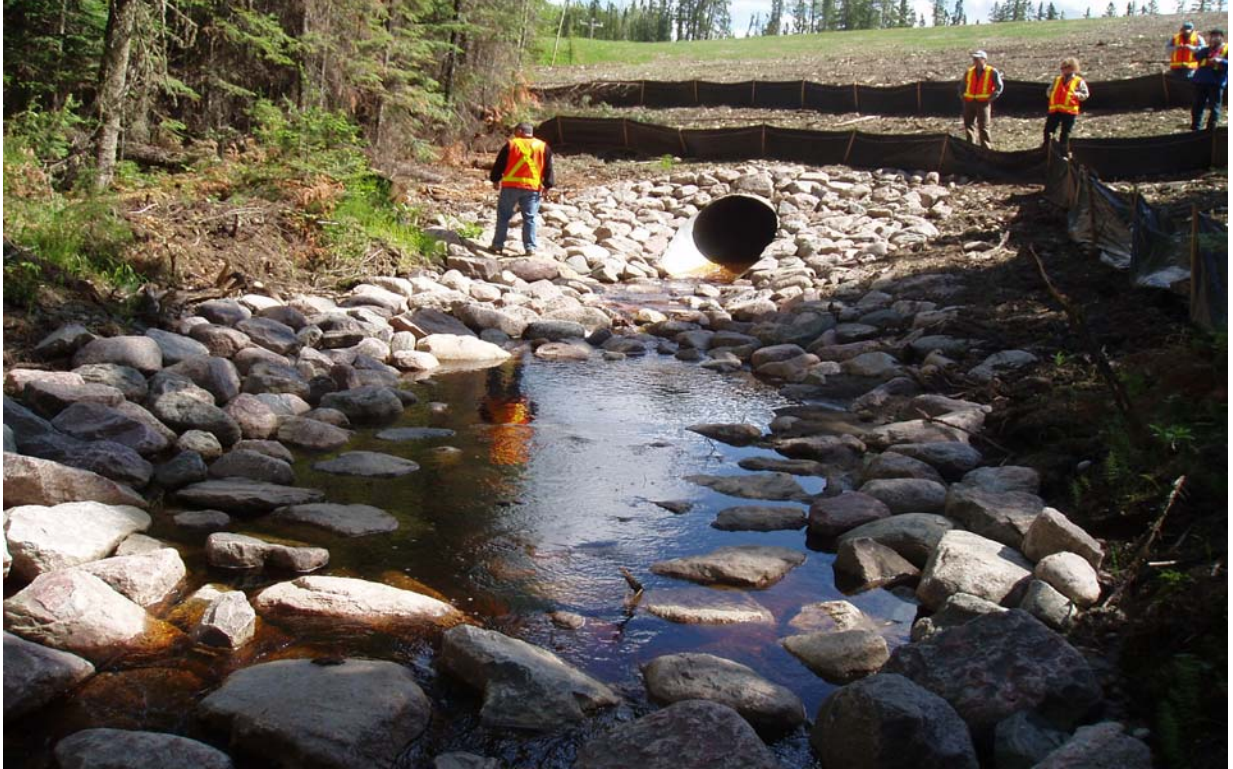
Photo 2: Looking northeast at culvert outlet. Note loose silt fence south of creek.

It is recommended that the lower silt fence along the south side of the creek, and the few loose spots on the silt fences further up the slope west of the highway be repaired by tightening and rebasing it into the soil. Similarly, the silt fence east of the highway above the culvert inlet should be reinstated until the grass has fully caught.

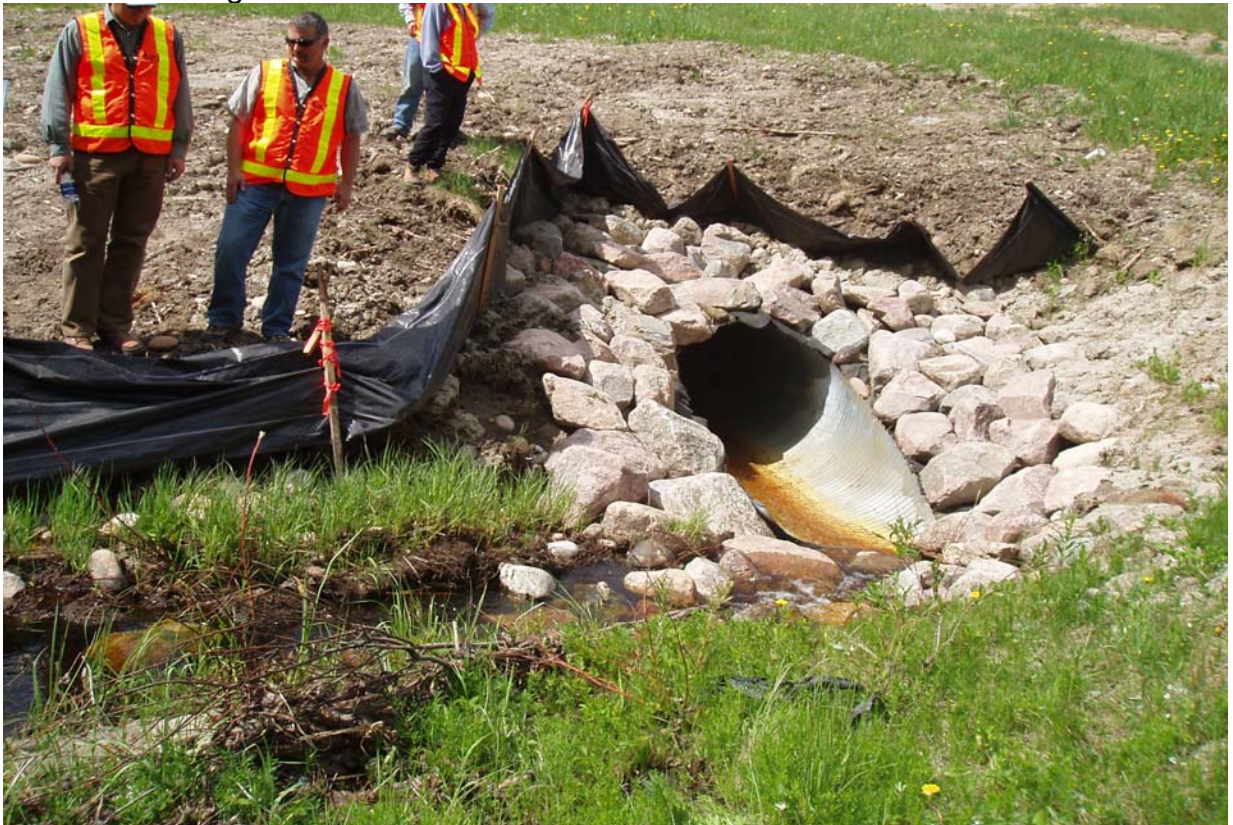
The creek channel immediately upstream of the rehabilitated culvert inlet on the east side of the highway was approaching the culvert at a severe skew to the culvert alignment. The freshly placed riprap was also slightly higher than the culvert invert elevation. During construction it was not possible to regrade the channel due to the presence of a gas line along the north edge of the highway right-of-way.

The slumping that occurred prior to repairs at the culvert inlet was likely caused by erosion, and possibly hampered by debris in the pipe. The recent repairs have remedied this situation, however ongoing erosion is possible due to the sharp bend in the channel immediately in front of the culvert inlet.

Photo 3: Looking west at culvert inlet. Note sharp channel bend in front of culvert and riprap higher than inlet.

Some additional riprap should be added to the outside bend of the channel upstream of the culvert inlet, to lower the risk of future erosion.
