THURBER ENGINEERING LTD.

December 8, 2006

**PEACE REGION (SWAN HILLS AREA) GEOHAZARD ASSESSMENT
HWY 33:12 EMBANKMENT SLUMP (SH 9)
2006 ANNUAL INSPECTION REPORT**

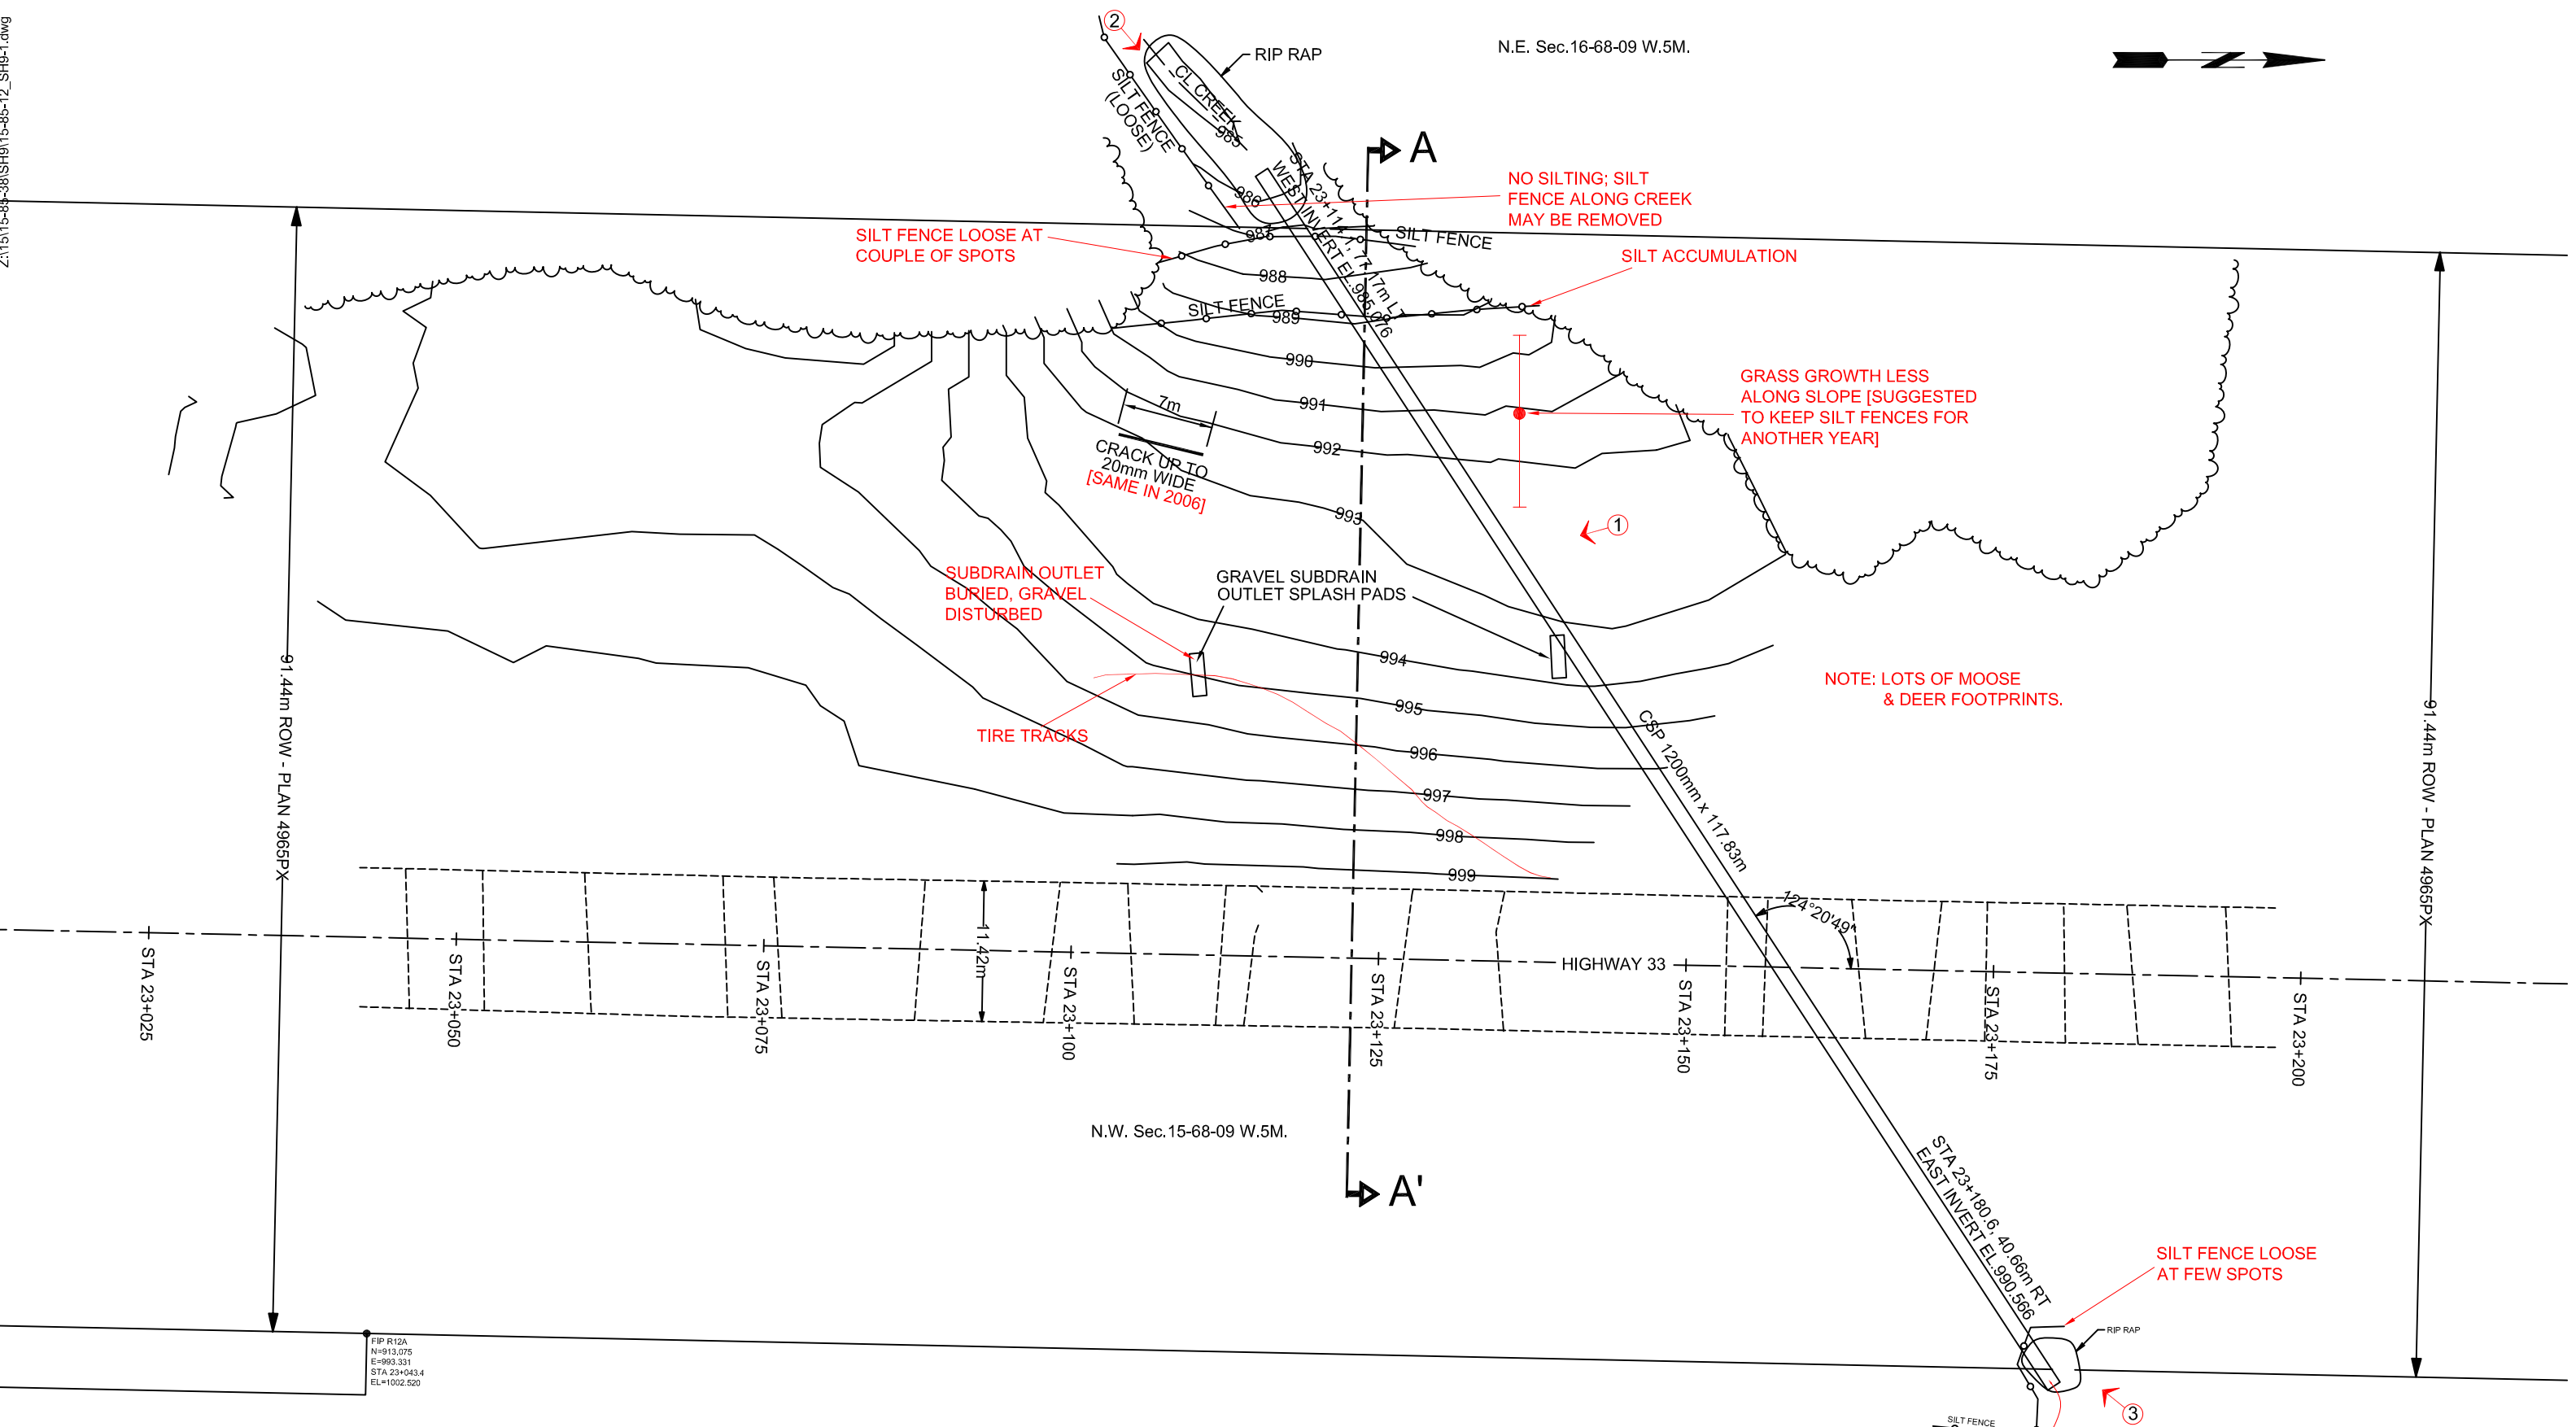
FIGURE SH9-1
HWY 33:12 EMBANKMENT SLUMP
23 km NORTH OF SWAN HILLS (SH9)
UPDATED SITE SKETCH PLAN

Grass growth was thinner along the steep section of the rehabilitated west side slope than that along the gentle slope section close to the highway. Two silt fences installed across the slope in a north-south fashion above the culvert outlet were in generally good condition, with only a couple of loose spots. It is recommended to keep the silt fences at the toe of the slope for another year, as silting was observed at the base of the silt fences. An additional silt fence located lower down the slope along the south edge of the creek was loose. No silting was observed on the silt fences along the creek and thus these silt fences may be removed. A 7 m long crack up to 20 mm wide observed in 2005, right at the grade change of the flatter upper slope and lower steeper slope nearer the south side of the old slump (see Figure), was still visible.

Prior to the 2004 repair, the previous instability was considered to have been triggered by ongoing erosion from the creek along the base of the slope. The fresh crack observed south of the culvert at the break in the west sideslope could simply be attributed to settlement of the freshly placed fill, but it could possibly be a reflection of the previous instability crack.

The 2004 remedial measures have improved the overall condition of the existing slump on both sides of the highway. However, the crack observed south of the culvert at the boundary of the slope segments should be periodically monitored, to see if it is a reflection of a portion of the previous slump or simply recent settlement of the fill, and to warn of a potential worsening of the condition.

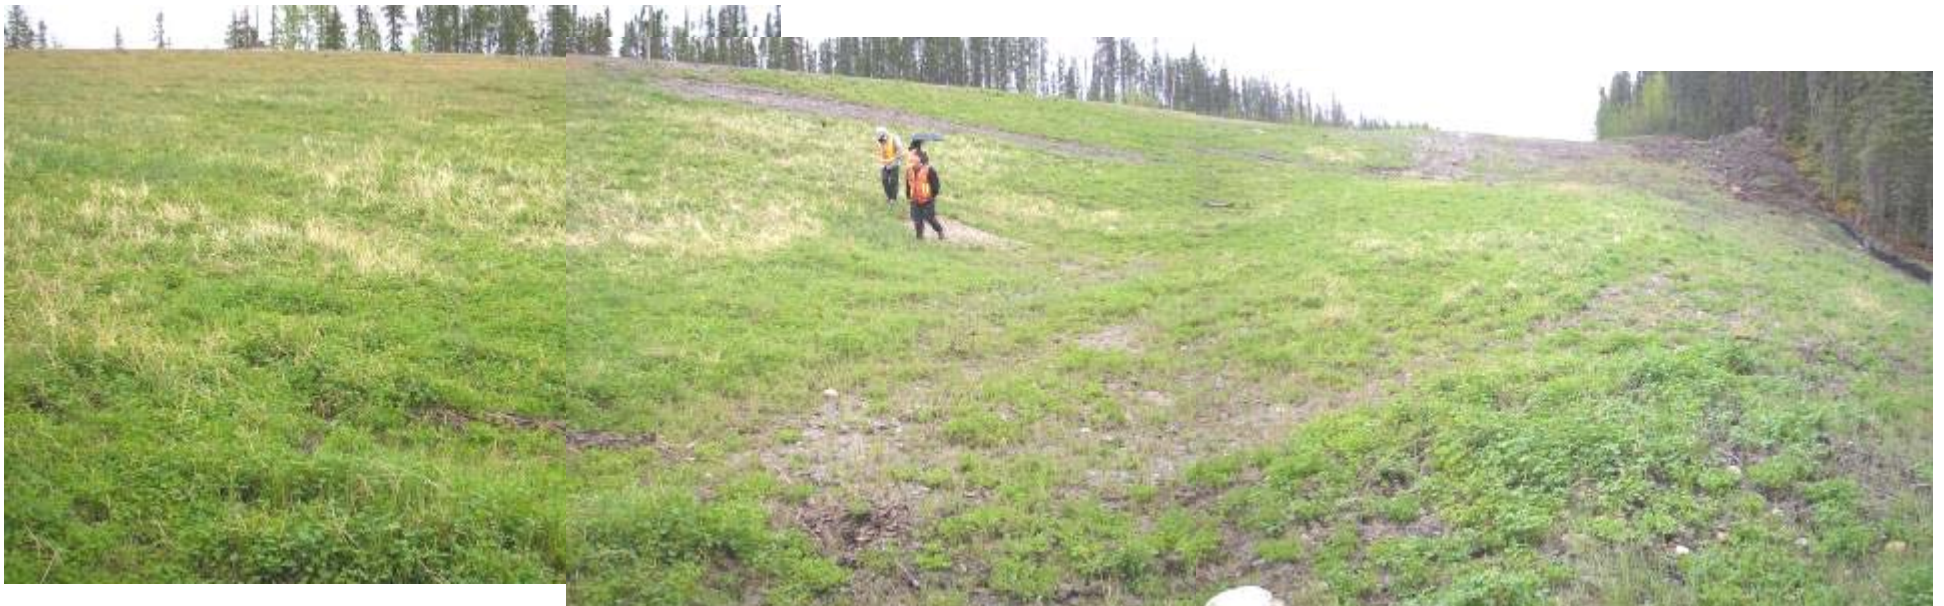
Photo 1 - Looking south to southwest along slope and culvert outlet, May 23, 2006.

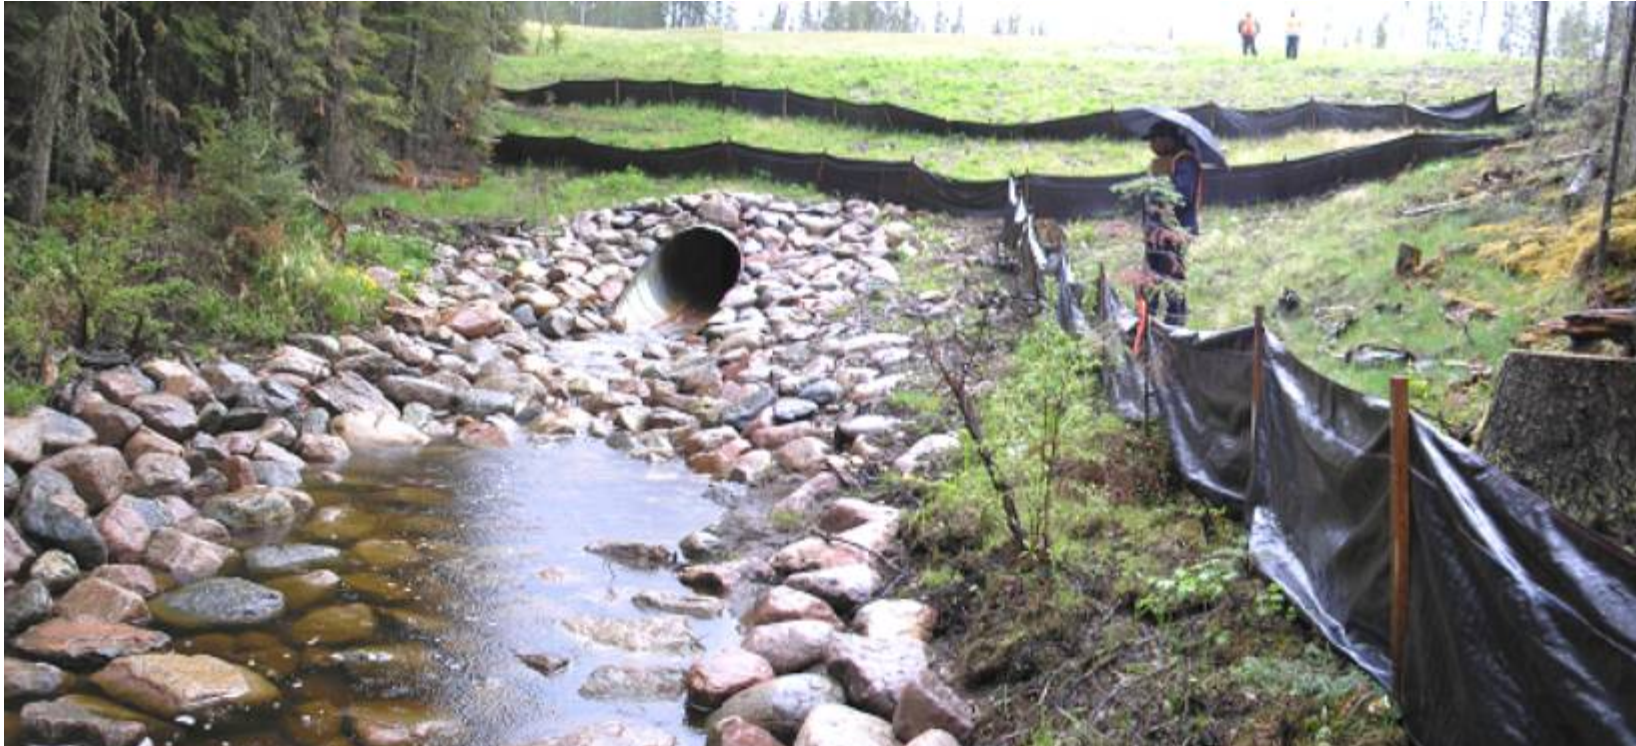
Photo 2 - Looking northeast at culvert outlet. Note loose silt fence south of creek, May 23, 2006.

It is recommended to tighten and re-base the lower silt fence at the toe of slope, west of the highway into the soil. The silt fence along the creek can be removed. Similarly, the silt fence east of the highway above the culvert inlet should be re-instated. The grass cover on the steep section of the slope was thin, and it might need reseeding if it does not get dense.

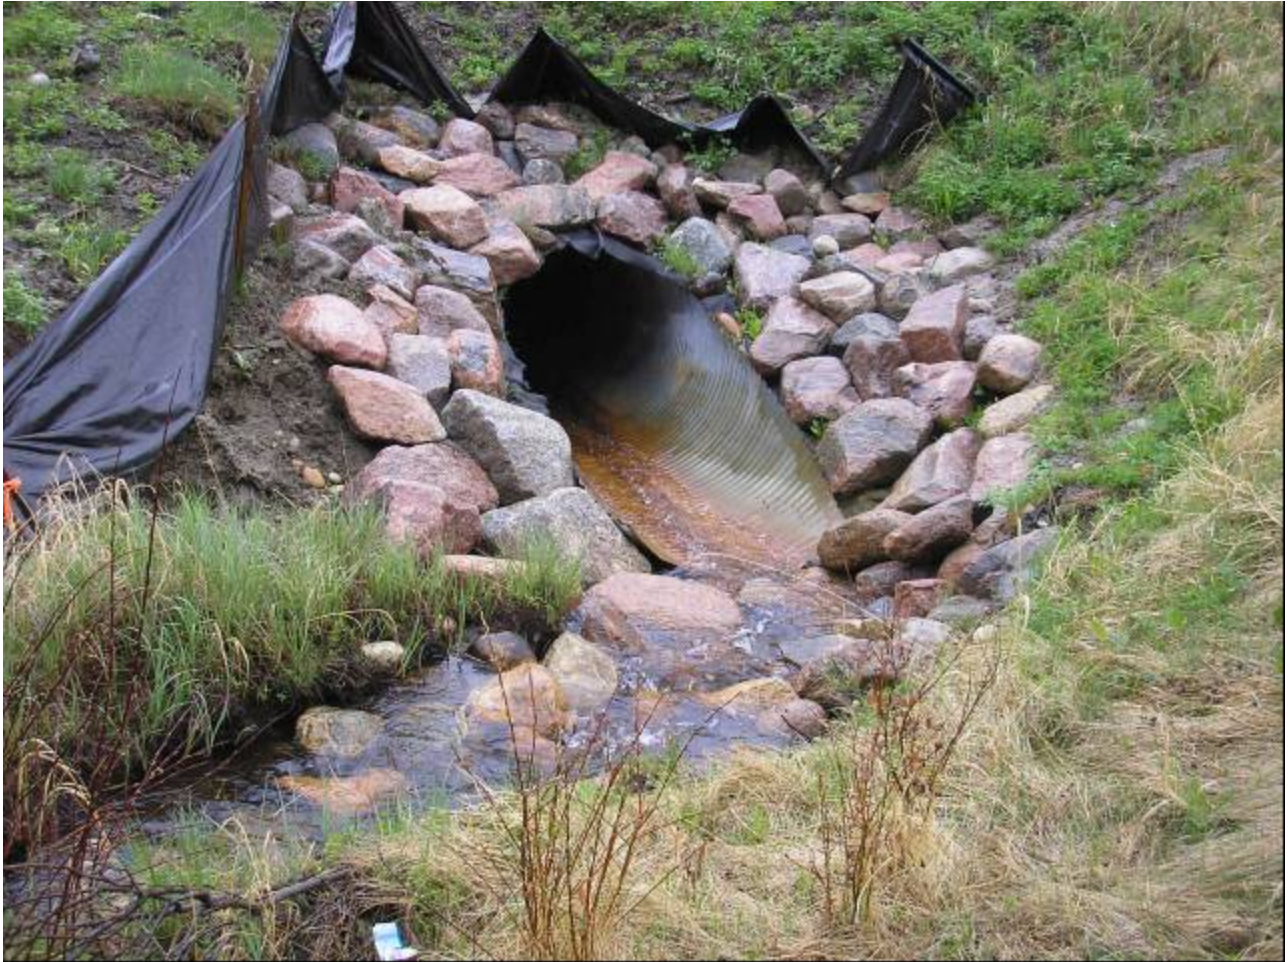
The creek channel immediately upstream of the rehabilitated culvert inlet on the east side of the highway was approaching the culvert at a severe skew to the culvert alignment. The freshly placed riprap was also slightly higher than the culvert invert elevation. The silt fence installed at the inlet was loose at couple of spots.

The slumping on the upstream side (east) was also likely caused by erosion, and possibly hampered by debris in the pipe. The recent repairs have remedied this situation; however future erosion is possible due to the sharp bend in the channel immediately in front of the culvert inlet.

Photo 3 - Looking west at culvert inlet. Note sharp channel bend in front of culvert and riprap higher than inlet, May 23, 2006.

Some additional riprap should be added to the outside bend of the channel upstream of the culver inlet, to lower the risk of future erosion.
