SITE NUMBER SH 18	SITE NAME Deer Mountain	HIGHWAY & KM HWY 33:14 KM 6	PREVIOUS INSPECTION DATE June 17, 2013	INSPECTION DATE July 2, 2014
LEGAL DESCRIPTION LSD 11-23-69-09 W5M	NAD 83 COORDINATES N 6,095,038 E 611,315	PREVIOUS RISK ASSESSMENT		
		PF: 9	CF: 2	TOTAL: 18
		CURRENT RISK ASSESSMENT		
		PF: 9	CF: 2	TOTAL: 18

CLIENT: 	DWN BY:	BGR	PROJECT: GEO HAZARD ASSESSMENT PEACE REGION (SWAN HILLS)	DATE:	NOVEMBER, 2014	
	CHK'D BY:	JAR		PROJECT No.:	EG10030	
 AMEC Environment & Infrastructure 5681-70 STREET, EDMONTON, ALBERTA, T6B 3P6 PHONE 780-436-2152, FAX 780-435-8425	DATUM:	-	TITLE:	SH18: HWY 33:14 km 6, DEER MOUNTAIN, AB SITE PLAN	REV. No.:	A
	PROJECTION:	-			FIGURE No.:	FIGURE 1
	SCALE:	1:500 (APPROX.)

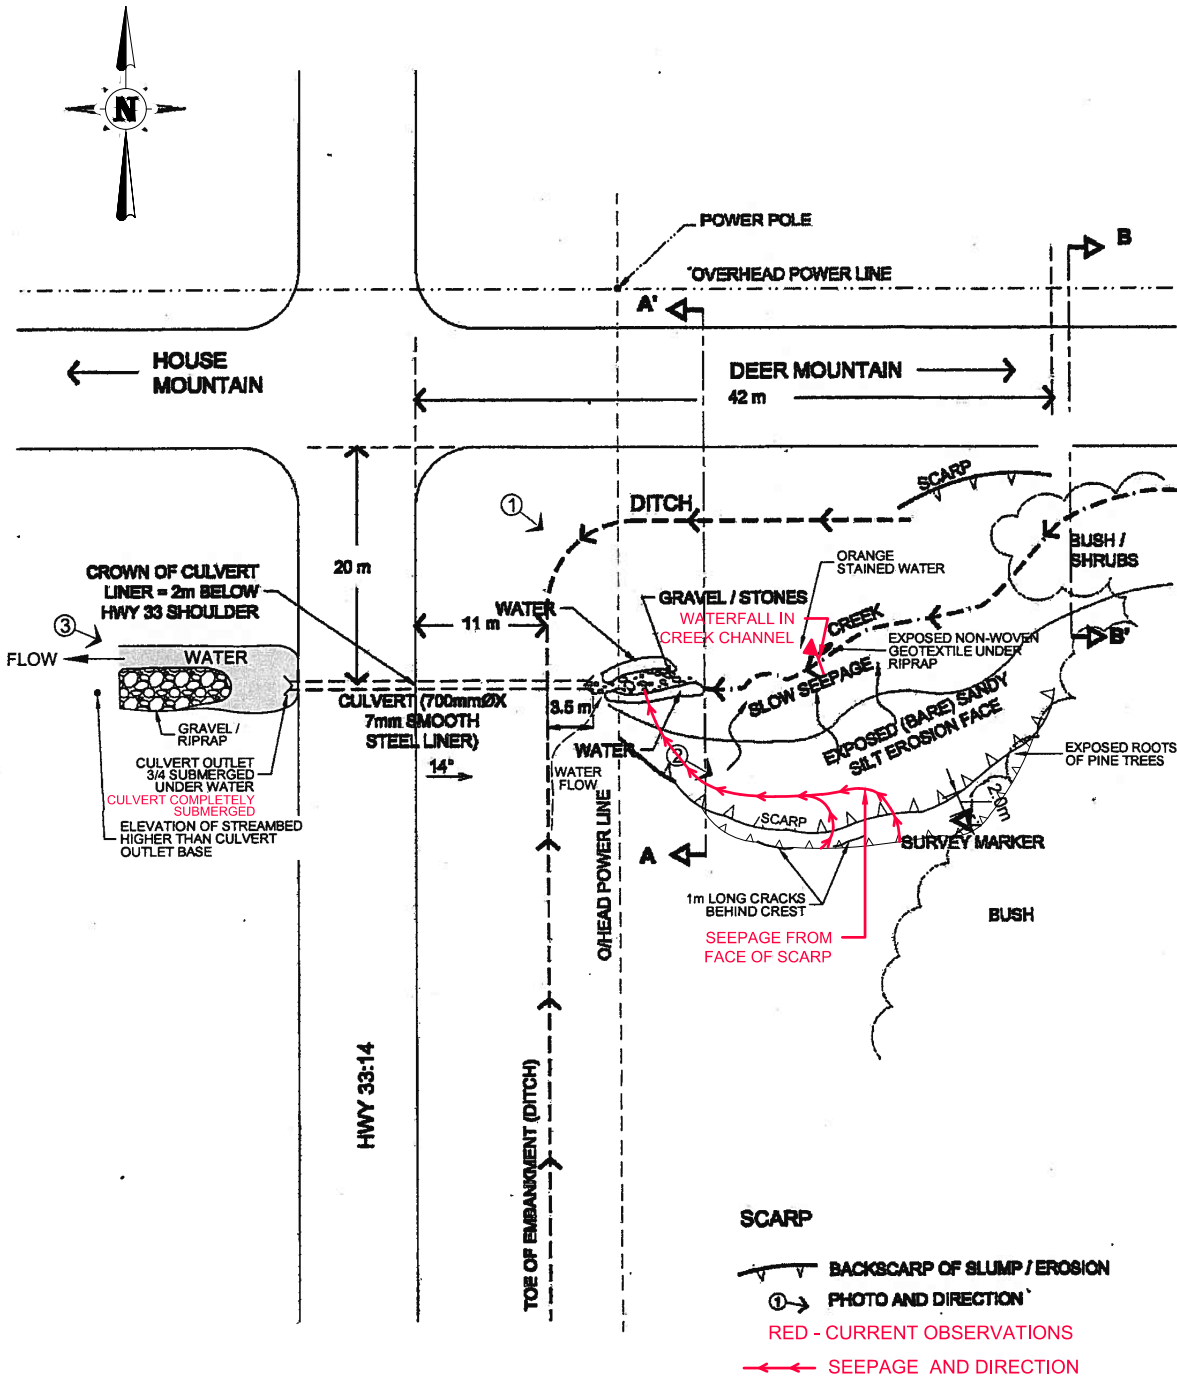
- ~ 30 m stretch of south creek bank with bowl shaped erosion/slump scarp undergoing active slumping and toe erosion. Slump scarp ~2 m high and the crest of the scarp was ~3 to 3.5 m above the elevation of the creek;
- Direction of ongoing retrogression of slump to the south/southeast away from Deer Mountain Road and Highway 33.
- Soils on the exposed scarp consisted mainly of silty clay with intermittent sand/silt seams;
- Typical width of creek ~1 m to 2 m.

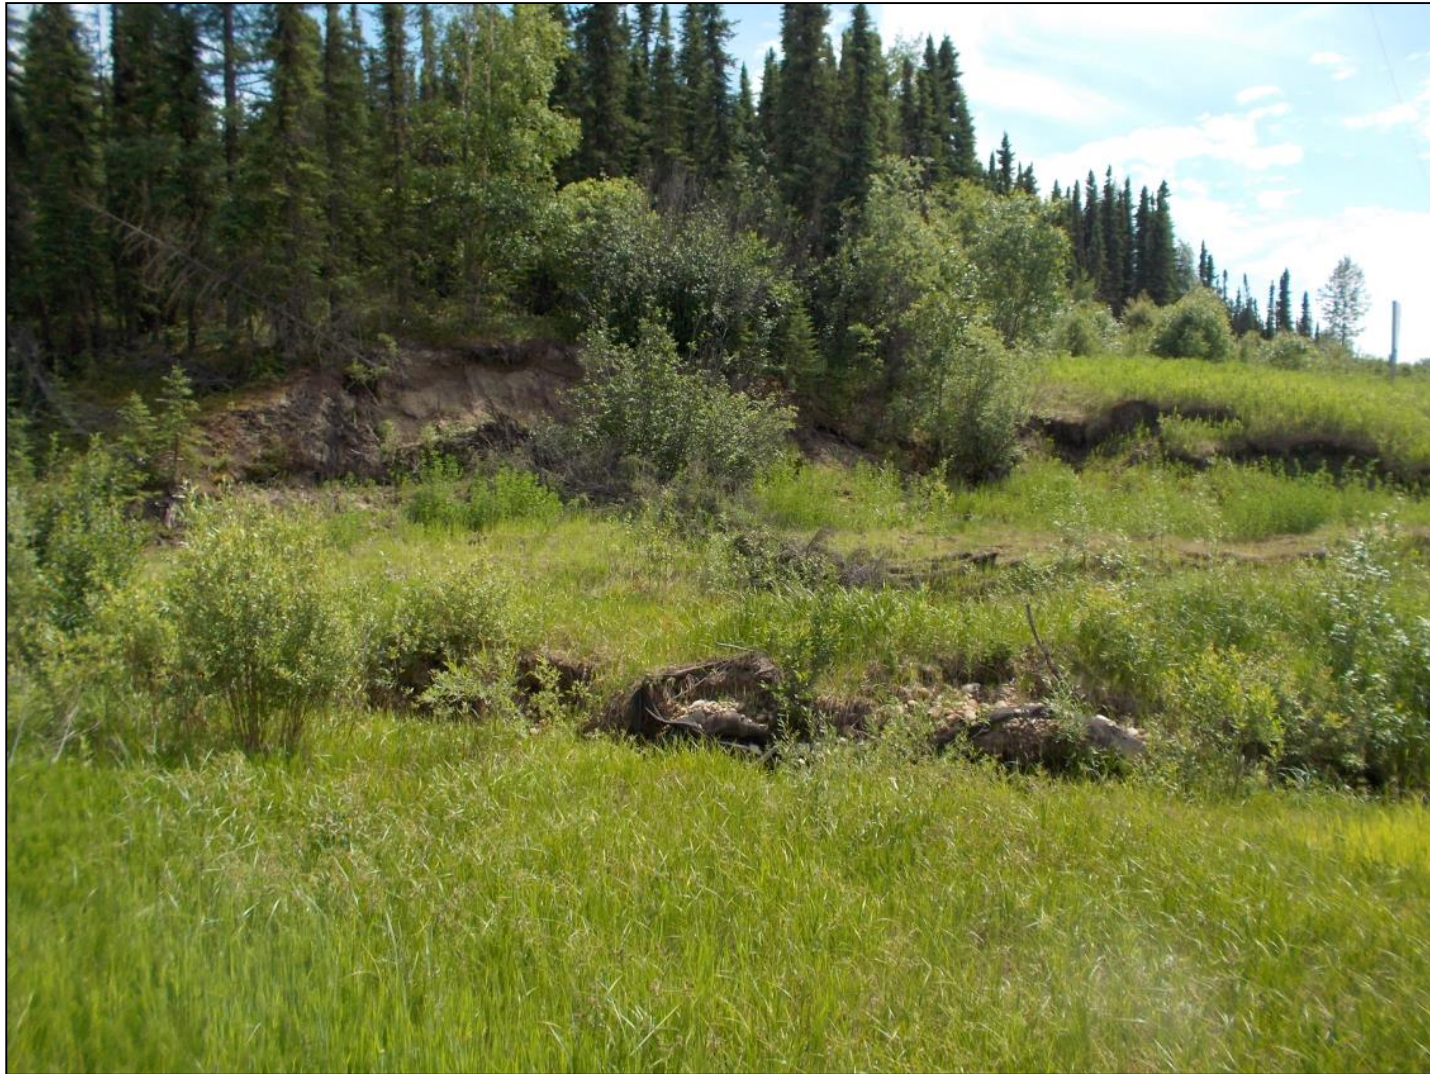
I) Slumping of slope (bank) adjacent to small creek at the south east corner of the intersection of Highway 33 and Deer Mountain Road (Photo's 1 and 2). Slumping is likely due to combination of toe erosion, silty/sandy soils, and seepage from slope.

The bioengineering wall designed to remediate the slumping/erosion failed shortly after construction (circa spring 2011). The wall may have blocked seepage from the face of the scarp and the material behind the wall became saturated. This may have been exacerbated by the natural overland drainage behind the crest of the scarp that is directed toward the slide. The wall may also have been constructed on the soft, wet, weak, colluvium within the main body of the slide mass. Although further investigation and a new design for remediation of the slumping/erosion could be considered, the slumping/erosion has not historically impacted, and currently has a low potential to impact, operation of Highway 33 and/or Deer Mountain Road. Long term remedial measures that could be considered consist of a combination of slope flattening, gravel buttressing, and seepage/drainage control with plantings.

Photo 1: Slumping of slope looking south from Deer Mountain Road. Failed biowall within main body of slide visible in centre/centre right of photo.

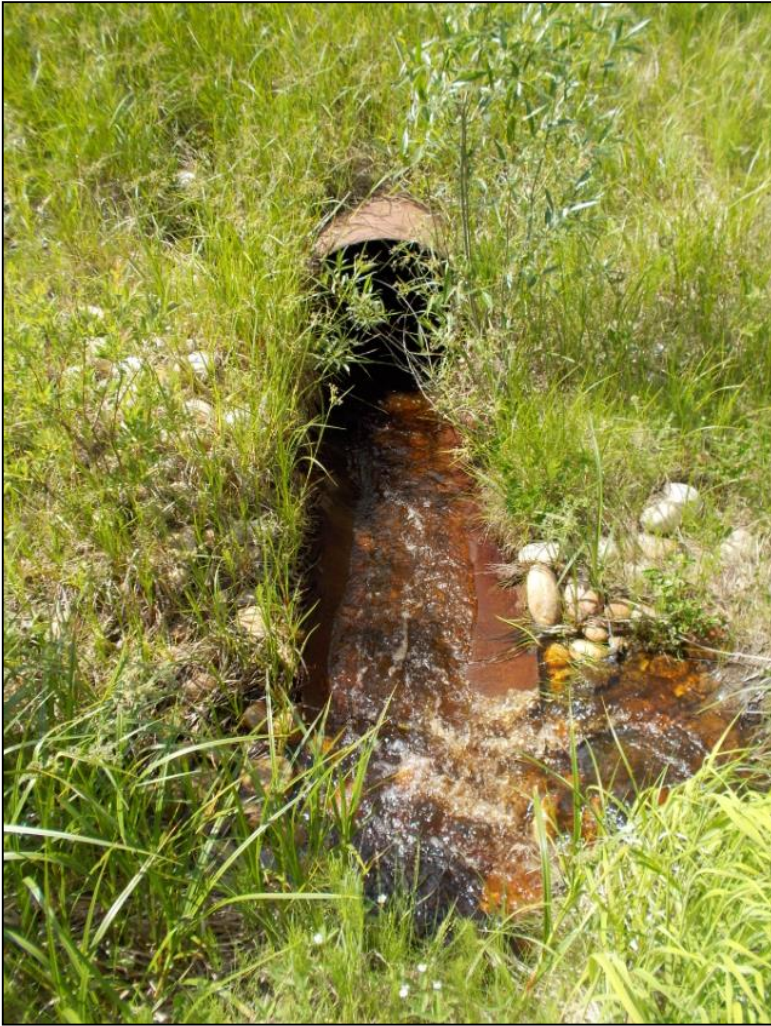
Photo 2: Culvert inlet east of Highway 33

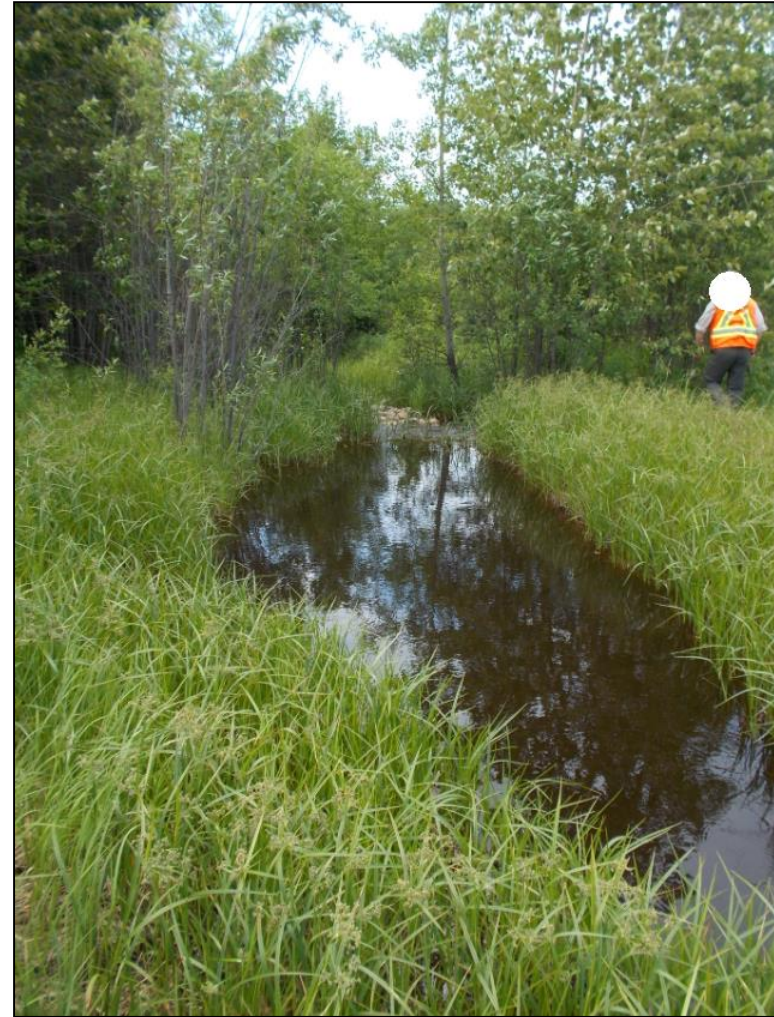
IV) At the time of the 2014 inspection, the outlet of the culvert west of Highway 33 was below water and a pond had formed downstream of the culvert likely due to a blockage in the channel (Photo 4). The culvert outlet was also below water during the 2012 and the 2013 site visits.

Photo 3: Looking west at pond downstream of culvert outlet west of Highway 33. Culvert outlet (not visible) below water at bottom of picture

Remediation of the suspected channel blockage downstream should be carried out by removal of the material causing the blockage.
