**PEACE REGION – SWAN HILLS
GEOHAZARD RISK ASSESSMENT
SITE INSPECTION FORM**

SITE NUMBER SH 18	SITE NAME Deer Mountain	HIGHWAY & KM HWY 33:14 KM 6	PREVIOUS INSPECTION DATE 02 July 2014	INSPECTION DATE 24 June 2015
LEGAL DESCRIPTION LSD 11-23-69-09 W5M	NAD 83 COORDINATES N 6095038 E 611315	PREVIOUS RISK ASSESSMENT		
		PF: 9	CF: 2	TOTAL: 18
		CURRENT RISK ASSESSMENT		
		PF: 9	CF: 2	TOTAL: 18

CLIENT: 	DWN BY:	VH	PROJECT: GEO HAZARD ASSESSMENT PEACE REGION (SWAN HILLS)	DATE:	JULY, 2015	
	CHK'D BY:	DJM		PROJECT No.:	EG10030	
amec foster wheeler Environment & Infrastructure 5681-70 STREET, EDMONTON, ALBERTA, T6B 3P6 PHONE 780-436-2152, FAX 780-435-8425	DATUM:	-	TITLE:	SH18: HWY 33:14 km 6, DEER MOUNTAIN, AB SITE PLAN	REV. No.:	A
	PROJECTION:	-			FIGURE No.:	FIGURE 1
	SCALE:	1:500 (APPROX.)

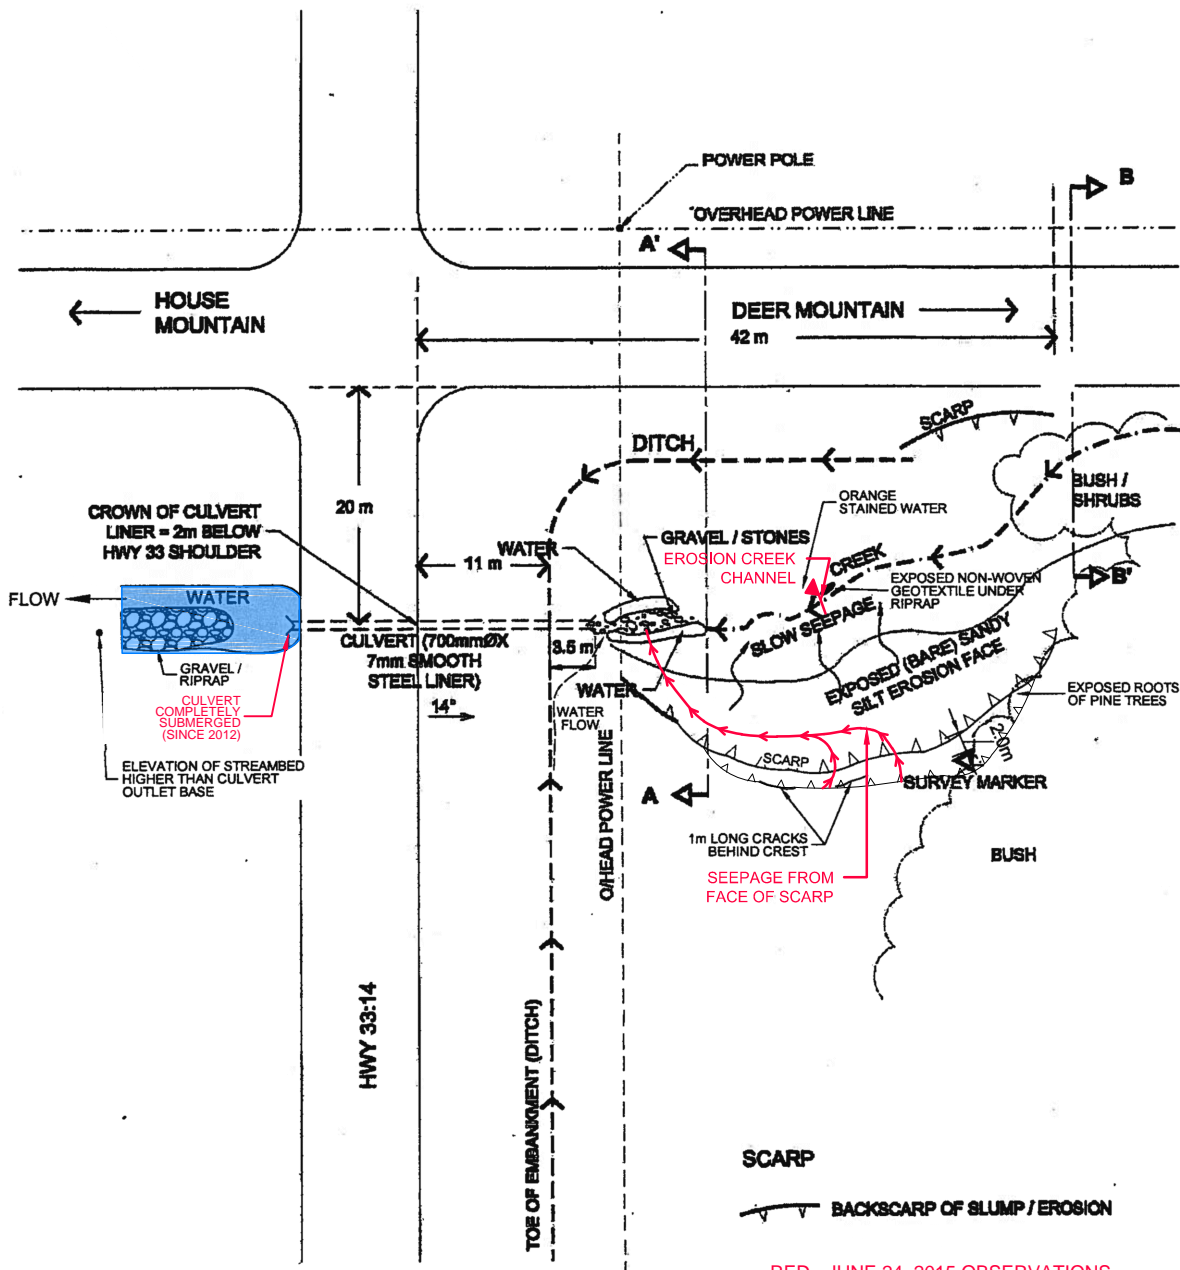
SCARP
BACKSCARP OF SLUMP / EROSION

RED - JUNE 24, 2015 OBSERVATIONS
SEEPAGE AND DIRECTION

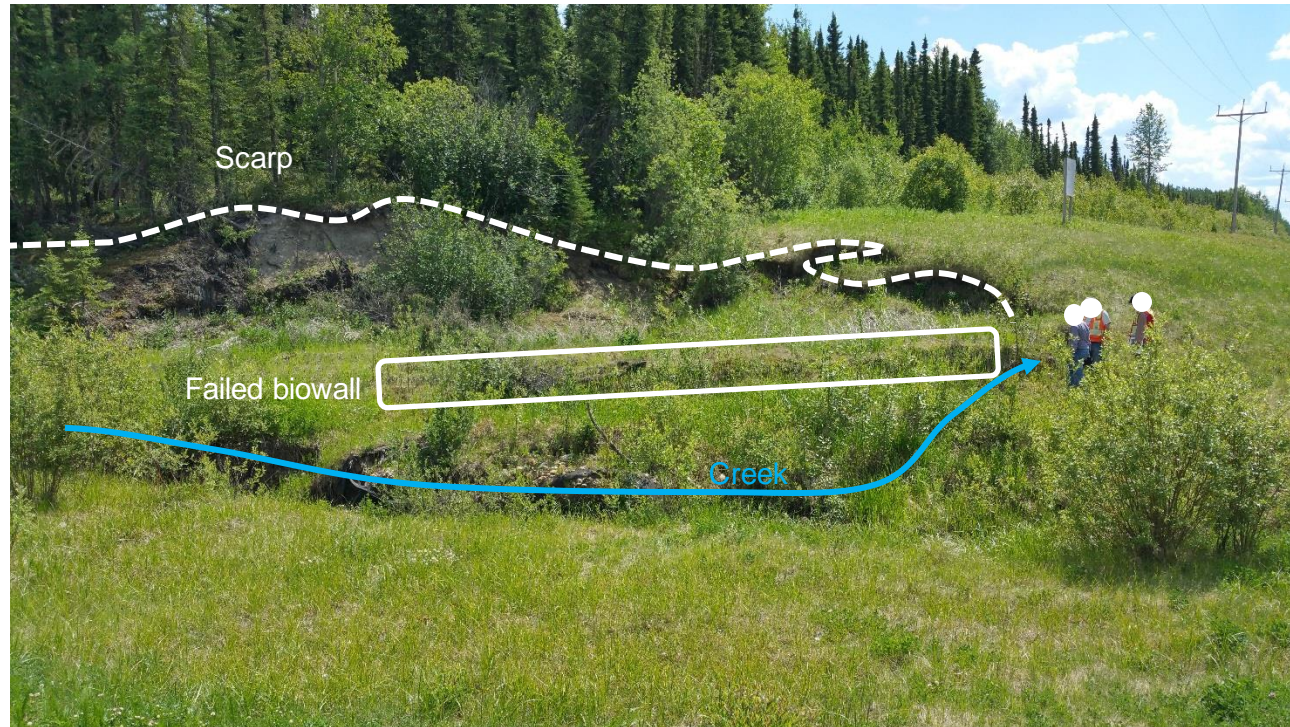
Little to no retrogression was observed between the 2014 and 2015 inspections. Seepage from the face of the scarp continues to be observed (Photo 1). Although further investigation and a new design for remediation of the slumping/erosion could be considered, the slumping/erosion has not historically impacted, and currently has a low potential to impact, operation of Highway 33 and/or Deer Mountain Road. Long term remedial measures that could be considered consist of a combination of slope flattening, gravel buttressing, and seepage or drainage control with plantings.

Photo 1: (looking south)
Slumping of the slope southwest of the intersection of Highway 33 and Deer Mountain Road. No significant changes were observed since the 2014 inspection.

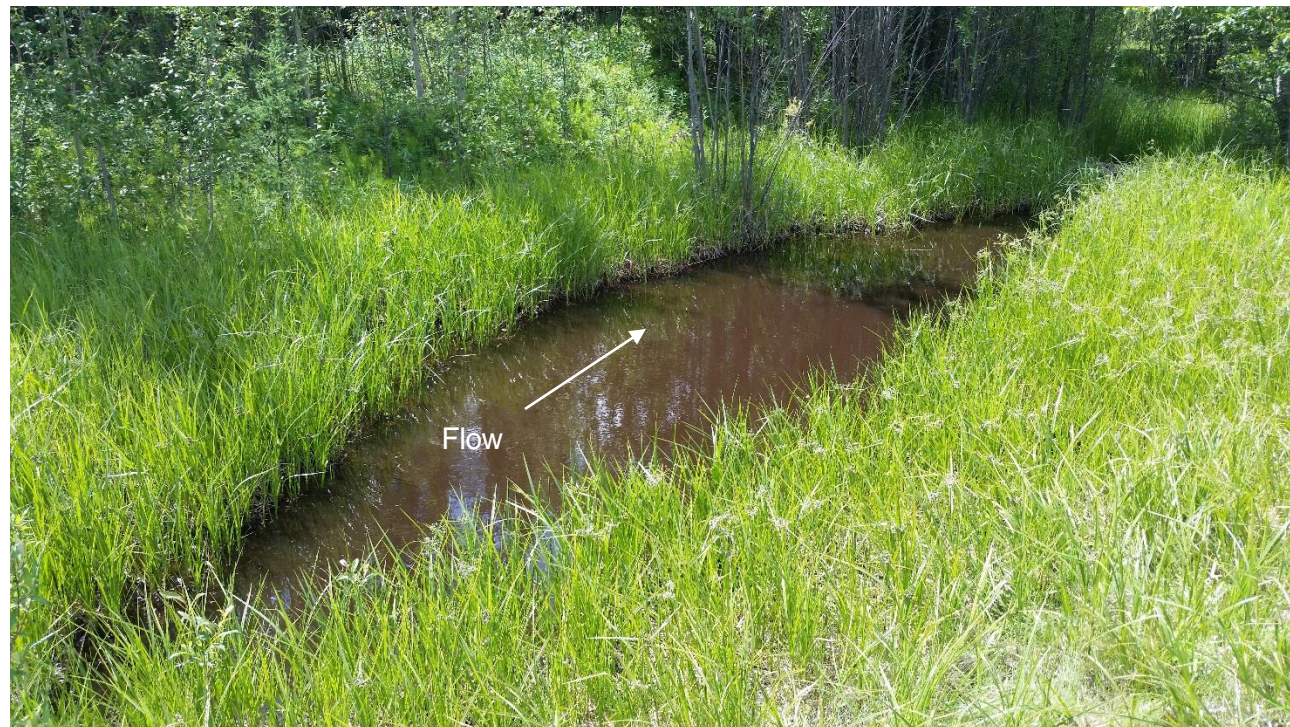
The outlet of the culvert west of Highway 33 is submerged, likely due to the close proximity of riprap near the tree line and overall low drainage gradients in the ditch line. The culvert has been submerged since the 2012 site inspection.

Photo 2: (looking west)
Looking at pond downstream of culvert inlet west of Highway 33. Culvert outlet is completely submerged. Similar conditions have been observed since the 2012 inspection.

At the time of the 2014 and 2015 inspection, the outlet of the culvert west of Highway 33 was below water. A pond had formed downstream of the culvert likely due a large pile of silted rip rap at the downstream end of the pond blocking flow (Photo 4). The culvert outlet has been below water since the 2012 site inspection. Remediation of the suspected channel blockage downstream should be carried out by removal of the material causing the blockage.

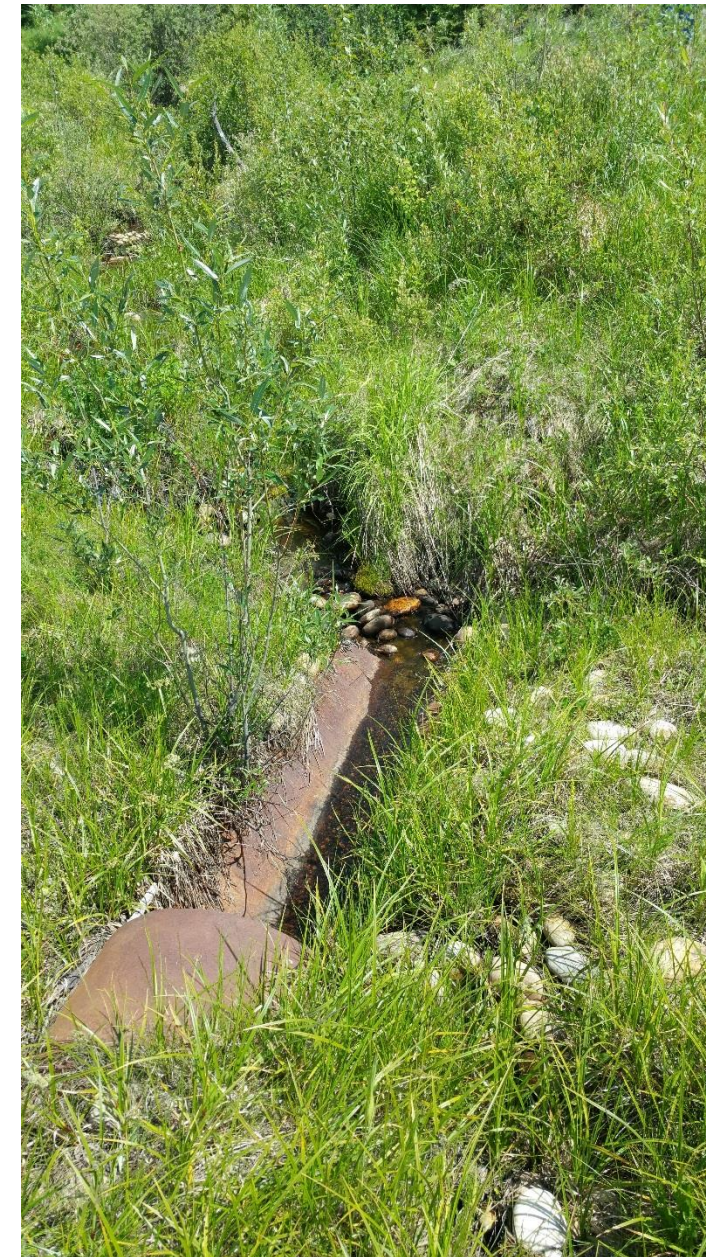
Photo 3: (looking east)
Culvert inlet east of Highway 33.
