**GEOHAZARD ASSESSMENT PROGRAM**

**PEACE RIVER / HIGH LEVEL AREA**

**2012 INSPECTION**

Site Number	Location	Name	Hwy	km
PH56	North of Manning, AB	Meikle River (South of Bridge)	35:08	26.8 Approx.
Legal Description		UTM Co-ordinates		
NW 6-94-22-5		11V N 6332271	E 467352

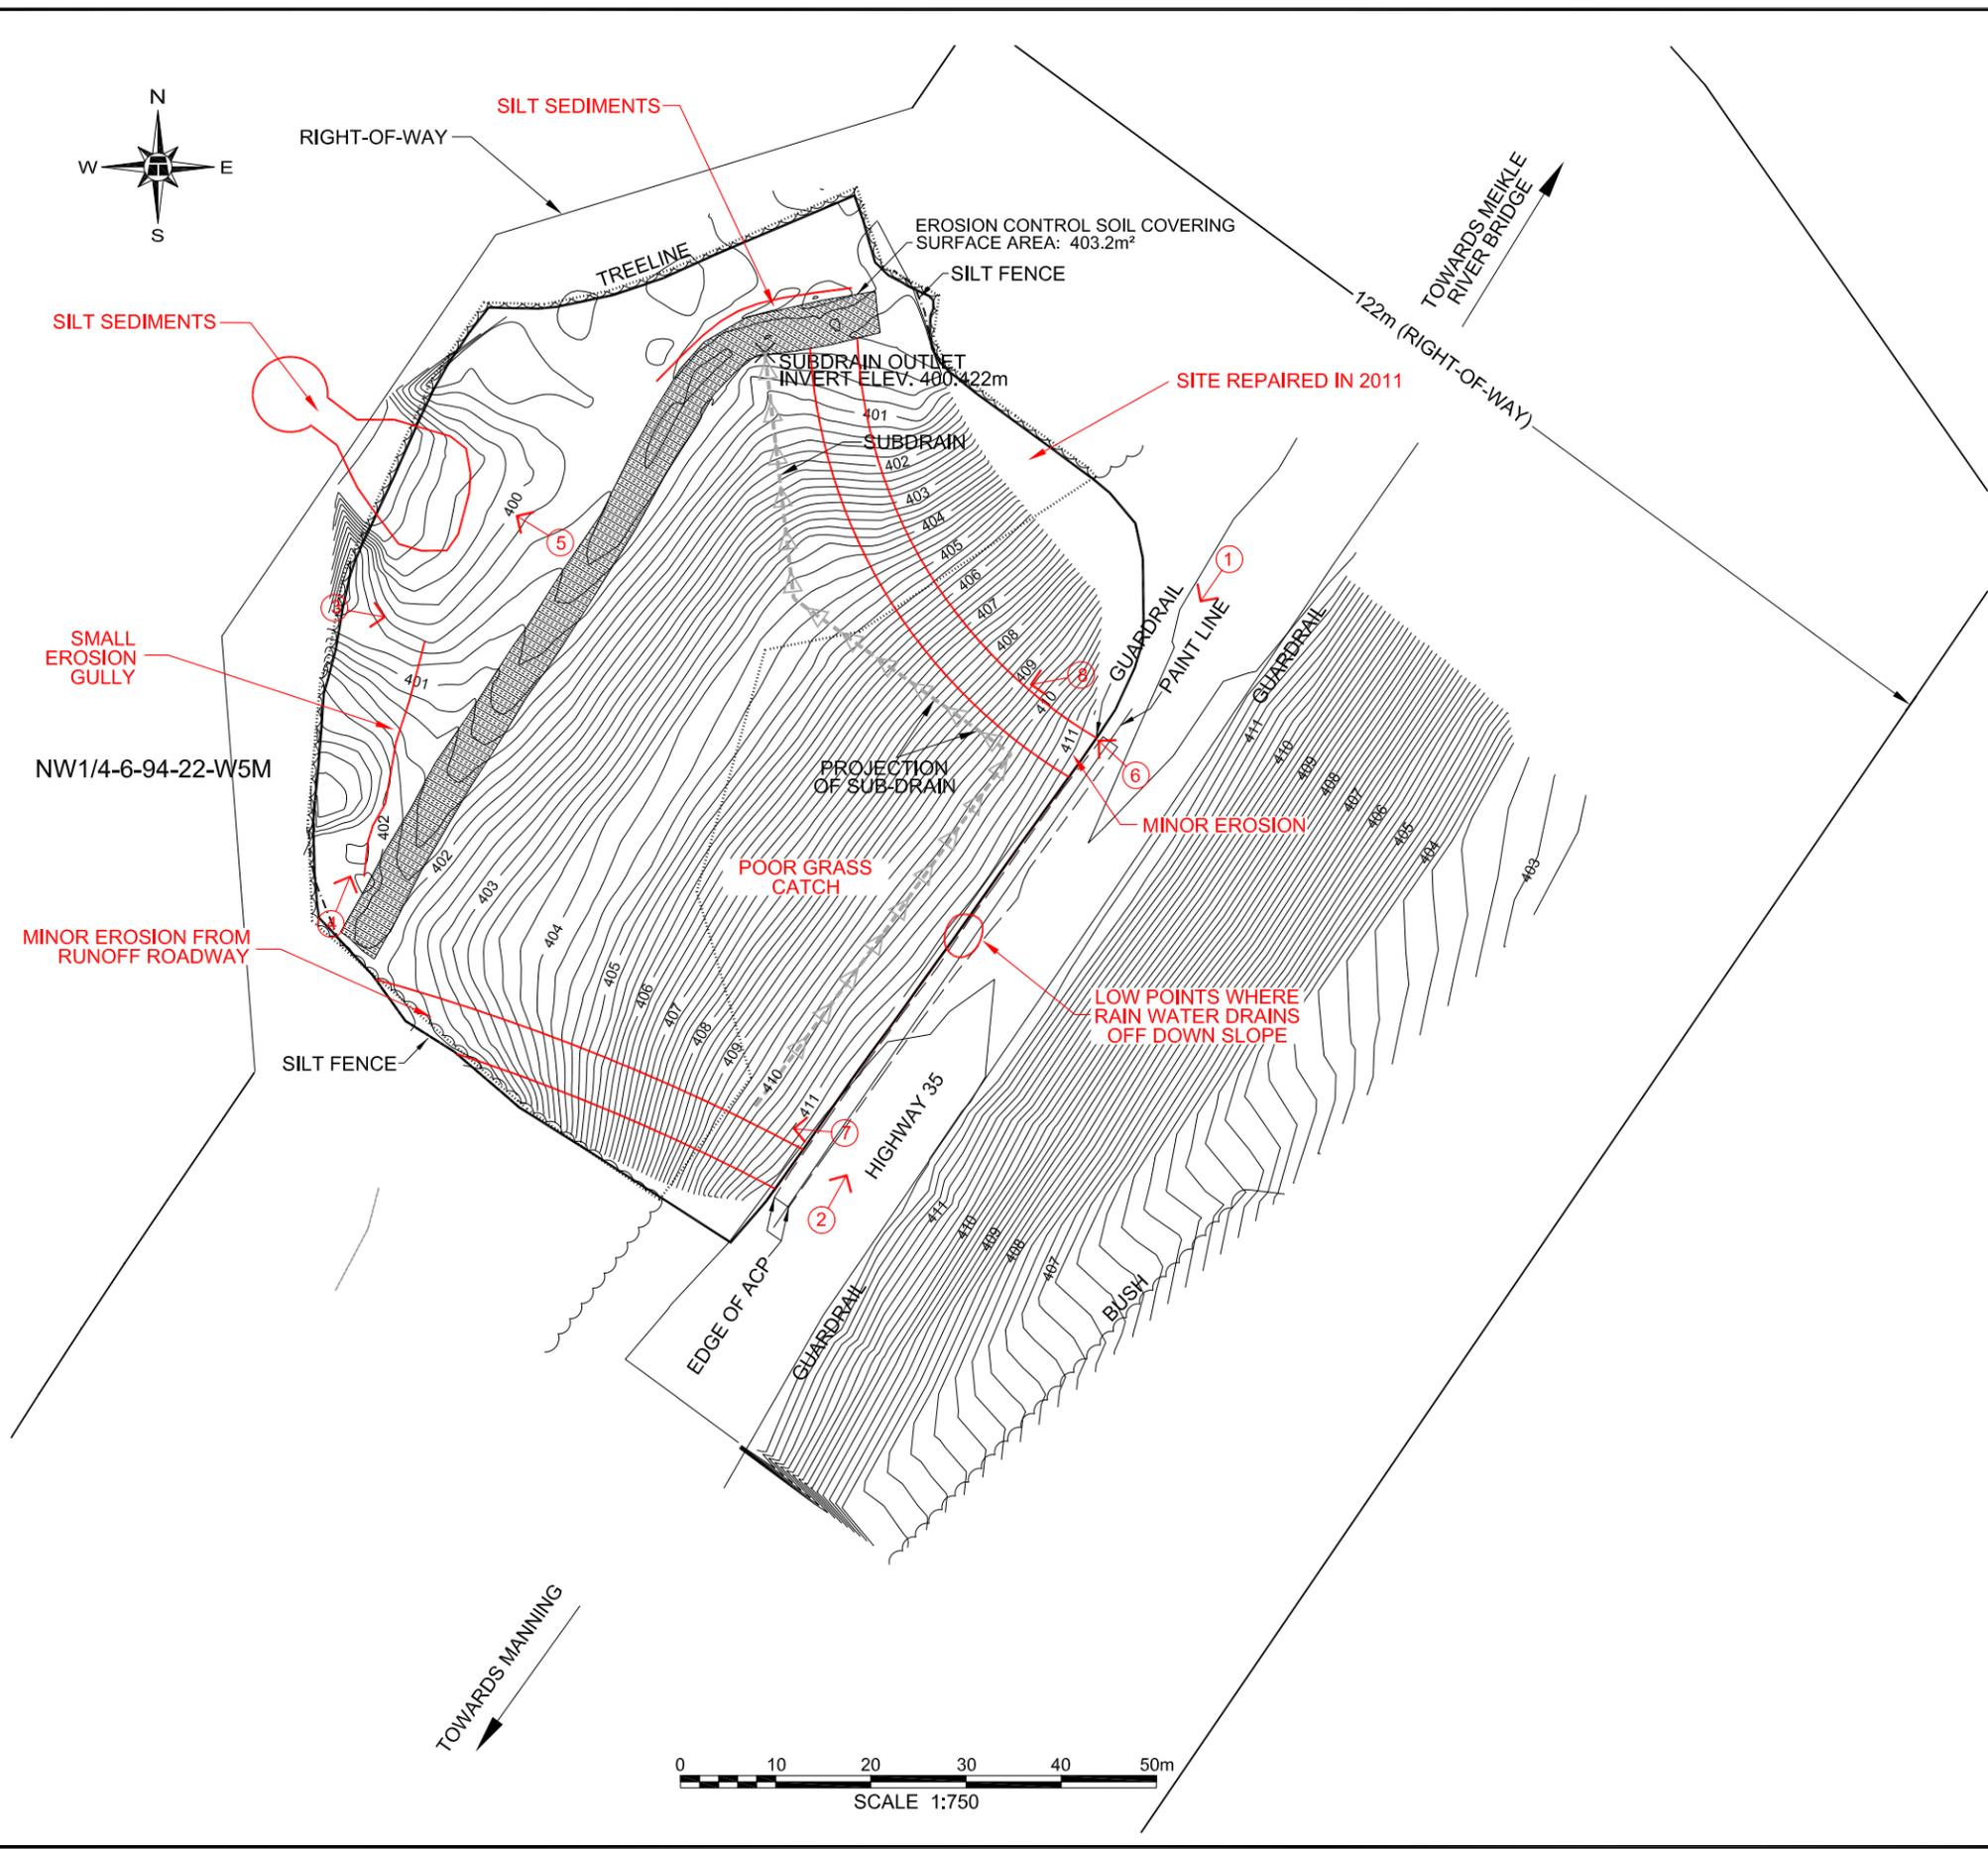
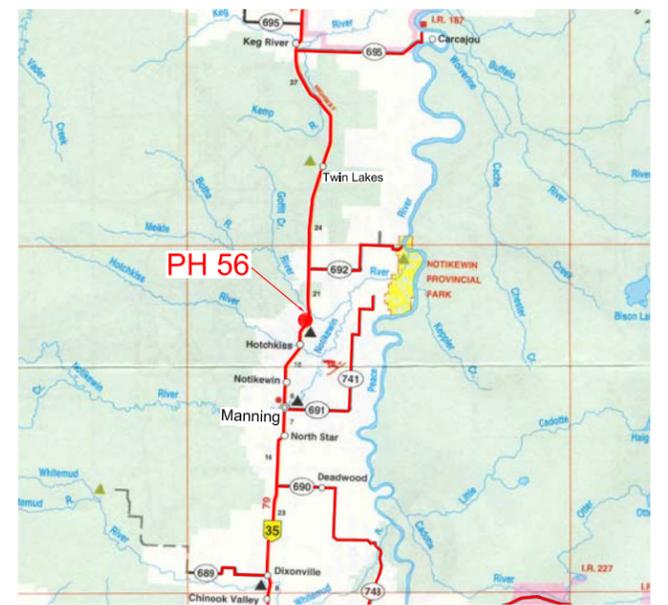
<b>Government of Alberta</b>													
Transportation													
PEACE REGION (PEACE RIVER / HIGH LEVEL)													
HWY 35:08 SOUTH OF MEIKLE RIVER GEOHAZARD ASSESSMENTS													
FIGURE PH56-1

During our 2012 site geo-hazard assessment no signs of instability were visible. Minor erosion gullies were noticed on the east and west sides of the slope caused by rainwater runoff from the road. The grass catch was very poor. Silt sediments were accumulated near the toe of the slope, mainly from the surface runoff coming from offsite.

Overall the slope appeared to be in a stable condition.

The slope should be re-seeded to promote growth of vegetation. This will supplement the stability of the slope.

Erosion control soil coverings should be placed on the eroded gullies to prevent further erosion due to surface water runoff.

The site should be inspected again next year to confirm that the recommended remedial measures are implemented and the slope is in stable condition.

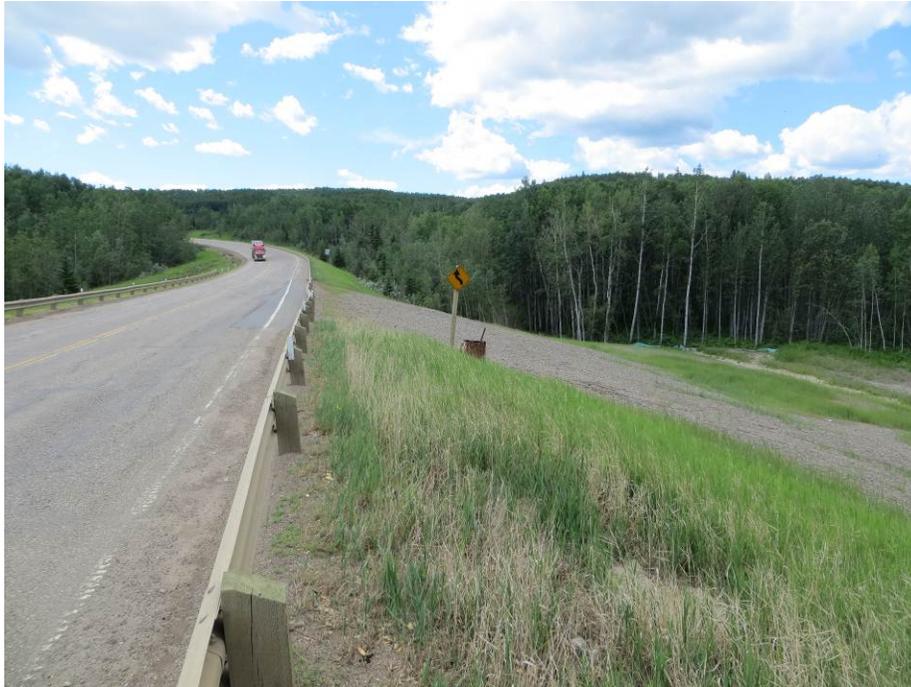
Photo 1 – View of side slope and highway, looking southwest

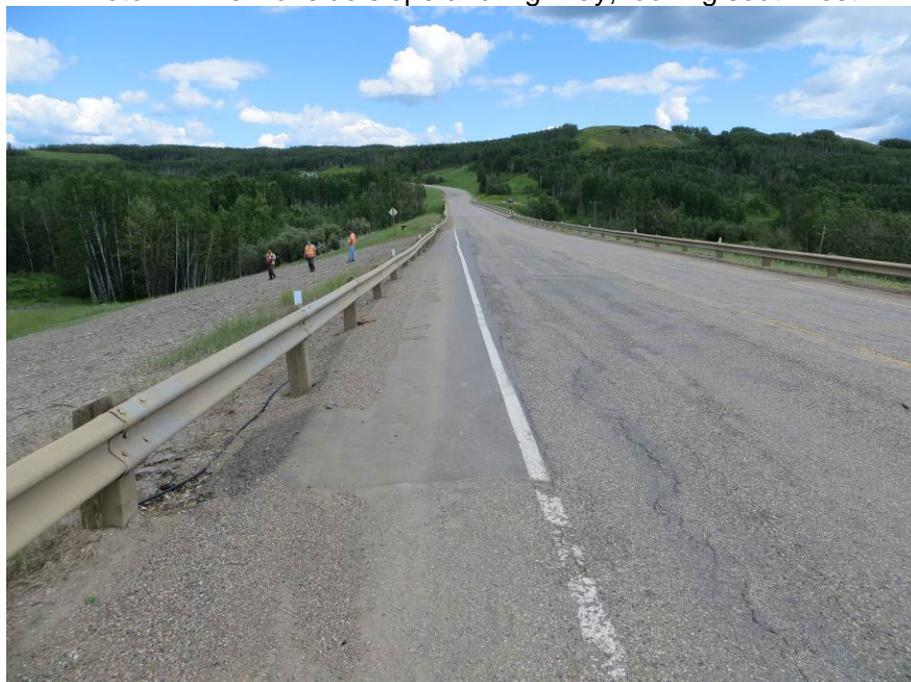
Photo 2 – Side slope and highway, looking northeast

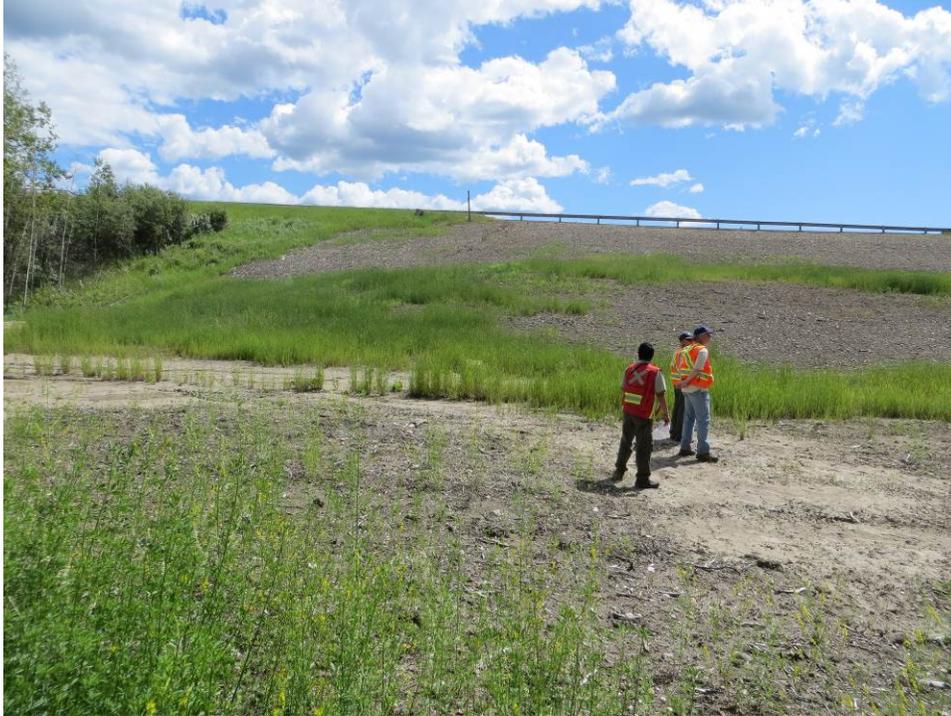
Photo 3 – Side slope, poor grass catch, looking east

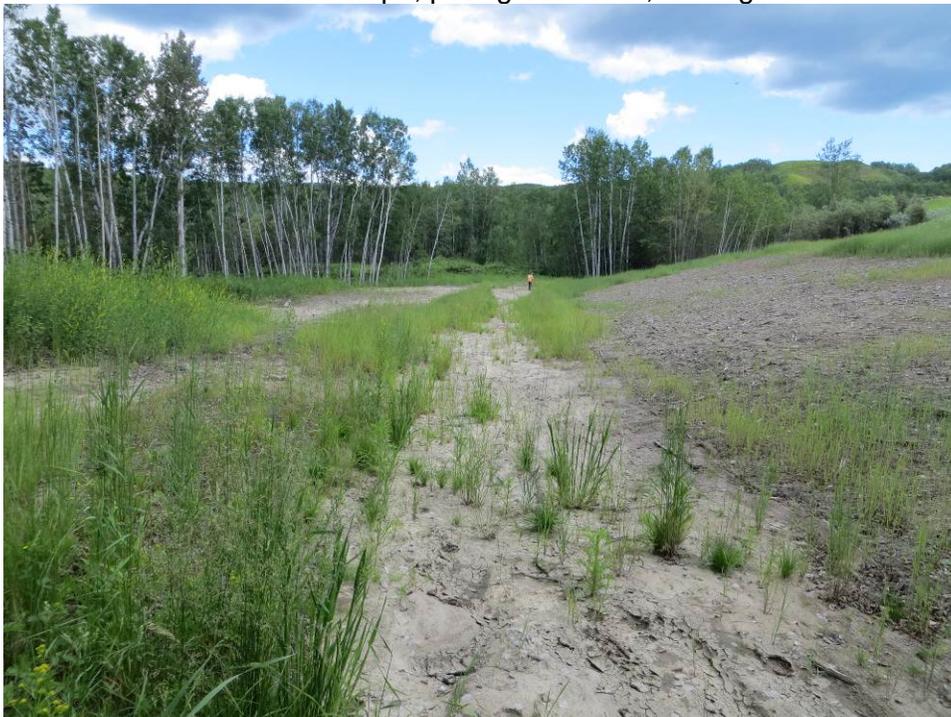
Photo 4 – Erosion control soil covering at the toe of the slope, looking northeast

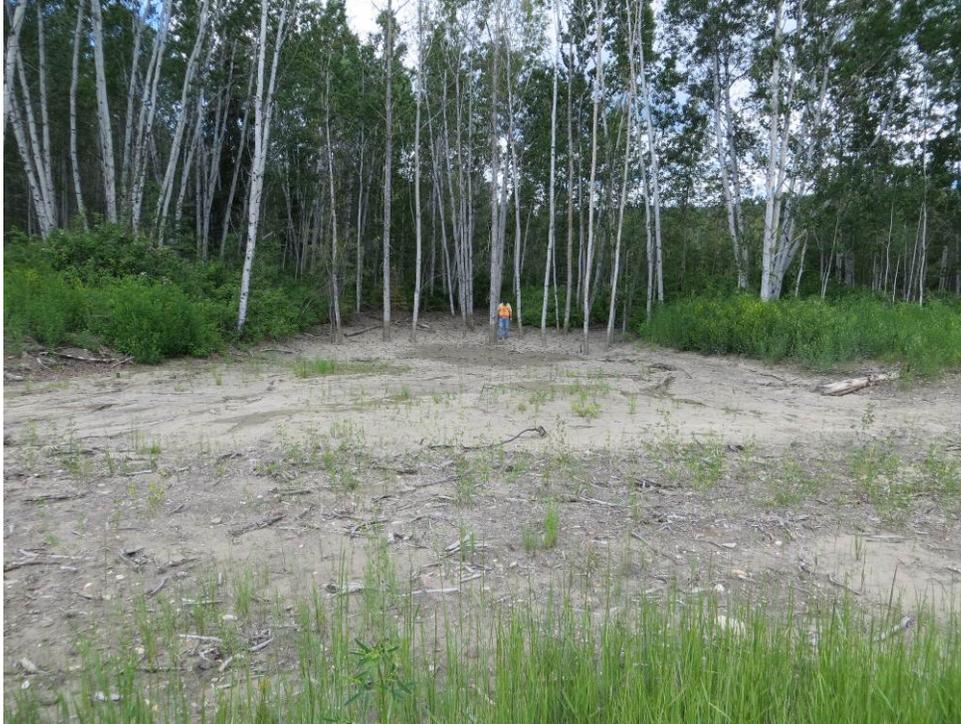
Photo 5 – Silt sediments accumulated near the toe of the slope, looking northwest

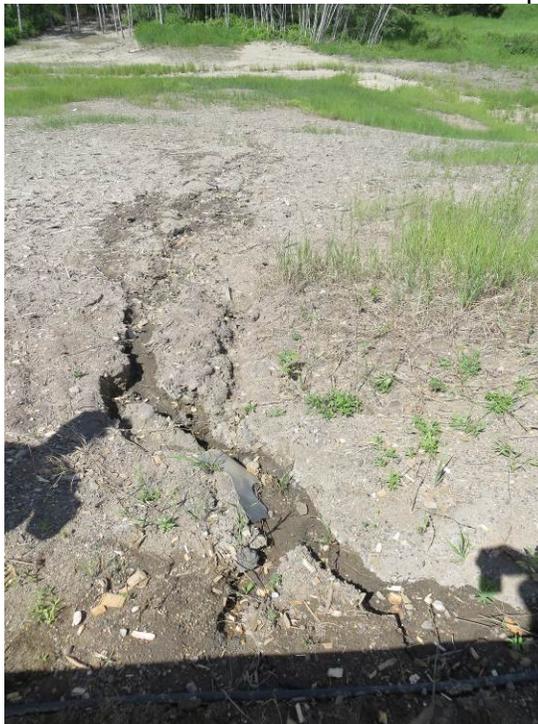
Photo 6 – Erosion gully on the east side of slope, looking northwest

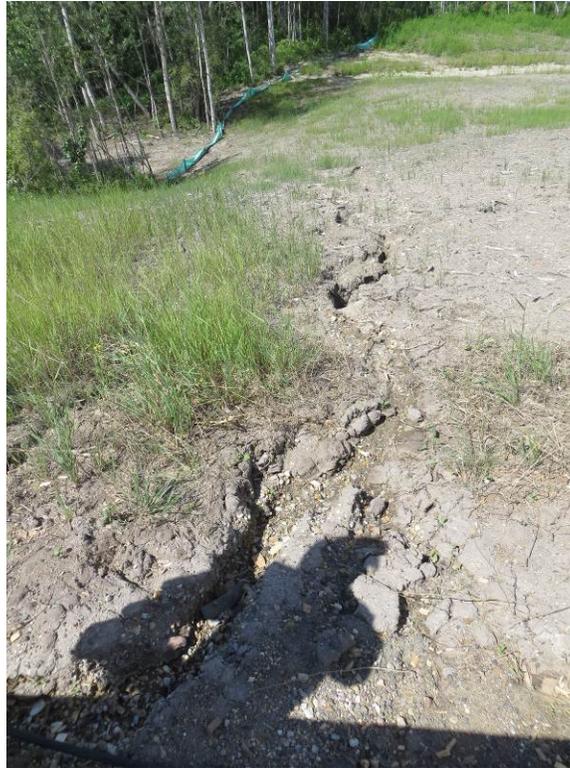
Photo 7 – Erosion gully on the west side, looking northwest.

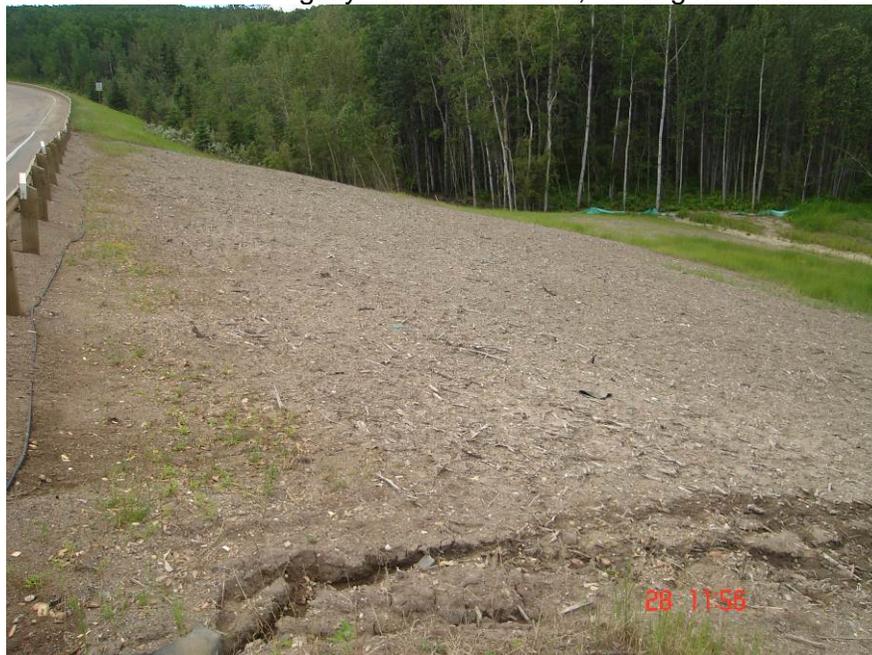
Photo 8 - Downslope view of remediated slope, looking west.
