GEOHAZARD ASSESSMENT PROGRAM

PEACE RIVER / HIGH LEVEL AREA

2013 INSPECTION

Site Number	Location	Name	Hwy	km
PH56	North of Manning, AB	Meikle River (South of Bridge)	35:08	26.8 Approx.
Legal Description		UTM Co-ordinates		
NW 6-94-22-5		11V N 6332271	E 467352

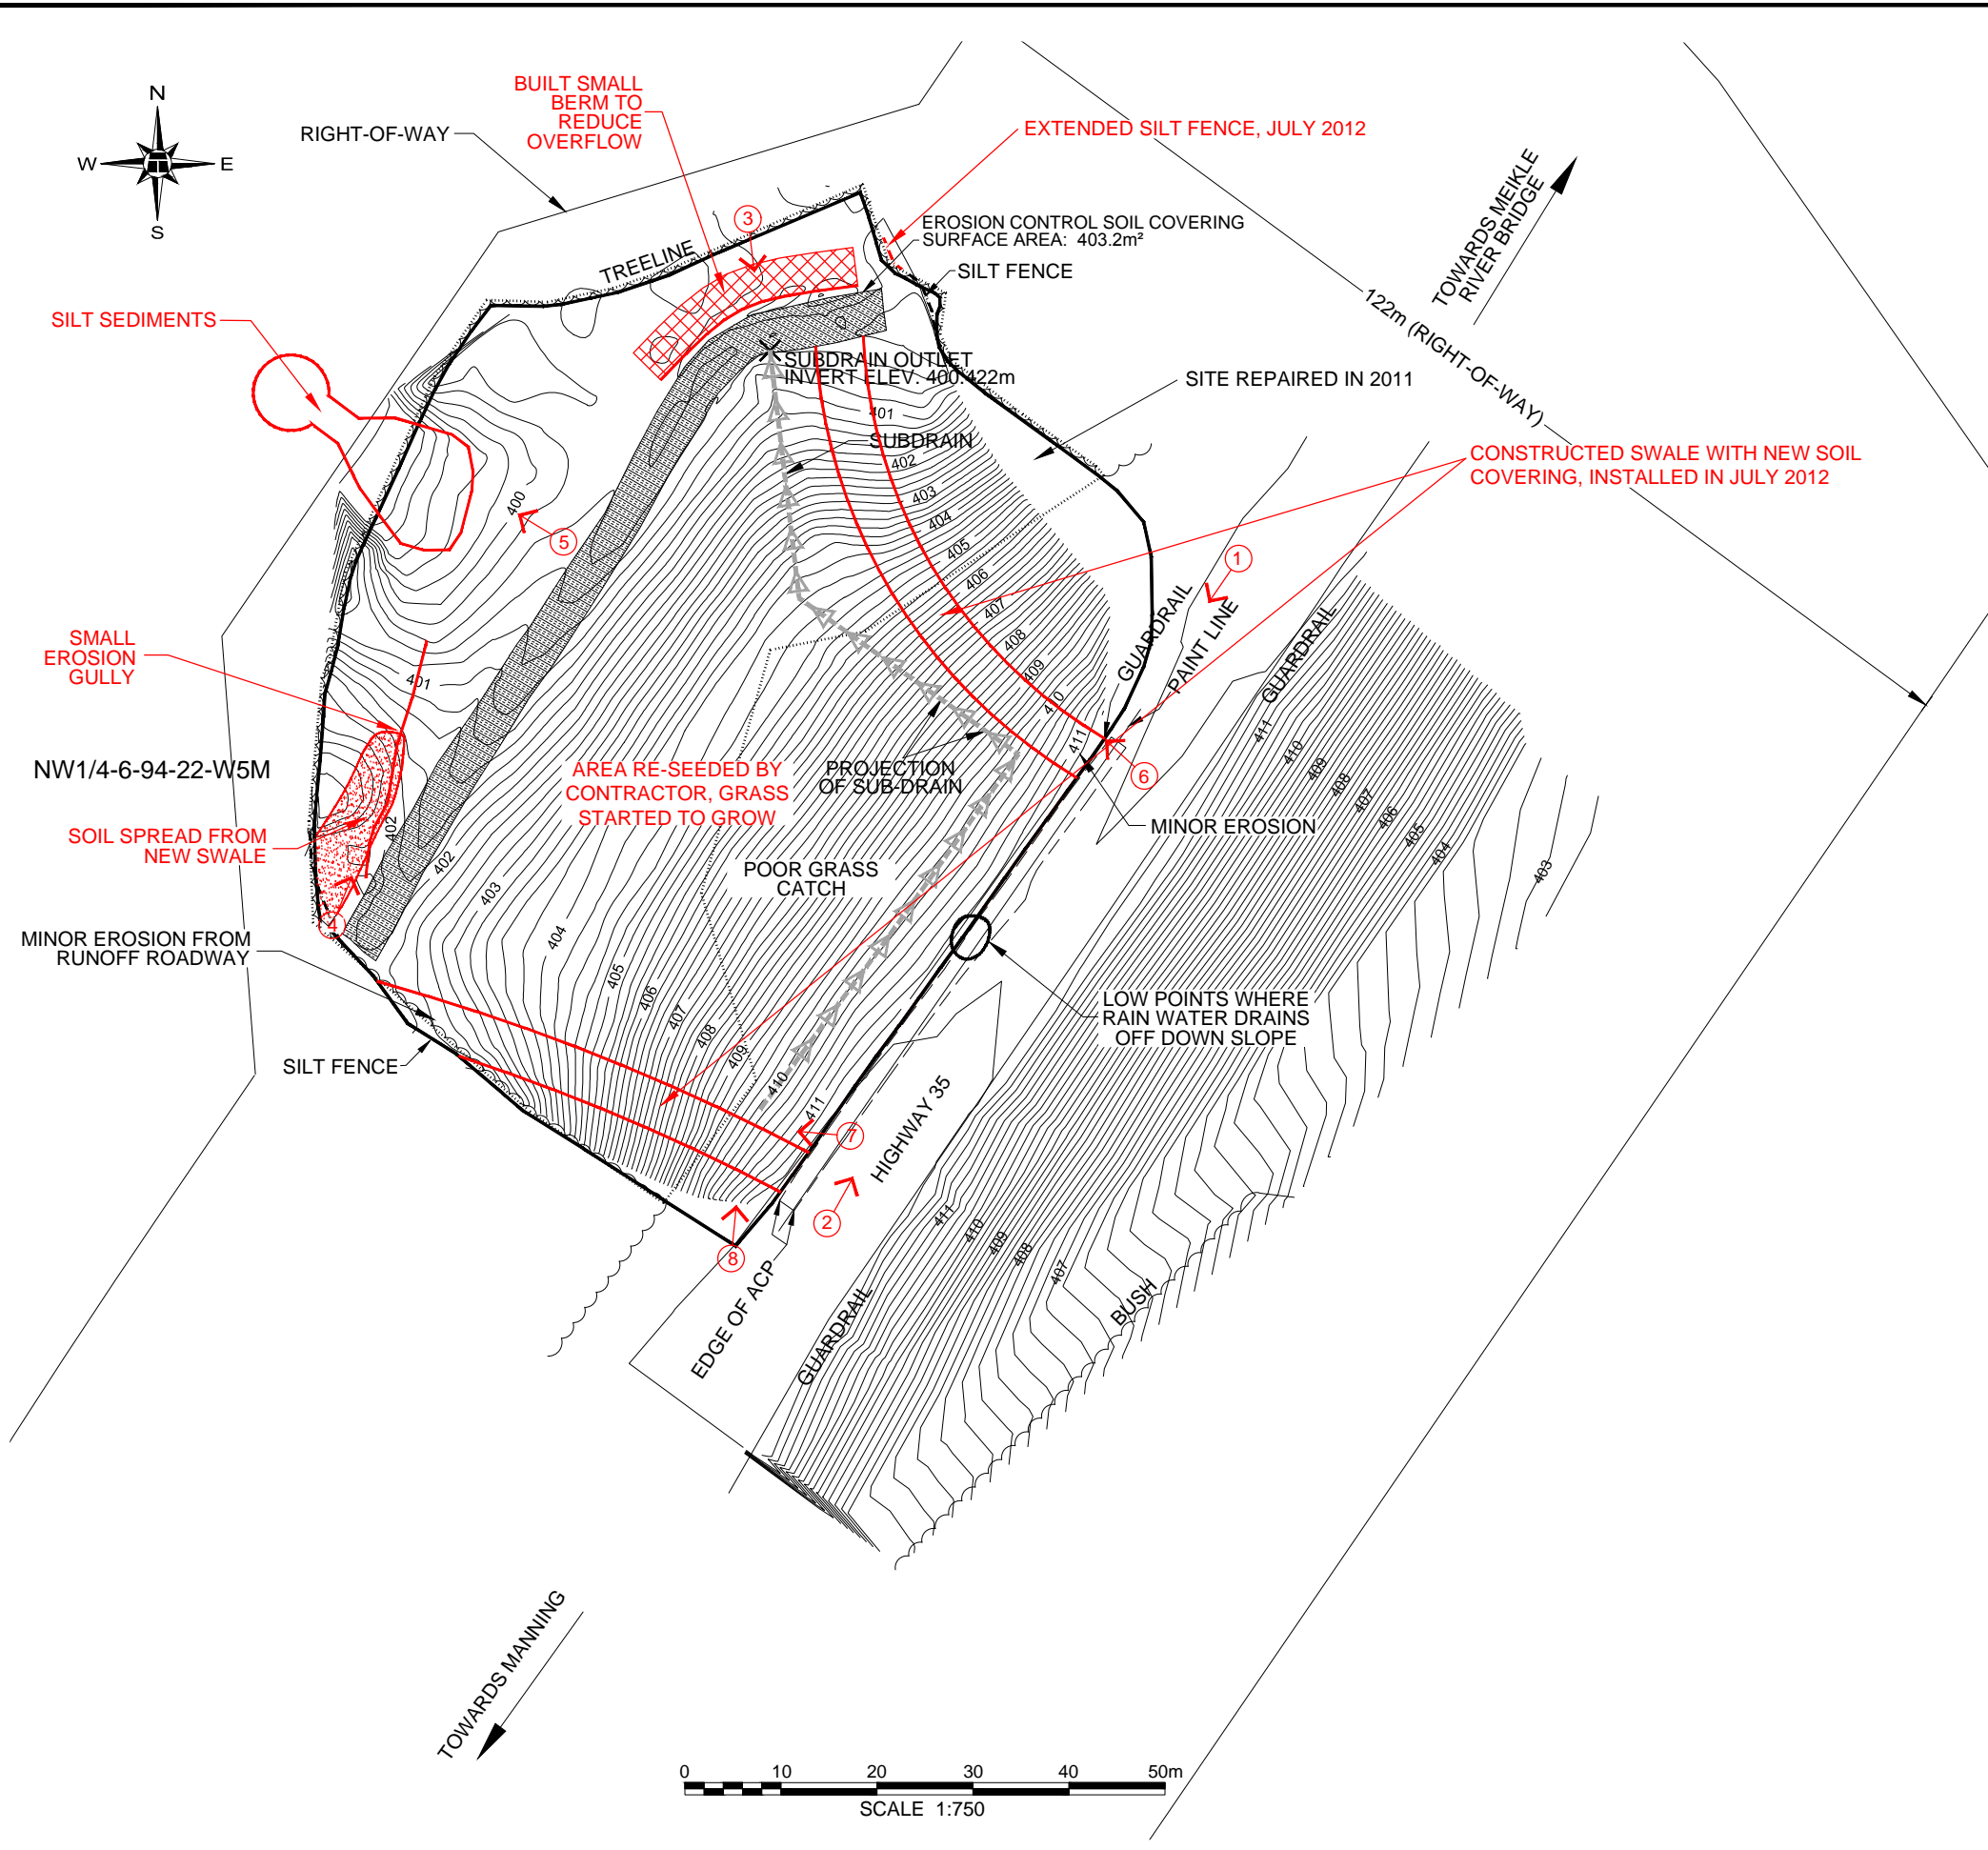
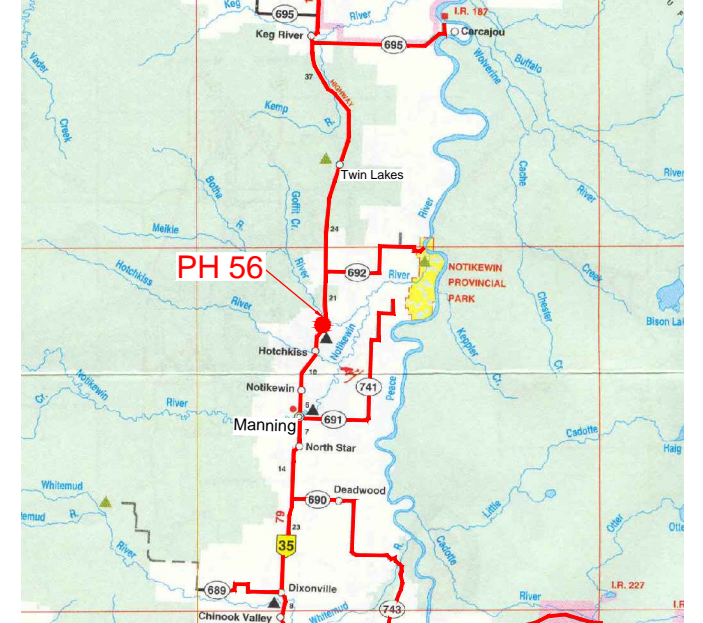
FIGURE PH56-1

The slope was remediated and re-constructed in 2011.

No signs of instability were visible in 2013. Drainage swale with new soil covering was constructed in July 2012 on either side of the slope. The slope was re-seeded in 2012 and the grass started to grow. Silt sediments were accumulated near the toe of the slope, mainly from the surface runoff coming from offsite.

Overall the slope appeared to be in a stable condition.

This site could be removed from the inspection program.

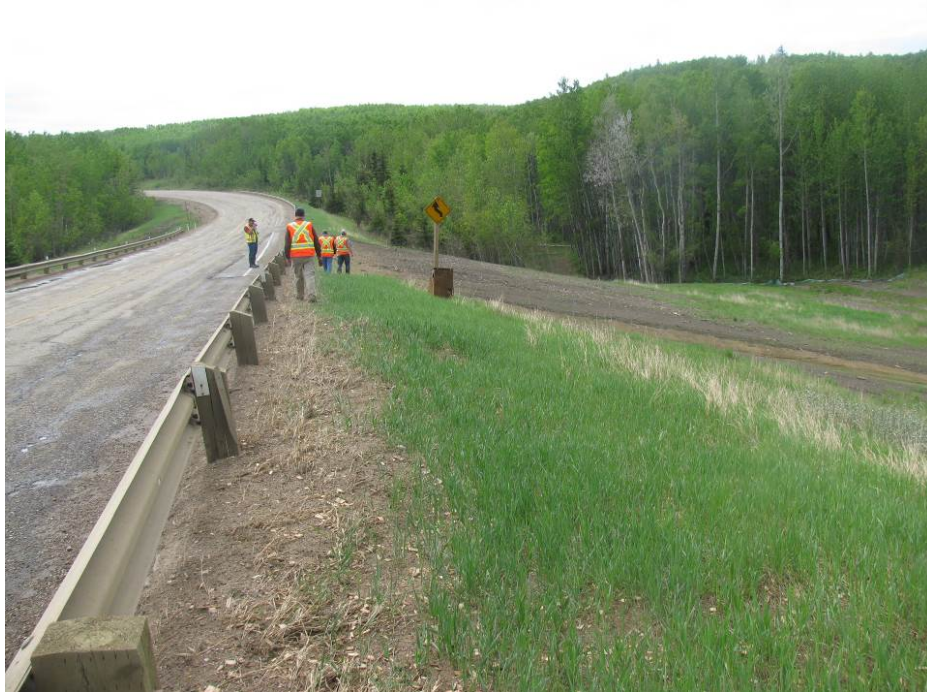
Photo 1 – Side slope and highway, looking southwest.

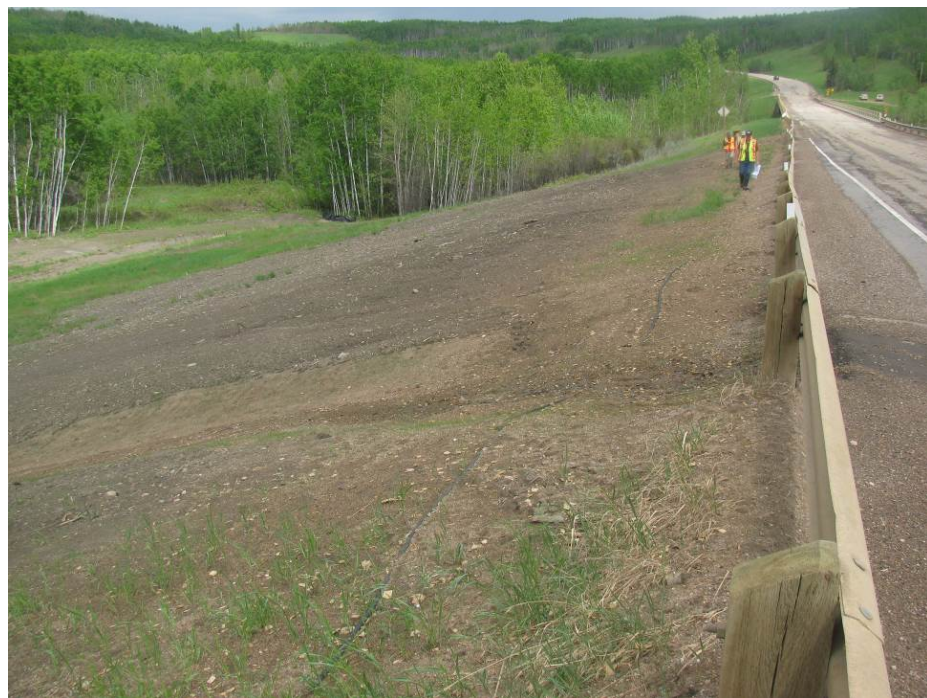
Photo 2 – Side slope and highway, looking northeast.

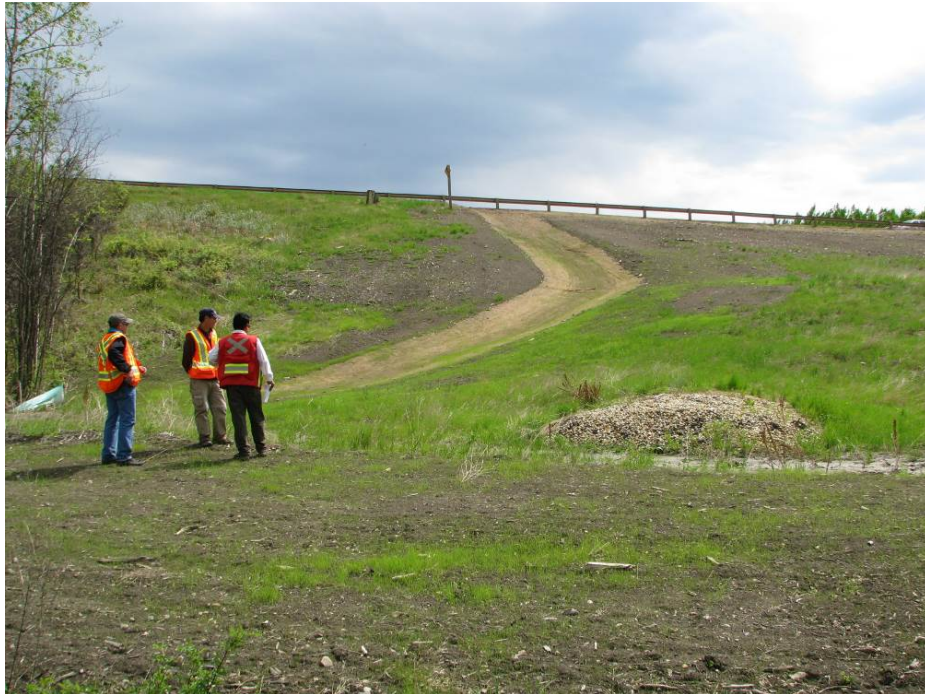
Photo 3 – Side slope and drainage swale, looking southeast.

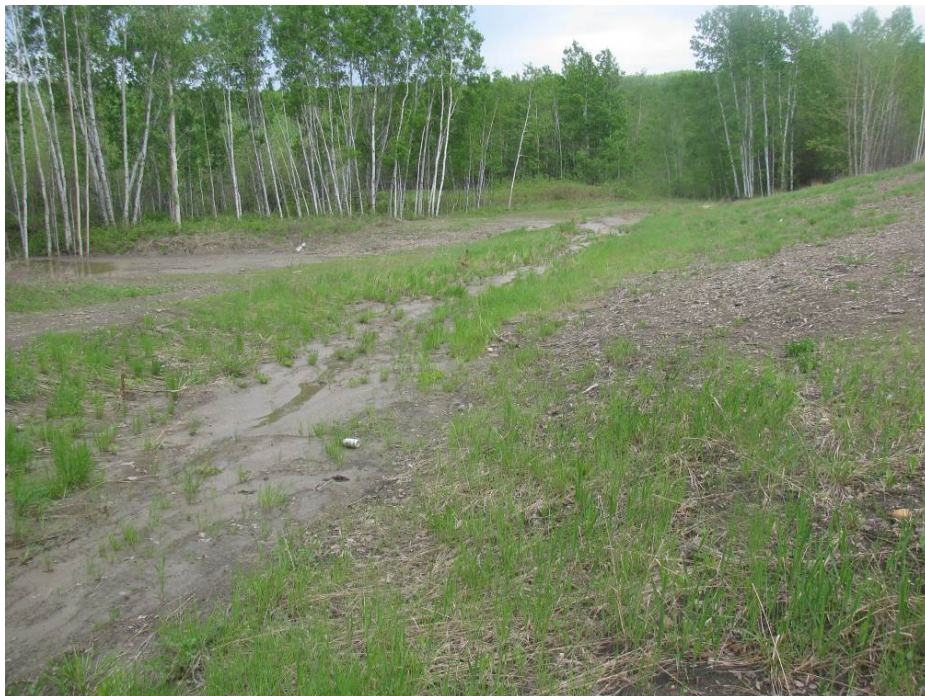
Photo 4 – Erosion control soil covering at the toe of the slope, looking northeast.

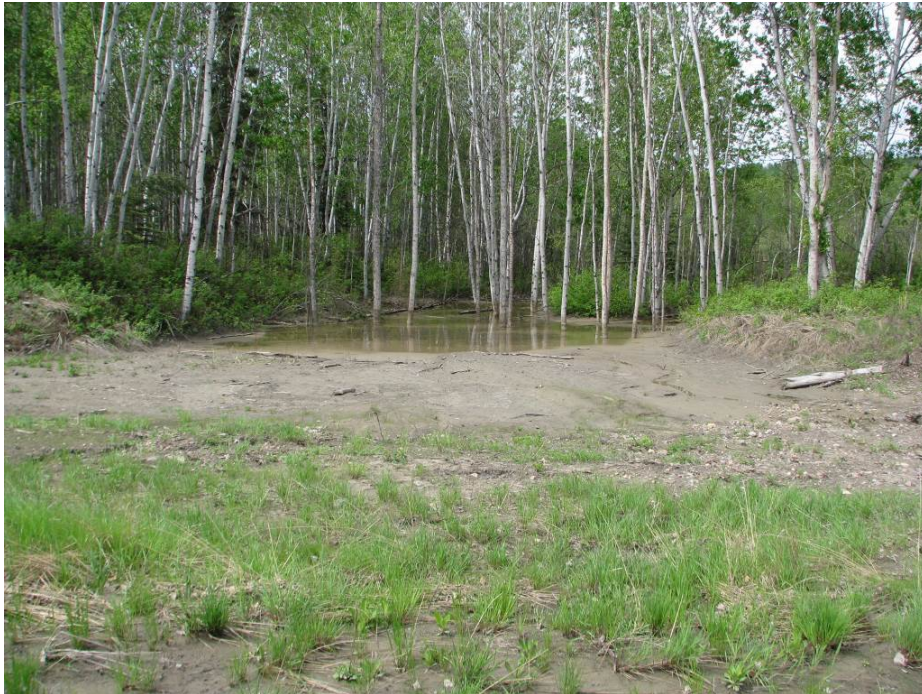
Photo 5 – Silt sediments accumulated near the toe of the slope, looking northwest.

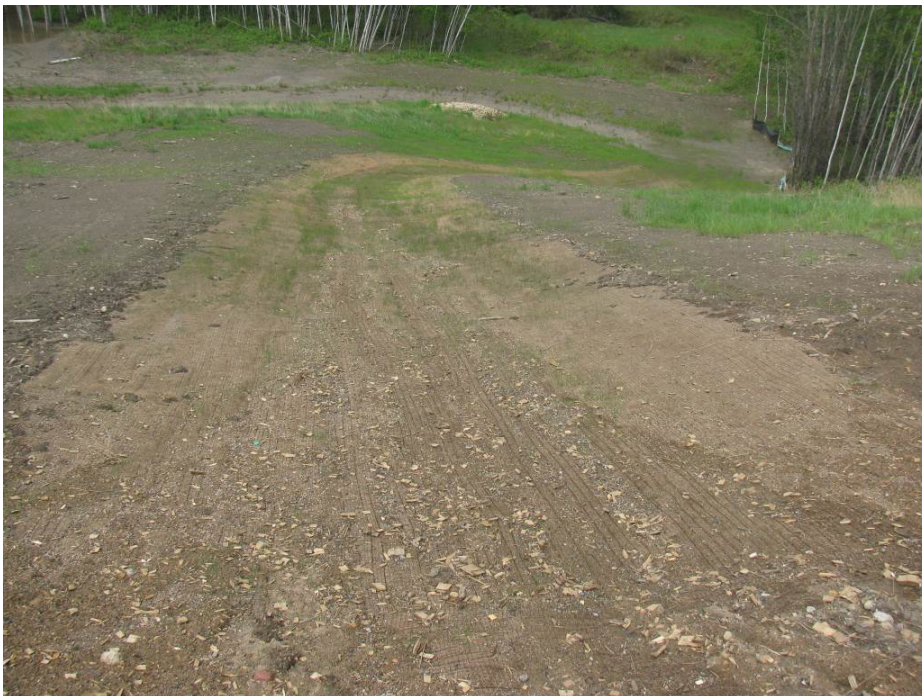
Photo 6 – Drainage swale on the east side of slope, looking northwest.

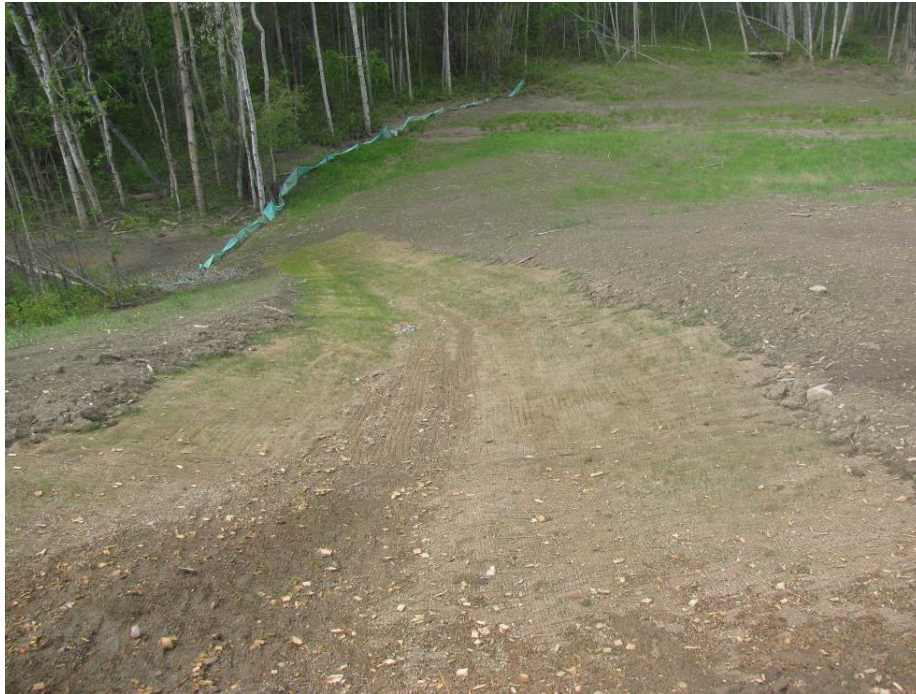
Photo 7 – Drainage swale on the west side of slope, looking northwest.

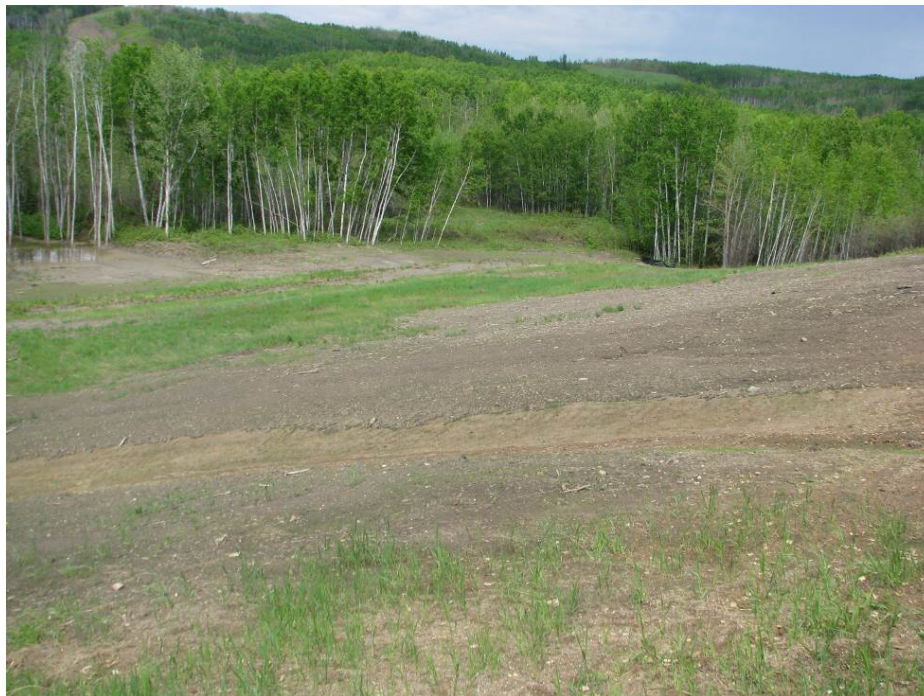
Photo 8 - Downslope view of remediated slope (grass started to grow), looking northeast.
