August 11, 2006

File: 15-85-37

**PEACE REGION (PEACE RIVER – HIGH LEVEL AREA)
GEOHAZARD ASSESSMENT
HWY 35:20, SITE PH 49, INDIAN CABINS FROST HEAVES
2006 ANNUAL INSPECTION REPORT**

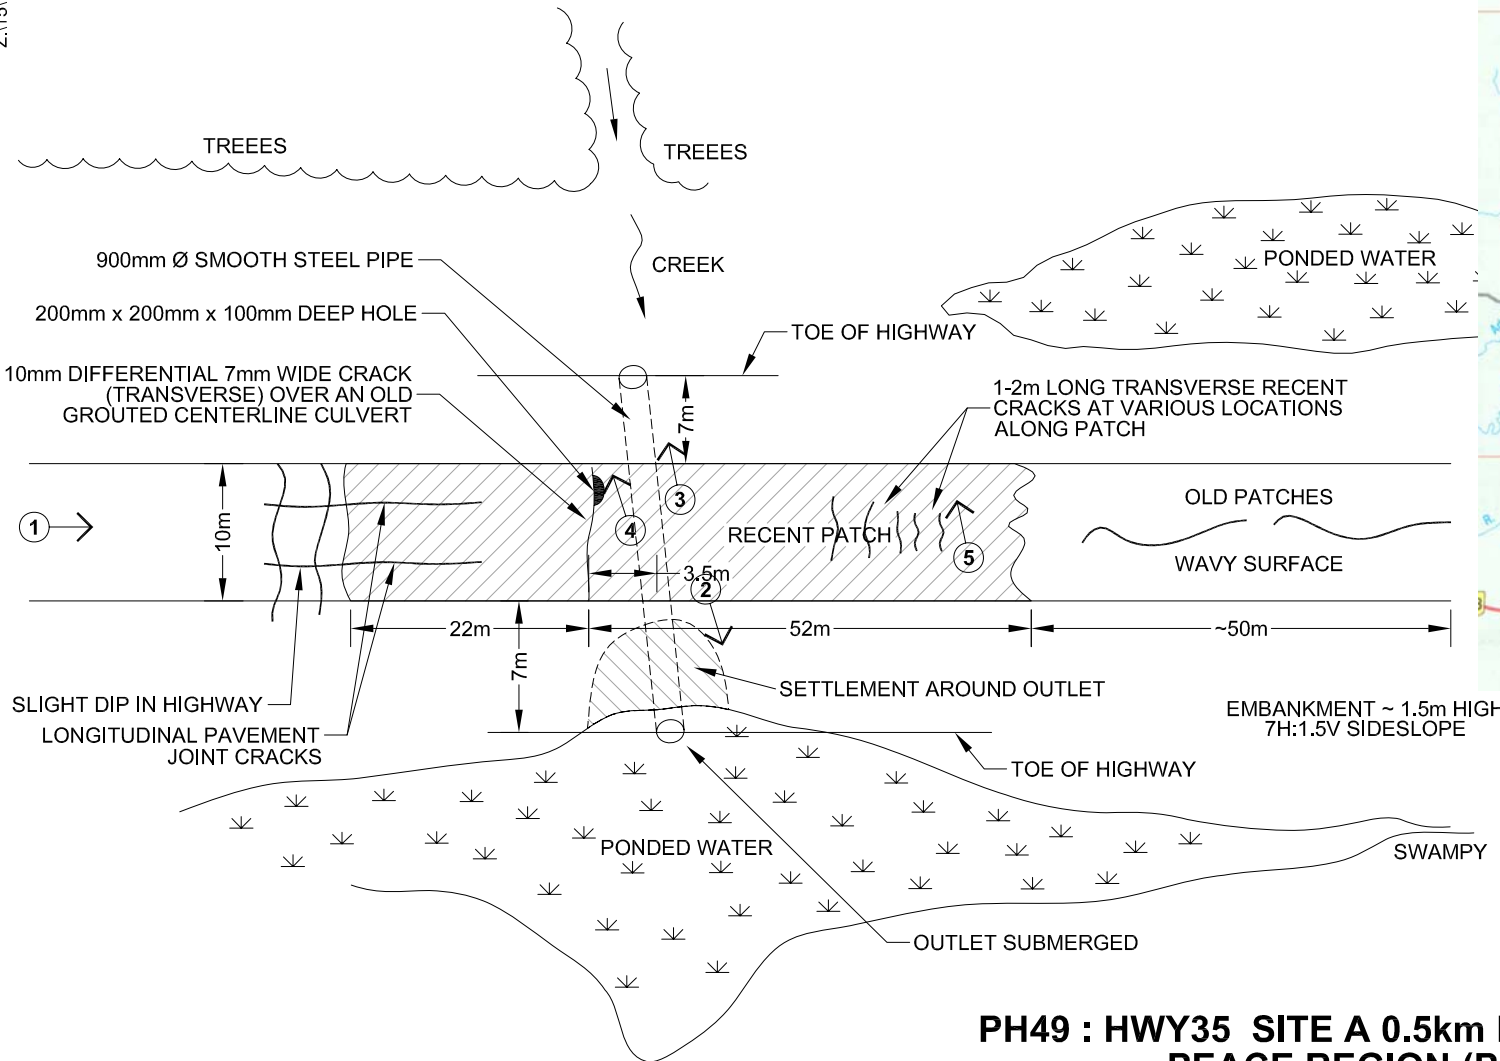
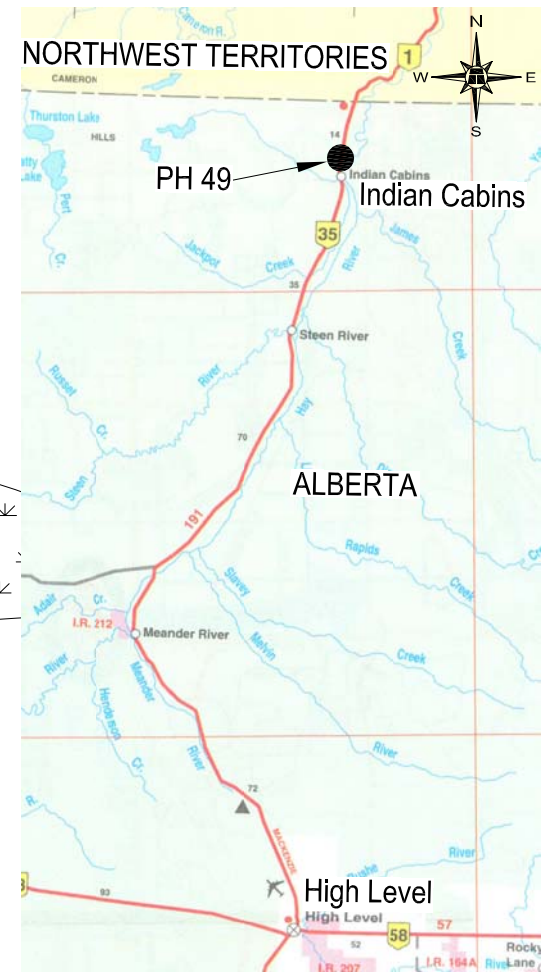
**FIGURE PH49-1
PH49 : HWY35 SITE A 0.5km NORTH OF INDIAN CABINS
PEACE REGION (PEACE RIVER / HIGH LEVEL)
GEOHAZARD ASSESSMENTS**

Our observations of the site are shown on the attached site sketch plan Figure PH49-1 and photos. The site has a recent patch covering about 74 m of the highway. The highway has a relatively smooth profile with slight dips at the south and north ends of the site.

Recent transverse cracks 1 m to 2 m long were noticed on the pavement, at 2 m to 5 m intervals, over a distance of 52 m along the highway, as is illustrated on Figure PH49-1.

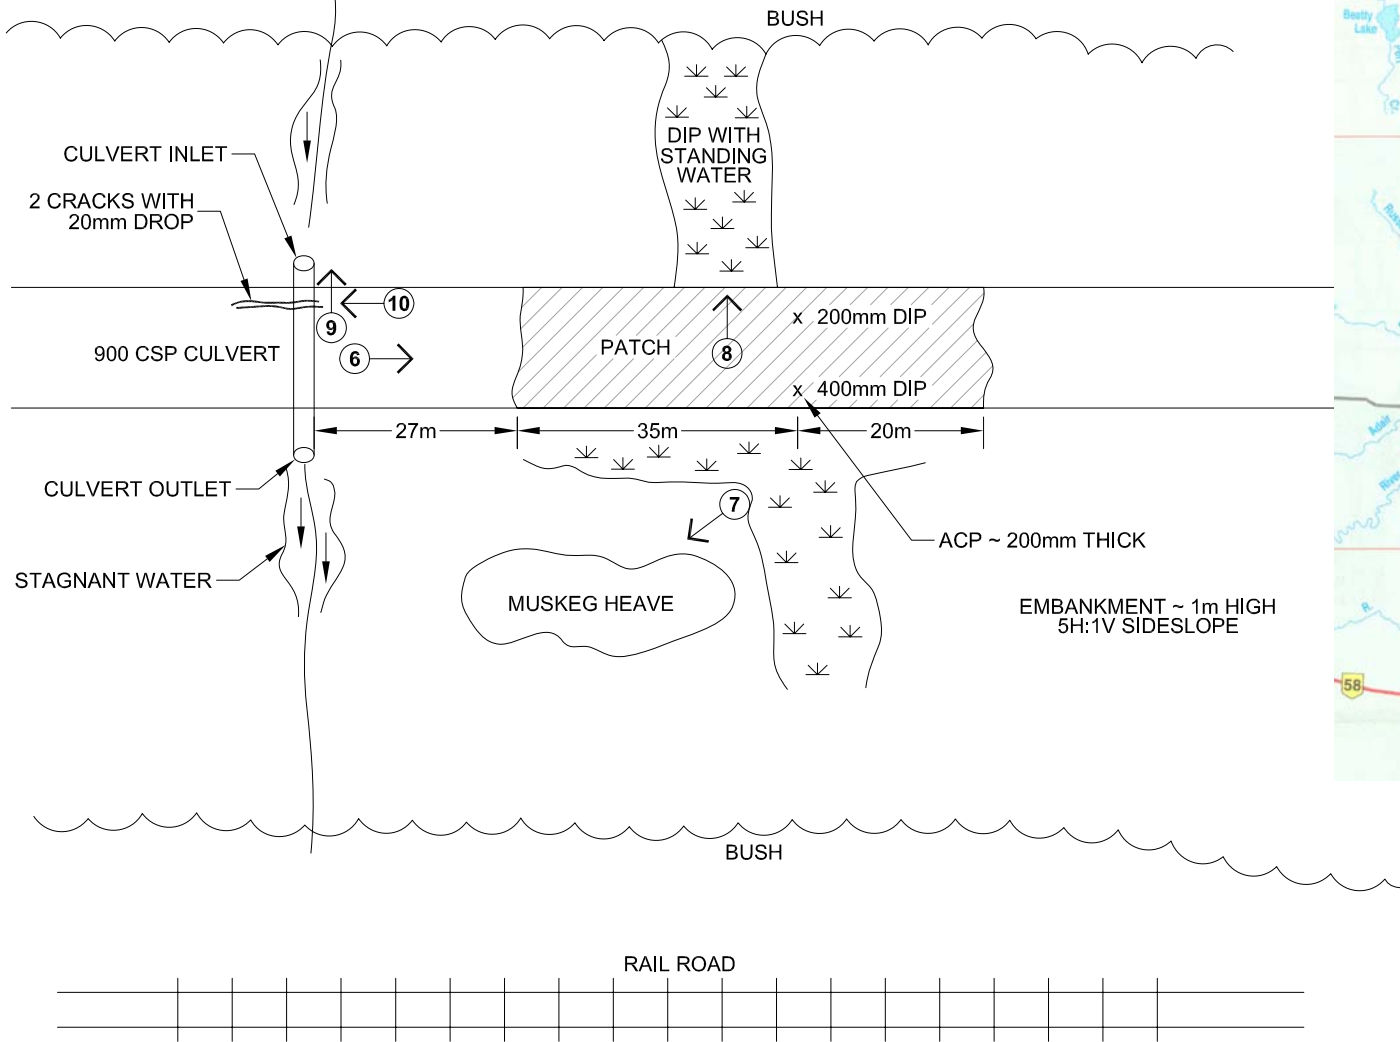
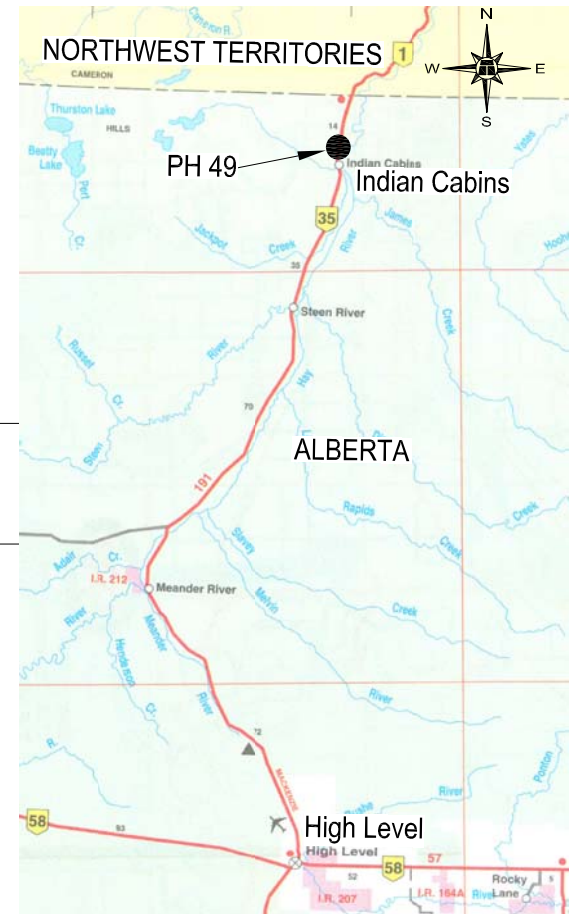
FIGURE PH49-2
PH49 : HWY35 SITE B 8.7 km NORTH OF INDIAN CABINS
PEACE REGION (PEACE RIVER / HIGH LEVEL)
GEOHAZARD ASSESSMENTS

A patch on the highway was noticed, placed over a dip approximately 55 m long. The roadway still shows a strong dip, ranging from 200 mm to 400 mm over the east and west shoulders, respectively, as is illustrated on Figure PH49-2. The thickness of the asphalt at that location was 200 mm.

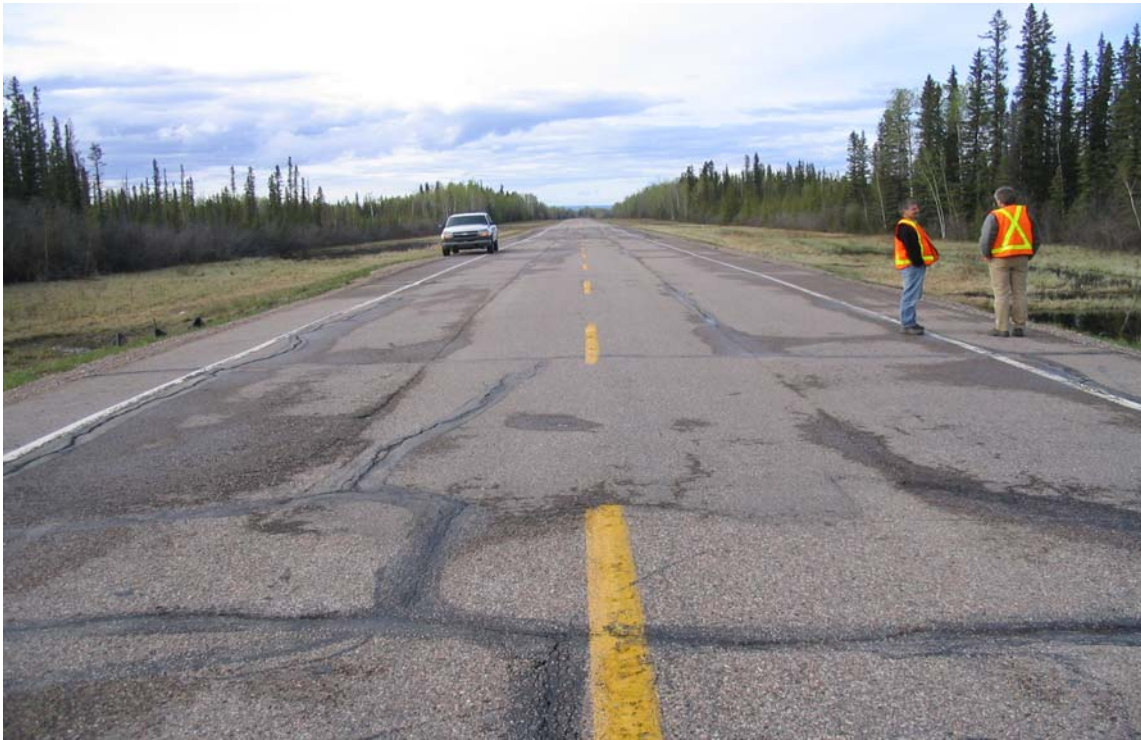
Many recently sealed cracks were noticed on the roadway. Several were beginning to open again. The same can be said about old longitudinal construction joints on the pavement, which appeared to be cracking open. The roadway along the northern 50 m of the site had a wavy surface.

PHOTO 1: View of Site A facing north. Reopening of cracks previously patched on the pavement.

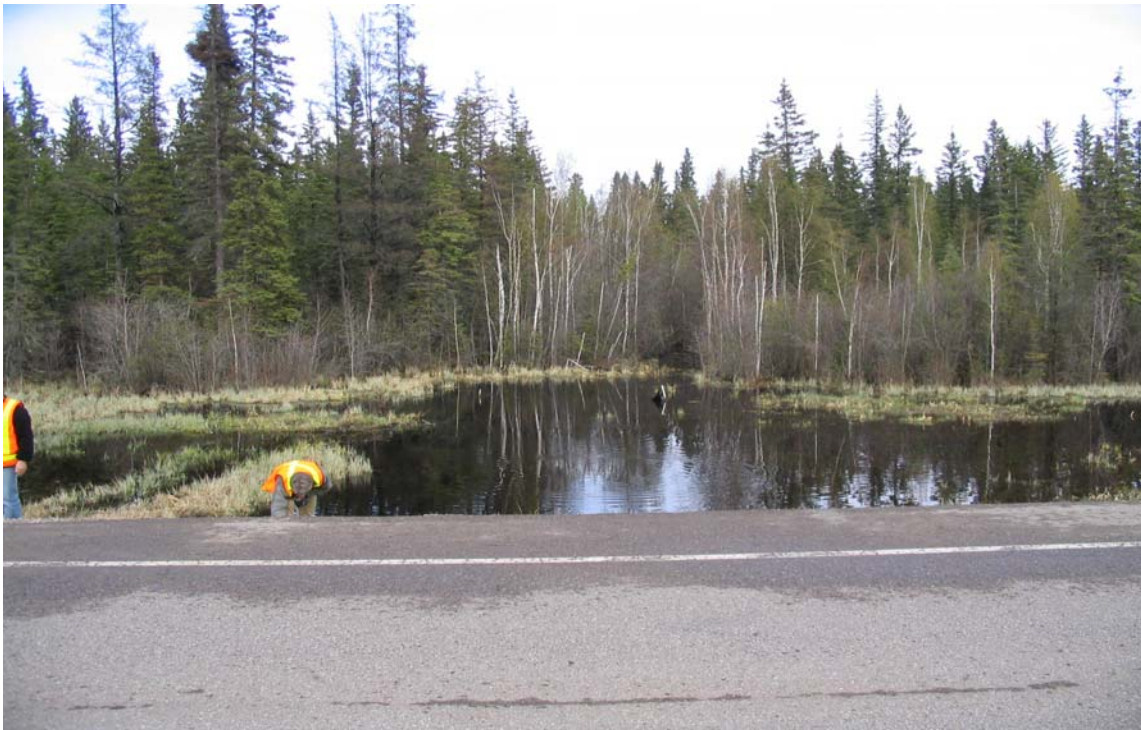
Ponded water was observed on both sides of the highway embankment. A shallow creek flows under the highway through a 900 mm diameter, smooth-wall steel culvert. The culvert outlet was submerged and could not be inspected. However, settlement around the outlet was noticed.

PHOTO 2: Ponded area on east side of highway at Site A.

Potential solutions consist of improving drainage through the use of deep muskeg ditches and better definition of the creek bed channels. Consideration could also be given to excavating frost susceptible peat and soils from Site B and replacing them with a wedge of free draining granular fill, possibly placed over a geogrid and non-woven geotextile. Highway, ditch and creek profiles should be carried out extending at least 500 m in each direction from each site to assist in the assessments.

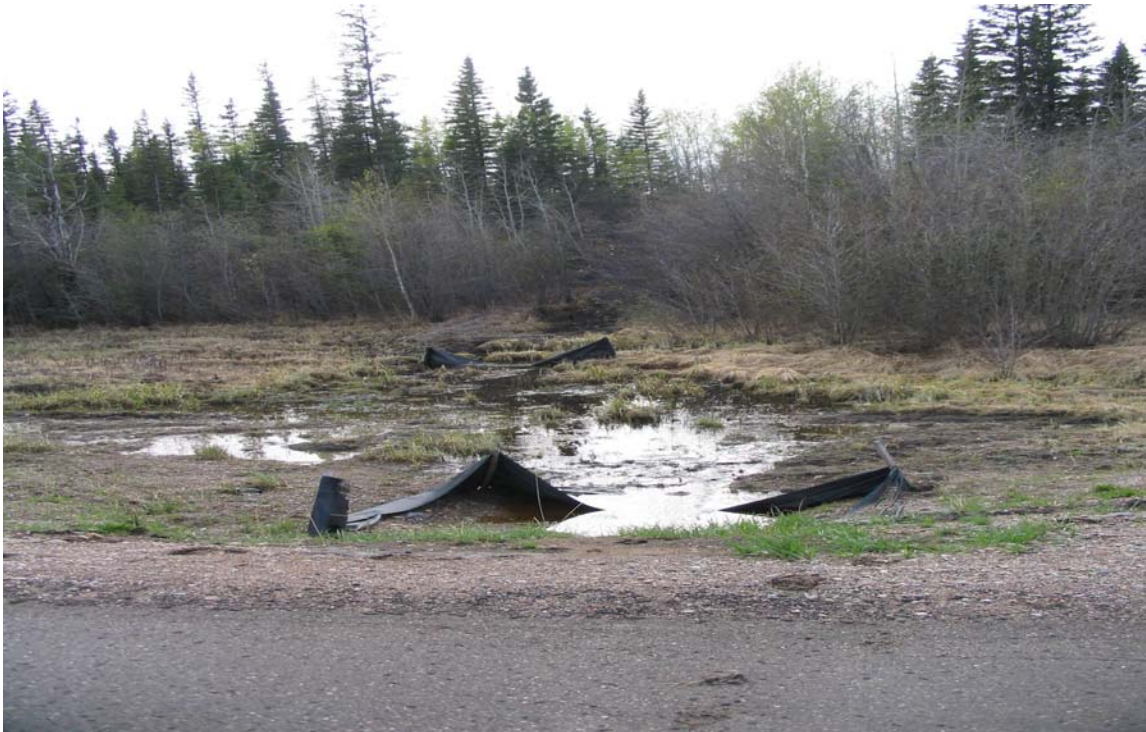
PHOTO 3: Creek and ponded area on west side of highway at Site A.

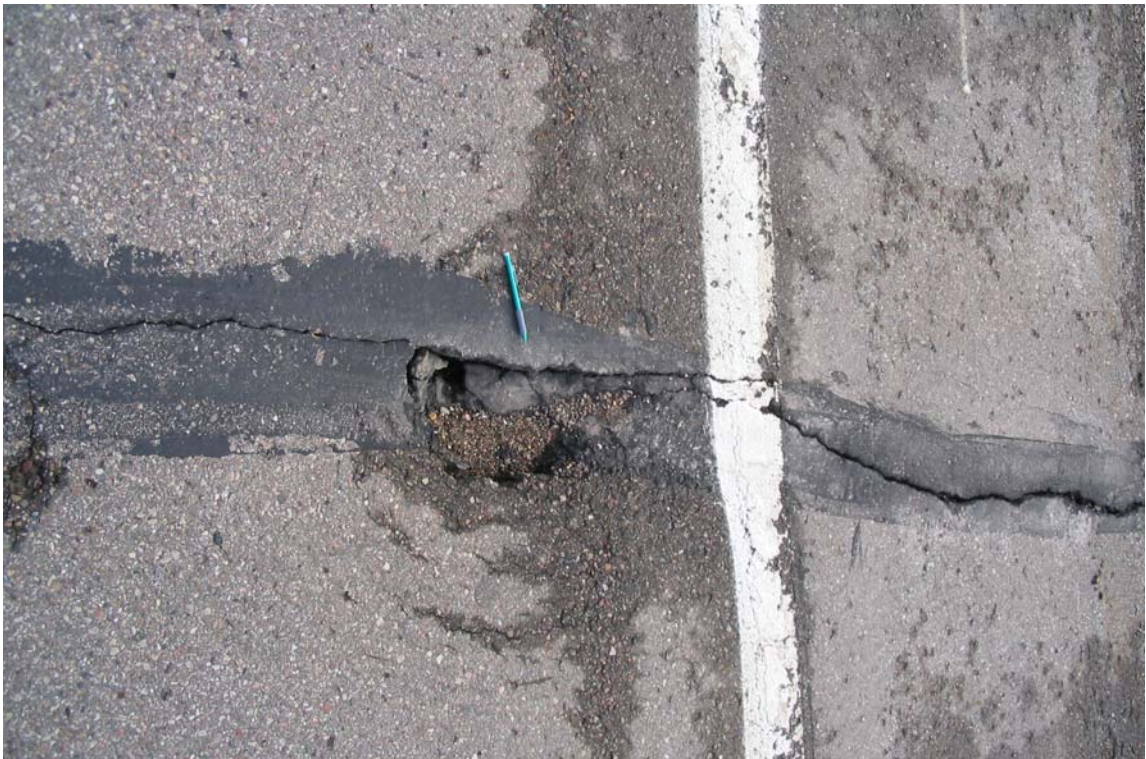
A hole, measuring about 0.2 m by 0.2 m and 0.1 m deep was observed in the pavement, about 3.5 m south of the culvert. A transverse crack, 7 mm wide, extending from the hole towards the edges of the road, was present over a former grouted center line culvert.

PHOTO 4: Hole on the roadway and transverse cracks at Site A.

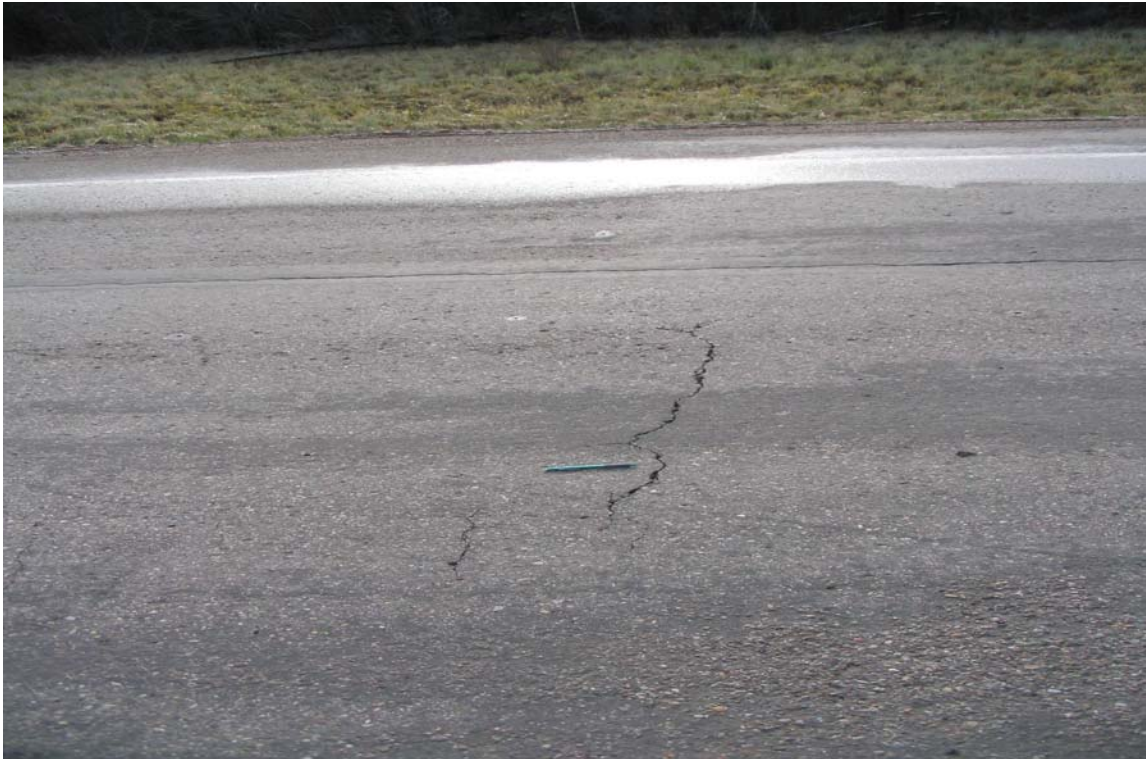
PHOTO 5: New transverse cracks in pavement at Site A.

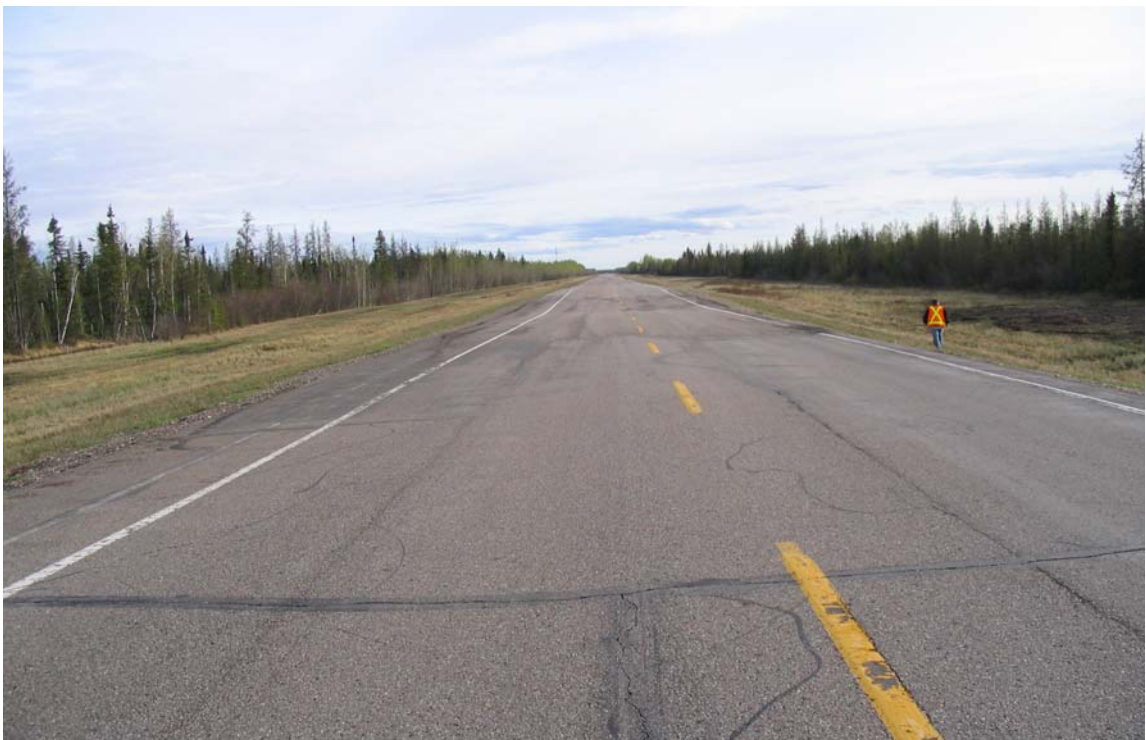
PHOTO 6: View of Site B facing south. Dip on the highway.

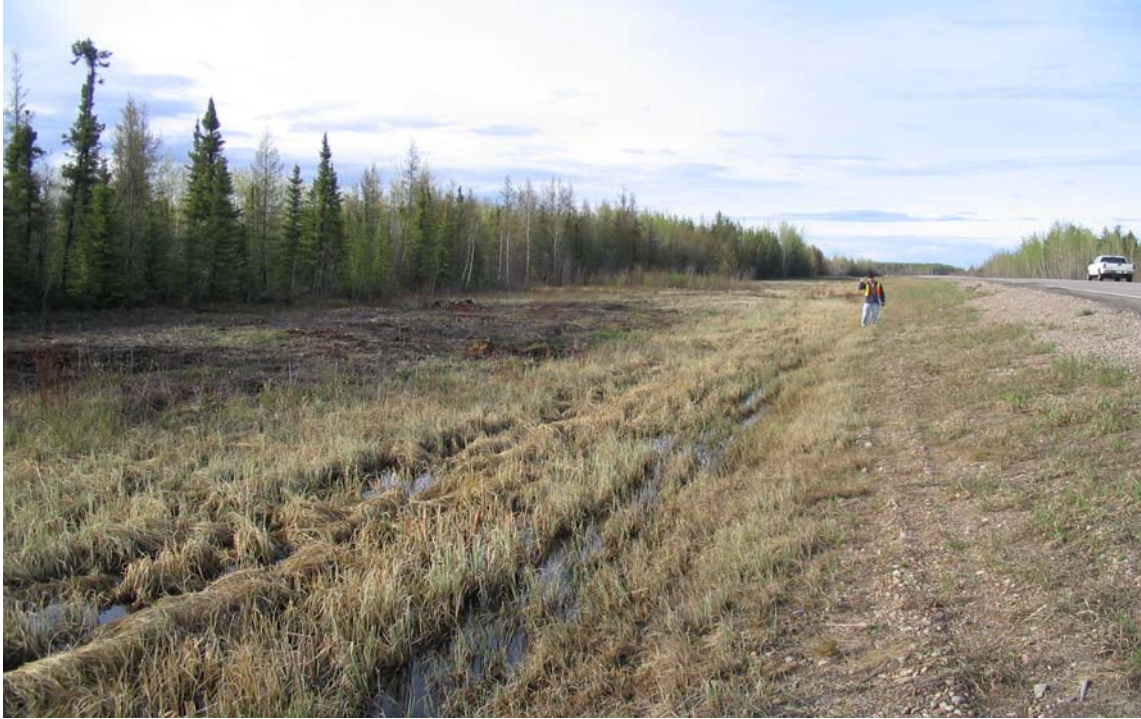
A muskeg heave appeared to be present on the west side of the road. Standing water was observed on the east side of the road, over a slightly depressed area.

PHOTO 7: Muskeg heave and stagnant water on west side of the highway at Site B.

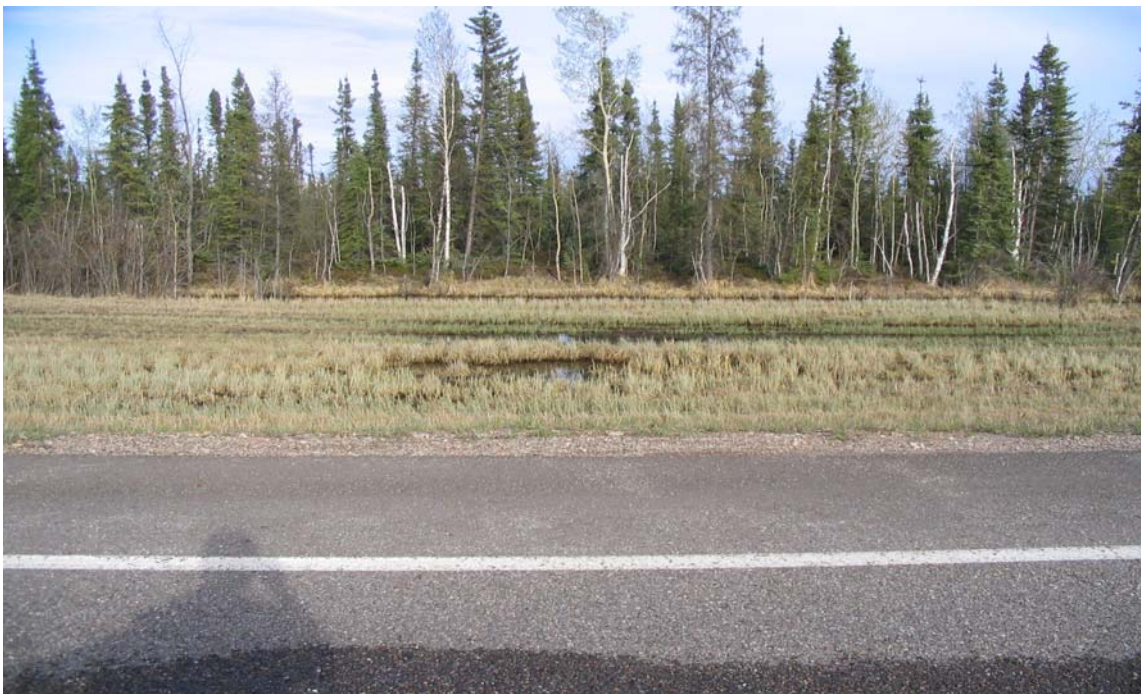
PHOTO 8: Ponded water and dip on right of way over the east side of the road at Site B.

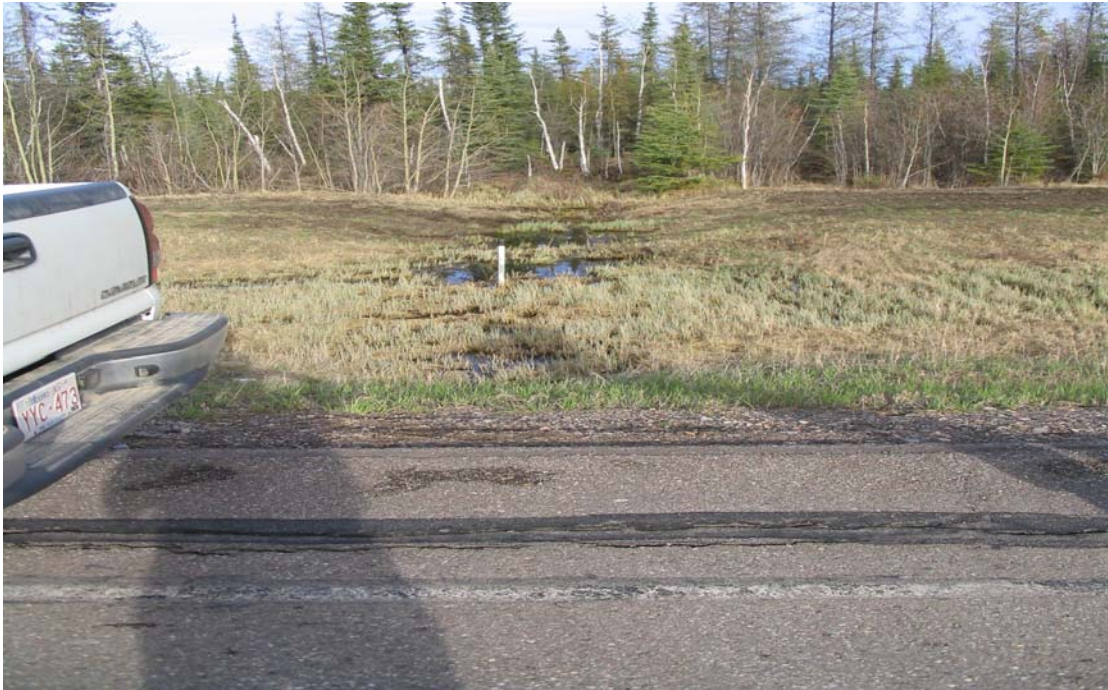
About 27 m further north, wet areas and ponded water were observed on both sides of the road, where an existing 900 mm diameter, CSP culvert crosses underneath the highway. Two longitudinal cracks with a 200 mm drop were observed on the roadway, over the above mentioned CSP culvert. One of them was previously patched but had cracked open again.

PHOTO 9: Longitudinal cracks and incoming creek on east side of road at Site B.

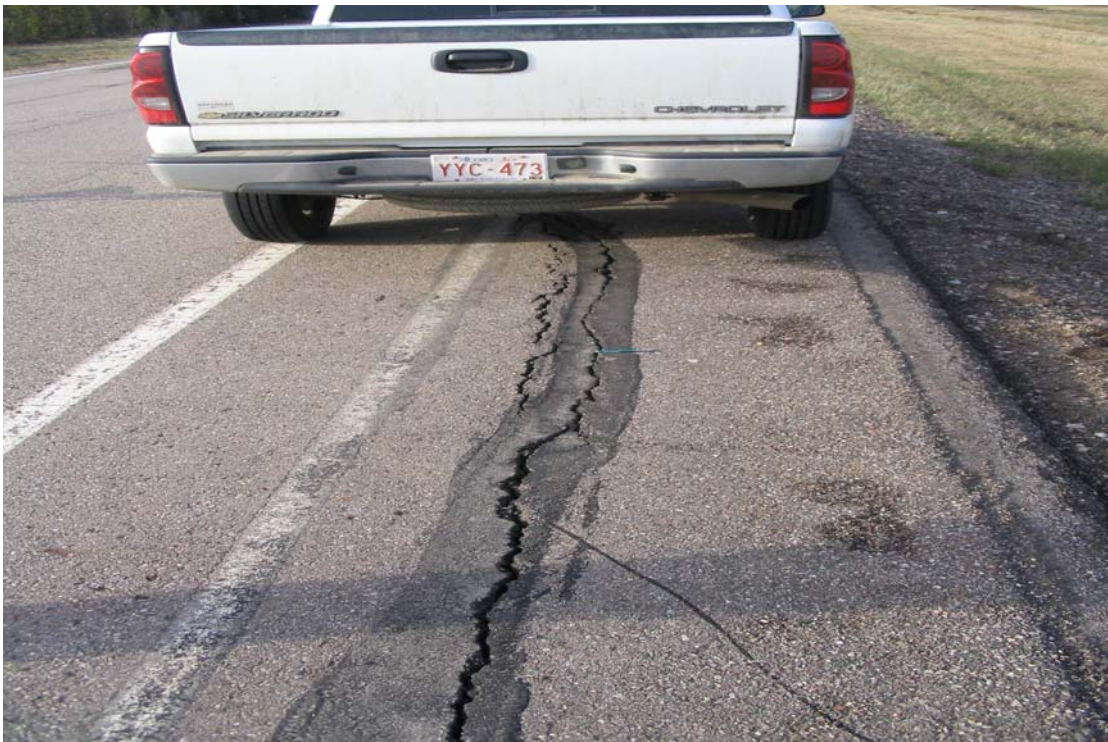
PHOTO 10: New longitudinal crack and reopening of a crack previously patched at Site B.
