January 18, 2008

File: 15-85-72

**PEACE REGION (PEACE RIVER – HIGH LEVEL AREA)
GEOHAZARD ASSESSMENT
HWY 35:20, SITE PH 49, INDIAN CABINS FROST HEAVES
2007 ANNUAL INSPECTION REPORT**

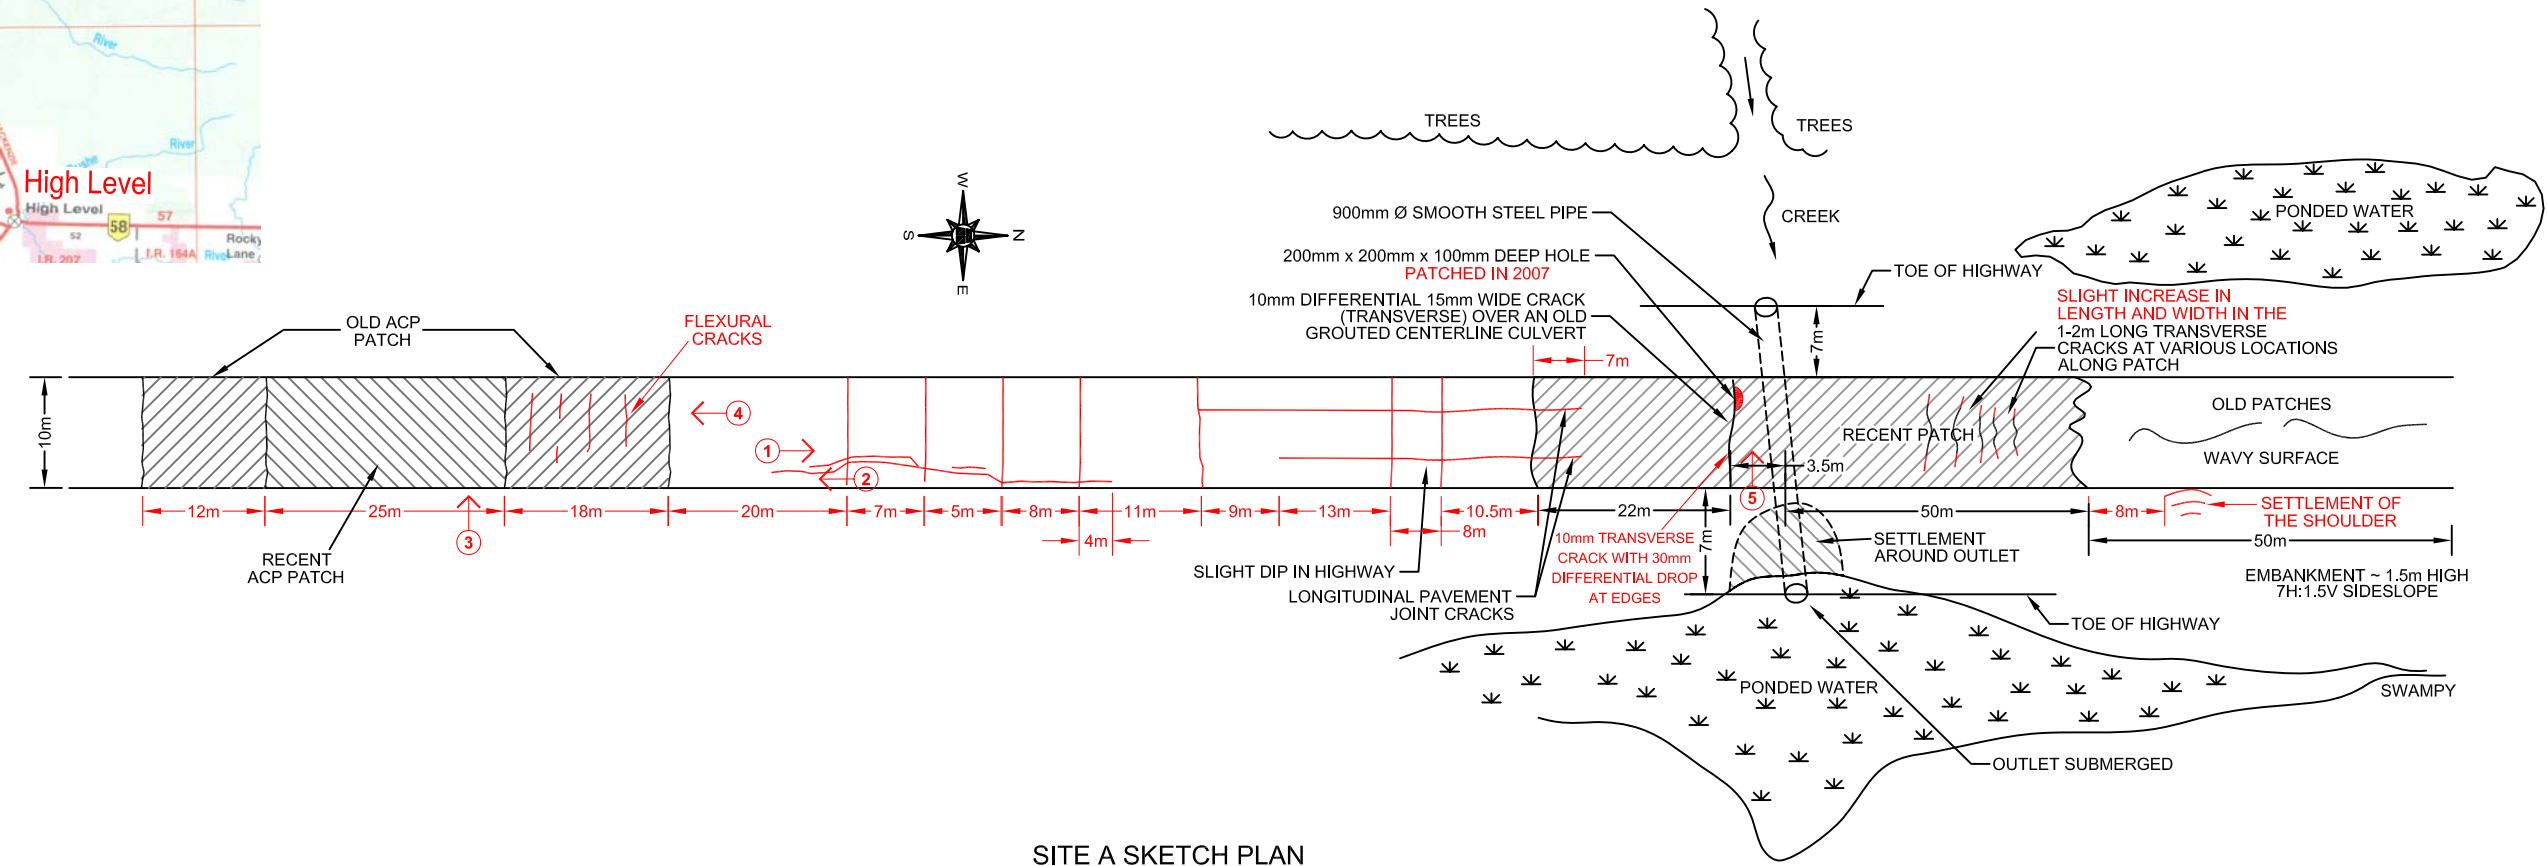
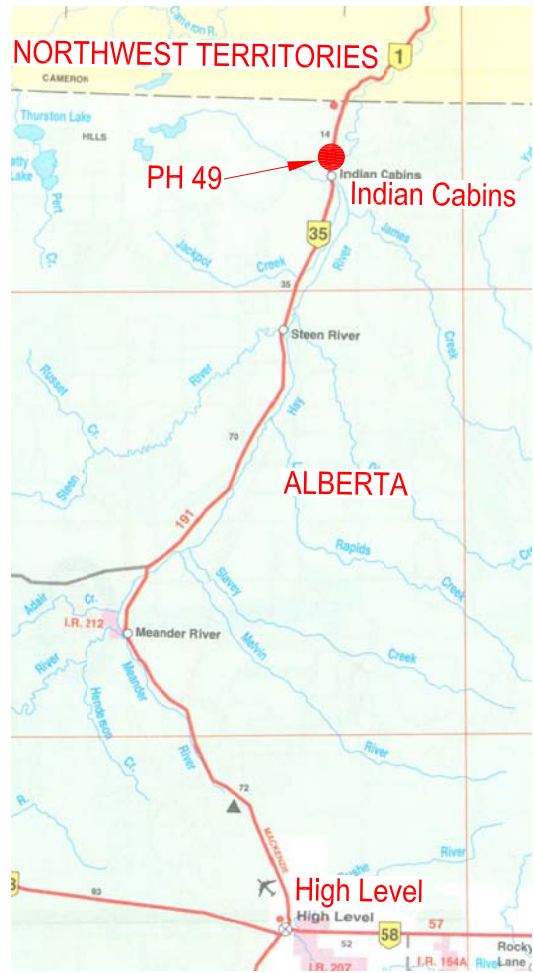
FIGURE PH49-1
PH49 : HWY35 SITE A, 0.5 Km NORTH OF INDIAN CABINS
PEACE REGION (PEACE RIVER / HIGH LEVEL)
GEOHAZARD ASSESSMENTS

Site A had a length of about 200 m. The highway surface had a relatively smooth profile with slight dips at the south and north ends of the site. Several longitudinal cracks were noted on the highway surface on the southern 100 m of the site. Most of these cracks had been previously patched in the past but they had cracked open again and increased their length.

At about the center of Site A, a creek crosses underneath the highway through a culvert. The highway at that location had an ACP patch, extending about 25 m to the south and 50 m to the north of the culvert. The hole noted in the 2006 site visit, located about 3.5 m south of the culvert, had been backfilled and sealed. However, the transverse crack extending from the hole towards the road shoulders still existed and had increased its width to about 10 mm. This transverse crack has a differential drop about 30 mm at the shoulders of the highway.

A slight increase in width and length was noted on the transverse cracks located south of the culvert, through the ACP patch mentioned above. The cracks were 1 m to 2 m long and were located at 2 m to 5 m intervals, as is illustrated on Figure PH49-1. The roadway along the northern 50 m of the site had a wavy surface.

At the time of the 2007 site visit, the surroundings of the highway were covered with snow. However, ponded water was observed on both sides of the highway embankment during the 2006 site visit. A shallow creek flowed under the highway through a 900 mm diameter, smooth-wall steel culvert. The culvert outlet was submerged and could not be inspected. However, settlement around the outlet was noticed.

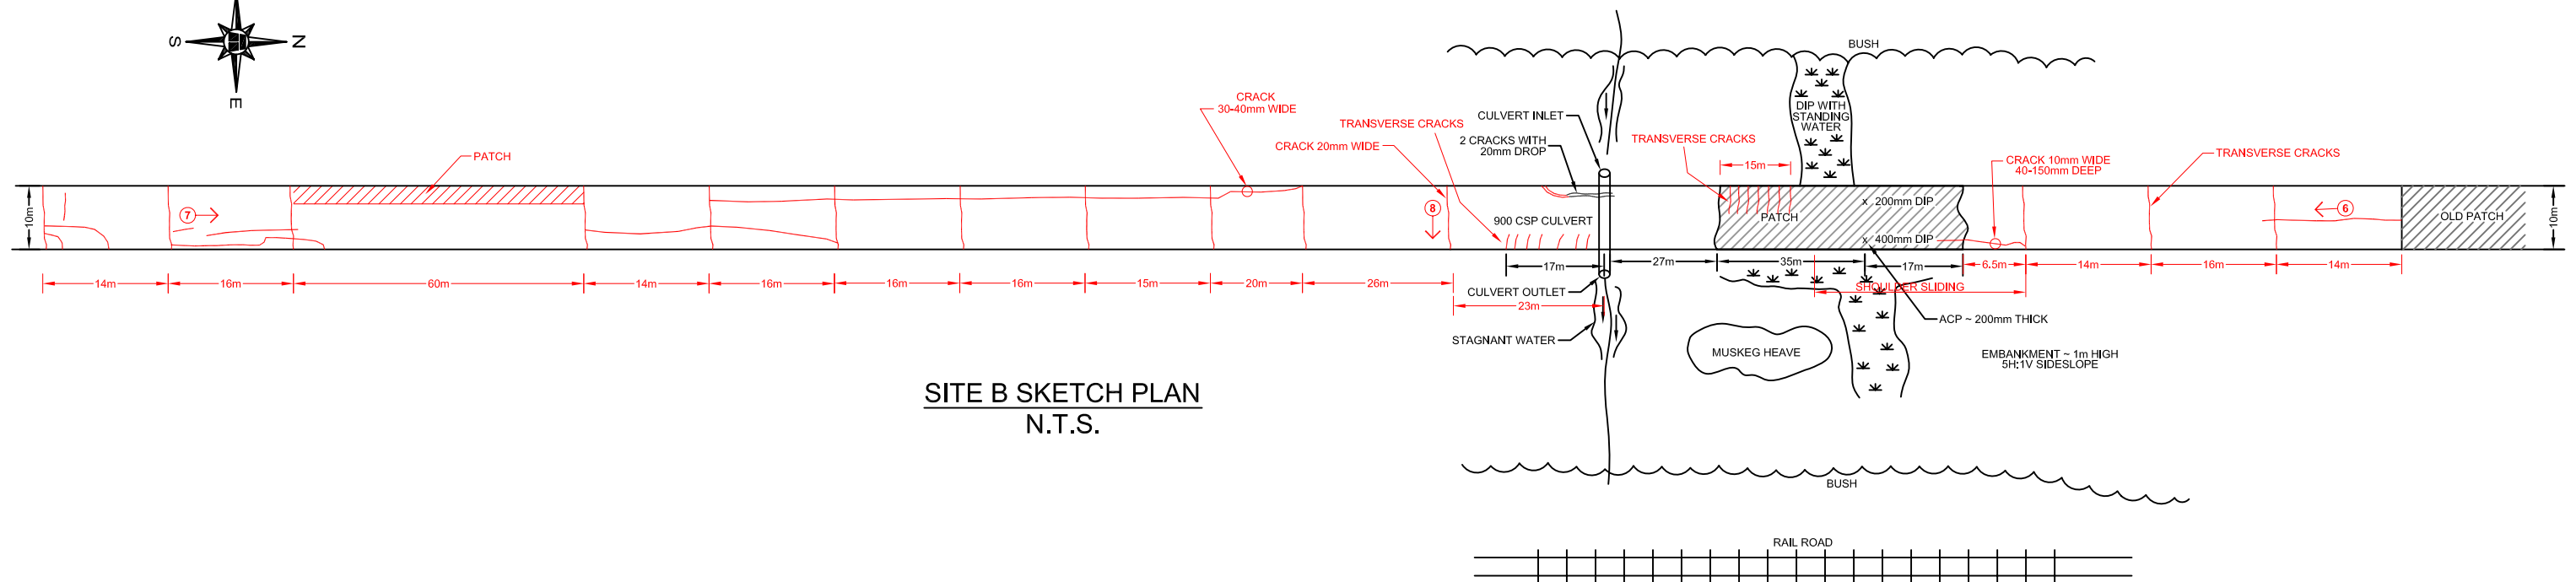
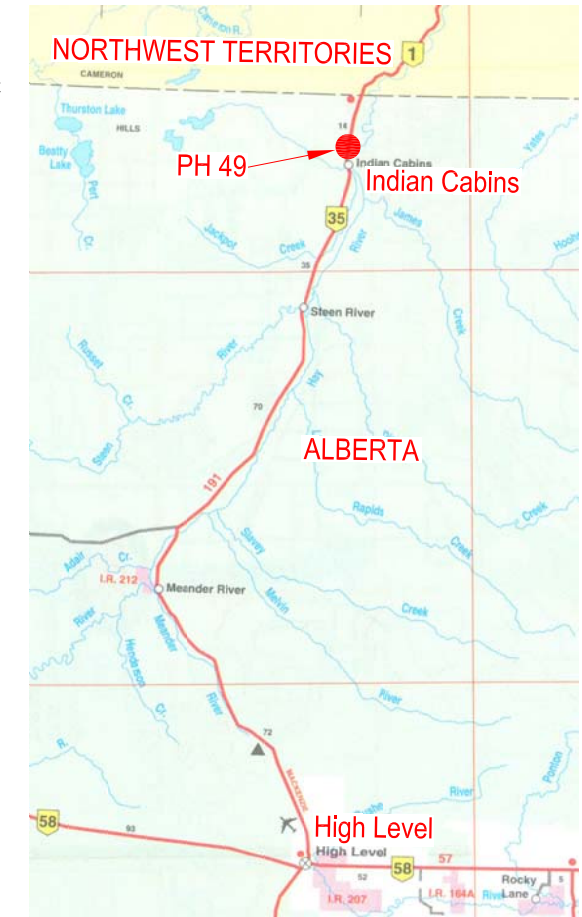
FIGURE PH49-2
PH49 : HWY35 SITE B, 8.7 Km NORTH OF INDIAN CABINS
PEACE REGION (PEACE RIVER / HIGH LEVEL)
GEOHAZARD ASSESSMENTS

The highway showed a greater number of longitudinal and transverse cracks since the 2006 site visit, and the previously existing cracks appeared to have increased

their width and length since last year. Due to this, the inspected length of Site B was increased from about 100 m in 2006 to 300 m in 2007.

The pronounced dip located south of the culvert, did not appear to have increased its height since the 2006 site visit. However, new transverse cracks about 2 m long were noticed on the ACP patch, as illustrated on Figure PH49-2. The maximum drop on the roadway ranged from 200 mm to 400 mm at the east and west shoulders, respectively. During the May 2006 site visit, a dip with standing water was observed at that location on both sides of the highway. Ponded water at both ends of the culvert was also observed during the 2006 site visit.

Many previously sealed cracks located north and south of the culvert were noticed to have opened again, as well as old longitudinal construction joints on the pavement, which appeared to be cracking open.

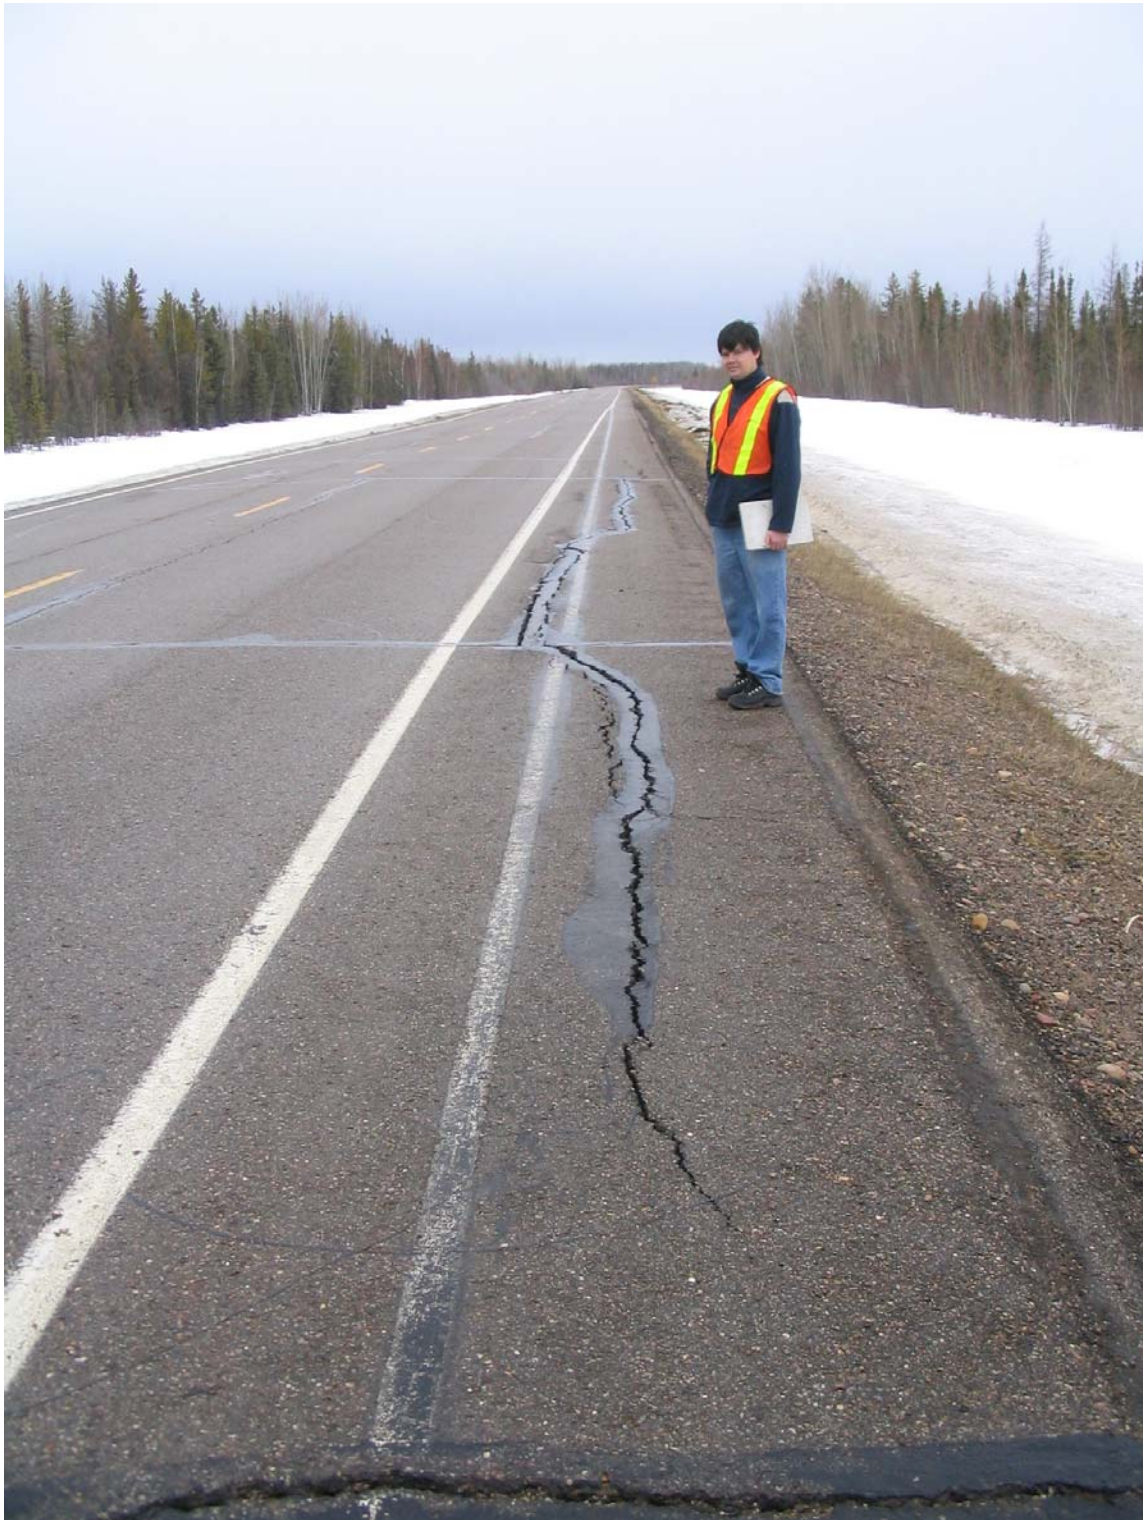
Photo 1 - Graben type crack at Site A.

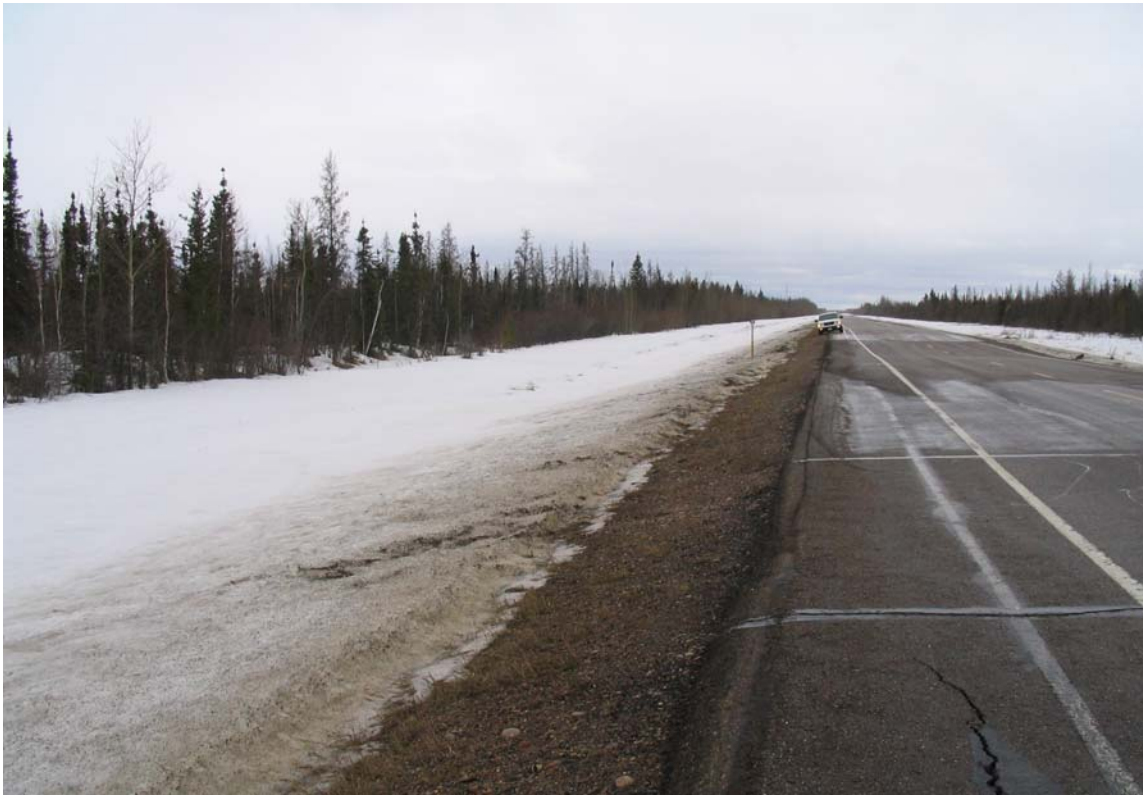
Photo 2 - View of ACP patches at south end of Site A, looking south.

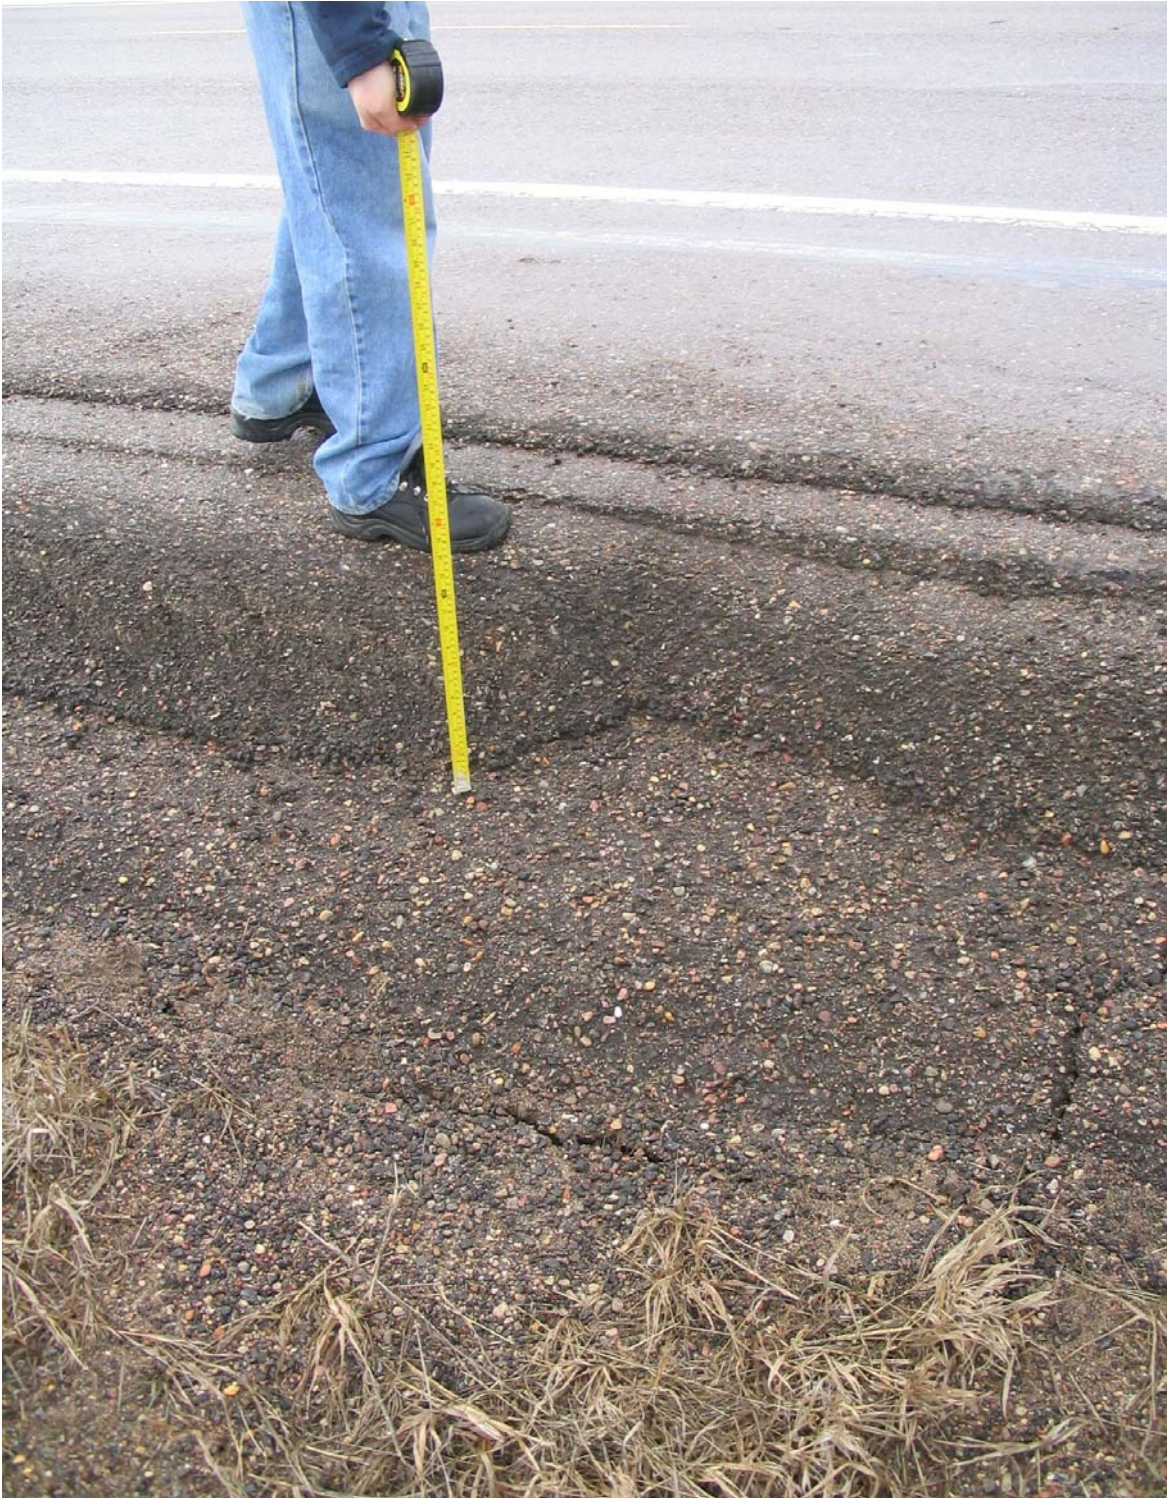
Photo 3 - Overlay 300 mm thick in ACP patch in Site A.

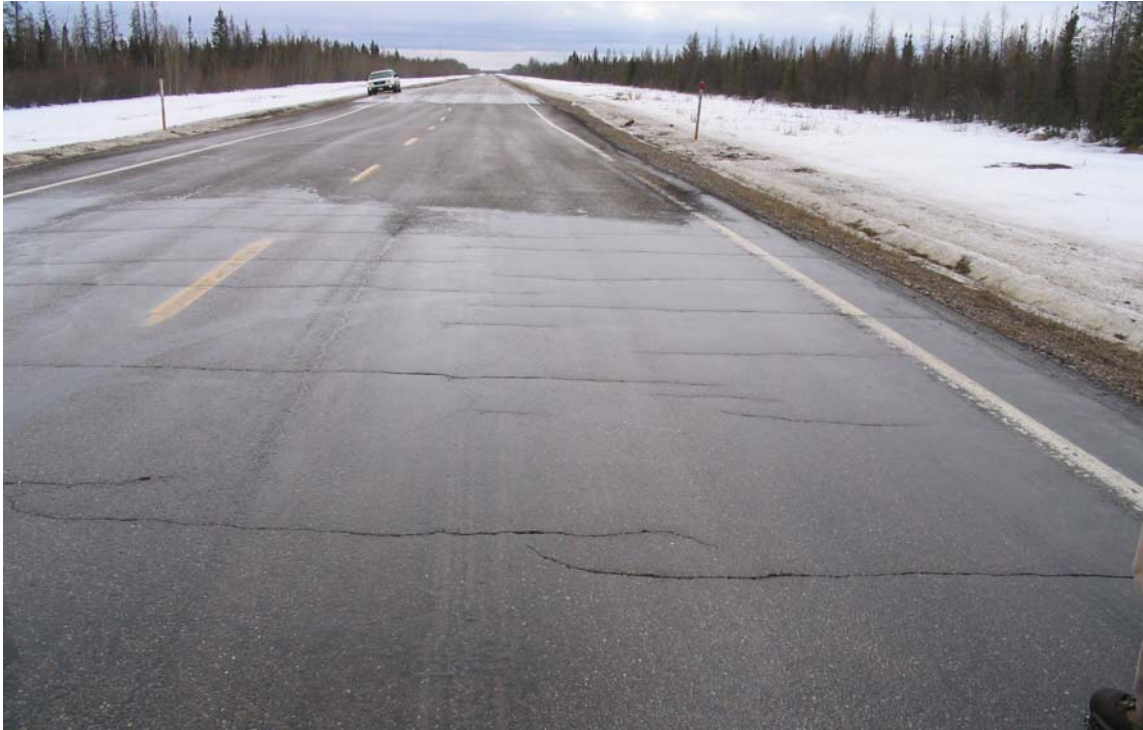
Photo 4 - Flexural cracks in old ACP patch at south end of Site A, looking south.

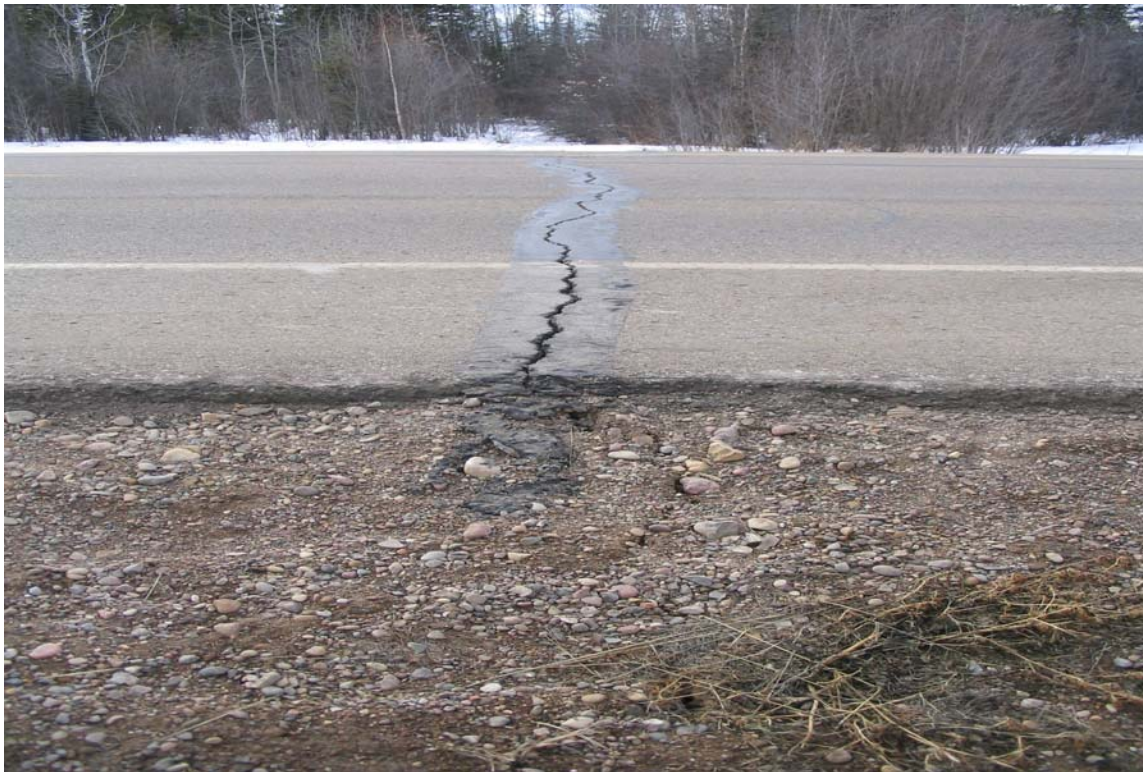
Photo 5 - Transverse crack above culvert in Site A, looking west.

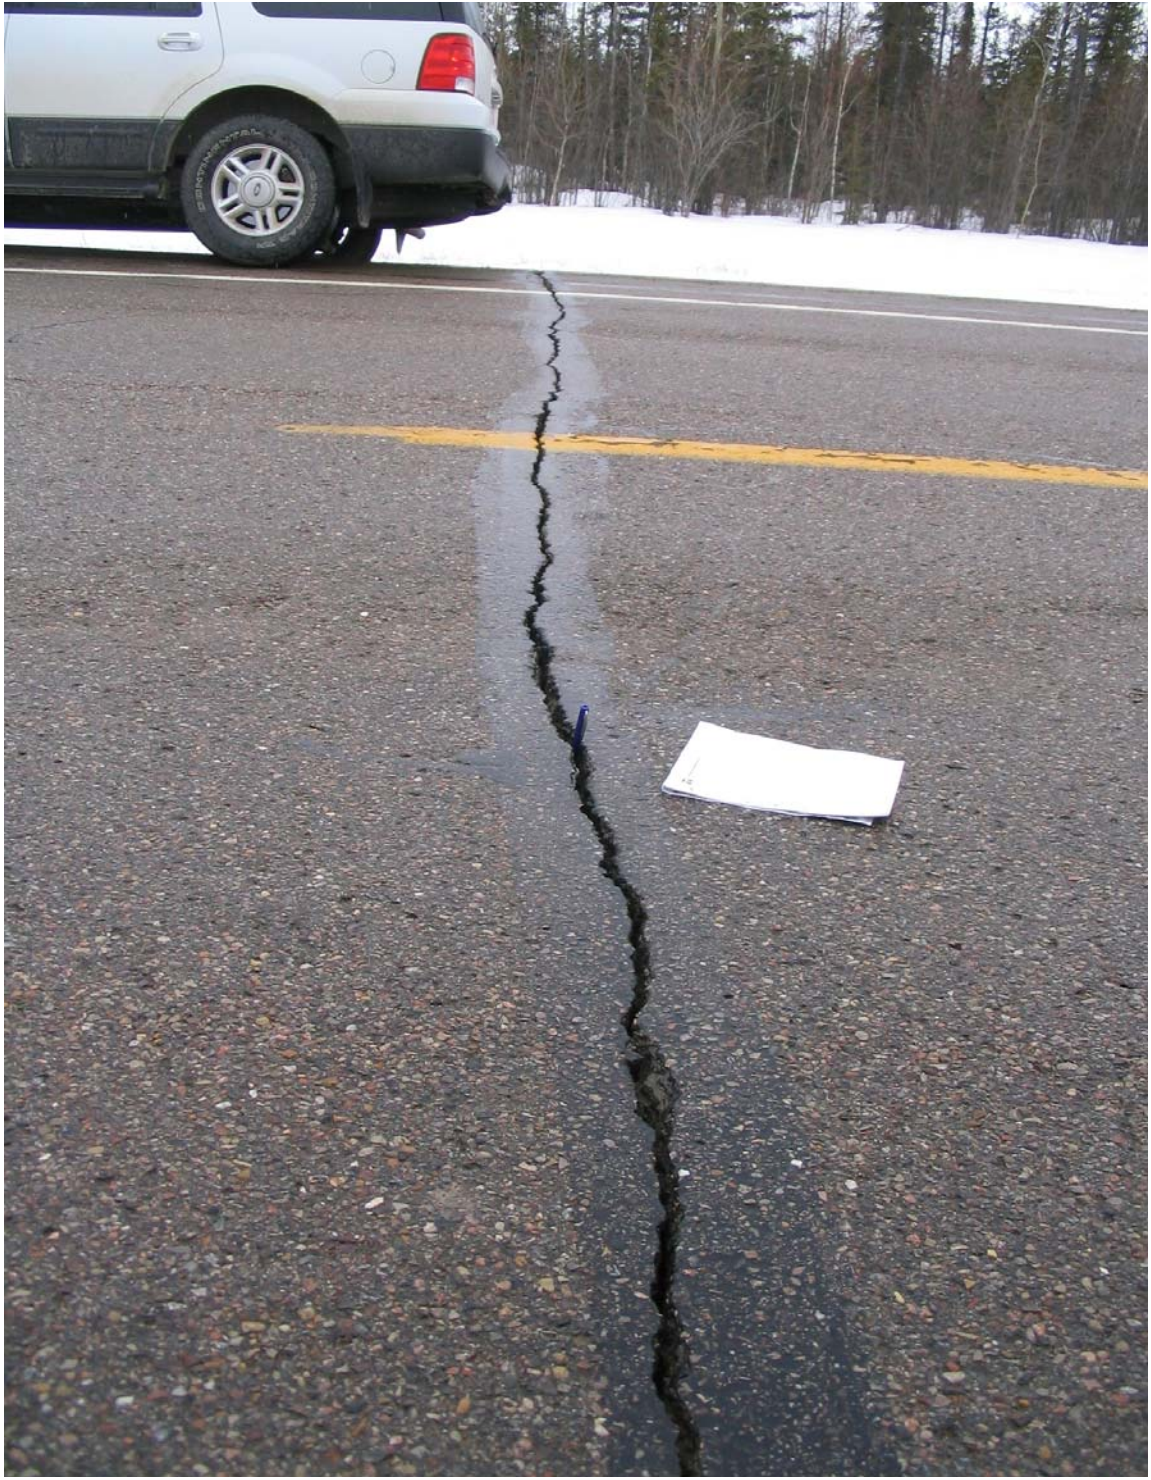
Photo 8 - Transverse crack 20 mm wide in Site B.
