GEOHAZARD ASSESSMENT PROGRAM

PEACE RIVER / HIGH LEVEL AREA

2010 INSPECTION

FIGURE PH63-1
PH63: HWY 88:12 - NORTH OF SLUG CREEK BRIDGE
PEACE REGION (PEACE RIVER/HIGH LEVEL)
GEOHAZARD ASSESSMENT

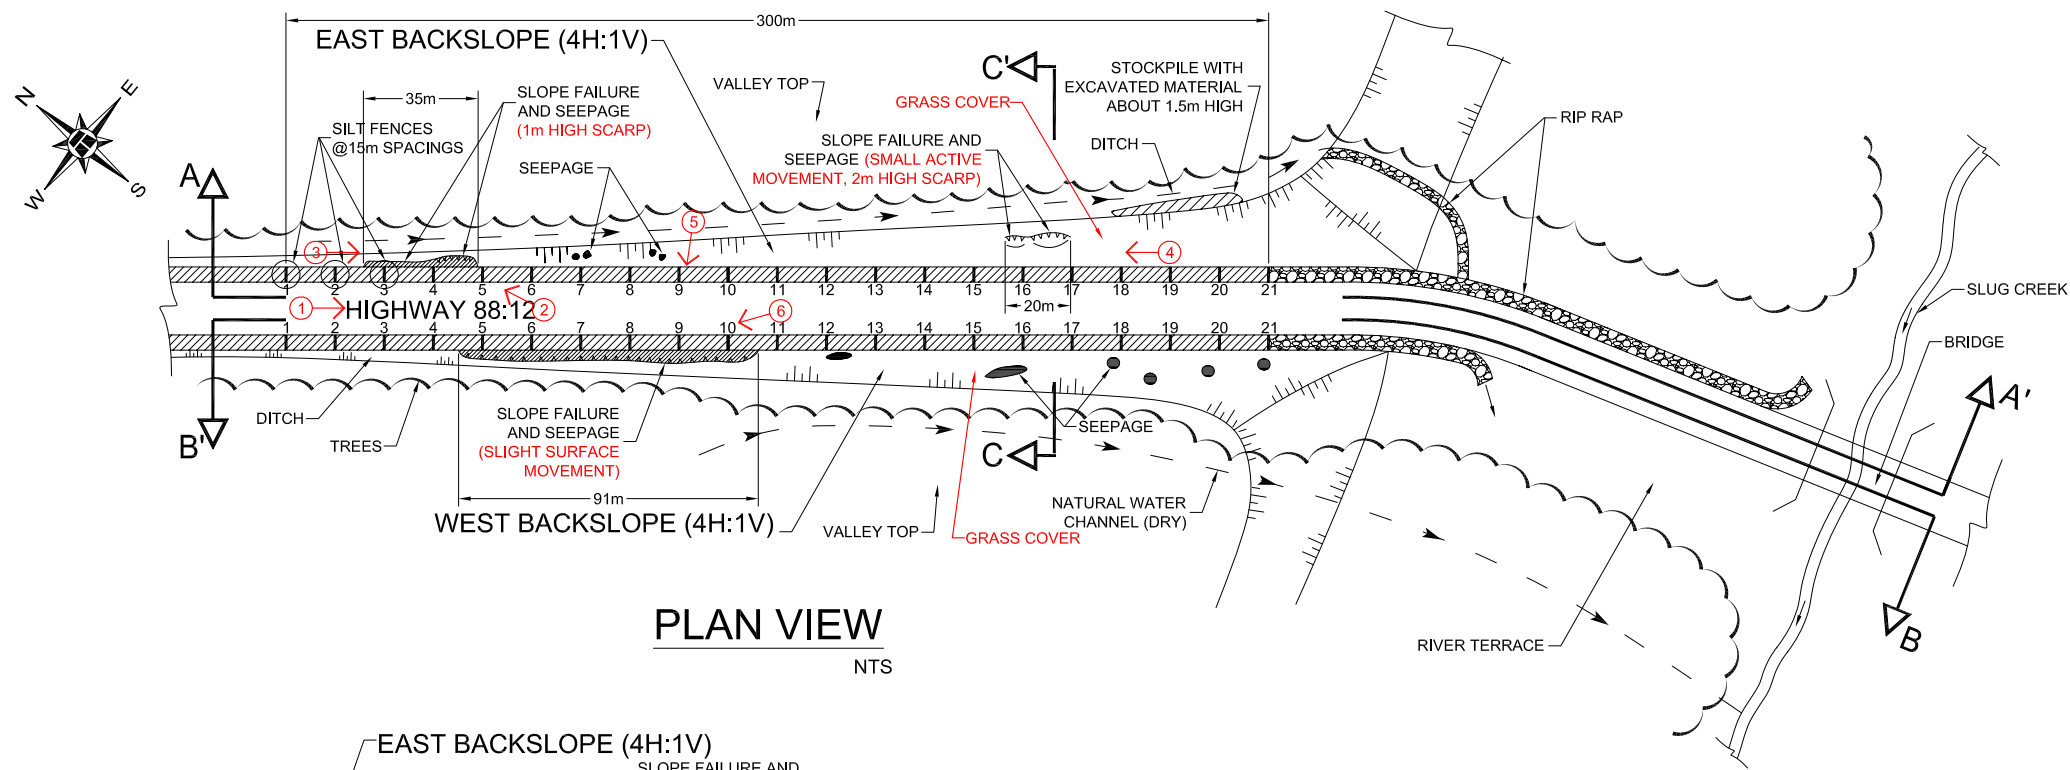
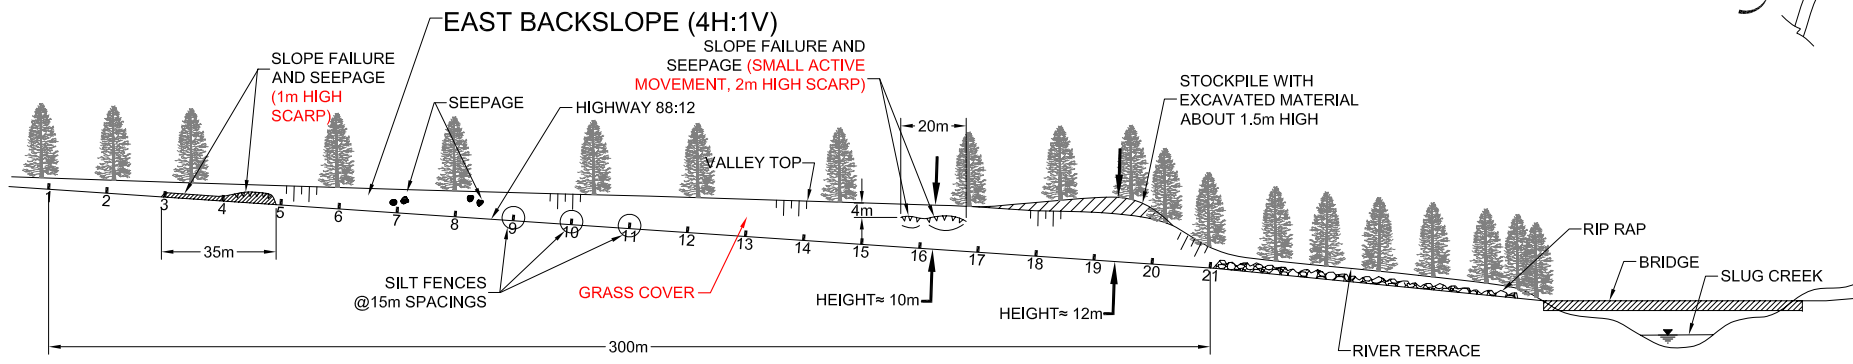
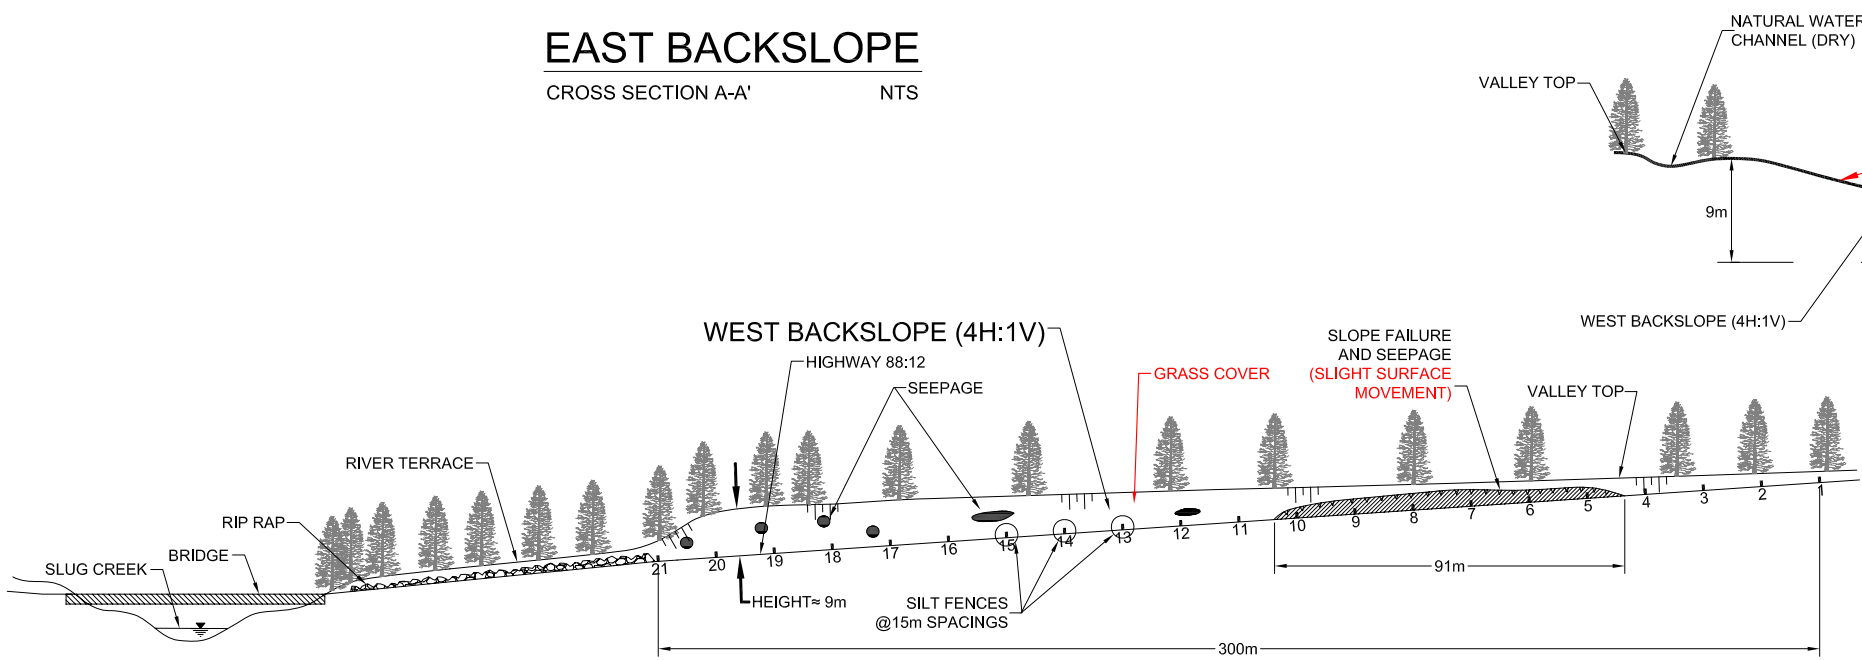
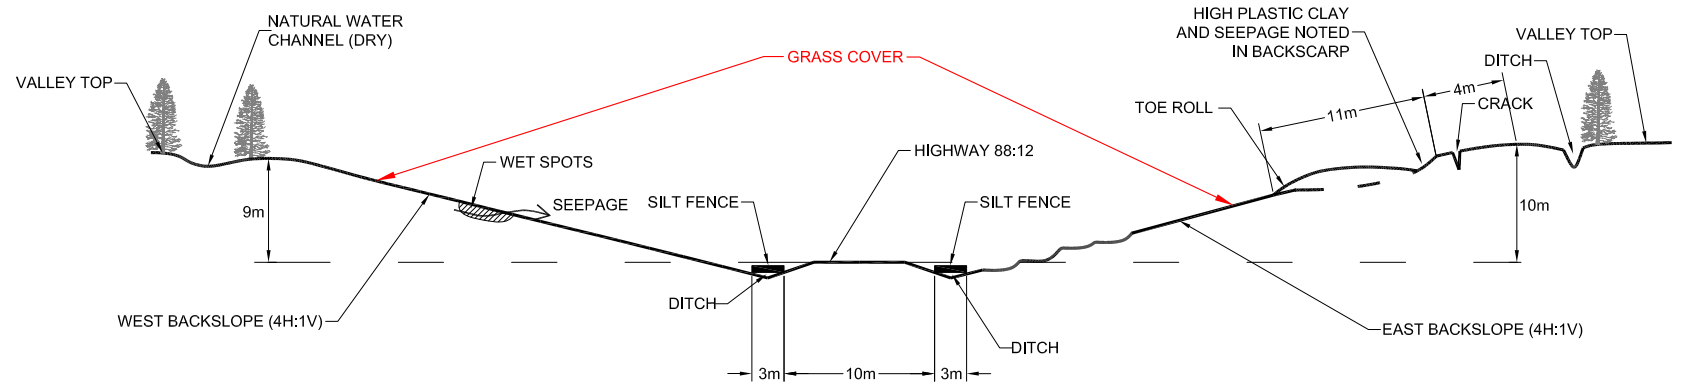
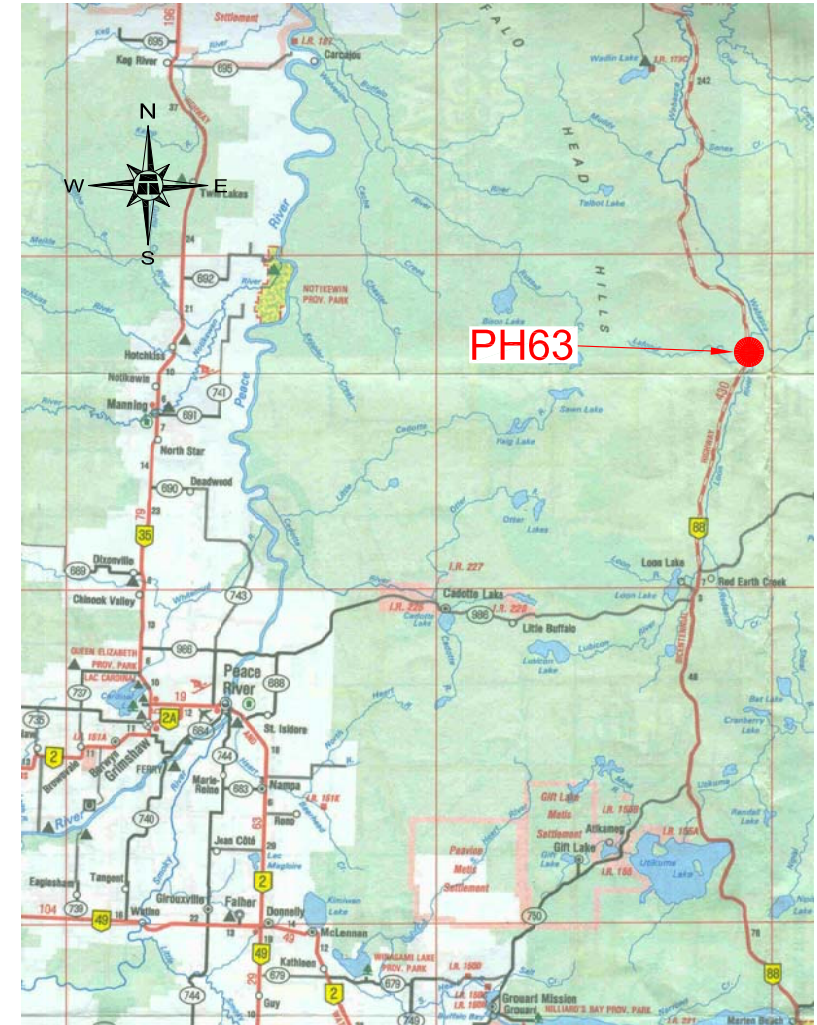
The slope failures appear to be the result of clay softening plus seepage forces flowing from the shallow ground water table on the valley top towards the backslopes. The wet areas noted on the backscarps may be zones where the material is more permeable and groundwater seeps in greater quantity through them. The excavation required for the cut and the presence of groundwater may have led to softening and swelling of the clay.

Subdrainage measures aiming to increase the stability of the backslopes are recommended. These may consist of gravel drains installed in the east and west backslopes to conduct the water downslope. For this purpose, ditches 1 m wide and 1.5 m deep could be excavated and backfilled with washed gravel enveloped in non-woven geotextile. The surficial 0.3 m of the excavated ditches should be backfilled with clay and topsoil and seeded. The gravel drains should be spaced about 10 m center-to-center across the affected backslope locations. The upslope end of the gravel drain should extend 1.5 m vertically along the affected 4H:1V inclination above the highest level of observed seepage. The water from the gravel drains should discharge into perforated subdrain pipes installed at least 1.5 m below the ditches at the toes of the backslopes. The subdrain pipes should also be surrounded by washed gravel enveloped in non-woven geotextile with a compacted clay cap of 0.5 m thickness constructed at the ditch bottom level.

After the slope drains have been installed and the slide area has dried, the slide material should be removed (taking care not to disturb the drains) and the lower slope benched and rebuilt to its original line with salvaged, moisture conditioned clay fill. It should then be promptly top soiled and seeded.

Additional measures would include seeding of the backslopes and removal of the loose material dumped on the crest of the west backslope, which should be disposed away from the site.

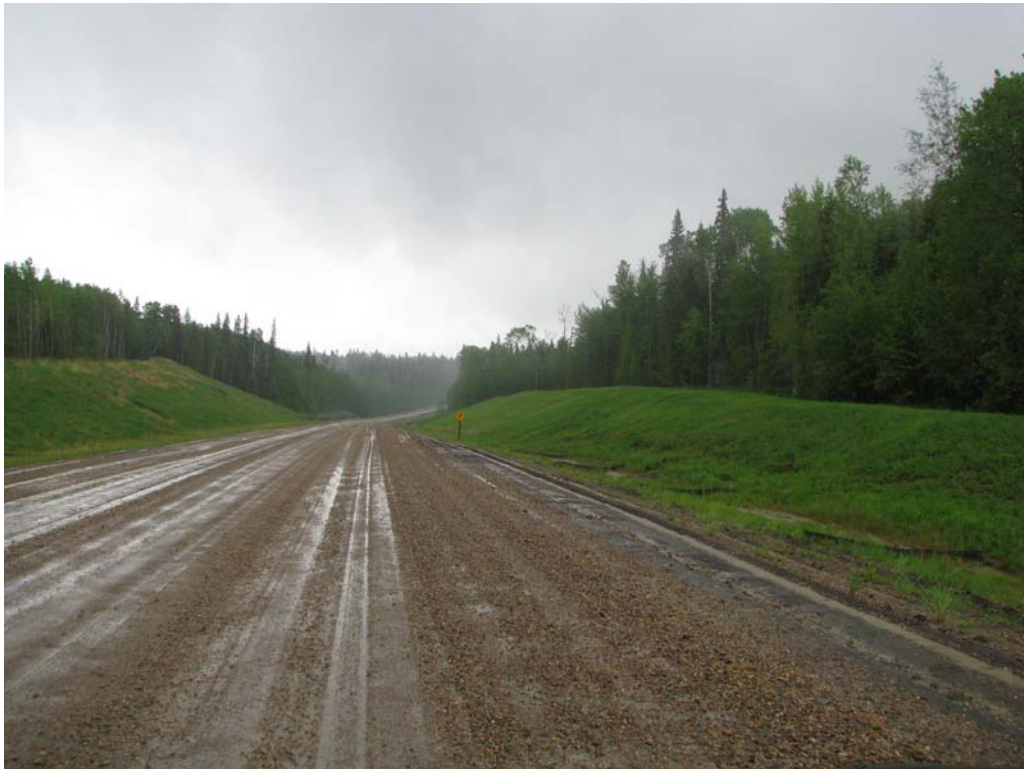
Photo 1 – View of the site showing east and west backslopes, looking southeast.

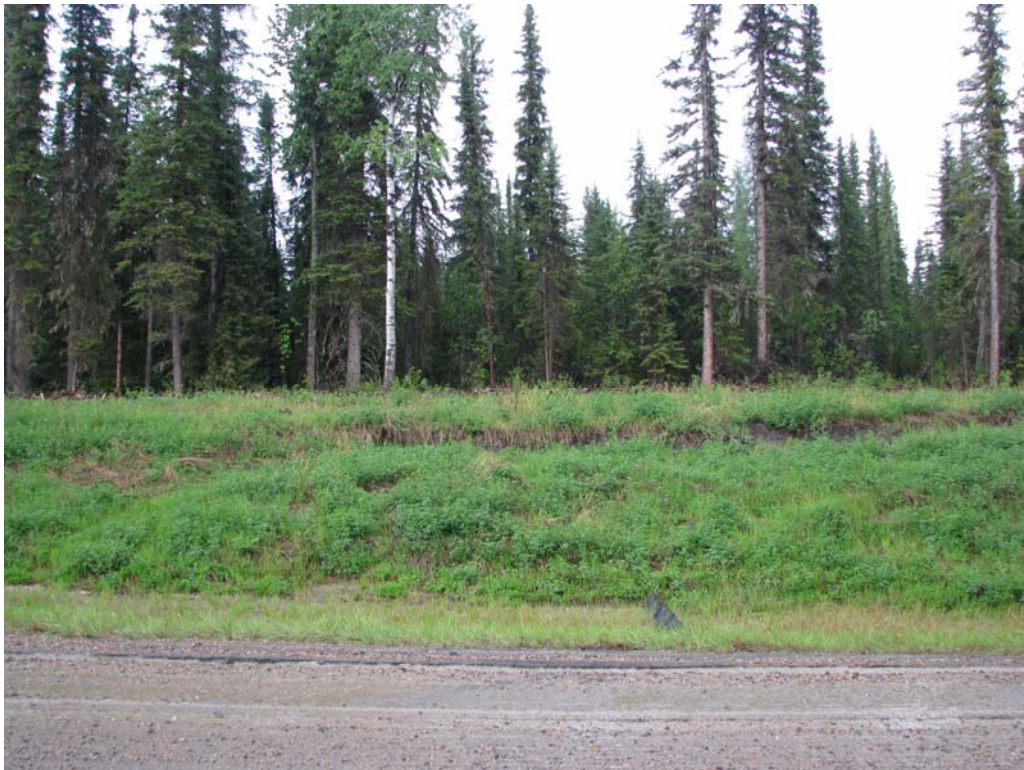
Photo 2 – Slope failure on east backslope, looking east.

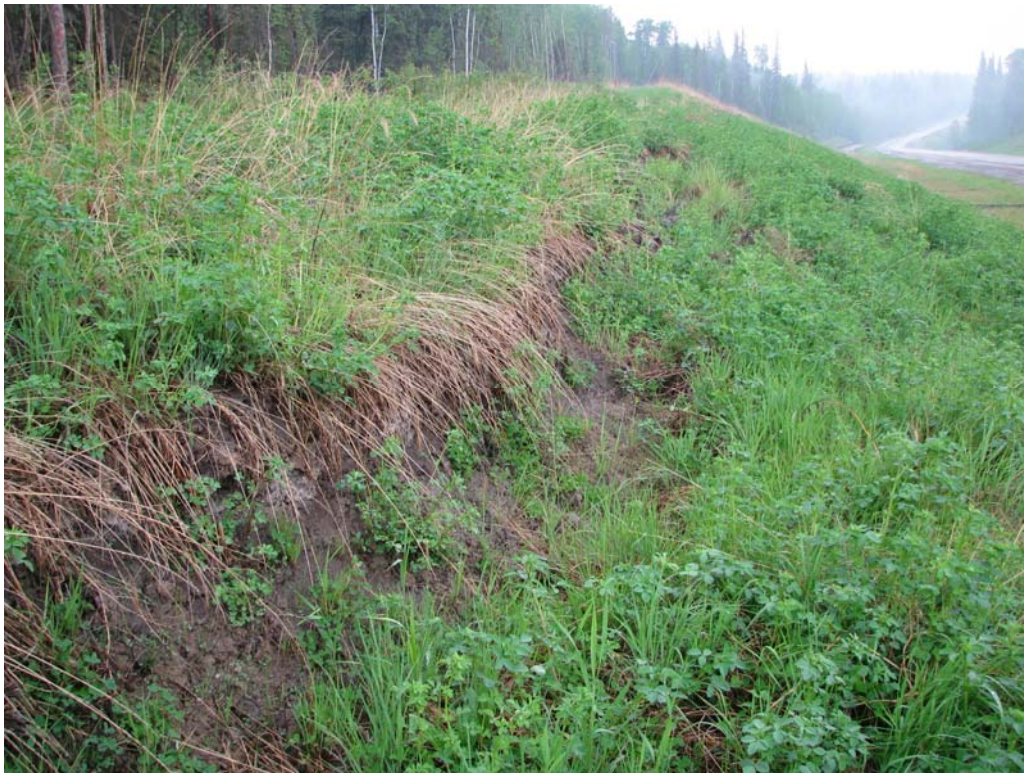
Photo 3 – Clay material along backscarp on east sideslope, looking south.

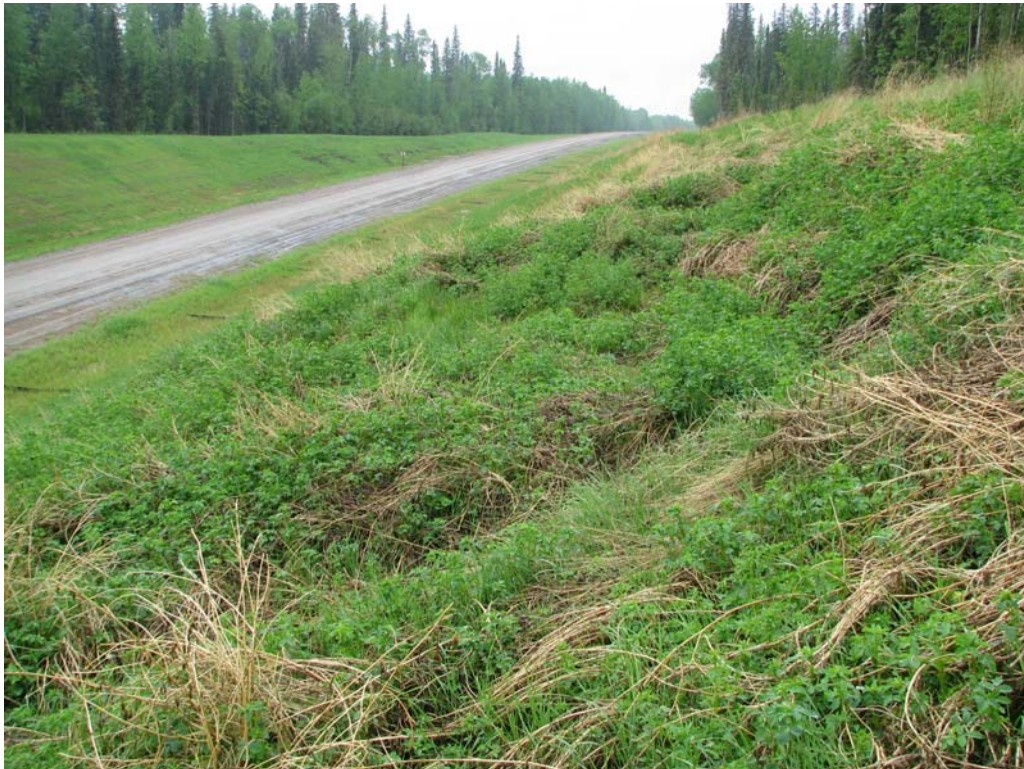
Photo 4 – Slump on east backscarp, looking north.

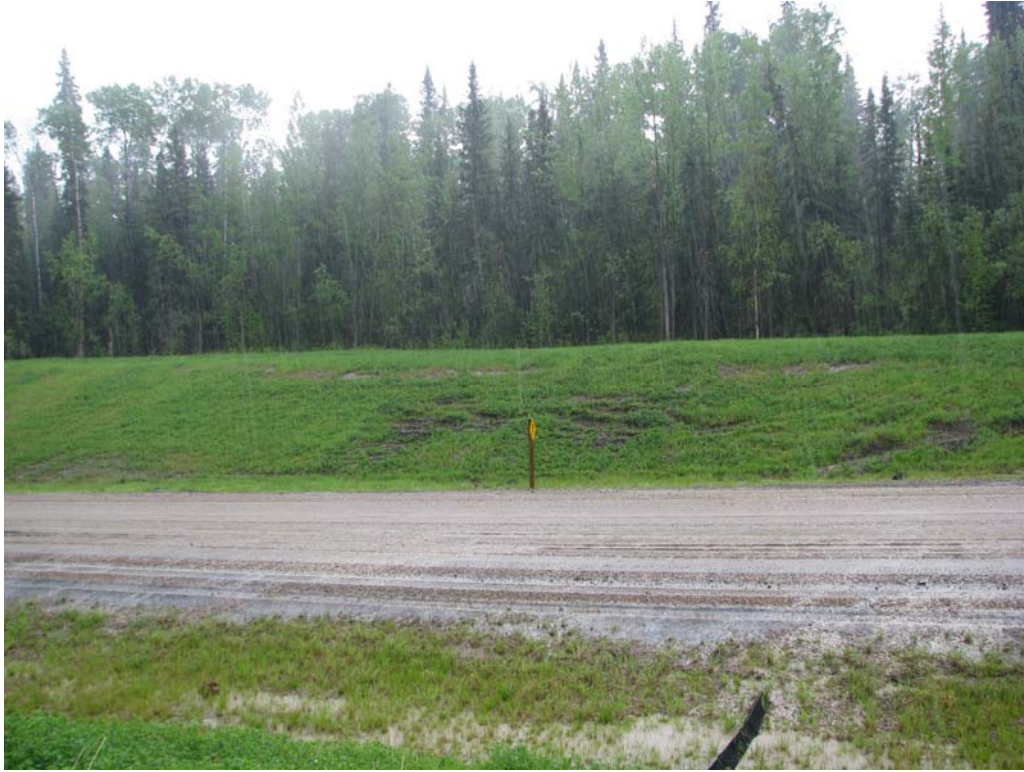
Photo 5 – Wet areas and surficial slope failures on west backslope, looking southwest.

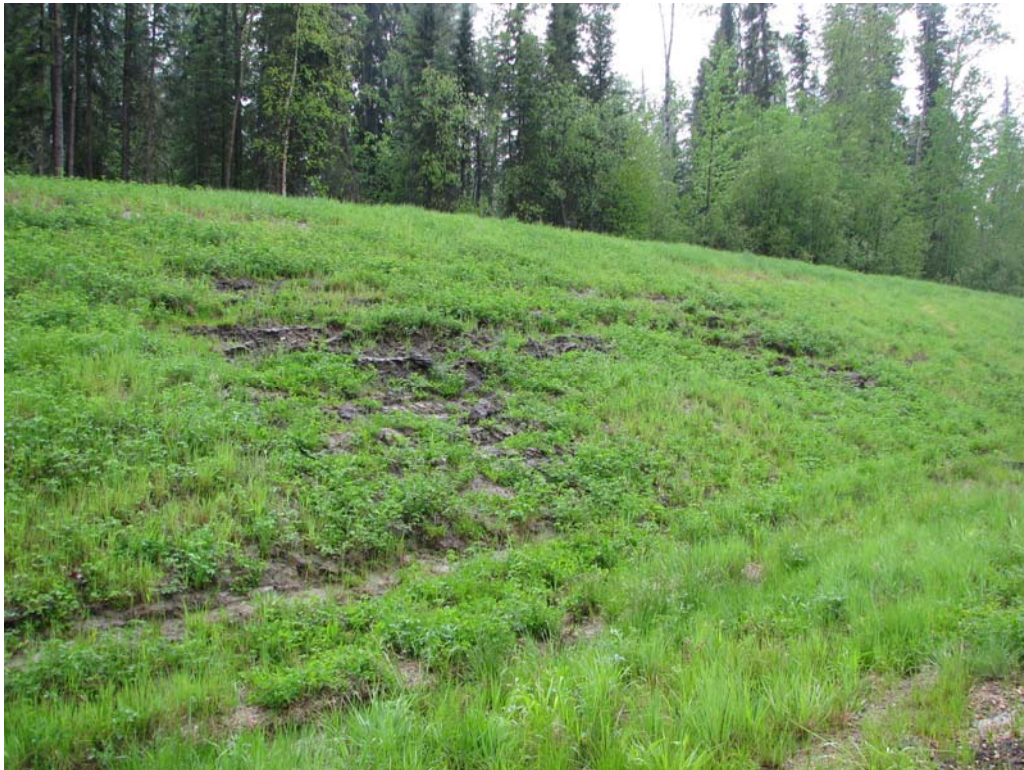
Photo 6 – Wet area and surficial slope failure on west backslope, looking west.
