GEOHAZARD ASSESSMENT PROGRAM

PEACE RIVER / HIGH LEVEL AREA

2011 INSPECTION

Site Number	Location	Name	Hwy	km
PH63	About 70 km north of Red Earth, AB	Slug Creek	88:12	Approx. 5
Legal Description		UTM Co-ordinates		
LSD13-17-93-07-W5M		11V N 6327155	E 615361

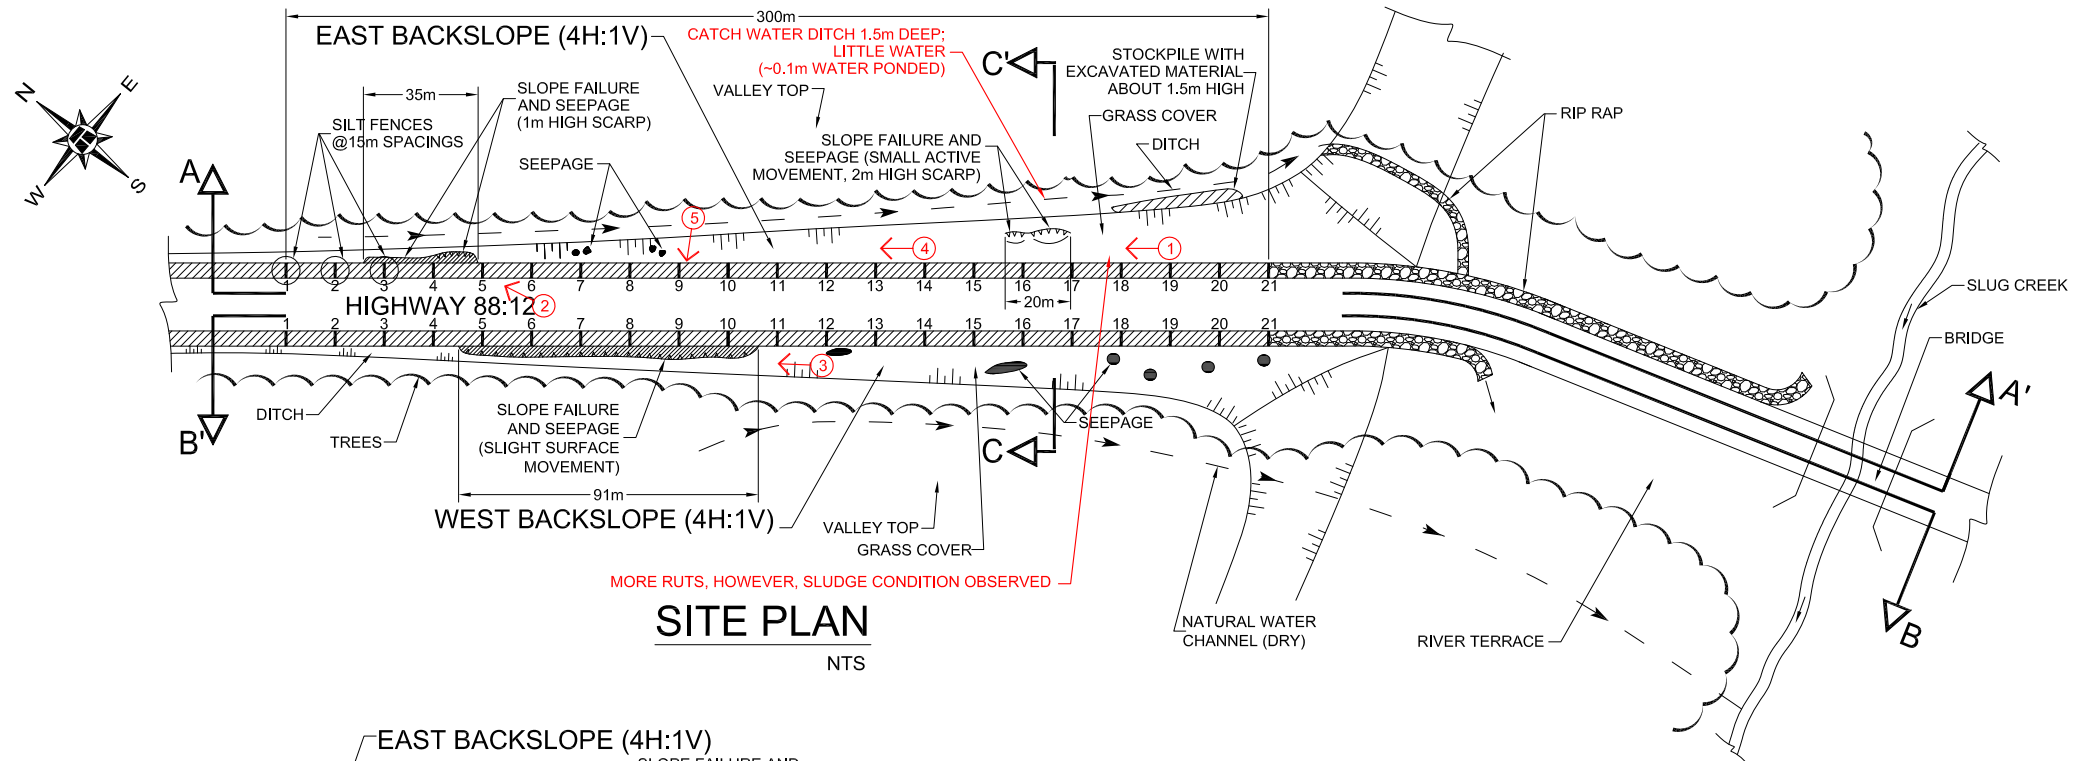
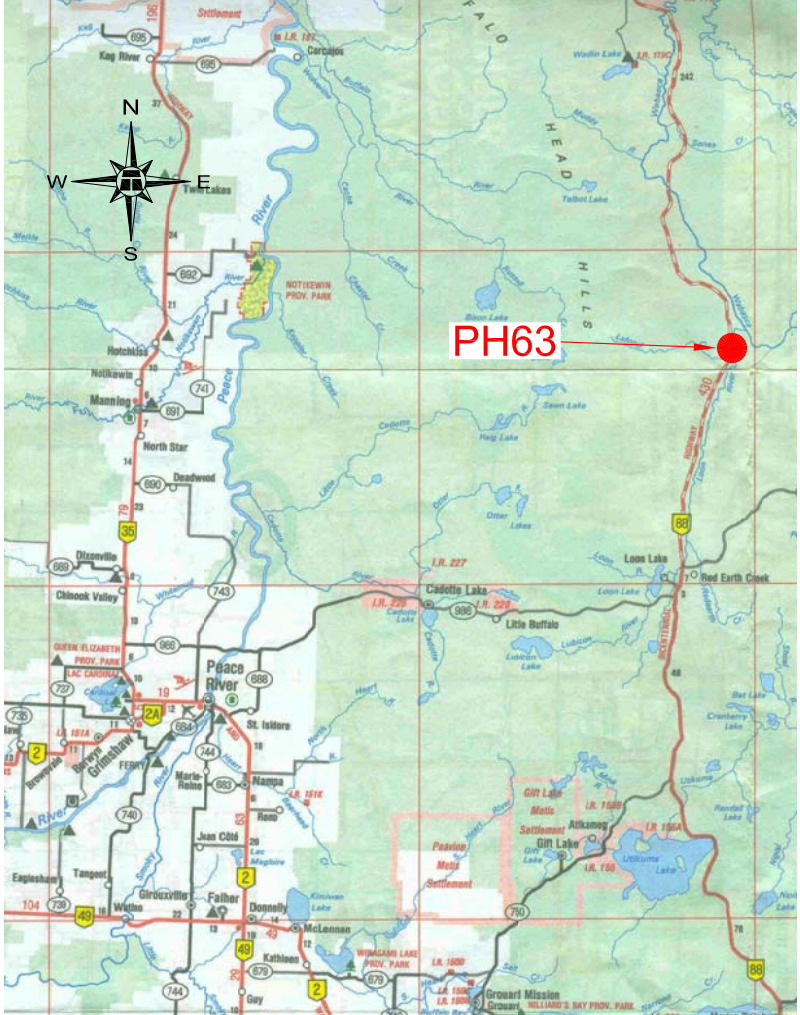
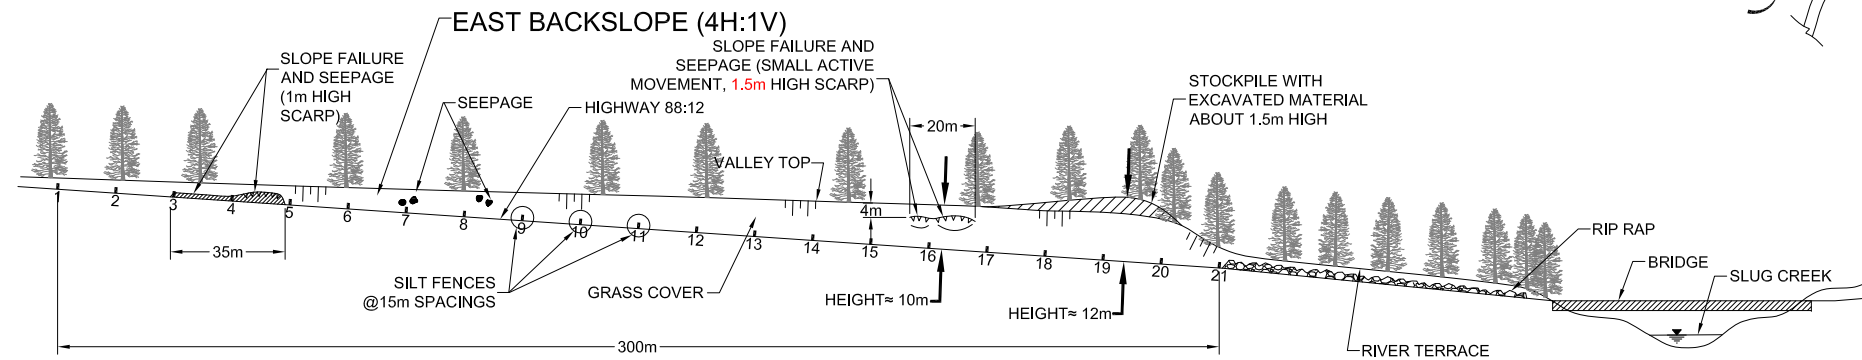
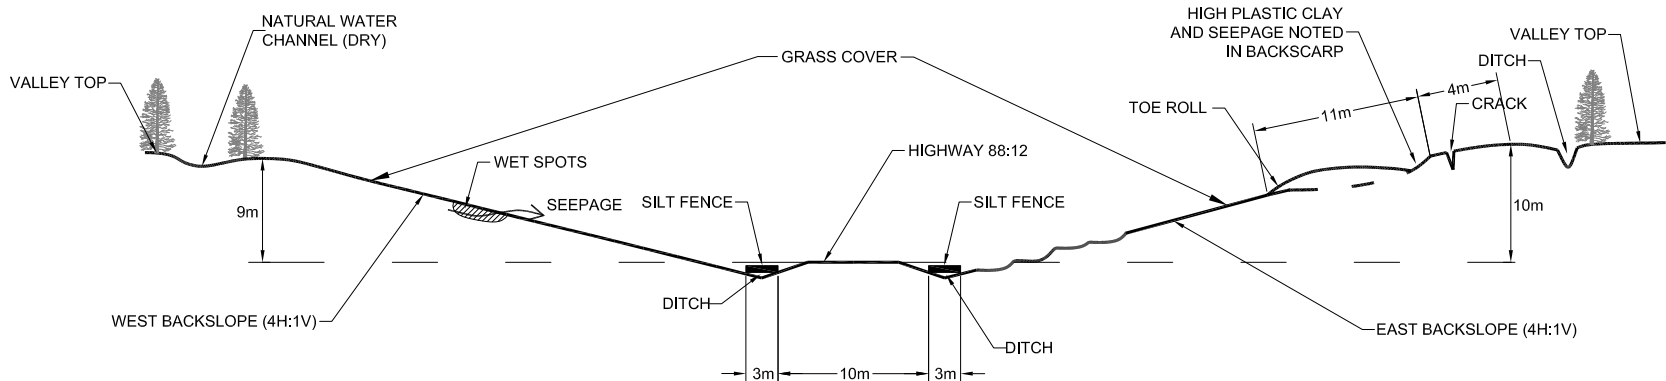
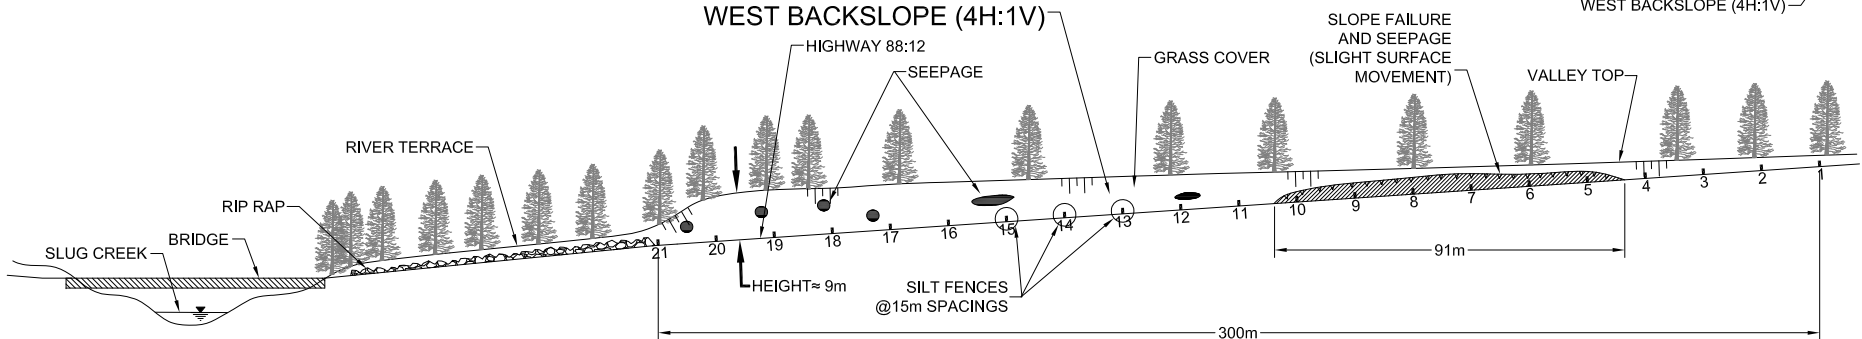
FIGURE PH63-1
PH63: HWY 88:12 - NORTH OF SLUG CREEK BRIDGE
PEACE REGION (PEACE RIVER/HIGH LEVEL)
GEOHAZARD ASSESSMENT

Instrumentation:	None		
Assessment (Refer to Figure PH63-1):	<p>The slope failures appear to be the result of clay softening plus seepage forces flowing from the shallow ground water table on the valley top towards the backslopes. The wet areas noted on the backscarps may be zones where the material is more permeable and groundwater seeps in greater quantity through them. The excavation required for the cut and the presence of groundwater may have led to softening and swelling of the clay.</p> <p>Generally the slope conditions appear to be similar to last year.</p>

Subdrainage measures aiming to increase the stability of the backslopes are recommended. These may consist of gravel drains installed in the east and west backslopes to conduct the water downslope. For this purpose, ditches 1 m wide and 1.5 m deep could be excavated and backfilled with washed gravel enveloped in non-woven geotextile. The surficial 0.3 m of the excavated ditches should be backfilled with clay and topsoil and seeded. The gravel drains should be spaced about 10 m center-to-center across the affected backslope locations. The upslope end of the gravel drain should extend 1.5 m vertically along the affected 4H:1V inclination above the highest level of observed seepage. The water from the gravel drains could be discharged into perforated subdrain pipes installed at least 1.5 m below the ditches at the toes of the backslopes. The subdrain pipes should also be surrounded by washed gravel enveloped in non-woven geotextile with a compacted clay cap of 0.5 m thickness constructed at the ditch bottom level.

After the slope drains have been installed and the slide area has dried, the slide material should be removed (taking care not to disturb the drains) and the lower slope benched and rebuilt to its original line with salvaged, moisture conditioned clay fill. It should then be promptly top soiled and seeded.

Additional measures would include seeding of the backslopes and removal of the loose material dumped on the crest of the west backslope, which should be disposed away from the site.
