GEOHAZARD ASSESSMENT PROGRAM

PEACE RIVER / HIGH LEVEL AREA

2010 INSPECTION

Site Number	Location	Name	Hwy	km
PH57	North of Red Earth, AB	Wabasca River Crossing	88:16	Approx. 52
Legal Description		UTM Co-ordinates		
NW1/4 22-102-09-W4M		11V N 6415765	E 595814

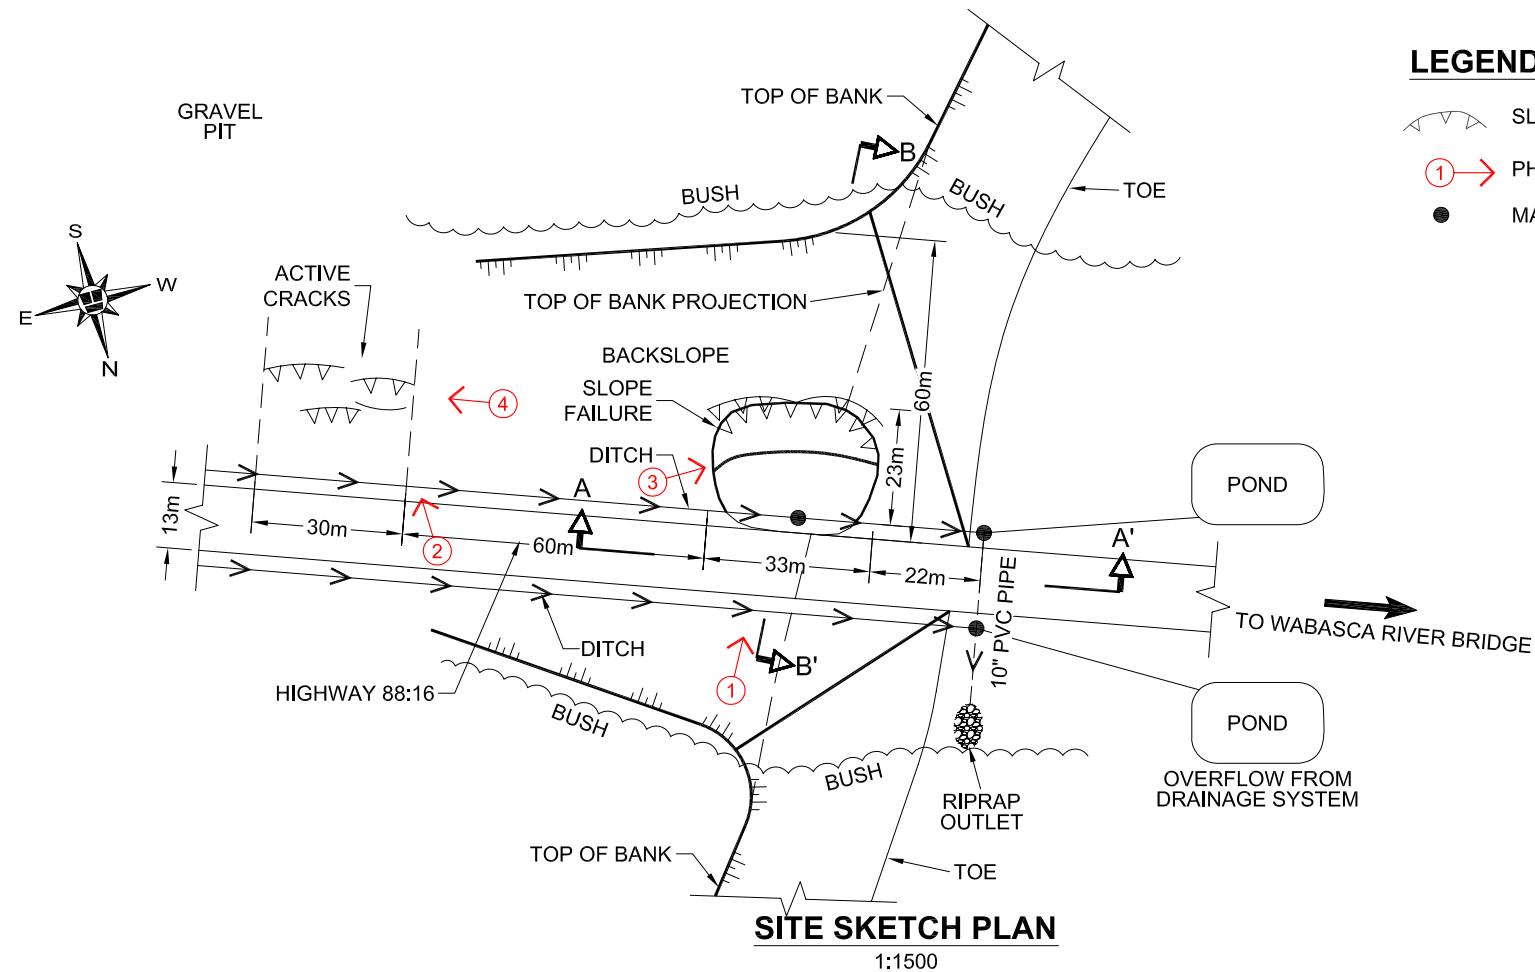
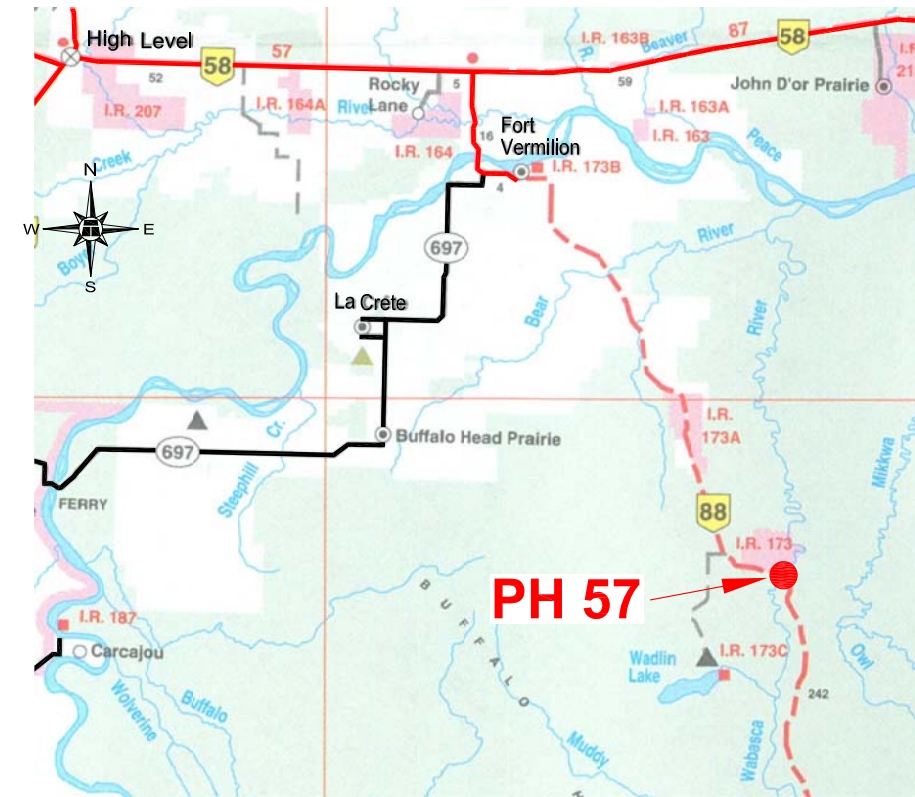
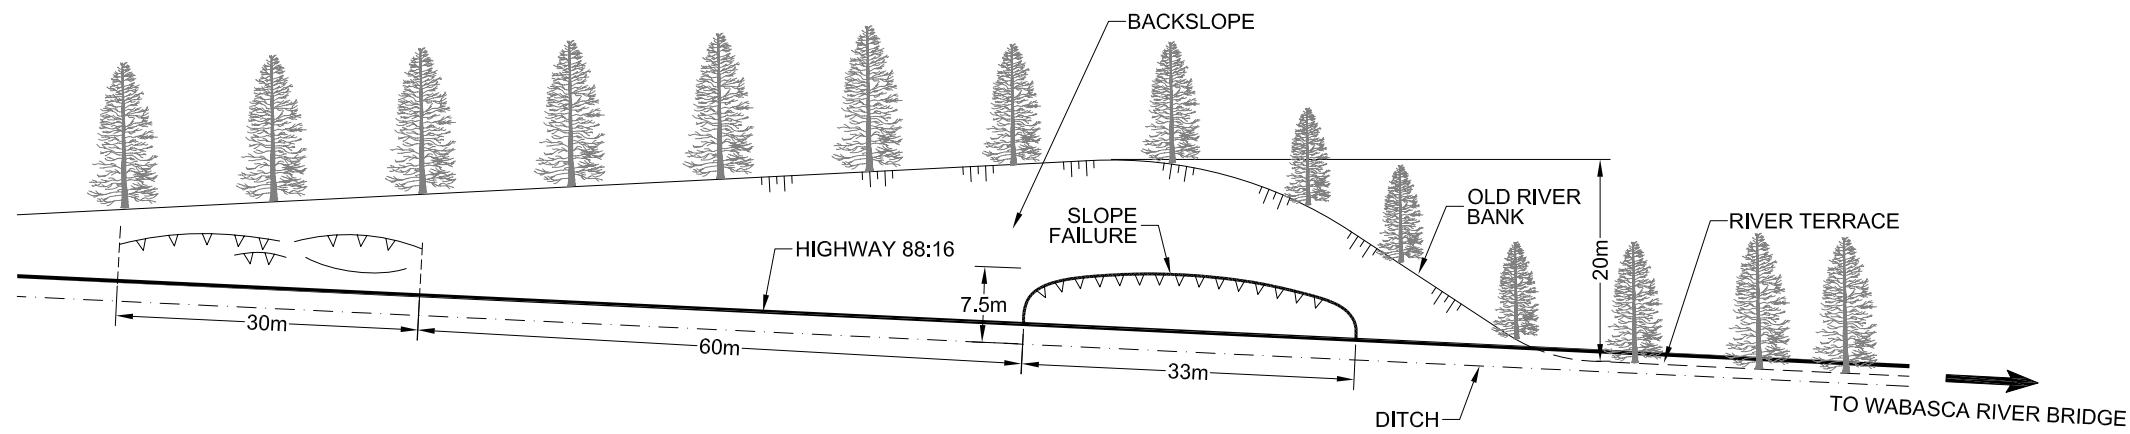
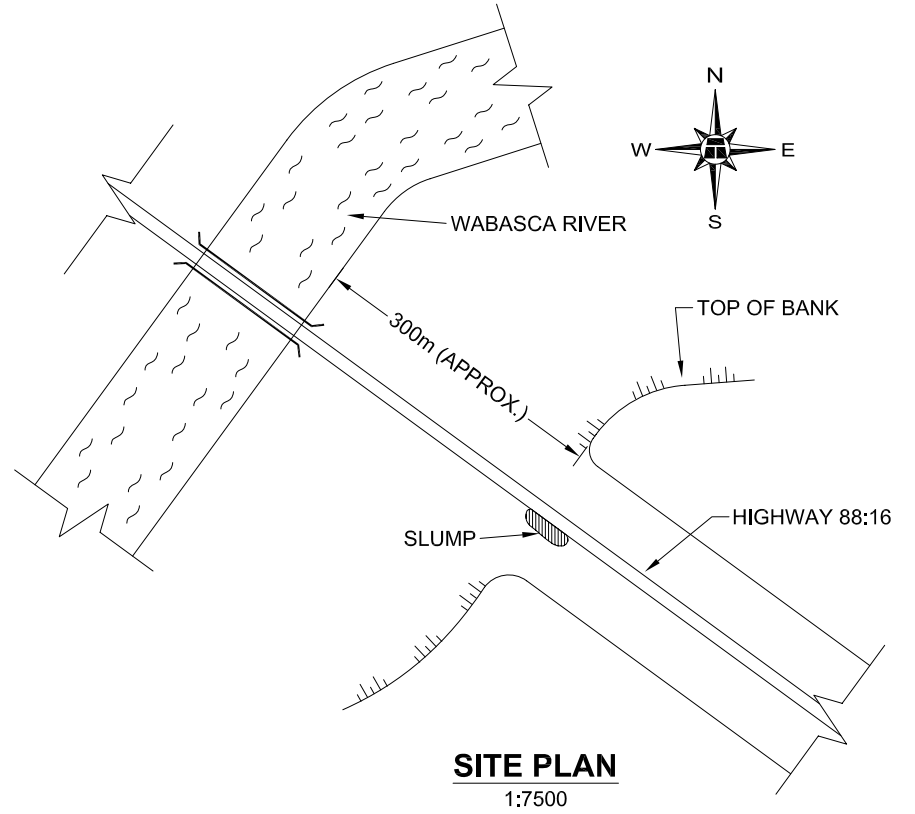
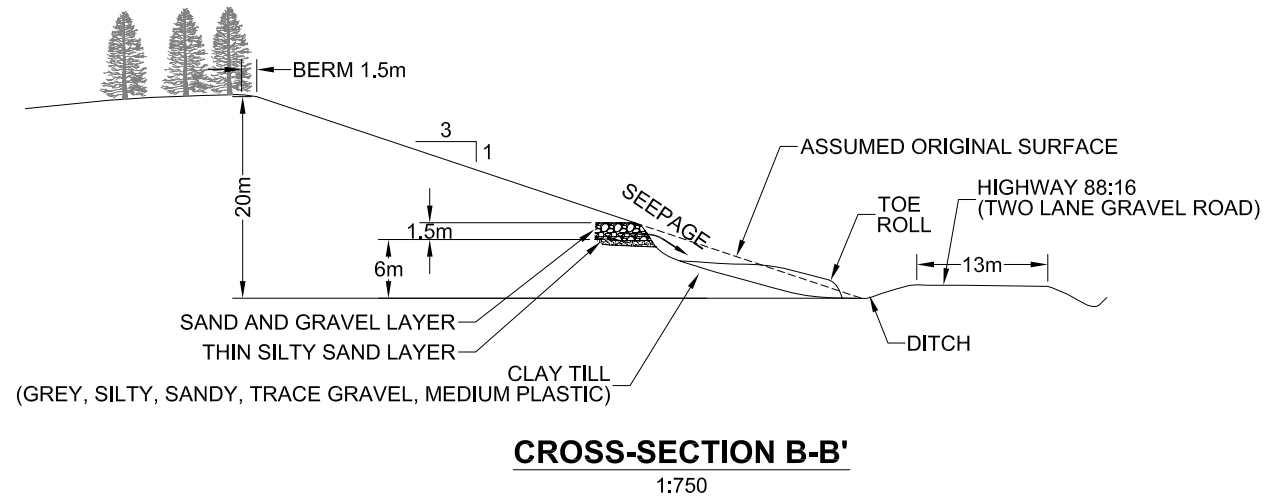
FIGURE PH57-1
PH57 : HWY 88:16 - EAST OF WABASCA RIVER CROSSING
PEACE REGION (PEACE RIVER / HIGH LEVEL) GEOHAZARD ASSESSMENTS

The slump appears to be a shallow slope failure produced by erosion and saturation of the clay till caused by seepage from water bearing sand and gravel layers located over the clay till. The seepage that drains from the gravel pit to the north towards the Wabasca River appears to be intercepted by the south backslope of Highway 88. This condition is supported by the observation of the discharge draining in the south highway ditch and subdrain system, which was considerably greater than the discharge draining on the north ditch and subdrain.

Seepage mitigation measures are recommended. These may consist of gravel drains installed in the south backslope to conduct the water downslope from the gravel and sand layer into the south subdrain system. For this purpose, trenches 1 m wide and 1.5 m deep could be excavated and backfilled with washed gravel enveloped in non-woven geotextile. The surficial 0.3 m of the excavated trenches should be backfilled with clay and topsoil and seeded. The gravel drains should be spaced about 7.5 m center-to-center across the backslope through the slump area. The upslope end of the gravel drain should extend at least 6 m (on 3H:1V inclination) upslope of the observed seepage zone. The water from the gravel drains would discharge into perforated stub pipes connecting into the top of the south ditch subdrain system at an estimated depth of about 1.5 m to 2 m. Details of the existing drainage system should be reviewed in developing the design.

After the slope drains have been installed and the slide area has dried, the slide material should be removed (taking care not to disturb the drains) and the lower slope benched and rebuilt to its original line with salvaged, moisture conditioned clay till. It should then be promptly topsoiled and seeded.

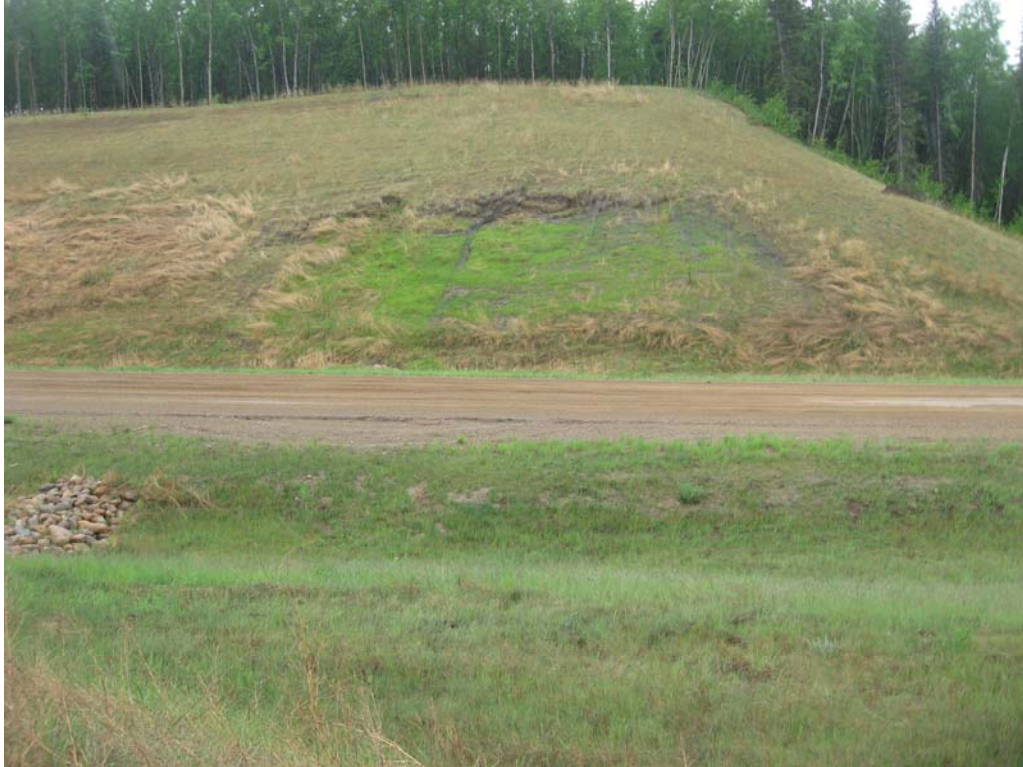
Photo 1 - View of slope failure on south backslope, looking south.

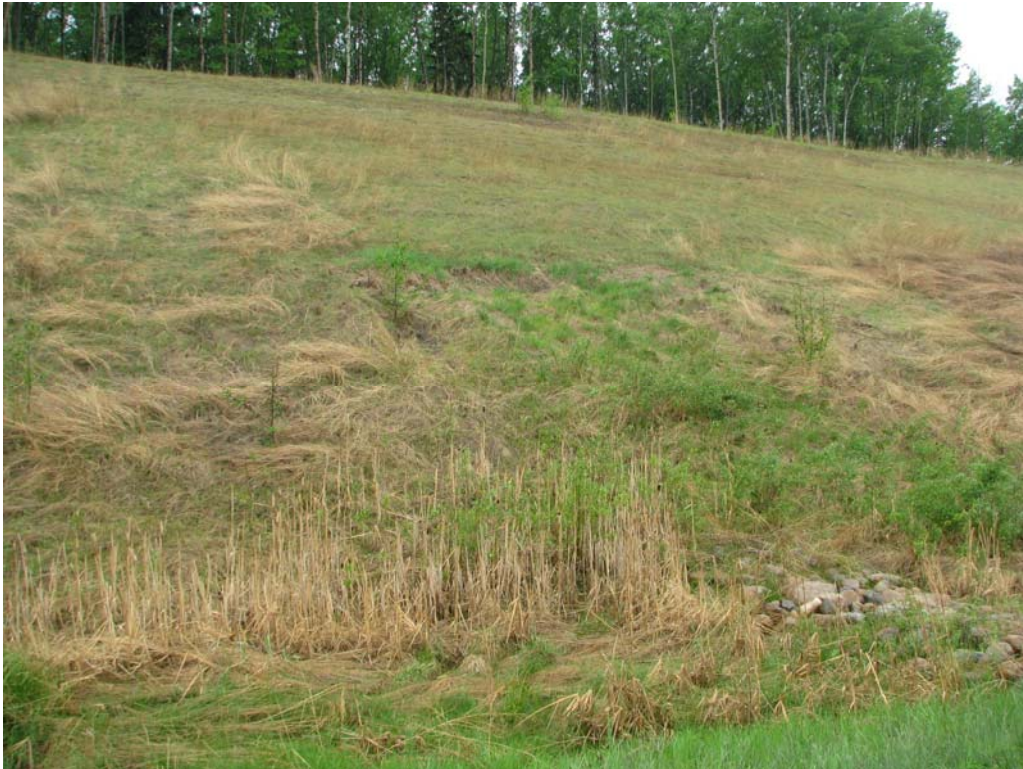
Photo 2 - View of active cracks east of main slump, looking south.

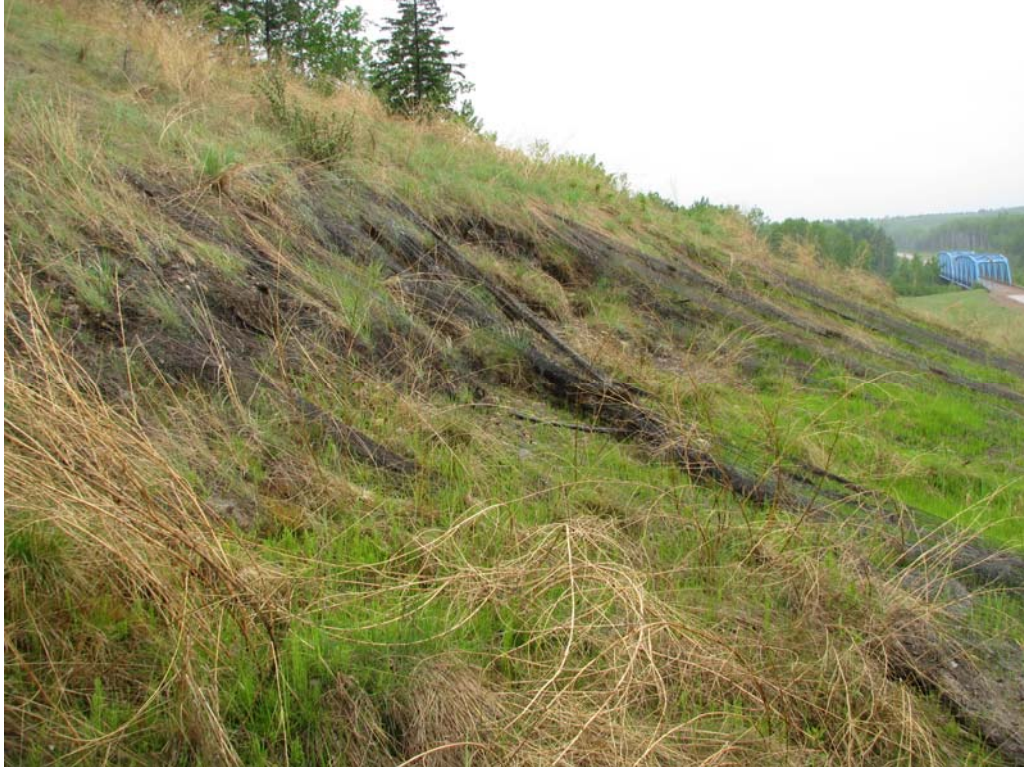
Photo 3 - View of backslope, looking west.

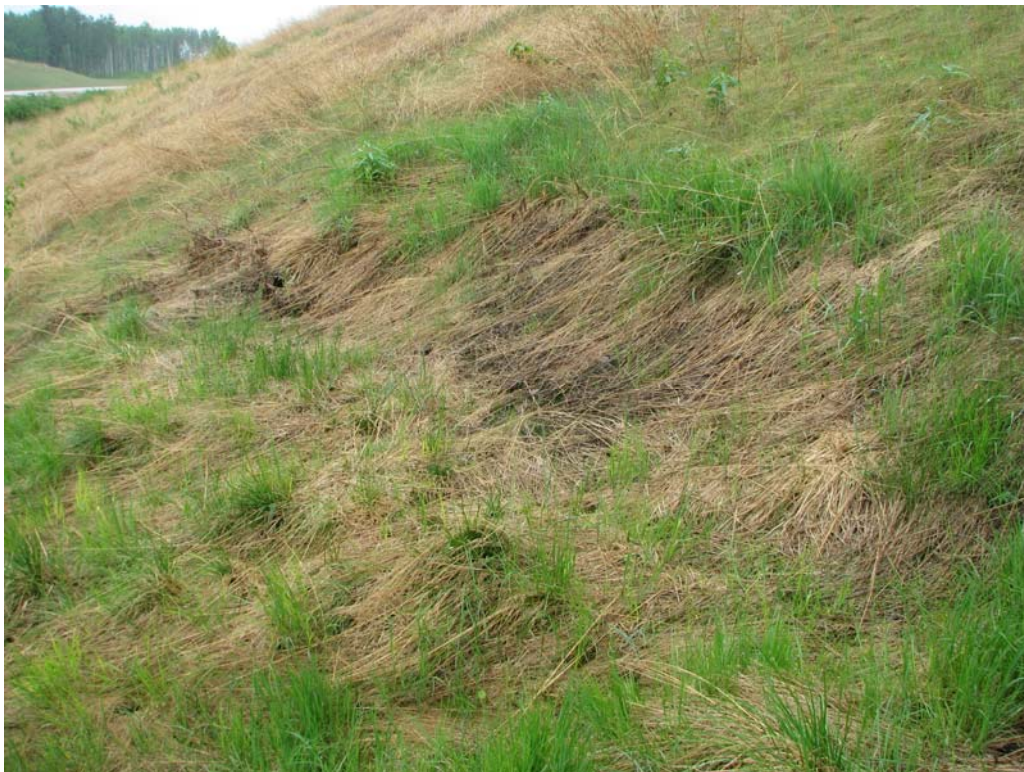
Photo 4 - View of cracks east of the site, looking east.
