GEOHAZARD ASSESSMENT PROGRAM
PEACE RIVER / HIGH LEVEL AREA
2011 INSPECTION

THURBER ENGINEERING LTD.

| Site Number | Location | Name | Hwy | km |
|---|---|---|---|---|
| PH57 | North of Red Earth, AB | Wabasca River Crossing | 88:16 | Approx. 52 |

FIGURE PH57-1
PH57 : HWY 88:16 - EAST OF WABASCA RIVER CROSSING
PEACE REGION (PEACE RIVER / HIGH LEVEL) GEOHAZARD ASSESSMENTS

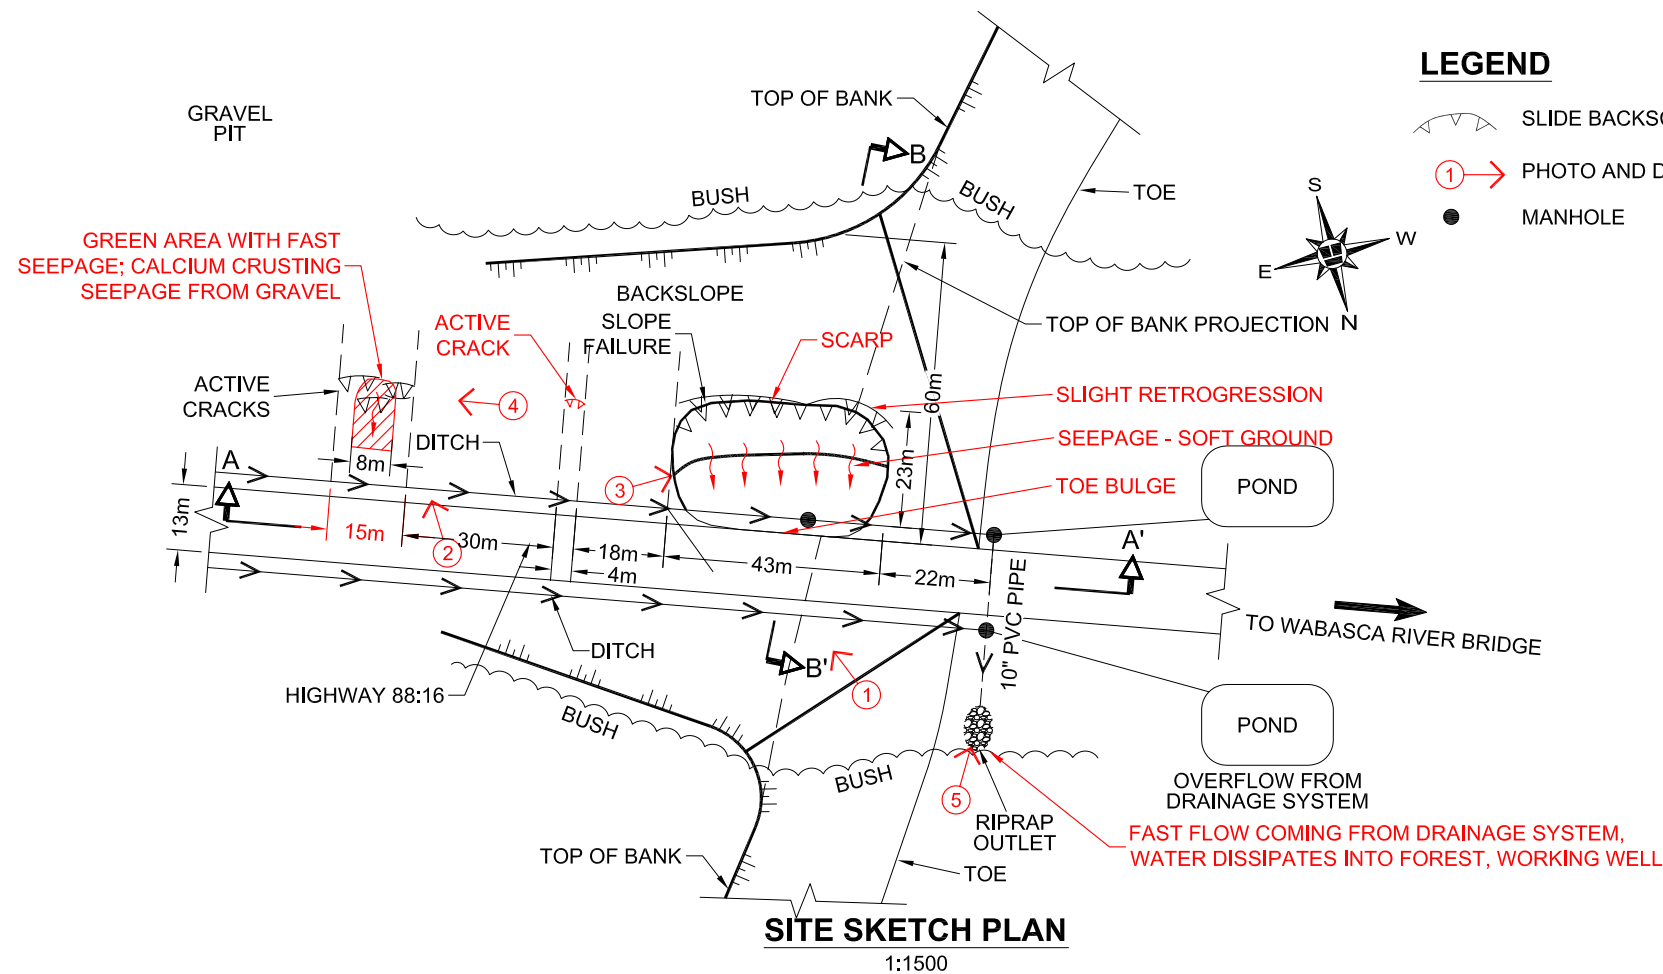
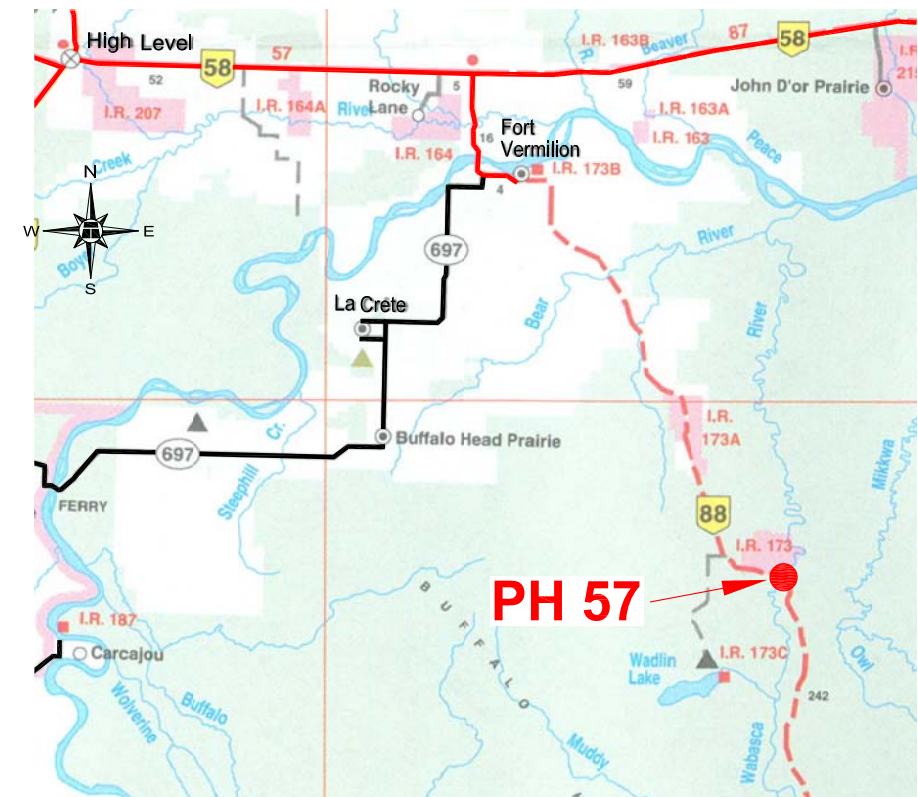
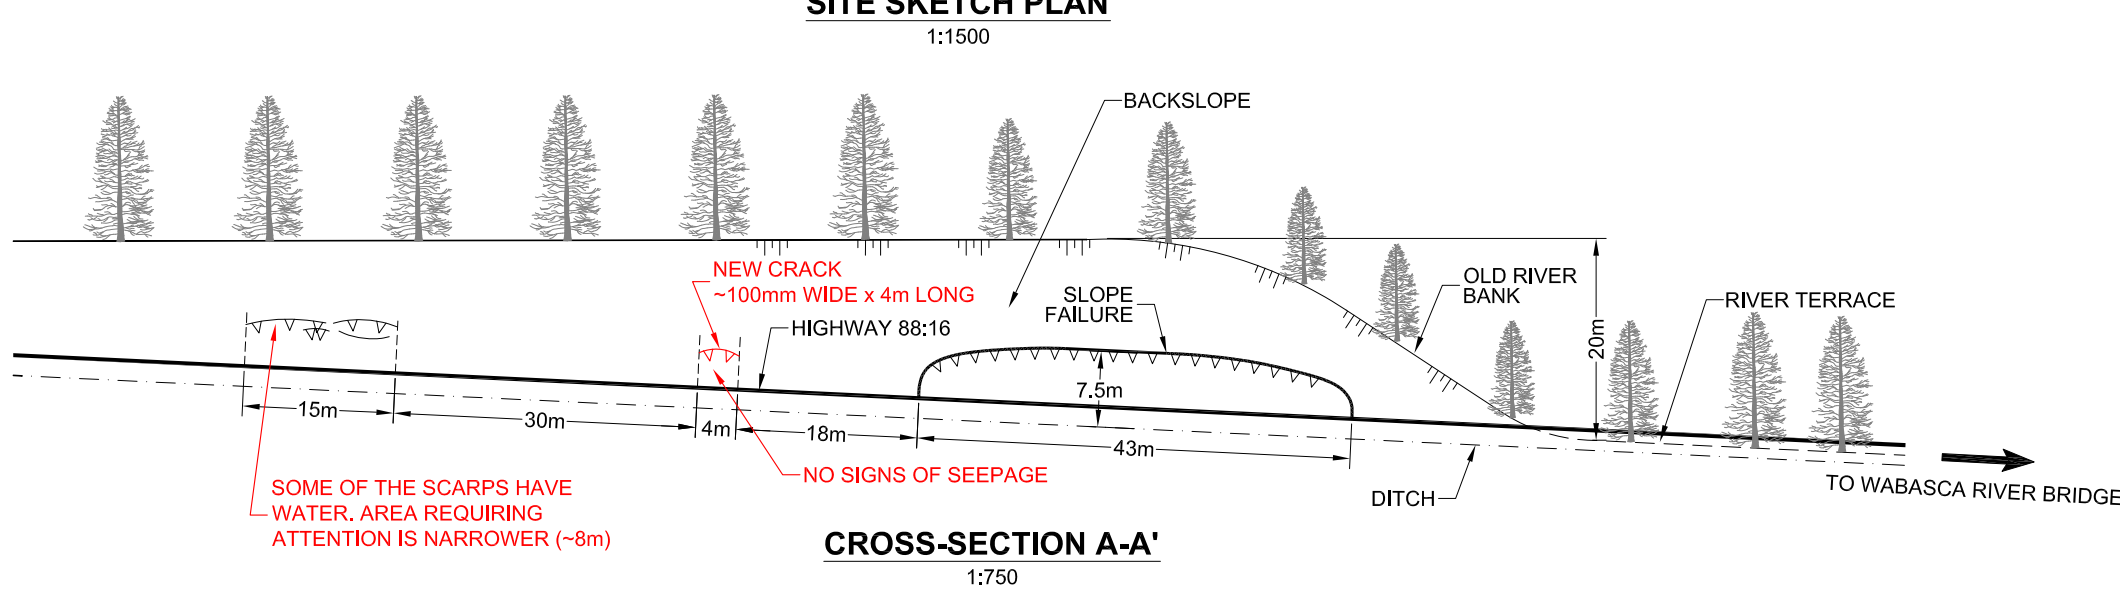
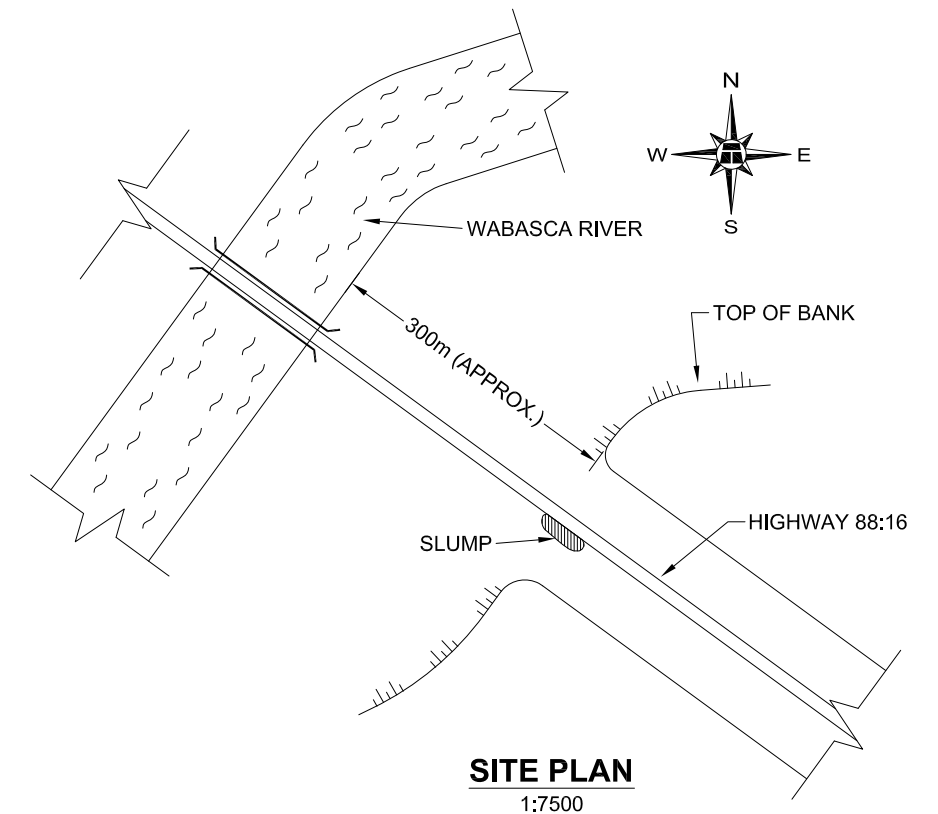
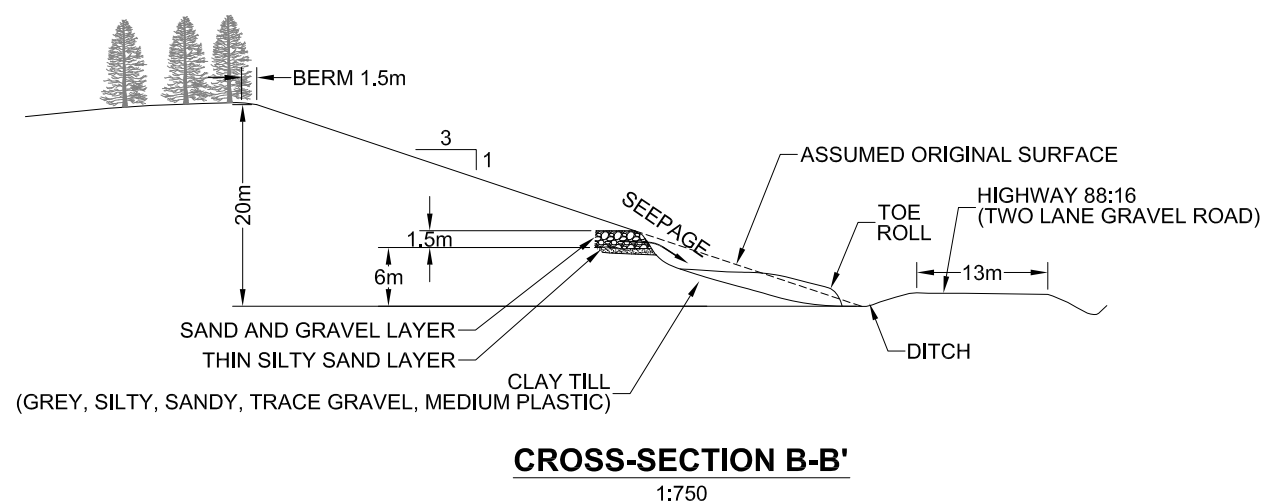
Assessment (Refer to Figure PH57-1):
The slump appears to be a shallow slope failure produced by erosion and saturation of the clay till caused by seepage from water bearing sand and gravel layers located over the clay till. Calcium crusting seepage was observed on active cracks east of the main scarp. The seepage that drains from the gravel pit to the north towards the Wabasca River appears to be intercepted by the south backslope of Highway 88. This condition is supported by the observation of the discharge draining in the south highway ditch and subdrain system, which was considerably greater than the discharge draining on the north ditch and subdrain. Fast water flow was observed through the subdrain system north of the highway and the water dissipates fast into the forest. The subsurface drainage system appears to be working well.

Seepage mitigation measures are recommended. These may consist of gravel drains installed in the south backslope to conduct the water downslope from the gravel and sand layer into the south subdrain system. For this purpose, five drains are recommended which may consist of trenches 1 m wide and 1.5 m deep excavated and backfilled with washed gravel enveloped in non-woven geotextile. The surficial 0.3 m of the excavated trenches should be backfilled with clay and topsoil and seeded. The gravel drains should be spaced about 7.5 m center-to-center across the backslope through the slump area. The upslope end of the gravel drain should extend at least 6 m (on 3H:1V inclination) upslope of the observed seepage zone. The water from the gravel drains would discharge into perforated stub pipes connecting into the top of the south ditch subdrain system at an estimated depth of about 1.5 m to 2 m. Details of the existing drainage system should be reviewed in developing the design.

After the slope drains have been installed and the slide area has dried, the slide material should be removed (taking care not to disturb the drains) and the lower slope benched and rebuilt to its original line with salvaged, moisture conditioned clay till. It should then be promptly topsoiled and seeded.

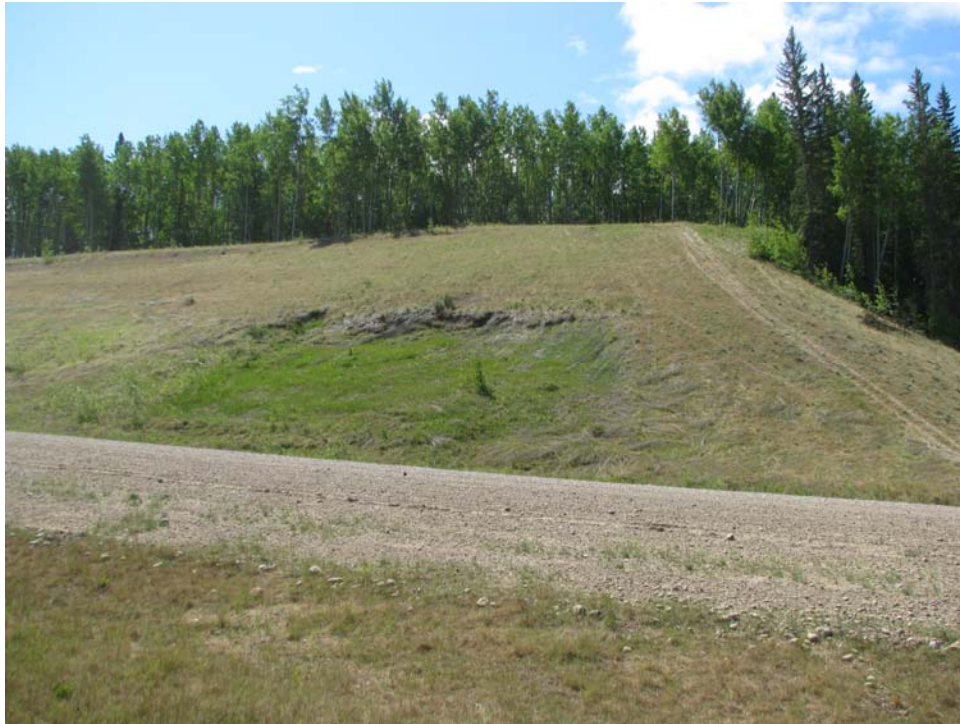
Photo 1 - View of slope failure on south backslope, looking south.

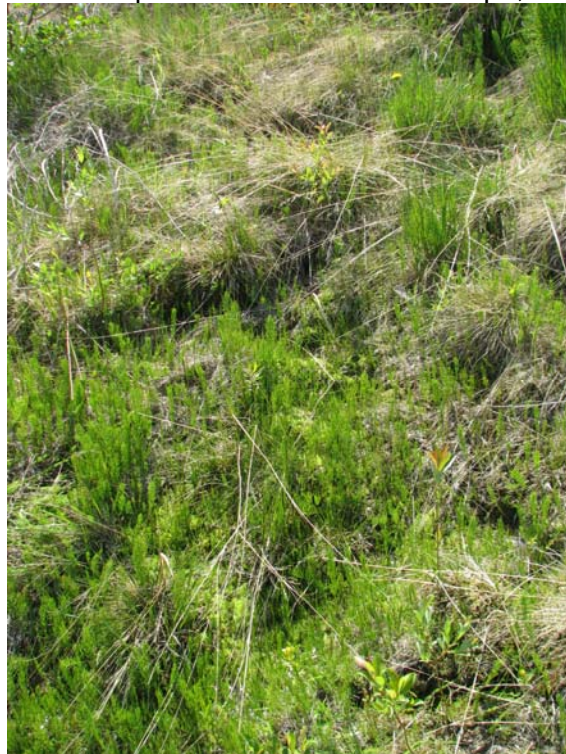
Photo 2 - View of active cracks east of main slump, looking south.

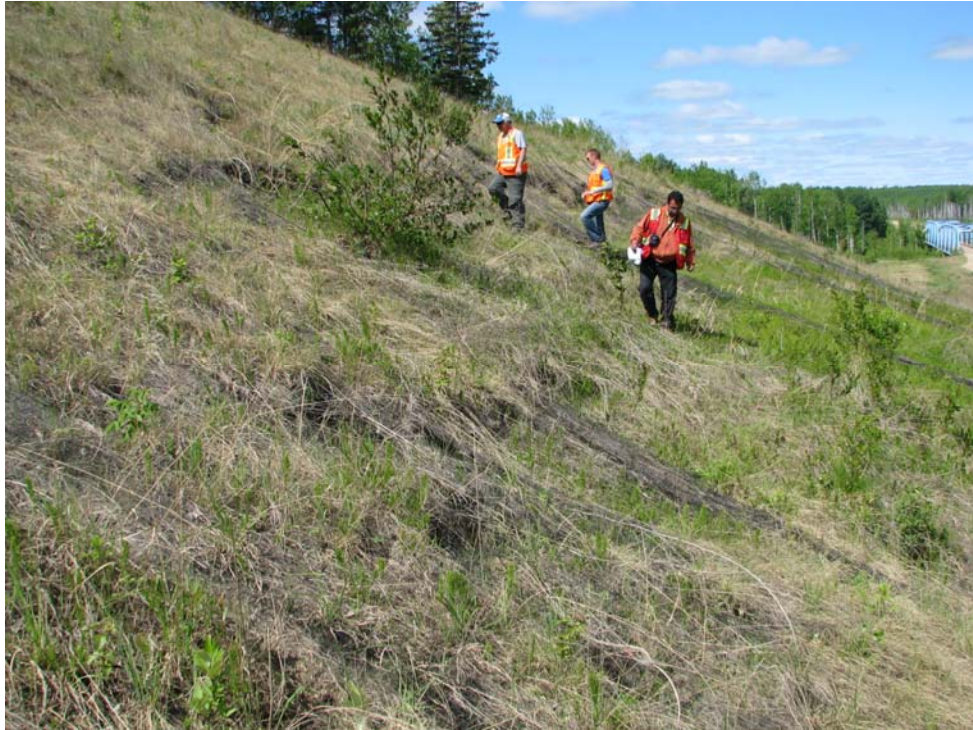
Photo 3 - View of backslope, looking west.

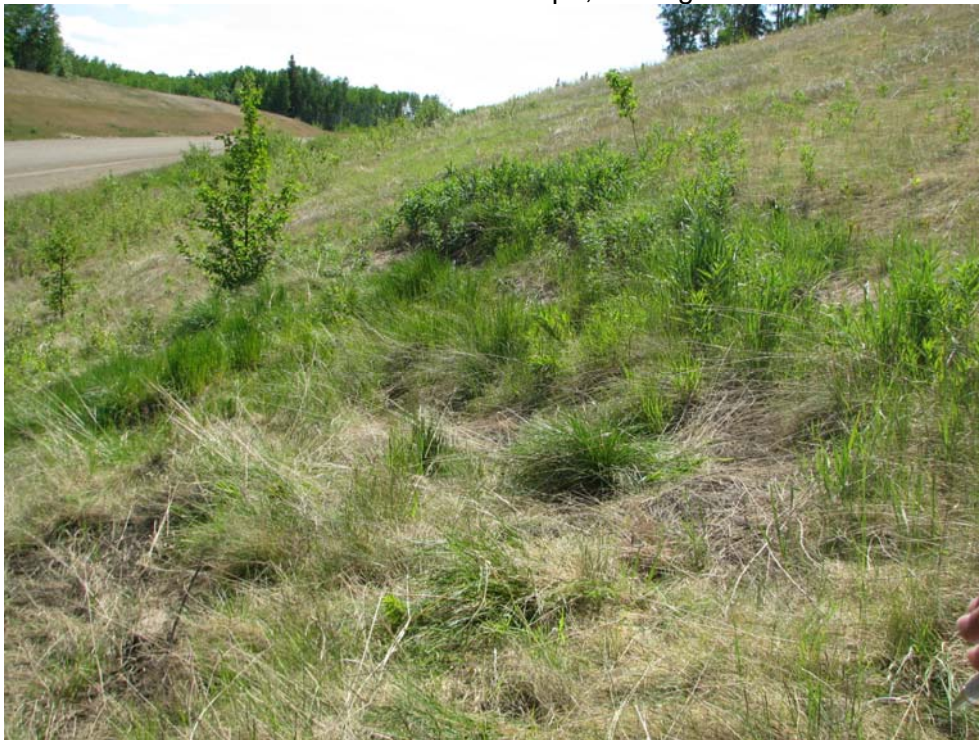
Photo 4 - View of cracks east of the site, looking east.

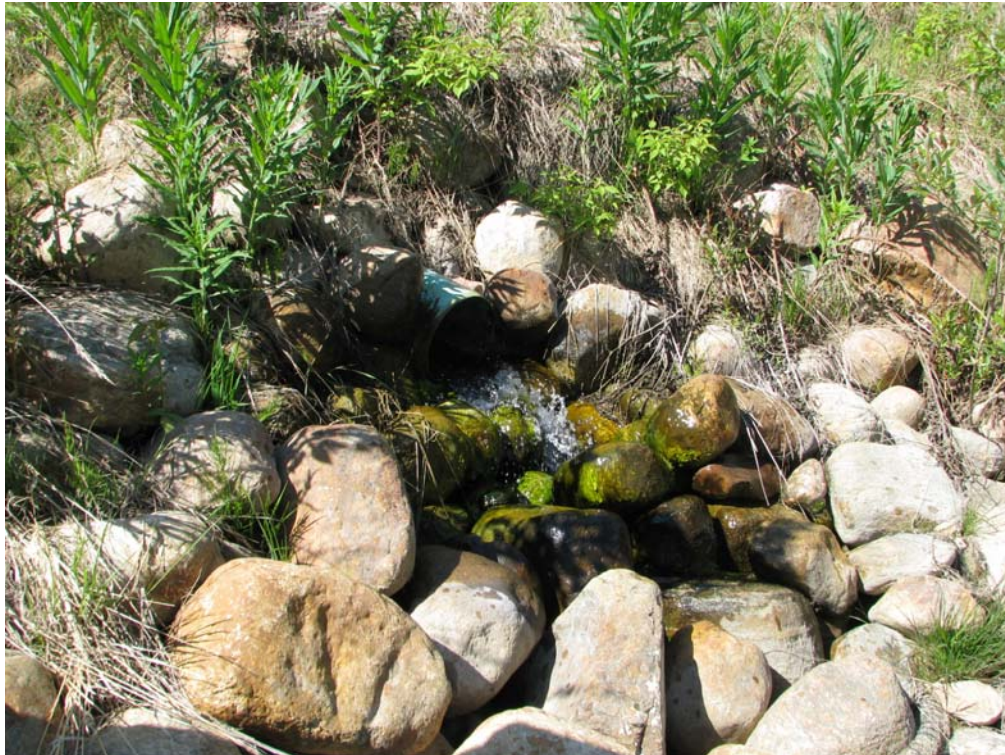
Photo 5 – Fast flow through subdrain, looking southwest.
