January 13, 2006

File: 15-85-13

**PEACE REGION (PEACE RIVER/HIGH LEVEL) LANDSLIDE ASSESSMENT
HWY 88:18 CULVERT REPLACEMENT NEAR FT. VERMILION - PH16
NORTHEAST QUADRANT SLOPE INSTABILITY**

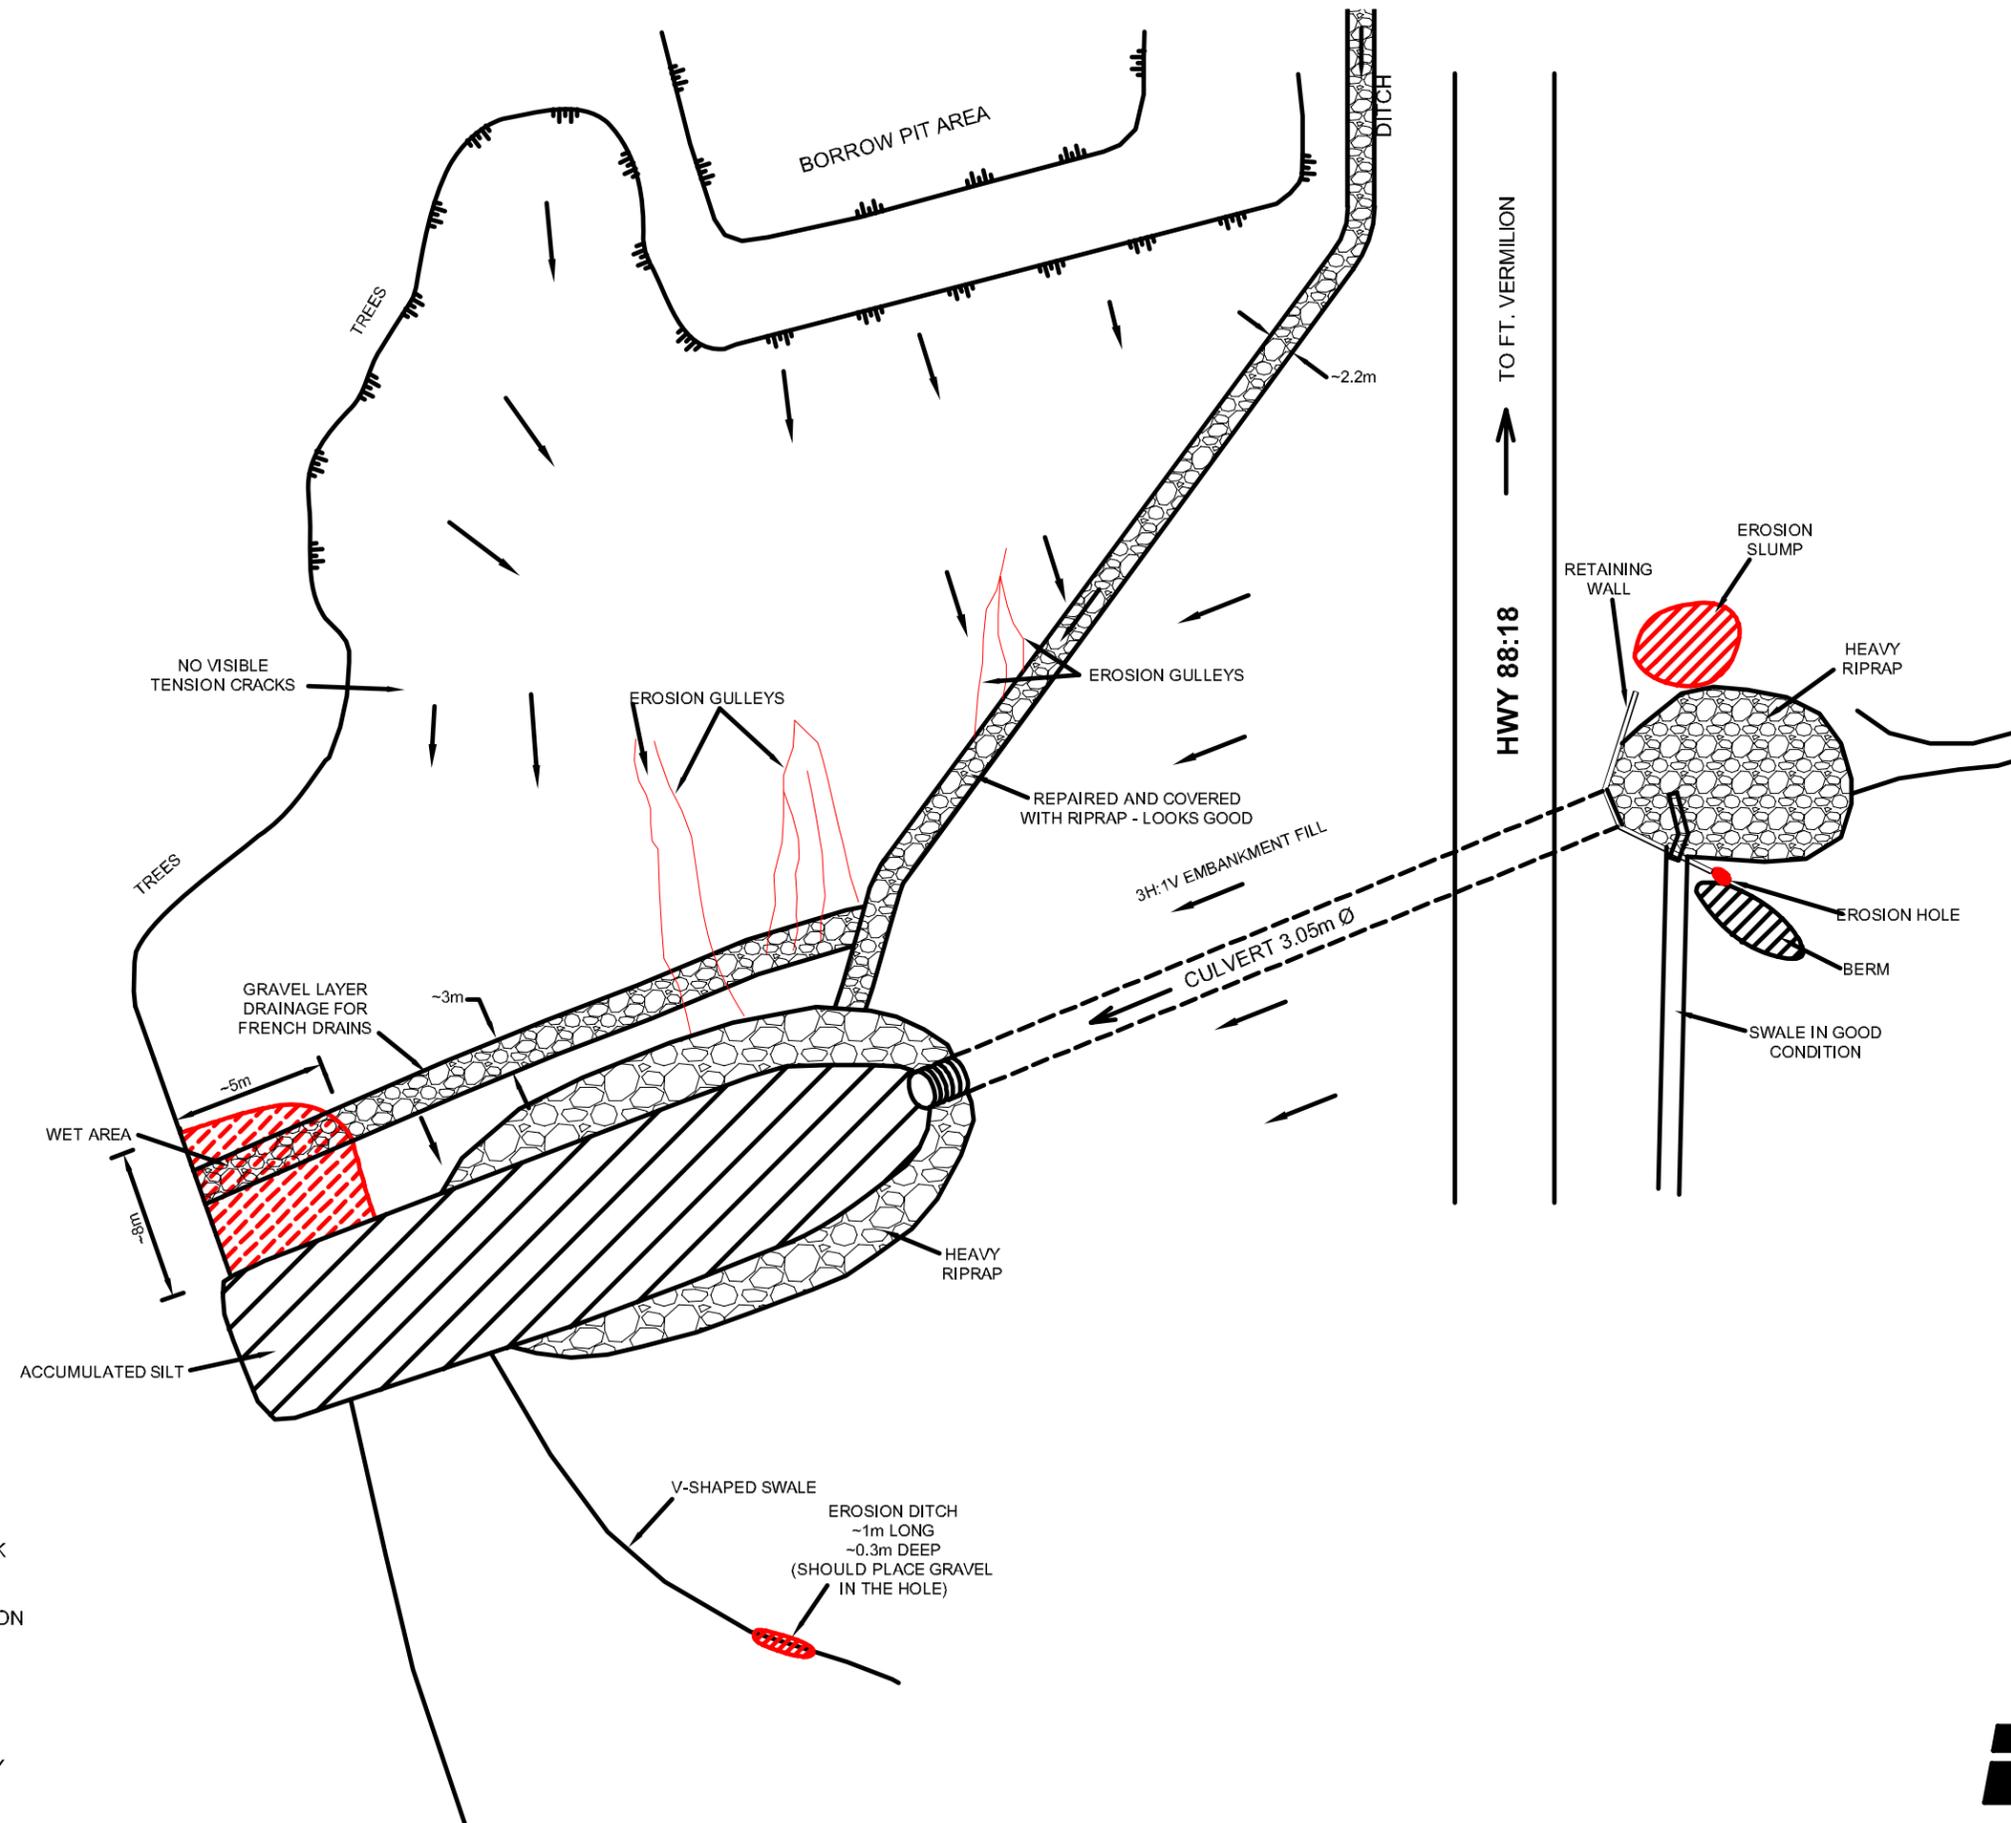
FIGURE PH16-1
HWY 88:18 FORT VERMILLION
SITE SKETCH PLAN
 DATE : JULY, 2005
 THURBER PROJECT #15-85-16

The borrow pit area, culvert and side slopes were inspected during the site reconnaissance. The site conditions at that time are shown on the attached site sketch plan. Selected photographs of the site taken on June 20, 2005 are also attached.

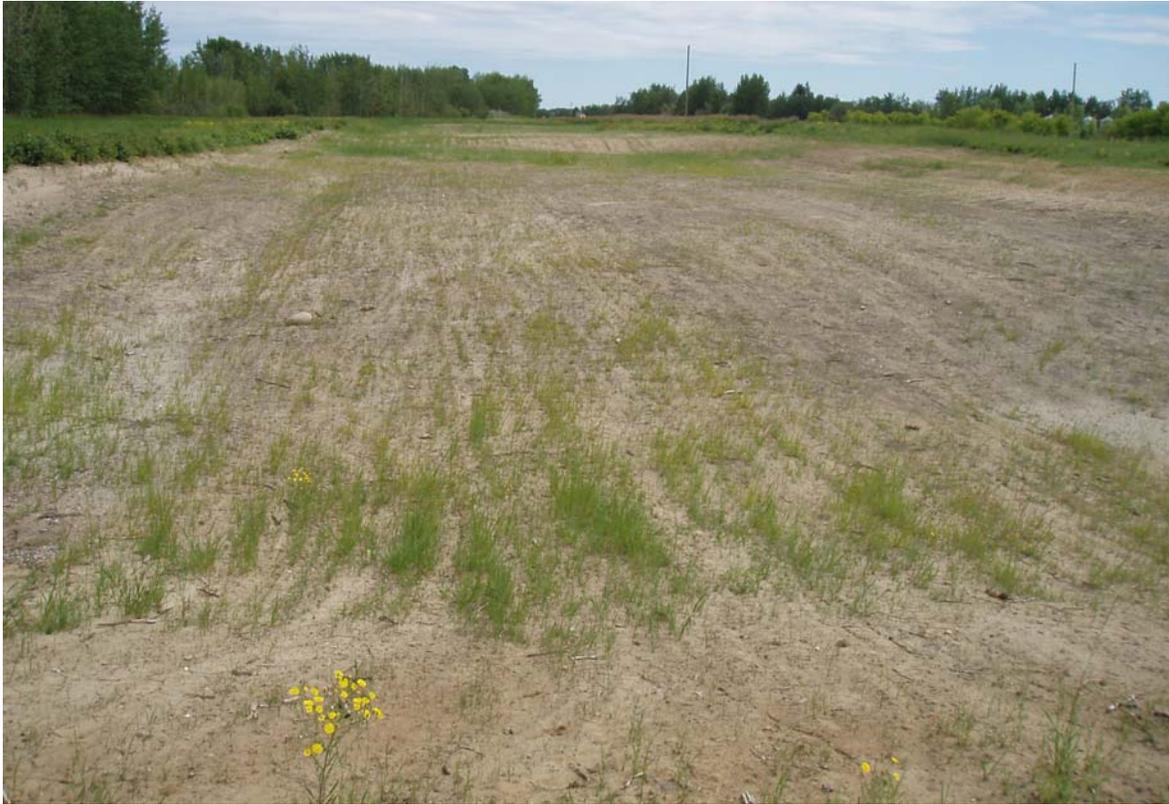
The borrow pit area did not contain any significant wet areas or free standing water.

PHOTO 1: Borrow pit area

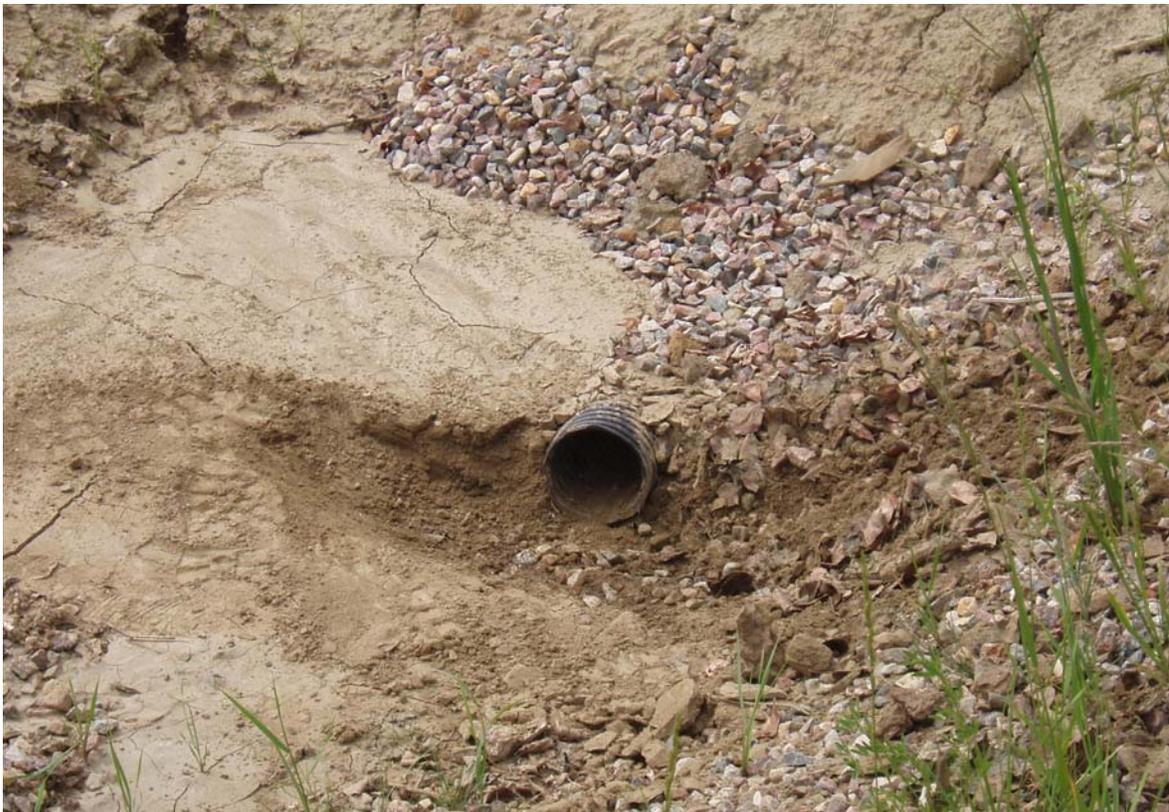
PHOTO 2: Inlet of the borrow pit drain pipe

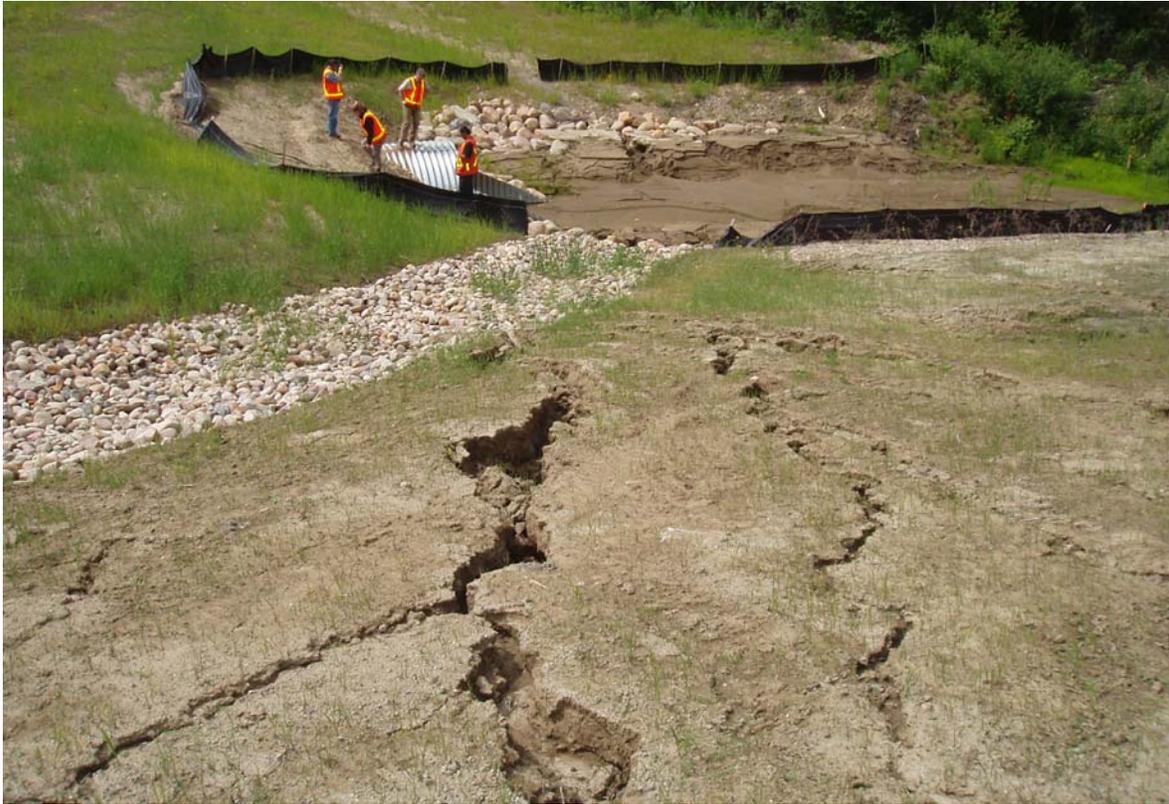
At the time of the site visit, the construction at the site was completed. The vegetative cover on the east side slope was sparse leading to slope erosion. A number of minor erosion gullies (approximately 0.6 m wide and up to 0.5 m deep) were noted along the east slope. In general the east slope was drier than last year, however, a wet area, containing saturated flowing silts, was noted in the north-west corner near the toe of the slope. This area measured 5 m by 8 m and was about 1 m deep.

PHOTO 3: Erosion gullies on the east slope

The mitigation measures implemented to stabilize the east slope appear to be working. The slope seemed to be stable and did not show signs of tension cracking or slope movement. However, due to poor vegetative cover, surface erosion was evident. In order to provide erosion protection the east slope should be double seeded to ensure sufficient grass coverage. Wattles (BMP #28b) should be installed along the erosion gullies to prevent further slope erosion and the gullies should be backfilled with soil. Additional seeding and installation of wattles would constitute a short term solution. A long term solution would involve re-grading the east slope, and creating three flat benches across the slope, which

would intercept and redirect the surface runoff to the nearby swale. The re-graded slope should be covered with straw matting (low flow soil covering) and seeded.

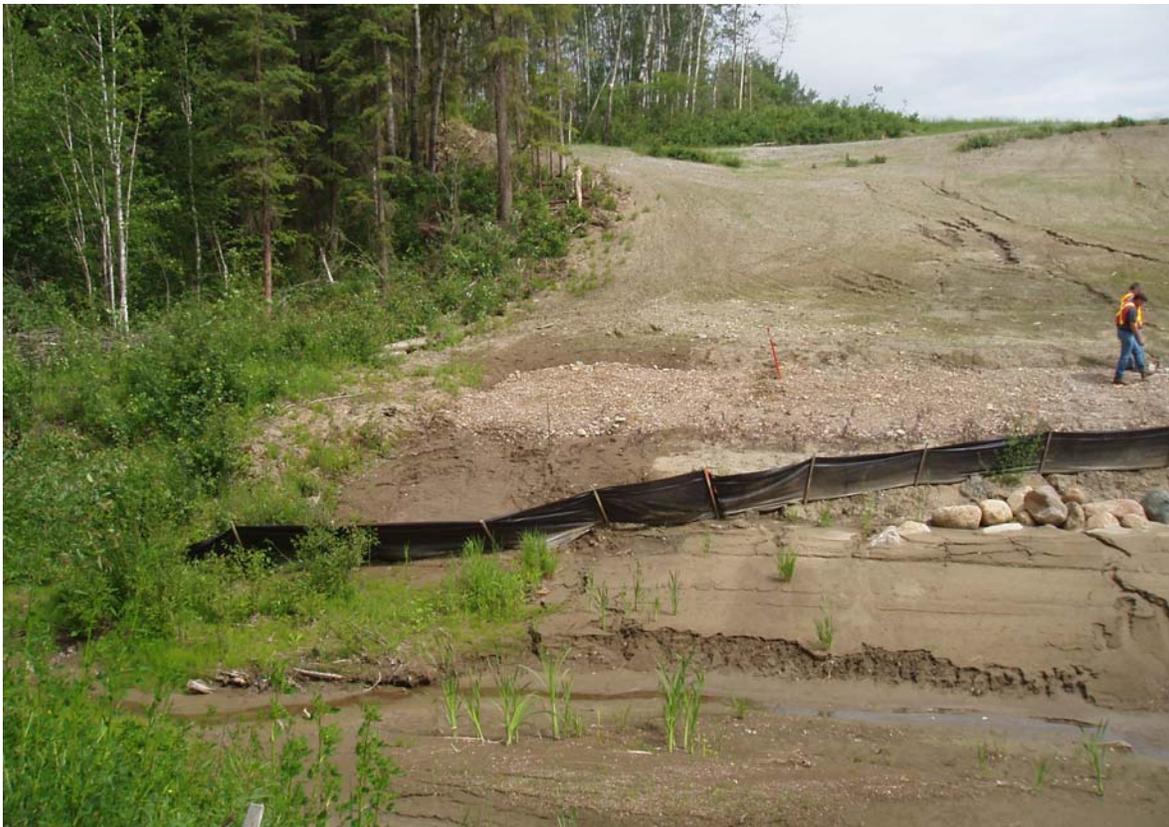
PHOTO 4: Wet area in the northwest corner of the east slope

The wet unstable area, located in the north-west corner of the east slope, should be subexcavated and replaced with clean granular backfill underlain by geotextile.

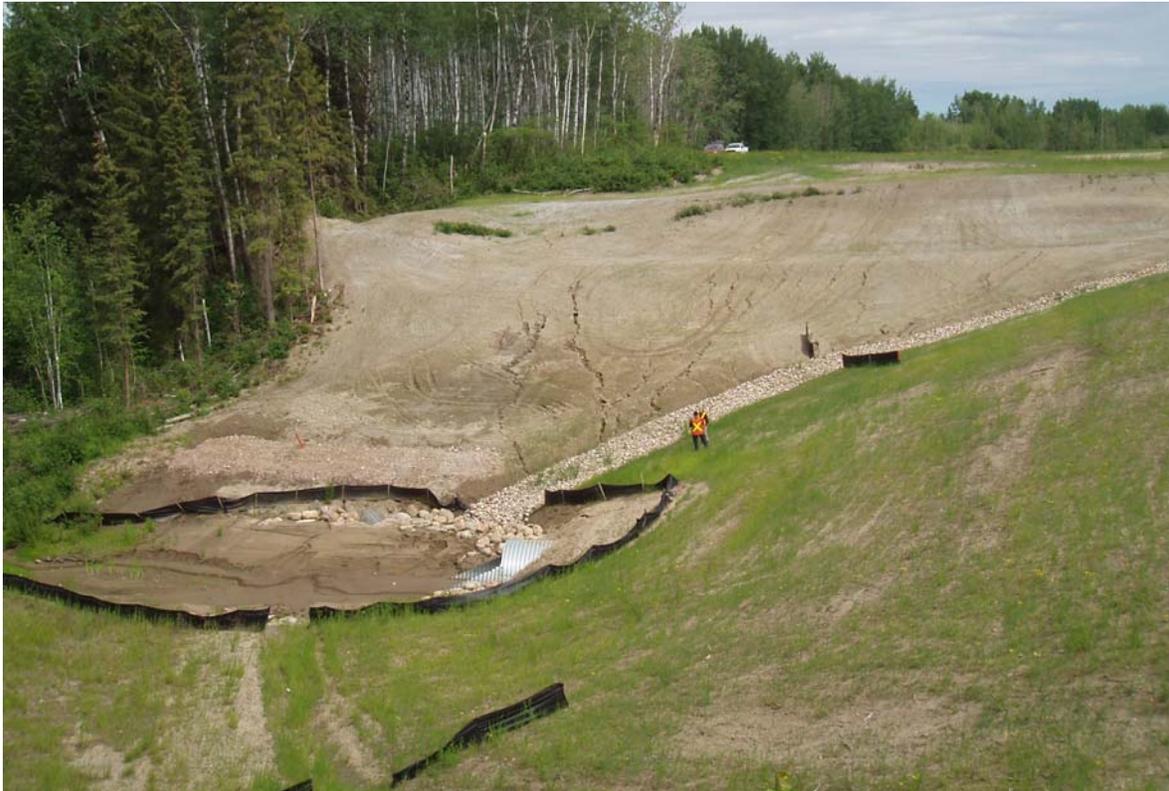
PHOTO 5: Overall view of the east slope

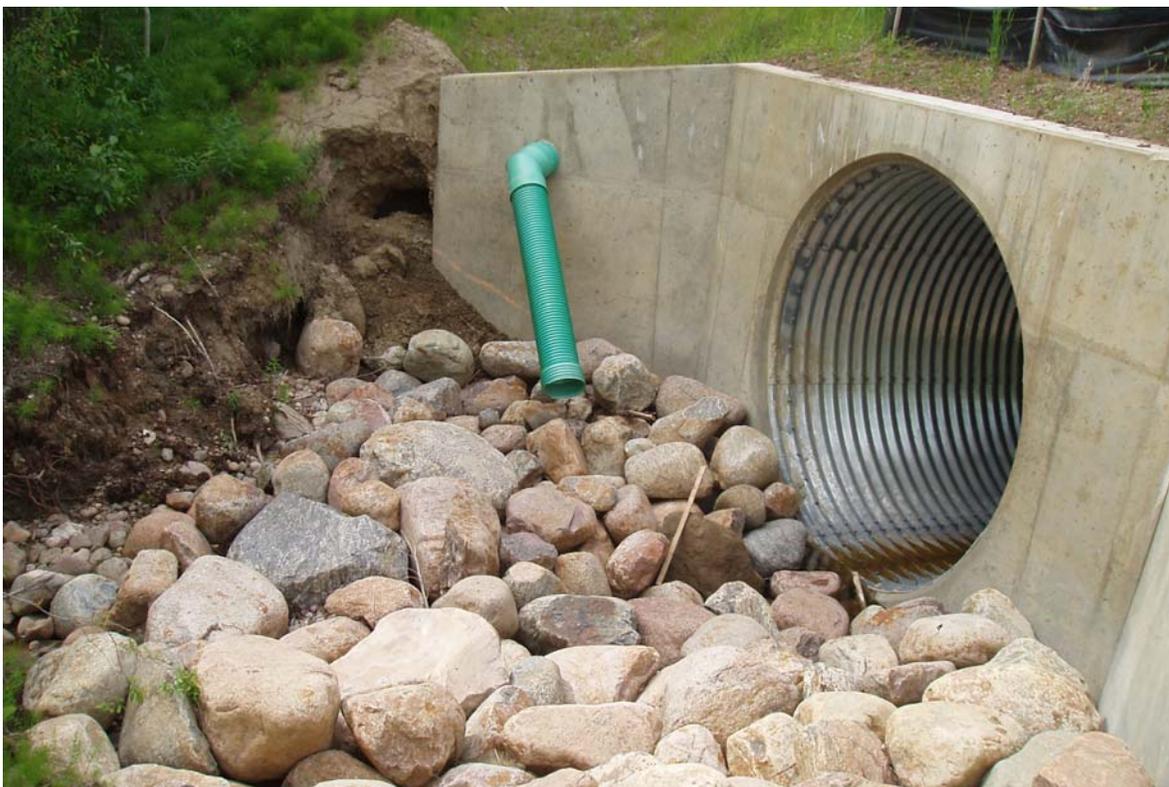
Soil erosion and a minor erosion triggered slump were noted above the rip rap level on the east side of the culvert inlet. A minor sink hole in the highway side slope was observed east of the borrow pit area.

PHOTO 6: Erosion damage at the culvert inlet

It is recommended that the rip rap covering at the culvert inlet be repaired around the perimeter. The area should be cleaned up, followed by placement of geotextile, pit run gravel, and heavy rip rap. If the ditch berm west of the culvert inlet is damaged during construction, it should be rebuilt upon placement of rip rap to ensure proper ditch drainage.
