August 11, 2006

File: 15-85-37

**PEACE REGION (PEACE RIVER – HIGH LEVEL AREA)
GEOHAZARD ASSESSMENT
HWY 88:18, SITE PH16, CULVERT REPLACEMENT NEAR FT. VERMILION
2006 ANNUAL INSPECTION REPORT**

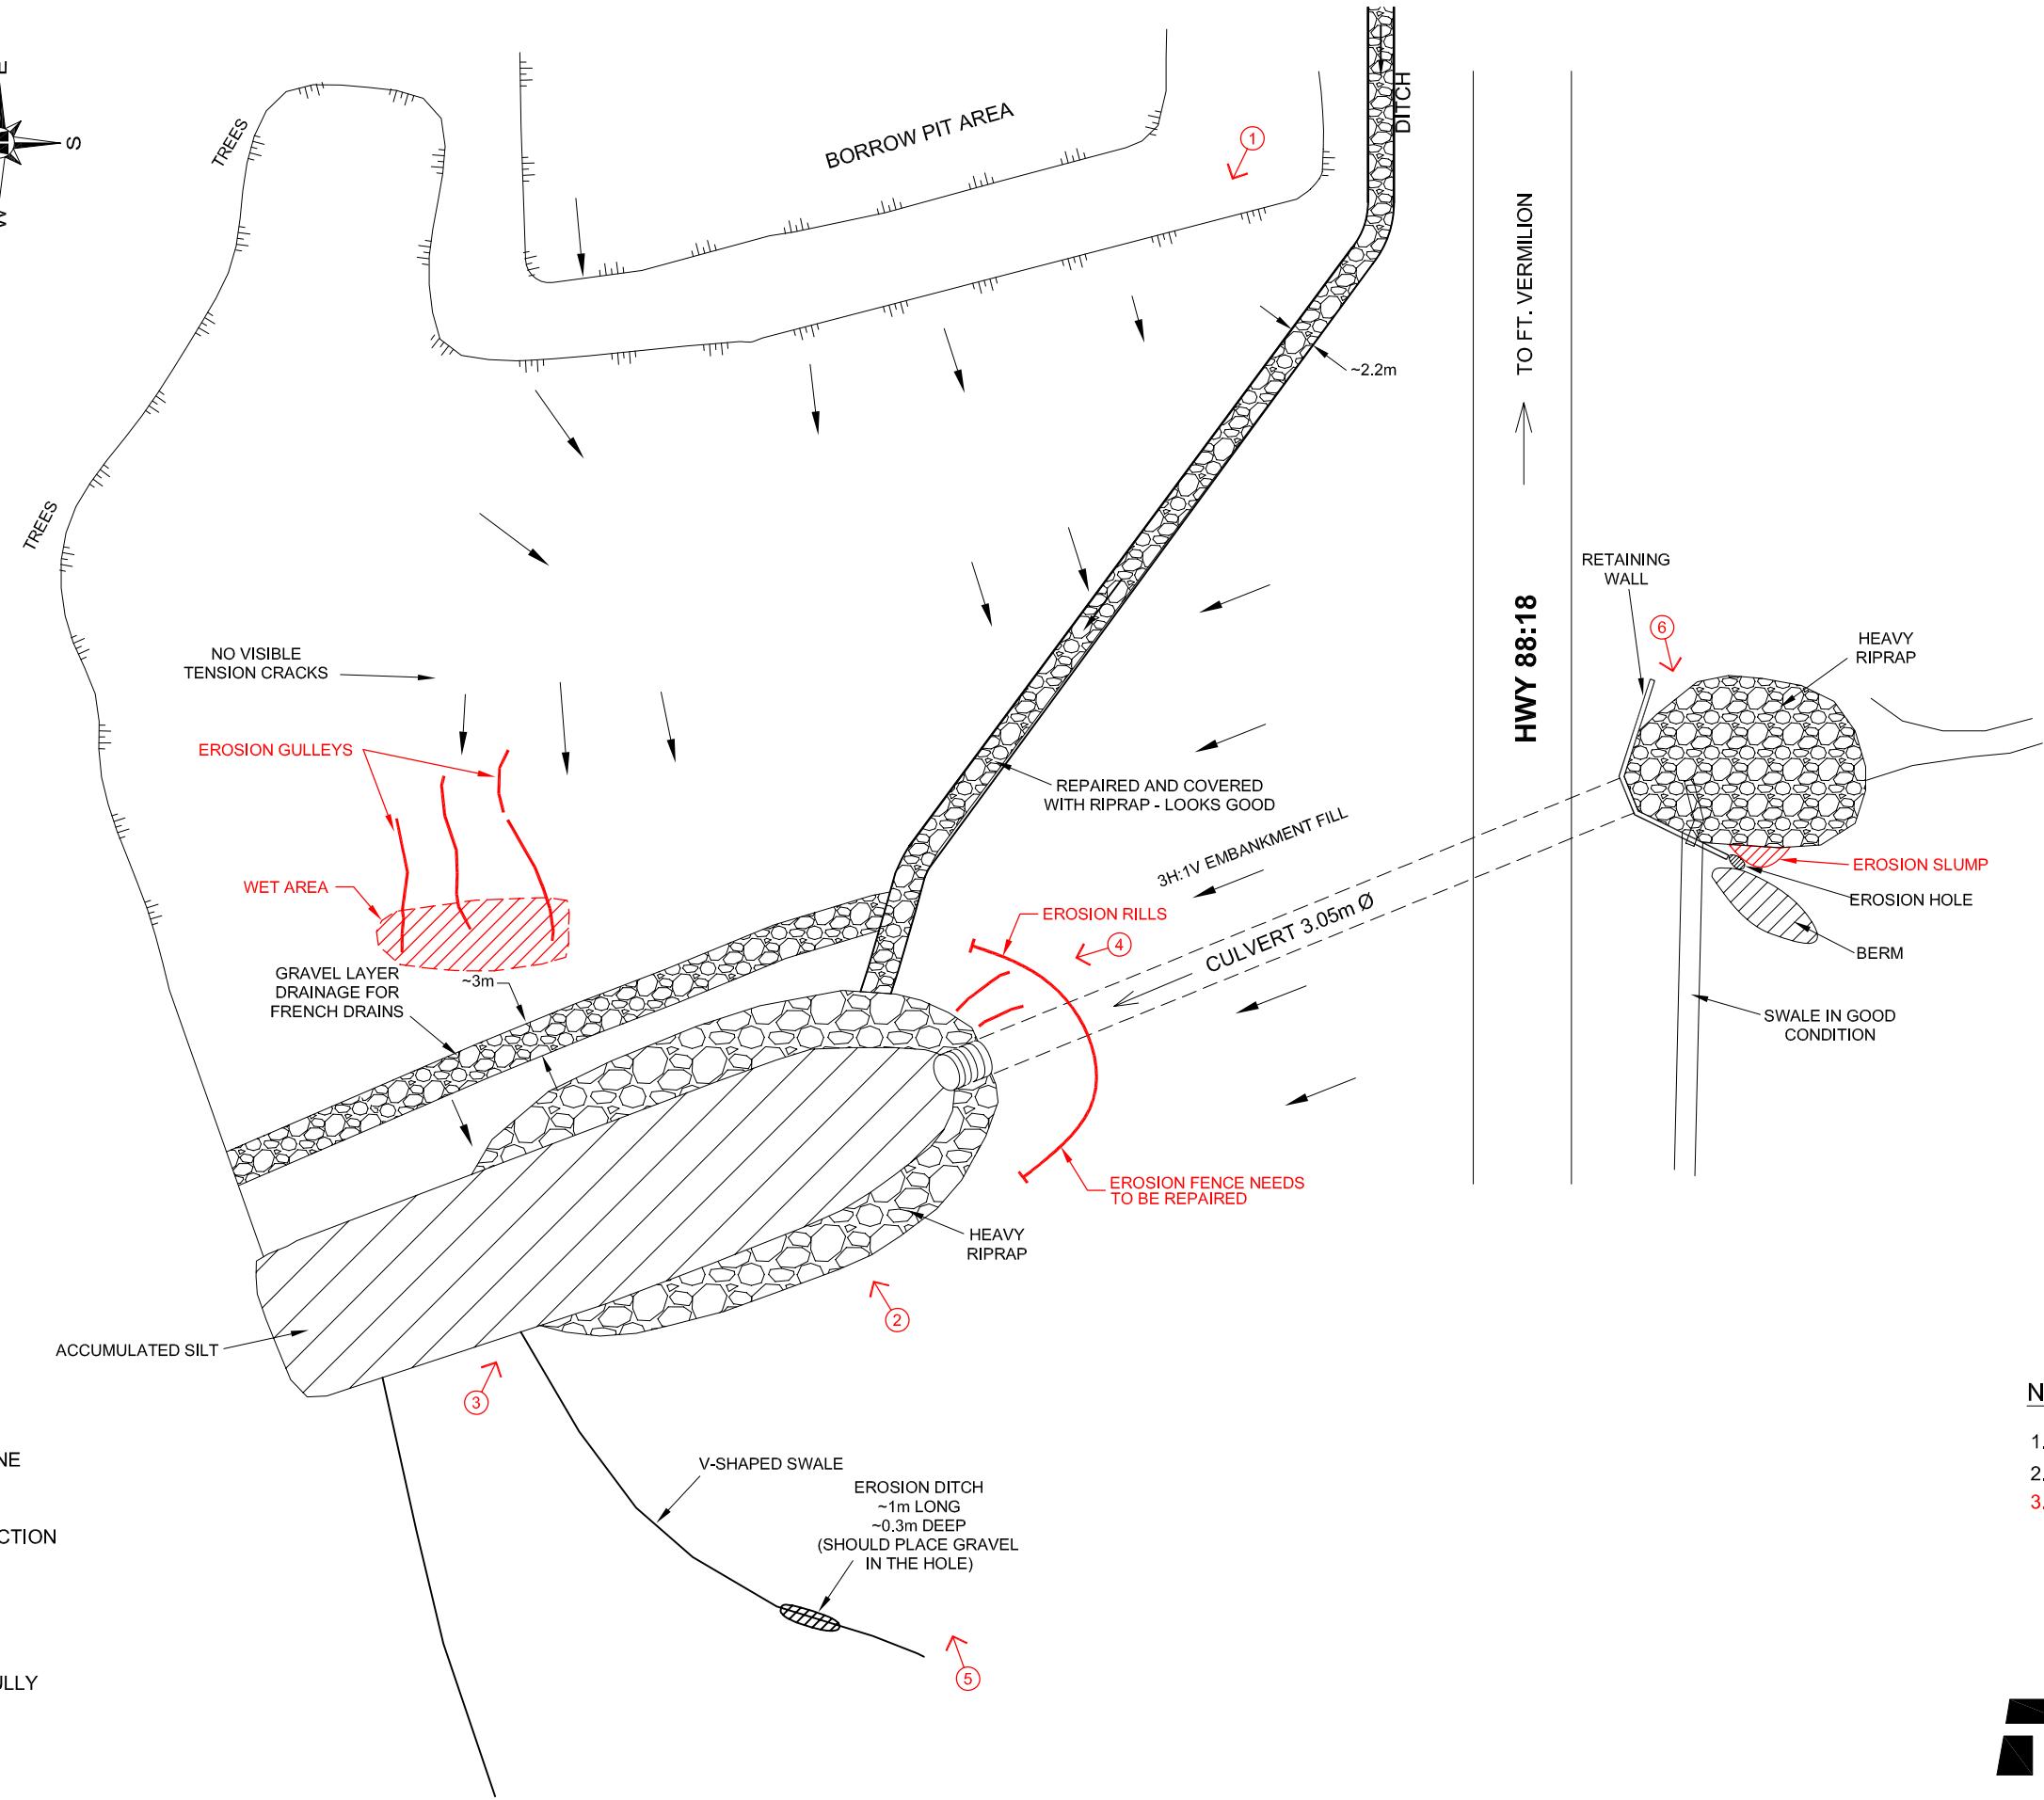
FIGURE PH16-1
HWY 88:18 FORT VERMILION
SITE SKETCH PLAN
 DATE : MAY 2006
 THURBER PROJECT #15-85-37

The vegetative cover on the east side slope was sparse leading to slope erosion. The erosion gullies noticed in the east slope in the June 20, 2005 site visit were repaired, but new minor erosion gullies were observed in that same slope, just 20 m north of the repaired erosion gullies. Seepage and a wet area were noticed near the toe of the slope, as shown in Figure PH16-1.

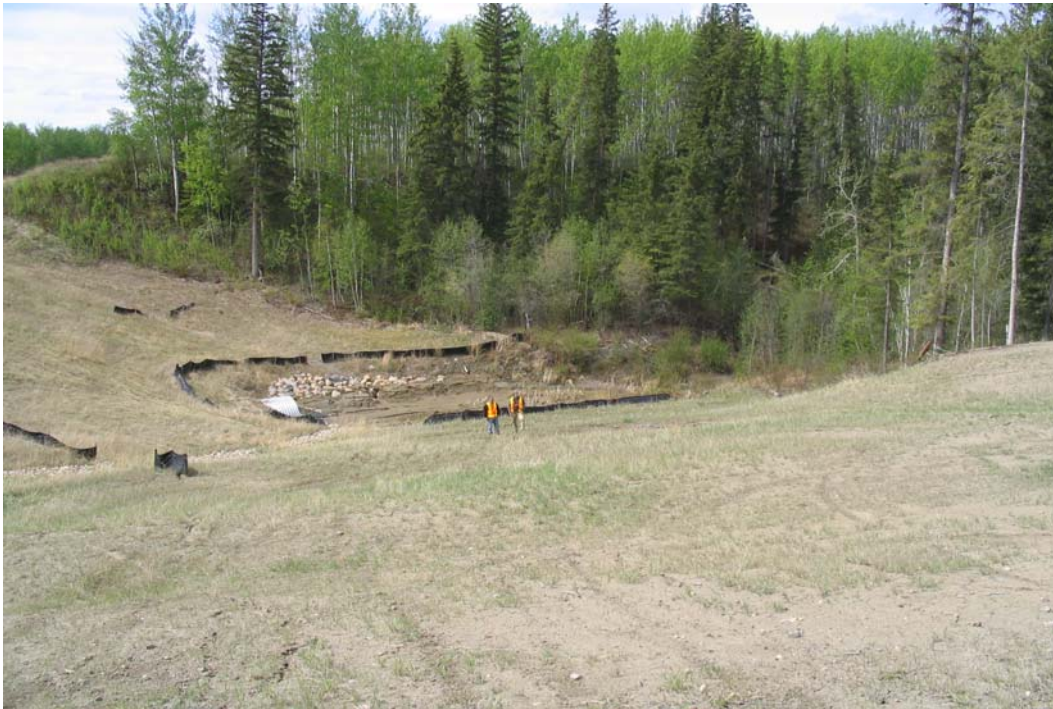
PHOTO 1: Overall view of the west slope.

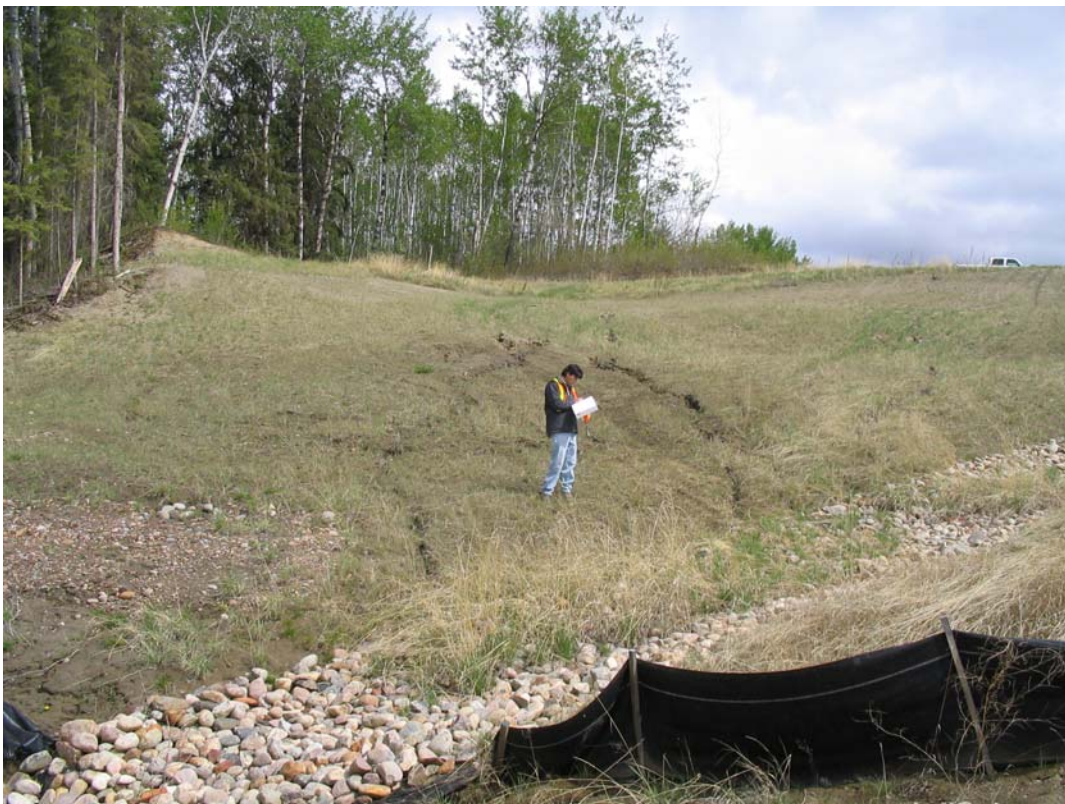
PHOTO 2: Erosion gullies on the east slope.

cracking of slope movement. However, the slopes are steep and long, therefore they may be considered as highly susceptible to erosion if not protected appropriately. In order to provide erosion protection the east slope should be double seeded and covered with straw matting to ensure sufficient grass coverage. The latter would constitute a short term solution. A long term solution, if required, would involve re-grading the east slope, and creating three flat benches across the slope, which would intercept and redirect the surface runoff to the nearby swale.

The erosion gullies noticed in the east and south slopes as well as in the north-west swale ("V" ditch) should be backfilled with gravel. The silt fence above the culvert outlet needs to be repaired. The accumulated silt at the culvert outlet should be removed.

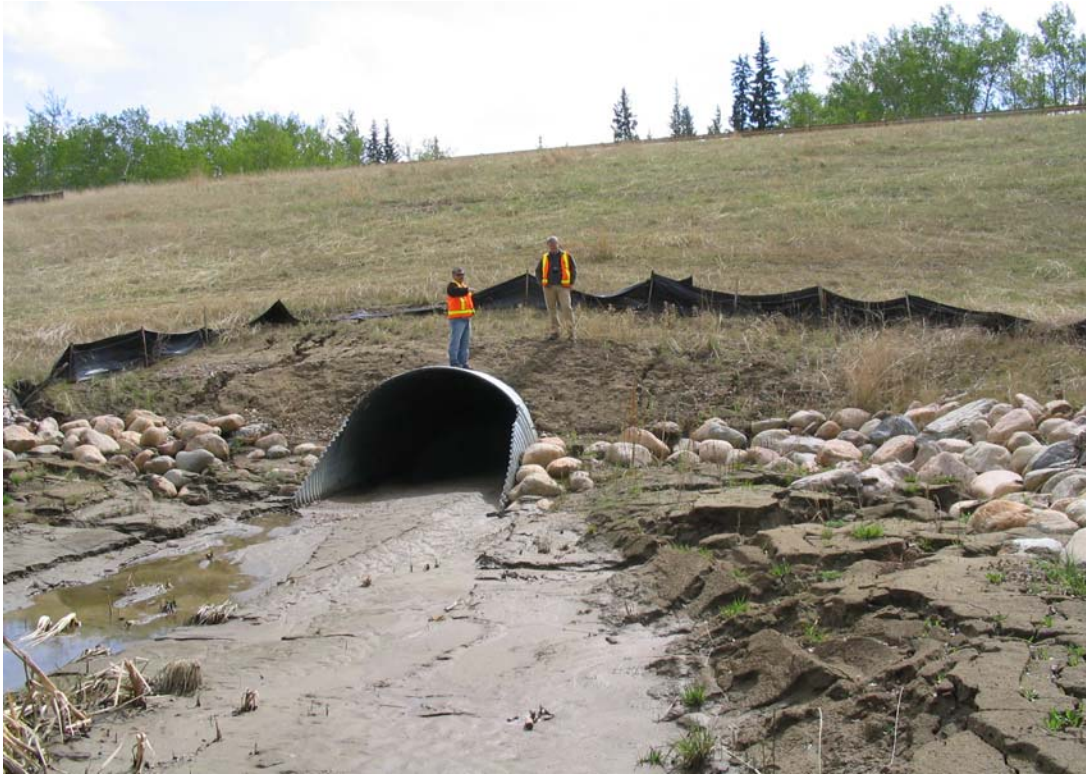
Noticeable silt accumulation was observed at the culvert outlet. This is consistent with last year's assessment. However, recent erosion gullies were observed on the south slope, close to the culvert outlet. Also, the silt fence above the culvert outlet is damaged.

PHOTO 3: Erosion gullies above culvert outlet, damaged silt fence and accumulation of silt.

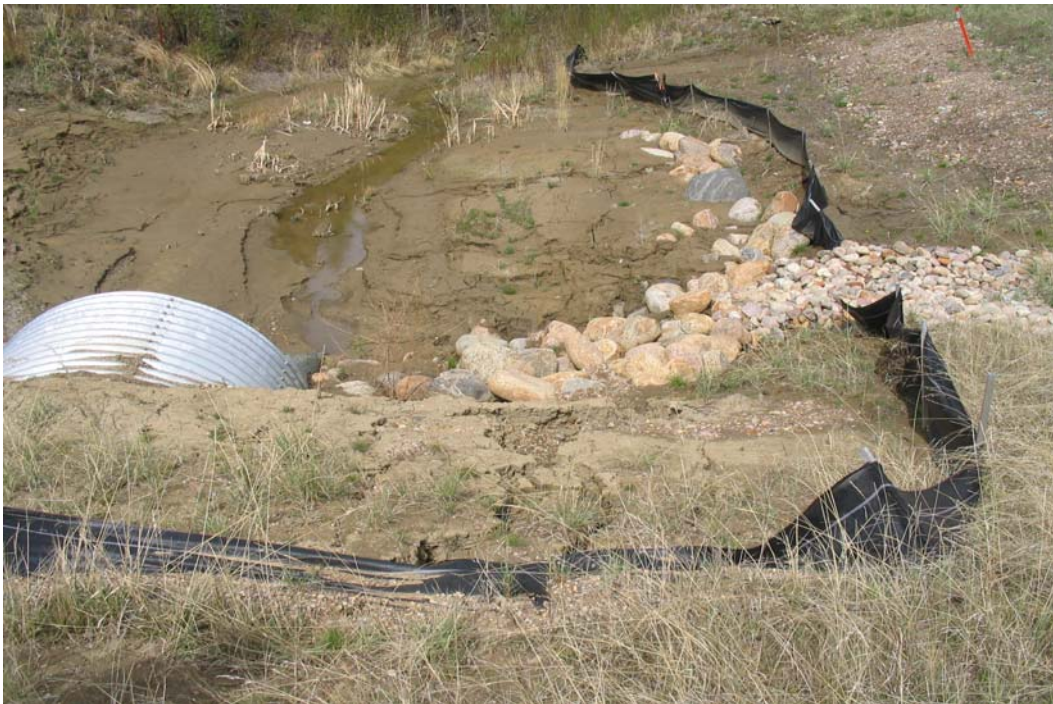
PHOTO 4: Erosion gullies above culvert outlet and accumulation of silt.

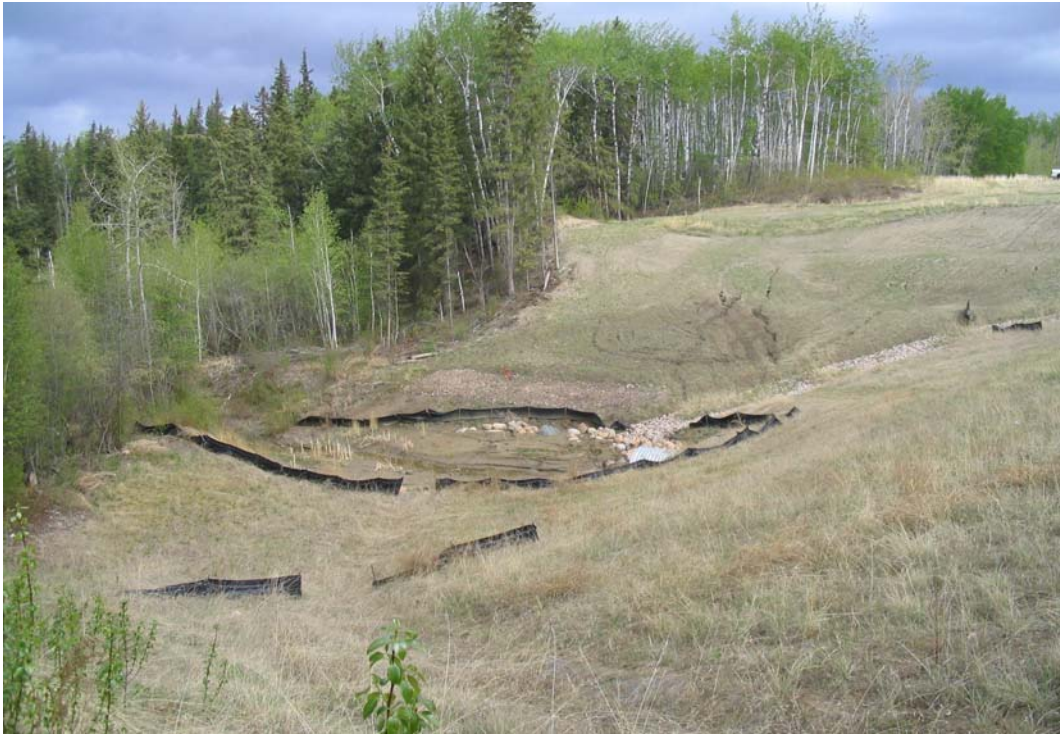
The mitigation measures implemented to stabilize the east slope appear to be working. The slope seemed to be stable and did not show signs of tension

PHOTO 5: Overall view of the east slope.

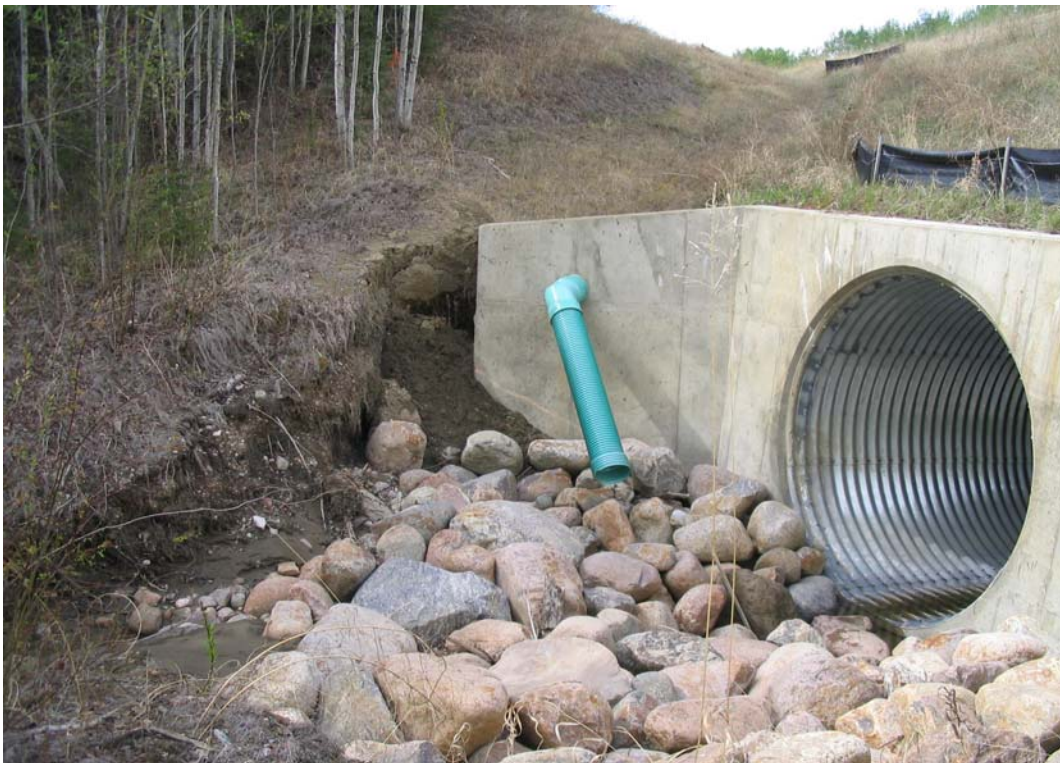
The soil erosion at the culvert inlet, above the rip rap level, has increased since our June 2005 assessment.

PHOTO 6: Erosion slump at the culvert inlet.

The erosion hole at the culvert inlet should be repaired. The area should be cleaned up, followed by placement of non-woven geotextile, pit run gravel, and heavy rip rap. The material quantities approximately needed are 10 m³ of gravel and 15 m³ of rip rap.
