October 18, 2004

15-16-203

**PEACE REGION SWAN HILLS AREA GEOHAZARD ASSESSMENT
SH20 (CE047/2004)
CALL-OUT FOR EMBANKMENT FAILURE
ON HWY 679:06, 3 KM WEST OF HWY 750**

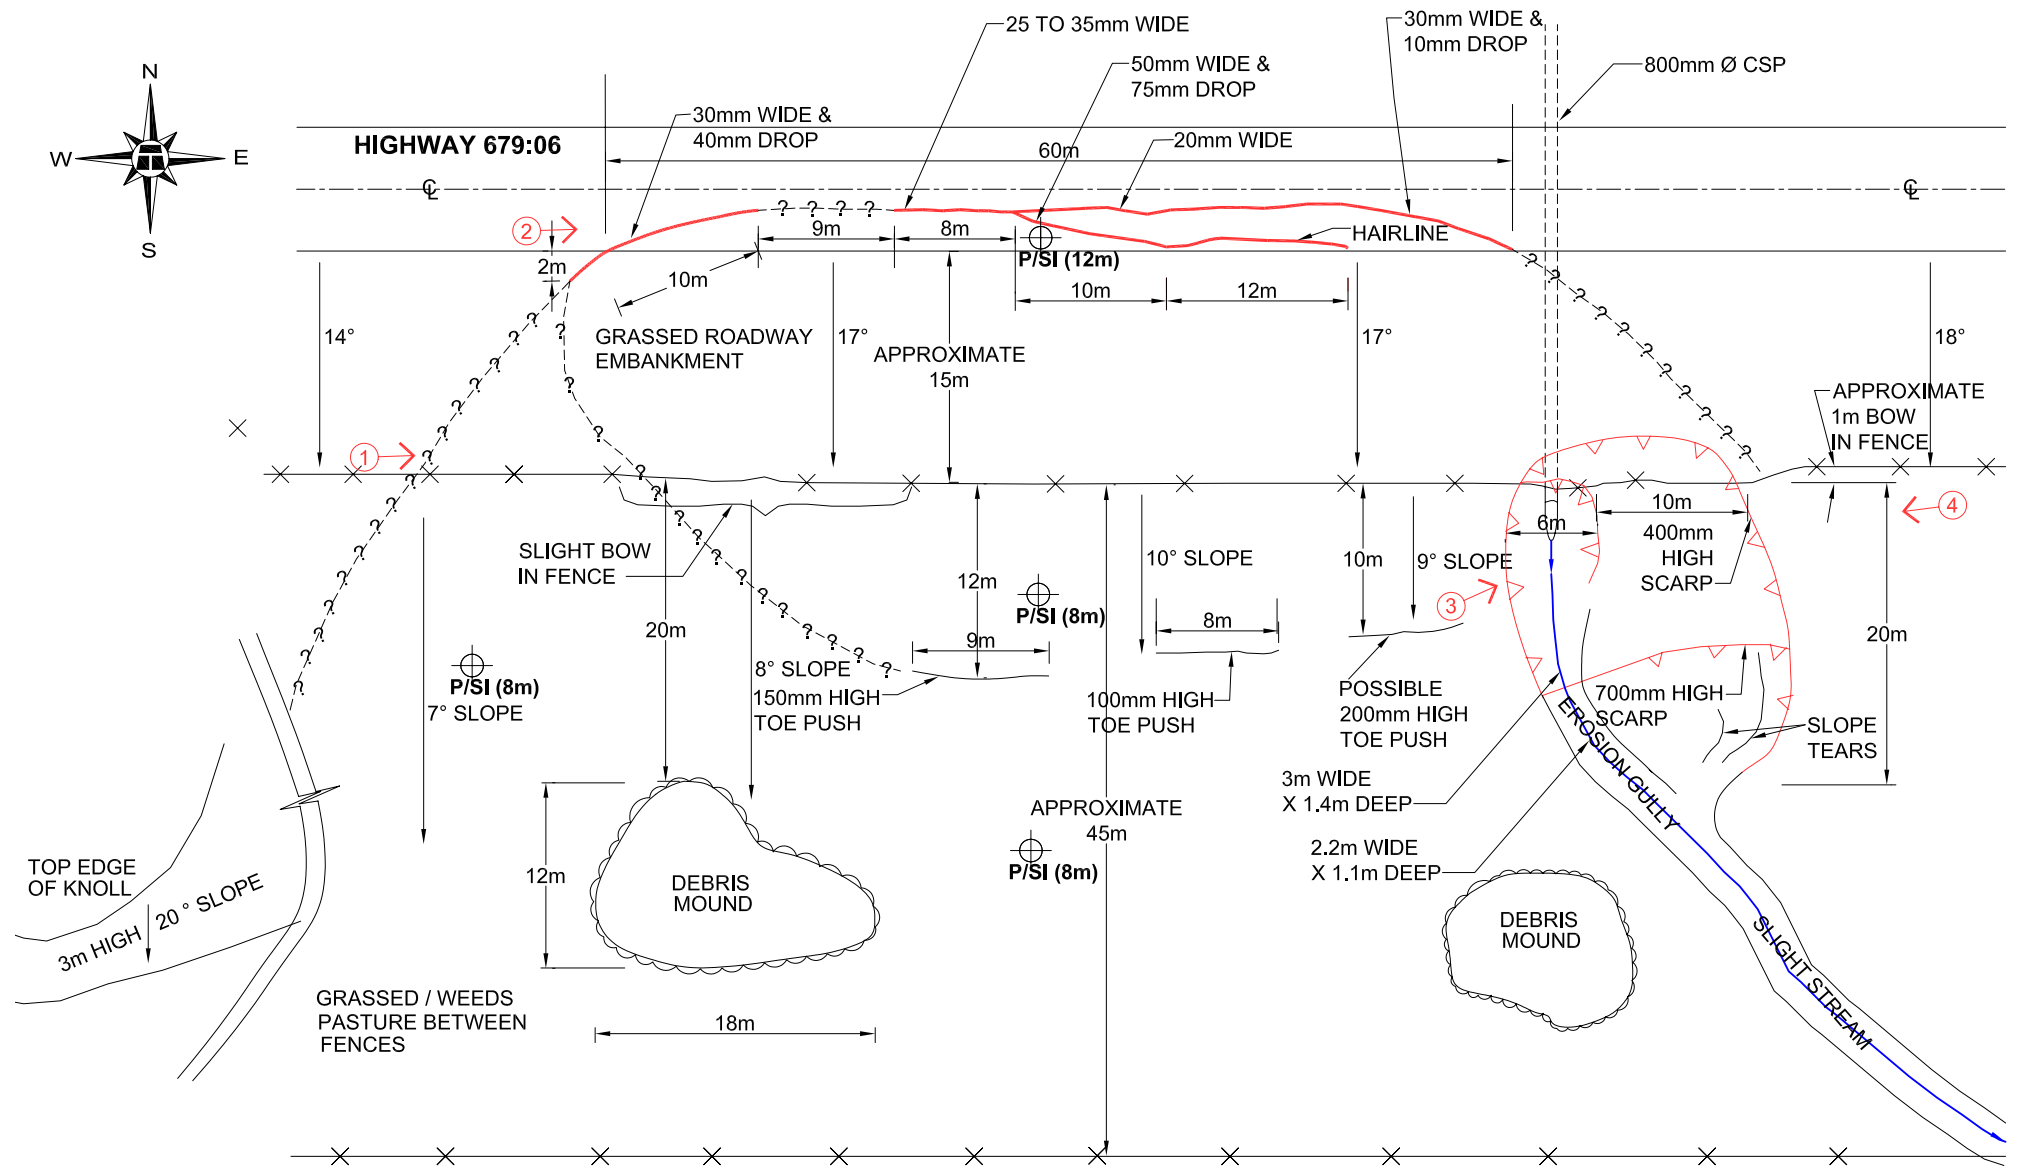
FIGURE 1 - SITE PLAN
 CALL OUT FOR SLIDE ON HWY 679:06
 3 Km WEST OF HIGHWAY 750
 SH20 PEACE REGION SWAN HILLS AREA

The slide occurred on the south side of the highway. The backscarp of the slide is located along the eastbound driving lane of the graveled road surface, marked by an intermittent crack along its length, containing a double crack over a portion of this distance.

The highway embankment is a fill along the slide area (estimated to be about 3 to 4 m in vertical height), containing a slope varying between about 15° to 18° . The toe of the highway embankment coincides with a fence line likely marking the south boundary of the highway right-of-way. South of the fence line for a distance of about 30 m, a slightly hummocky area existed which had average slopes varying between 8° to 10° over this distance. Two shallow debris mounds containing old wood/soil marked the southern boundary of this hummocky area. Beyond the debris mounds further south, the ground surface was nearly flat. A second fence line was located about 45 m south of the highway embankment toe. The highway embankment was grassed, while the area between the two fences contained a grass/weed pasture surface.

The crack marking the slide along the highway surface was observed to extend about 60 m wide along the highway surface, and the slip surface appeared to extend below the highway embankment sideslope, toeing out about 10 m to 12 m down slope of the fence line (for a total length of about 25 m). The backscarp of the slide is well defined, with the crack as much as 50 mm wide, and containing a vertical drop as much as 75 mm across the crack. The toe roll was only observed over two or three distances of 8 to 9 m in length, with no continuous toe roll observed along the entire slide length. It is possible that the above described toe could be an intermediate toe roll, with the final toe extending further south at the terminus of the hummocky ground at the south end of the debris mounds.

It is understood that since this road is scheduled to be reconstructed in the future, long-term remedial recommendations will likely not be undertaken in the immediate future. Consideration should be given to installing 4 slope inclinometers (SI's) at this site to track the magnitude and depth of movements, and also to define the position of the slide toe. The test holes as part of the inclinometer installations would also be used to assess the soil conditions down slope of the highway embankment, where the relatively flat natural slope exists. The proposed locations and depths of the SI's are shown on Figure 1. Piezometers should also be installed in separate holes near each SI location to determine the governing piezometric surface at the site. Surveying of this site is recommended prior to implementing permanent remedial measures, to properly assess drainage and to better define quantities.

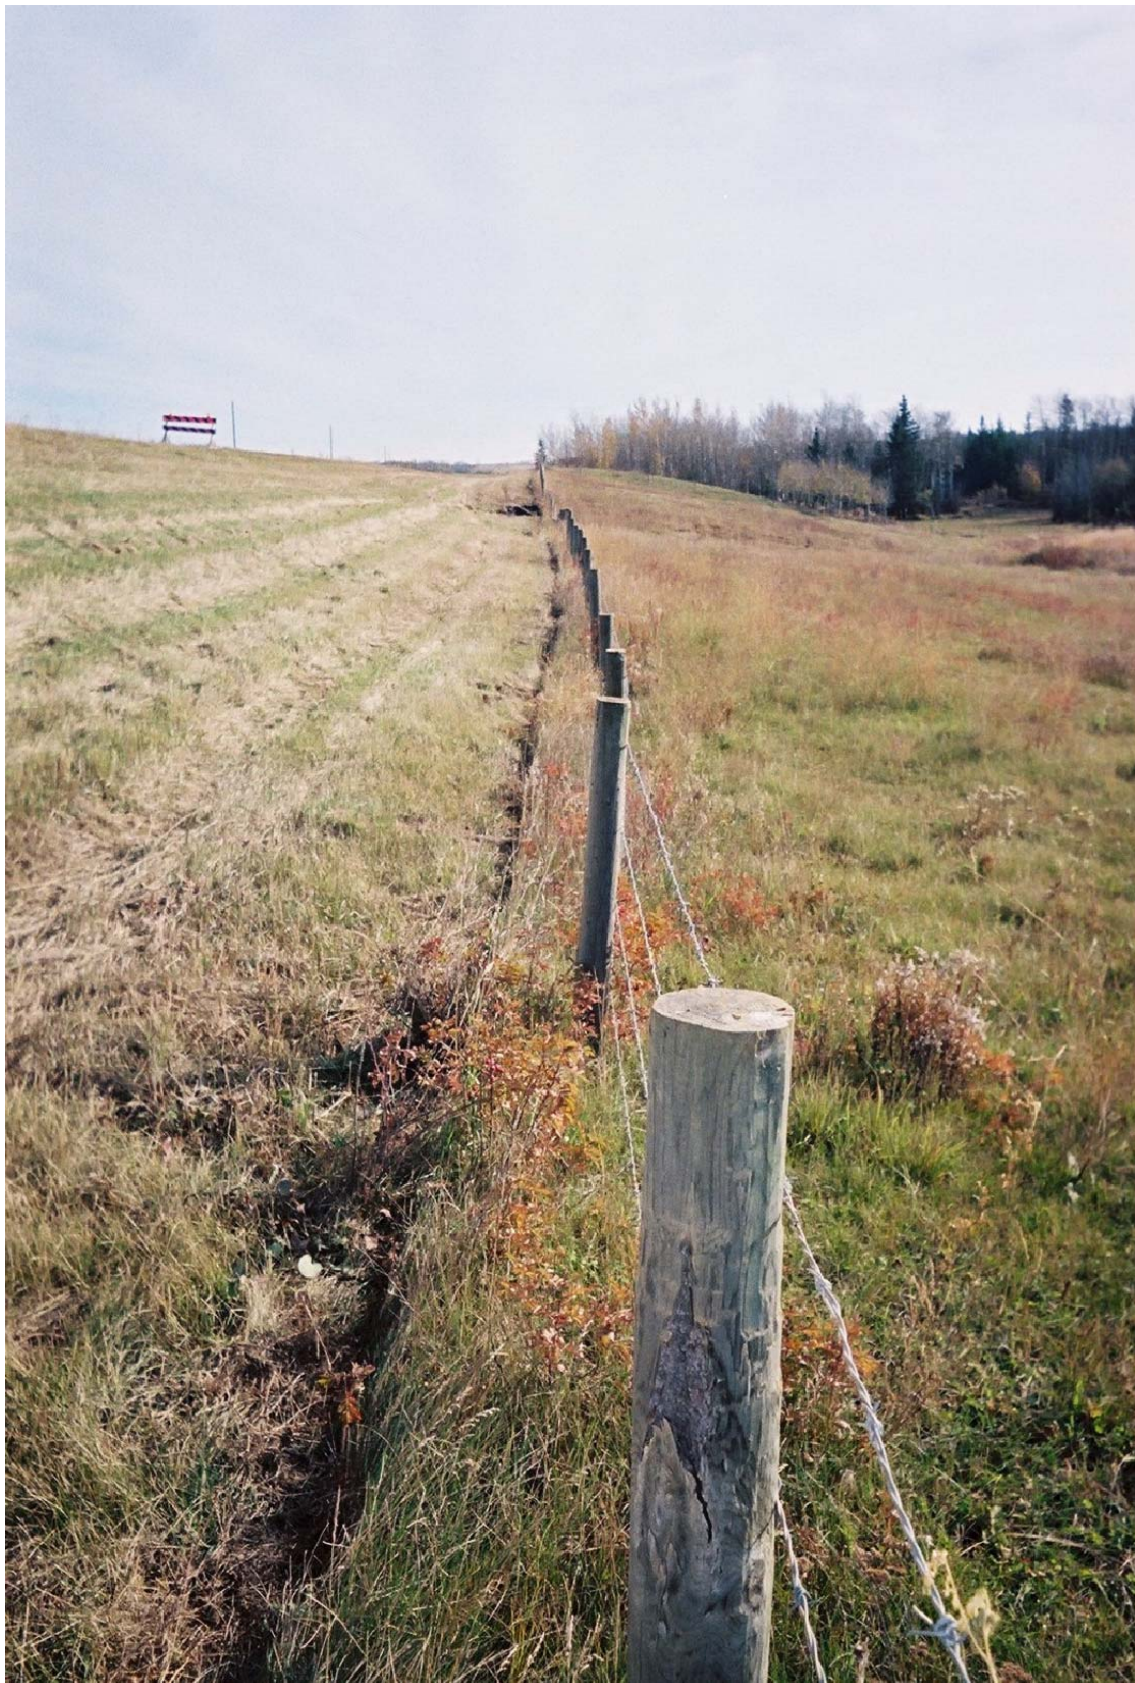
southwest to the toe of the knoll, but more likely extends southeast towards the more identifiable toe roll observed. The soil exposed in the scarp around the CSP outlet consisted of highly plastic clay. The slide movement has bowed out the barbed wire fence by about 1 m adjacent to the CSP culvert outlet, and a more gradual bow appeared to be visible in the fence down slope of the western end of the crack observed in the fence. No seepage or ponding of water was observed from the scarp or toe of the slide.

PHOTO 1 - LOOKING EAST ALONG FENCELINE ACROSS SLIDE AREA
NOTE SLIGHTLY BOWED FENCE

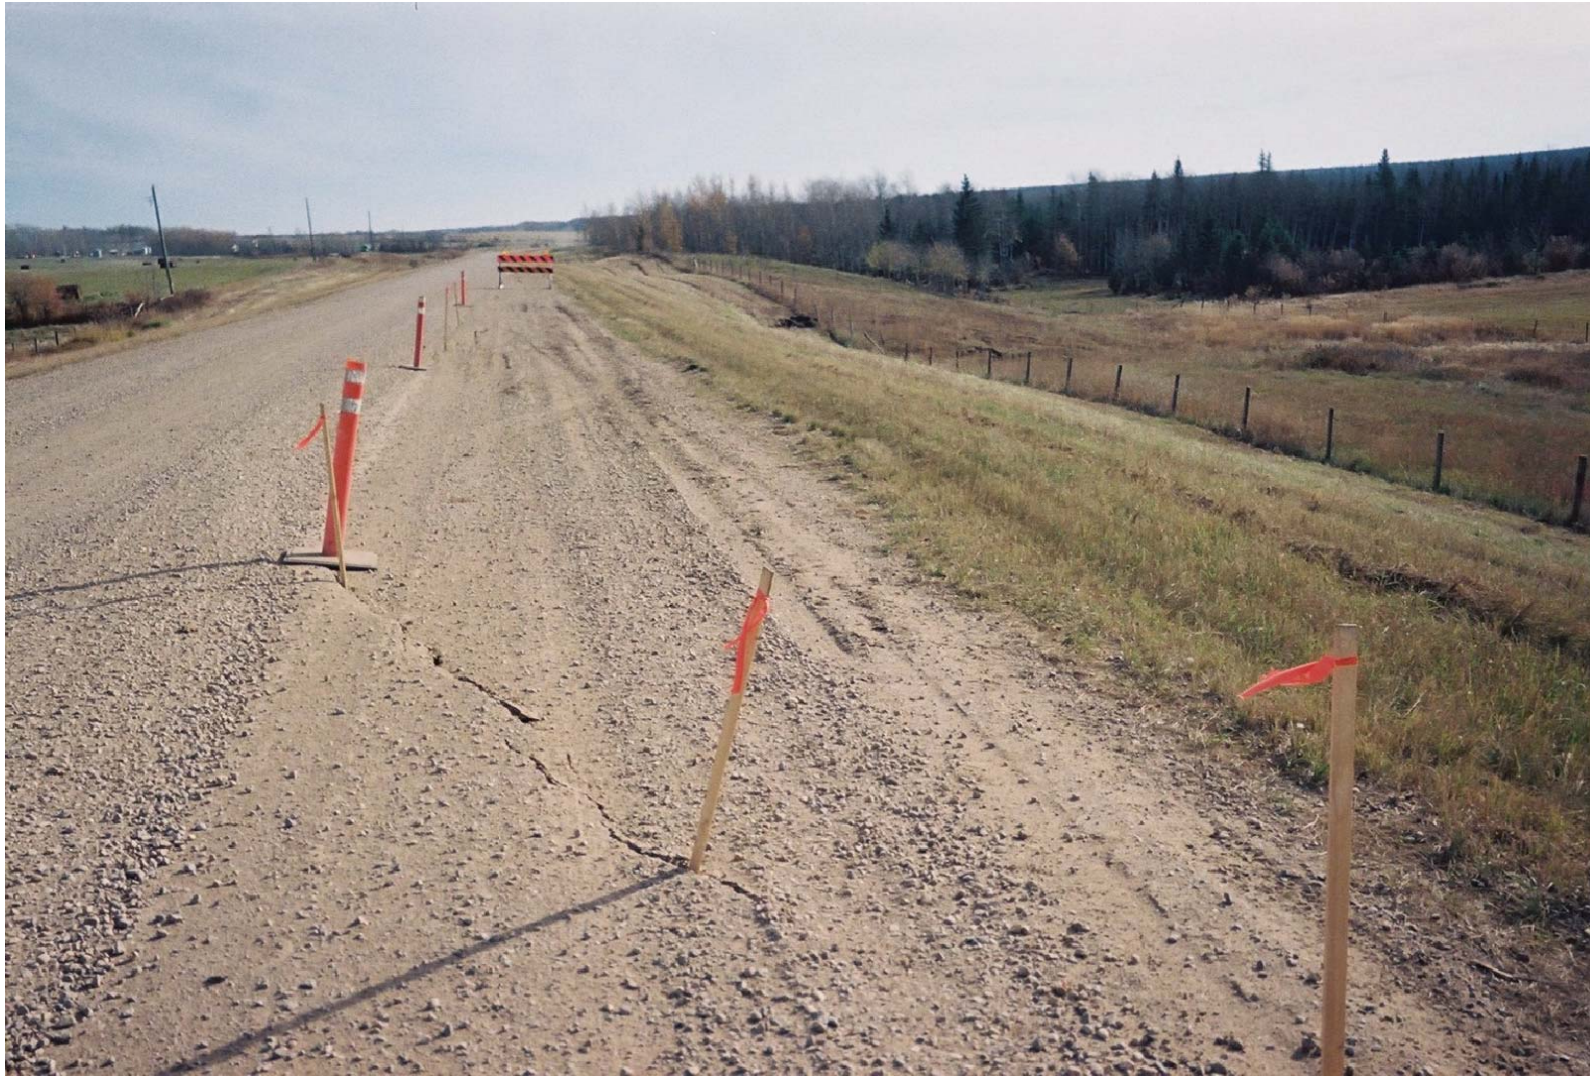
PHOTO 2 - LOOKING EAST ALONG ROAD AT CRACK IN HIGHWAY. THE PILONS MARK THE SLIDE SCARP BOUNDARY

For the short term, it is recommended that the top edge of the slide area across the roadway surface should be graded and replenished with gravel to reduce water infiltration into the slide cracks, and to taper runoff off of the graveled roadway surface onto the sideslope. It is anticipated that continued movements should slow or possibly cease during the winter, due to the anticipated shallow nature of this slide.

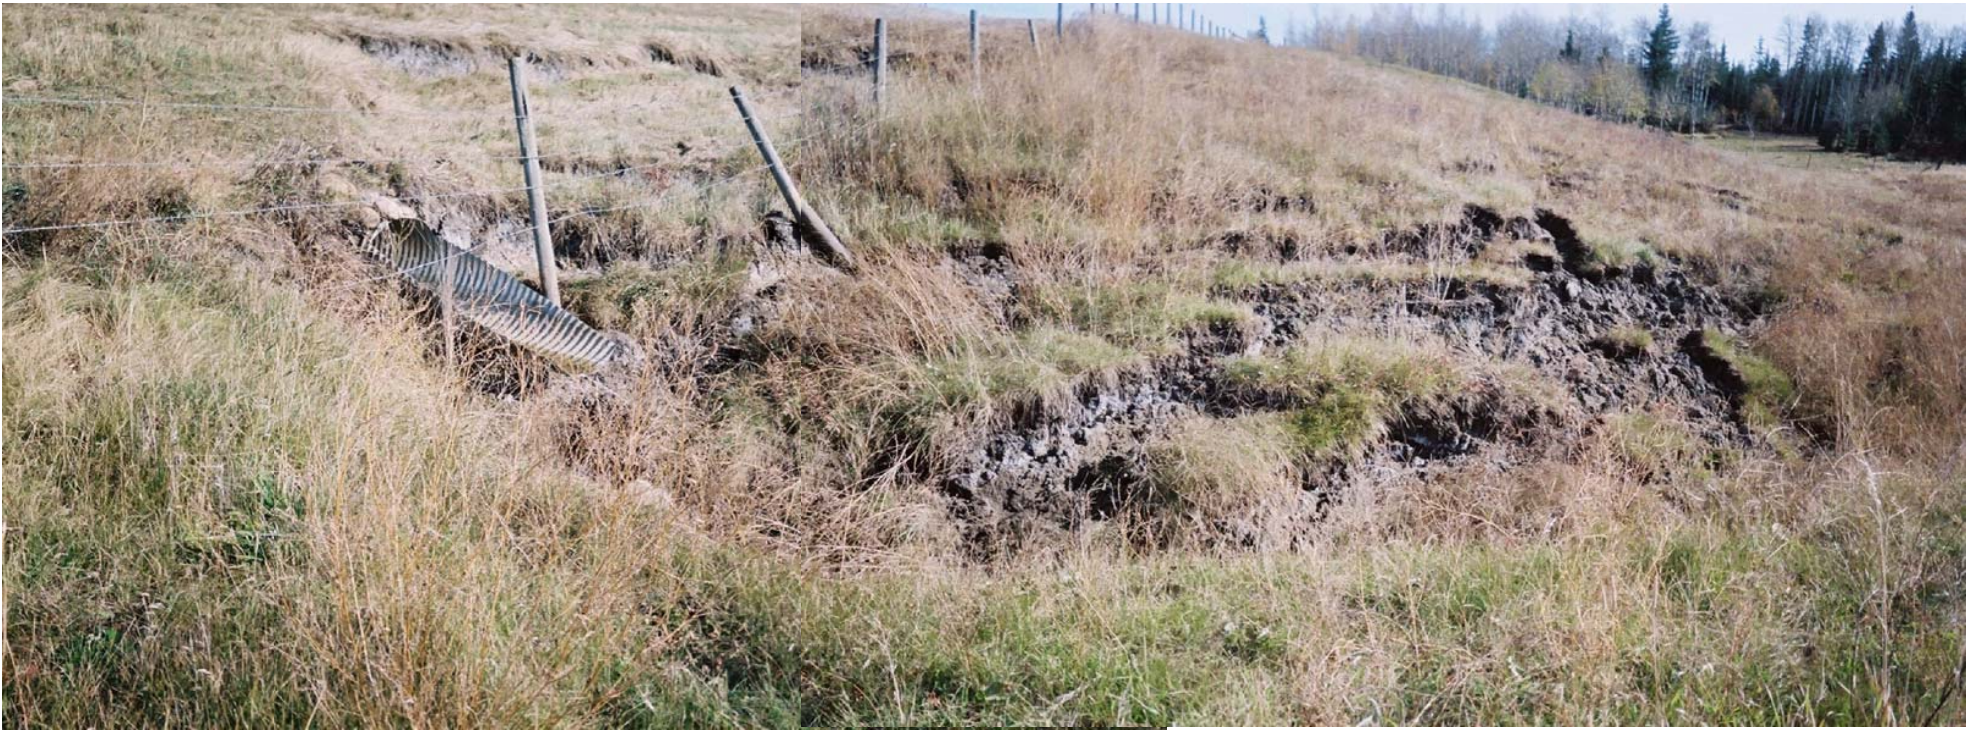
The outlet to an 800 mm diameter CSP culvert was exposed at the eastern edge of the slide area, exiting at the fence line. An erosion gully and scarp about 6 m wide and 1.4 m deep existed immediately around the culvert outlet. Adjacent to the east side of the erosion gully, a larger slump was observed, with the 400 mm deep scarp extending north a few meters into the highway embankment, and about 20 m south of the fence. A number of successive slope tears and intermediate scarps were observed within this well defined slump. A steady trickle of water was observed emanating from the CSP outlet.

In addition, the significant erosion and associated slumping observed around the CSP outlet at the toe of the embankment fill adjacent to the east end of the slide could possibly have triggered the slope movement.

PHOTO 3 - LOOKING NORTHEAST AT EROSION / SLUMPING ADJACENT TO 800mm Ø CULVERT OUTLET

The erosion and slump around the CSP culvert outlet would also need to be repaired as part of these long term remedial measures. This would involve excavate/remove all fallen trees and any soft/wet material in the eroded scour hole and slump area, and backfill the area with clay fill to the underside of the existing culvert in thin lifts to a minimum of 95% of standard proctor maximum dry density.

The tapered end section of the culvert should be removed and replaced if it is damaged. If necessary, a smooth wall steel drop pipe should be attached to the proposed culvert liner to lower the culvert outlet until it meets grade downstream of the scour hole. Riprap, over a non-woven geotextile should be placed around and downstream of the outlet. It may be desired to place silt fence at the base of the slope along the edge of the drainage channel.

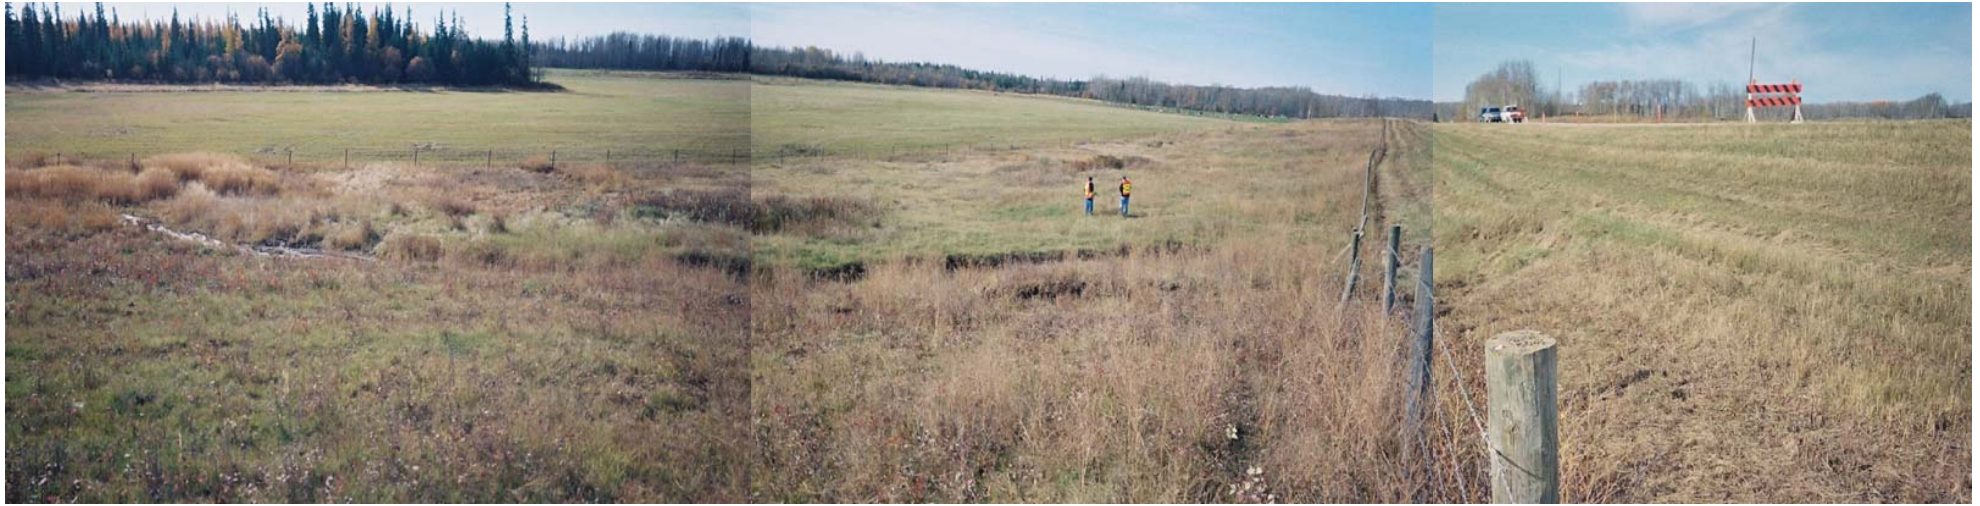
PHOTO 4 - LOOKING SOUTH TO WEST ACROSS SLIDE AREA FROM EAST END OF SLIDE. NOTE BOWED FENCE AND TWO DEBRIS PILES

The recommended potential long-term solutions would be to construct a toe berm, or alternatively, install a gravel shear key, to stabilize the slide area.
