August 10, 2007

**PEACE REGION (PEACE – HIGH LEVEL AREA) GEOHAZARD ASSESSMENT
SHAFTSBURY TRAIL (NORTH SITE)
2007 CALLOUT INSPECTION REPORT**

This letter documents the 2007 callout site inspection of an area of slope instability located below Shaftsbury Trail (Hwy 684:02) within the Town of Peace River. The site is located 1.7 km south of the intersection of Shaftsbury Trail and Highway 2.

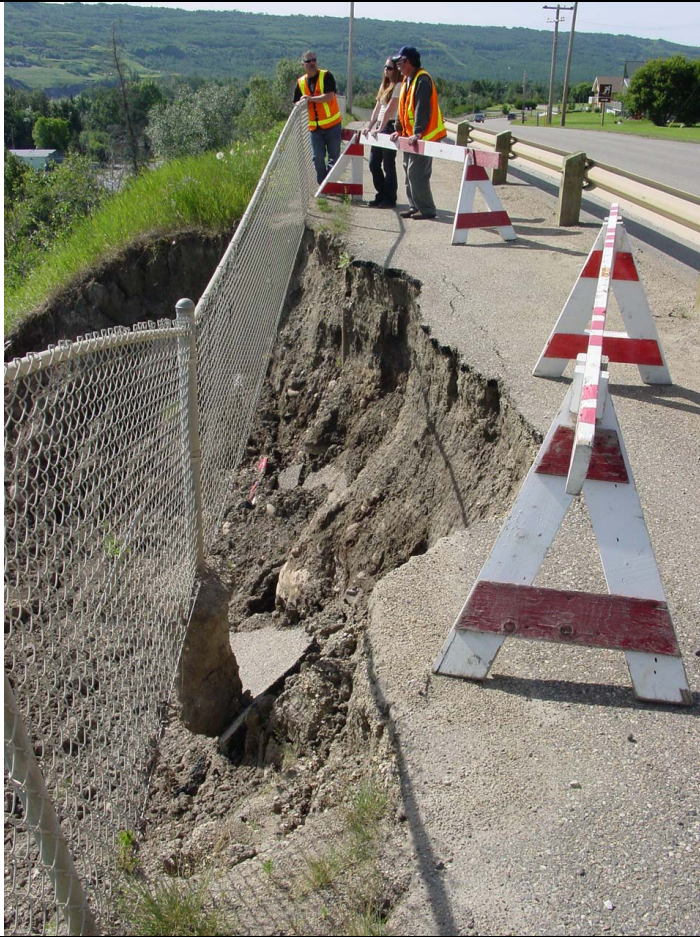
As shown in Photos 1 and 2, the failed area has impacted an approximate 8 m length along the sidewalk. The scarp in this area was 2 m to 2.5 m high and located 1.75 m from the guard rail at the time of the site visit. The slide appeared to be contained solely in the upper clay soils and the debris formed an apron of colluvium at the toe of the slope, typically at an angle of 30° and 32°, although some boulders have traveled beyond the apron toward the residences (See Photos 4 and 6).

Photo 1.
Looking south at scarp in the path along Shaftsbury Trail. Near vertical scarp is 2 m to 2.5 m high

The slide area along the sidewalk should be fenced and/or closed to keep pedestrians away from the slide.

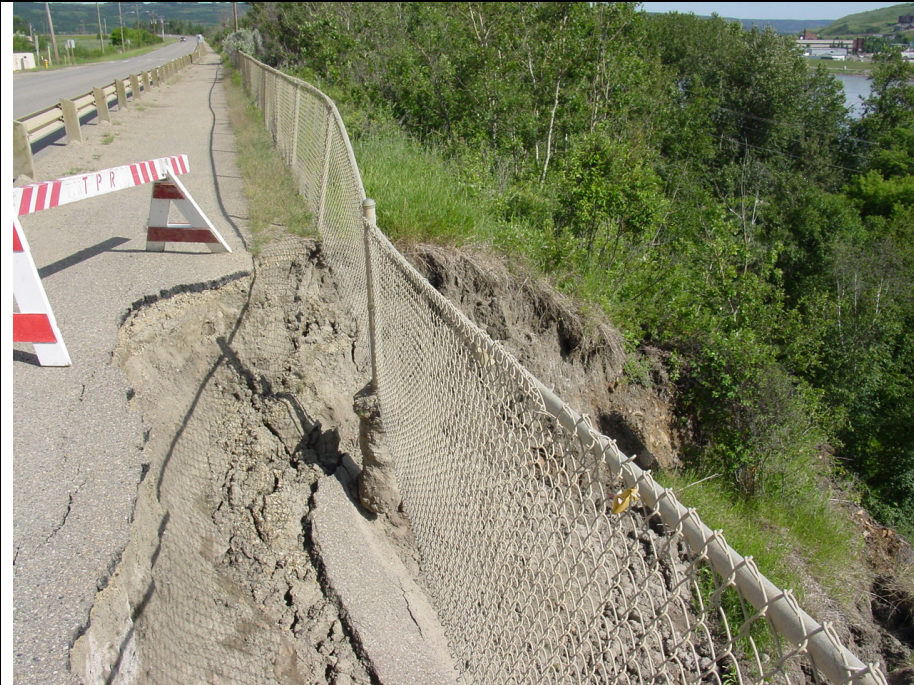
Photo 2.
Looking north at scarp in the path along Shaftsbury Trail.

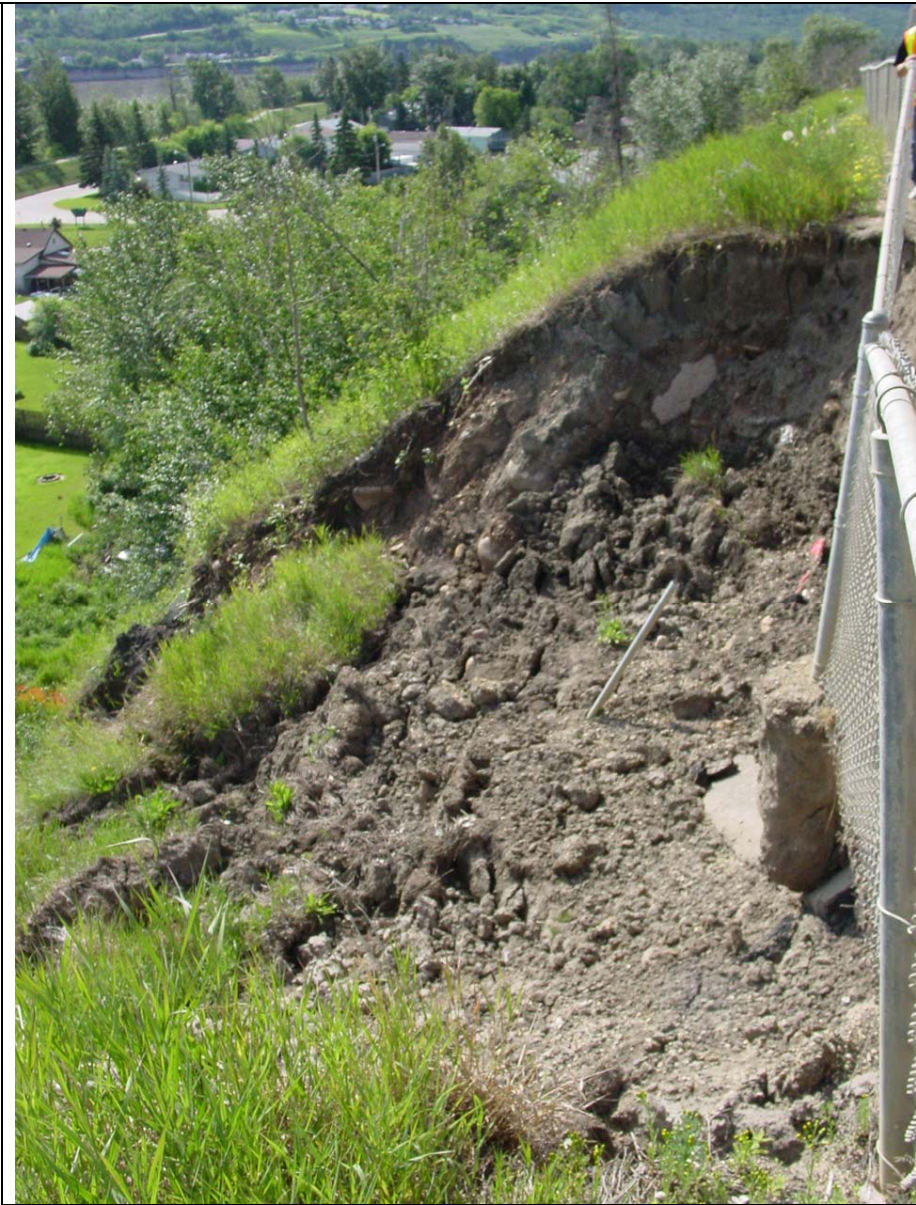
Photo 3.
Debris in slide area.

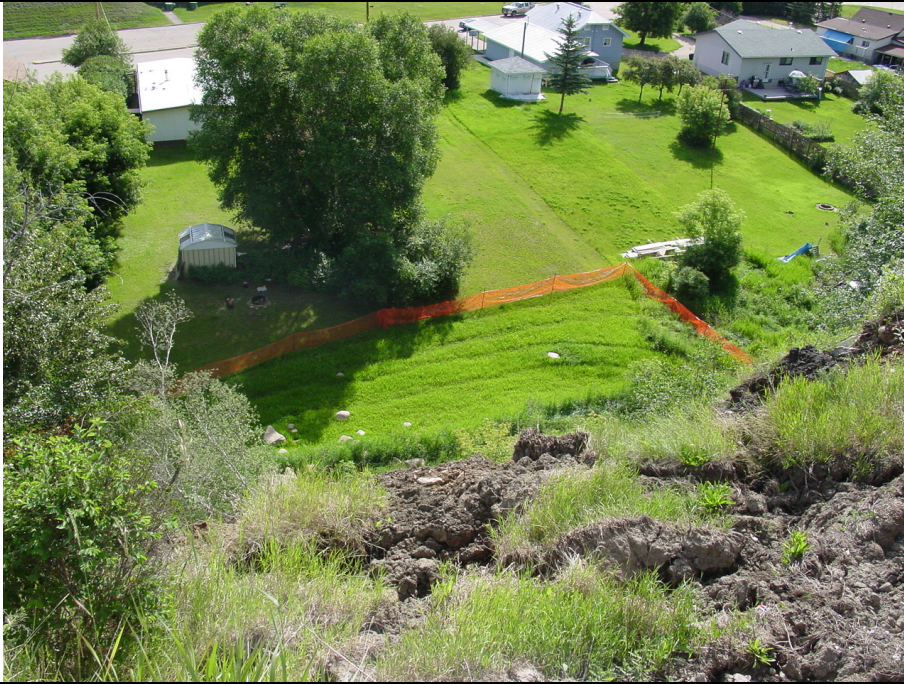
Photo 4.
Looking down the slide area. Note boulders up to 1.75 m in size have traveled toward the residences.

To protect the residences below the slope a barrier should be installed to stop boulders or other debris reaching the property lines. In the short term it is considered that New Jersey Barriers would be a suitable option, placed approximately along where the snow fence has been installed (see photos).

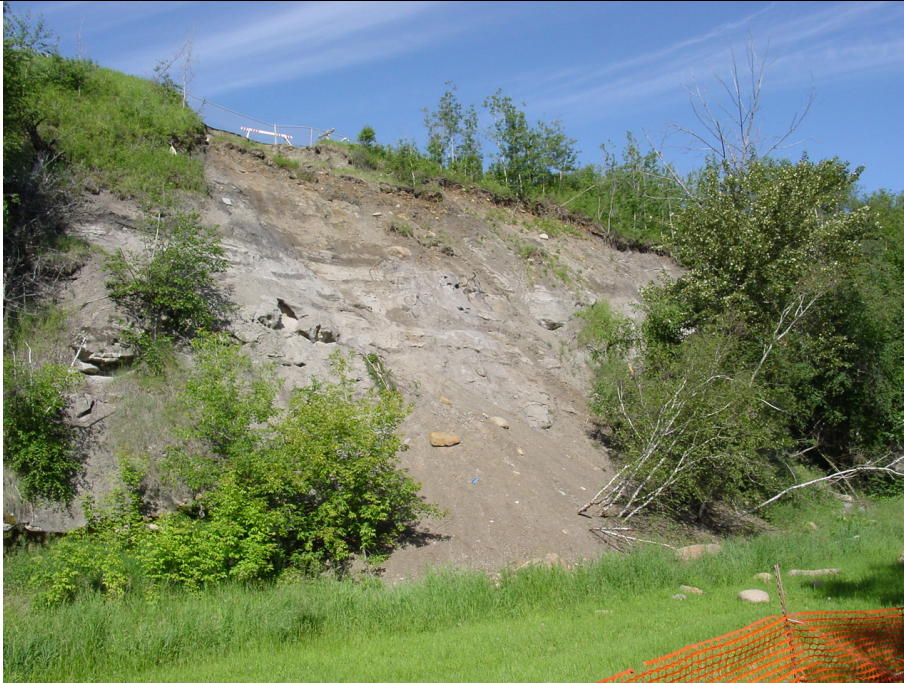
The upper portion of the slope (estimated as 8 m to 10 m vertically) is comprised of a silty sandy clay, containing clasts ranging from gravel size to boulders observed up to 1.75 m in diameter. This portion of the slope had an angle of typically between 34° and 40°. Beneath this the slope was comprised of sandstone, forming a steep cliff over the remainder of the slope.

The slide is considered to have been triggered by either a temporary raise in groundwater or a concentration of surface water at this location. Either of these could have been caused by the reported heavy rainfall prior to the slide. The upper clay soils have lost strength and/or support and failed over the underlying sandstone cliffs. The sandstone appears to be relatively intact.

Photo 5.
Slope in failed area. Note the stratigraphy is silty sandy clay with up to boulder sizes overlying sandstone, which forms the cliffs in the lower portion of the slope. Overall slope height is ~20 m. Note the surface failure just above the soil-rock interface to the north of the slide (right of picture)

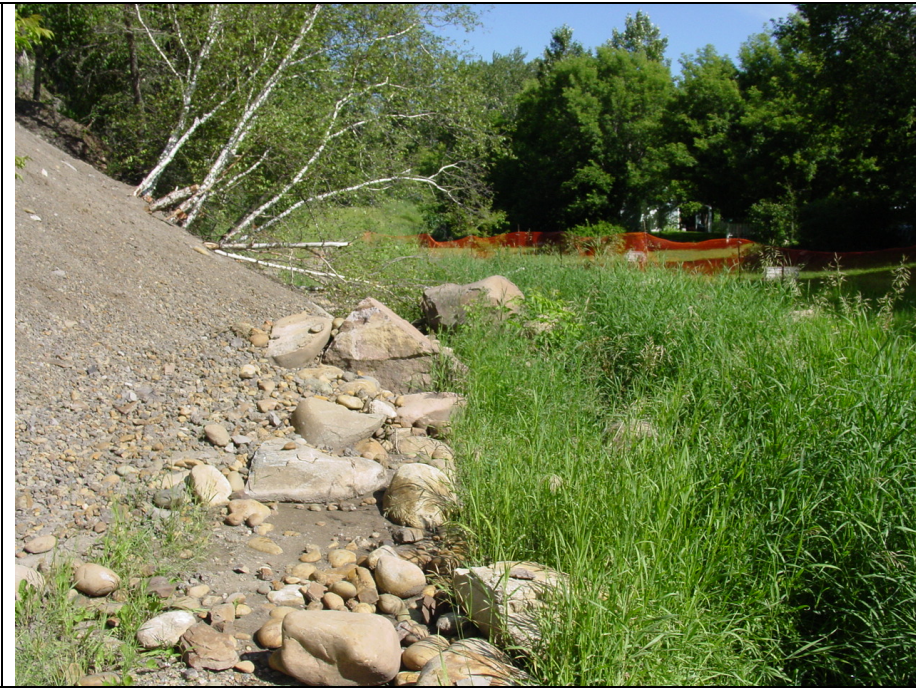
Photo 6.
Debris at toe of slide area.

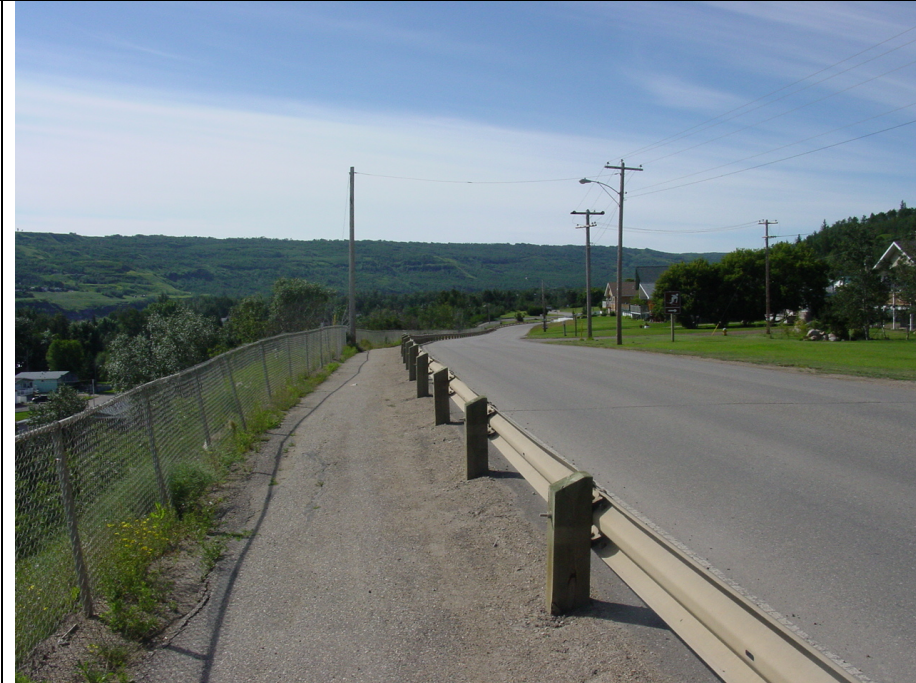
Signs of the potential for similar failures, including slides below the road and cracks in the sidewalk were noted extending up to 25 m on either side of this failure, for a total potential failure length of 60 m.

Photo 7.
Tilted fence and cracks in the path immediately south of the slide area. The telegraph pole in the middle distance doesn't show signs of tilting (the support wire isn't taut).

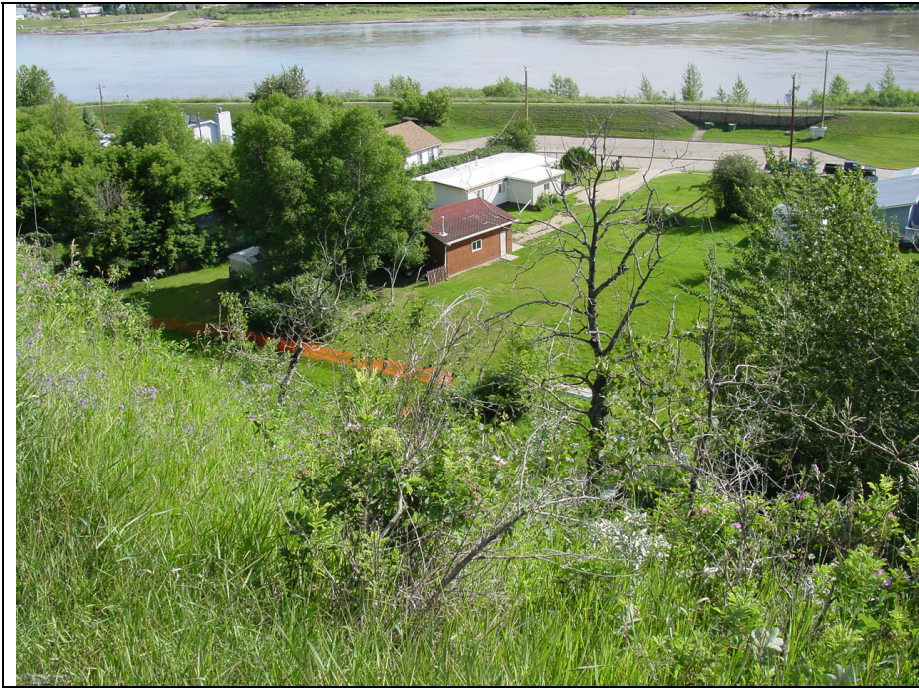
Photo 8.
Typical intact slopes south of
the slide area.

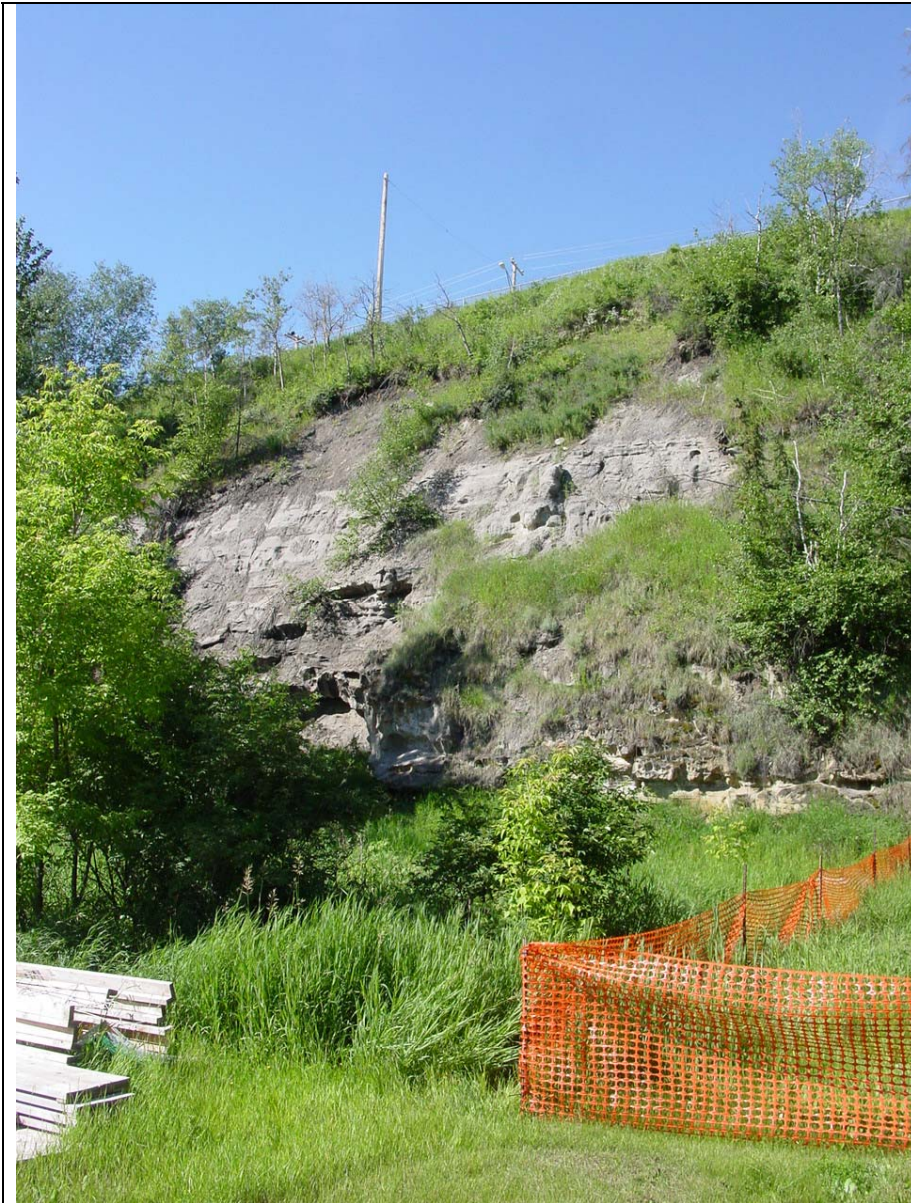
Photo 9.
Typical slopes south of the slide area. There have been past failures in this area, and there is cracking near the crest of the slope.
