THURBER ENGINEERING LTD.

June 22, 2018

**GEOHAZARD ASSESSMENT PROGRAM
CALL-OUT INSPECTION REPORT
HWY 684:02 KM 29.46
(PH053-2) SHAFTESBURY TRAIL NORTH SITE**

**PH053-2: HWY 684:02, km 29.461
2018 CALLOUT PLAN**

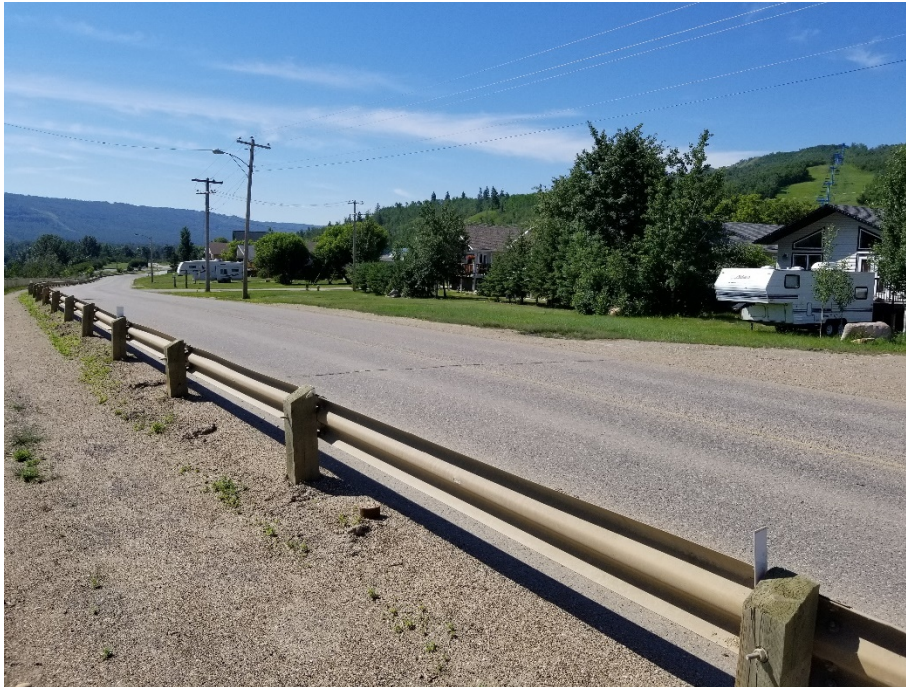
Photo 1: Looking SW at HWY 684 from the NE side of the intersection with 105 Avenue.

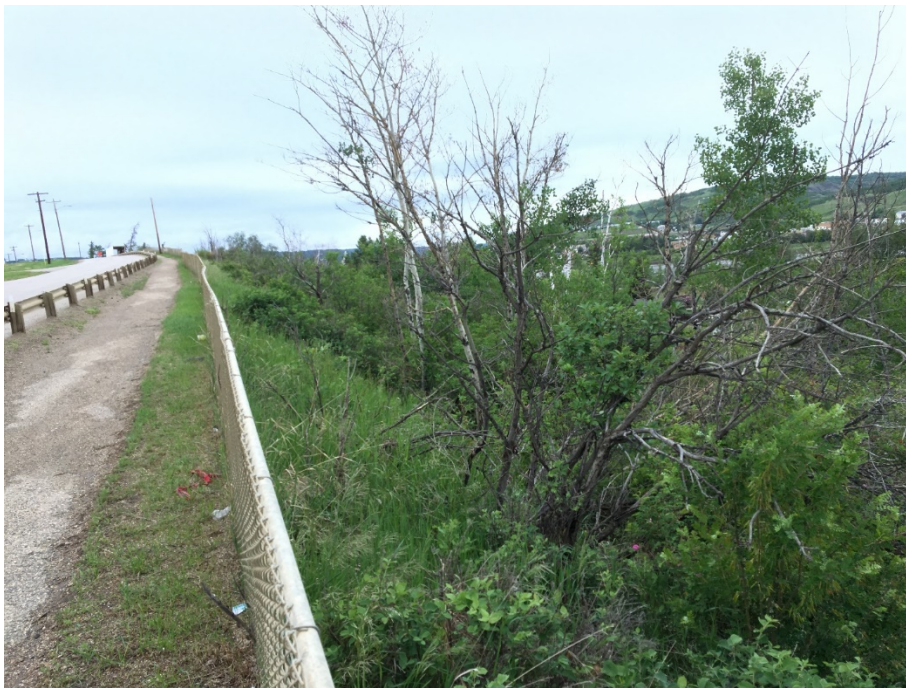
The overall slope varies in height from the top of pavement along Hwy 684 to the lower terrace from about 6 m to 8 m. There are no signs of distress to the guardrail, paved surface of the highway and the immediate sideslope of the embankment above the landslide. There is a slight dip in the ACP walkway and distinct bend in the chain link fence at the crest of the slope on the east side of the roadway.

Photo 2: Looking N at the dip in the ACP trail and the bend in the fence above the slide.

The slide area below the pedestrian trail should be monitored and the pedestrian trail should be closed if the slide backscarp continues to retrogress.

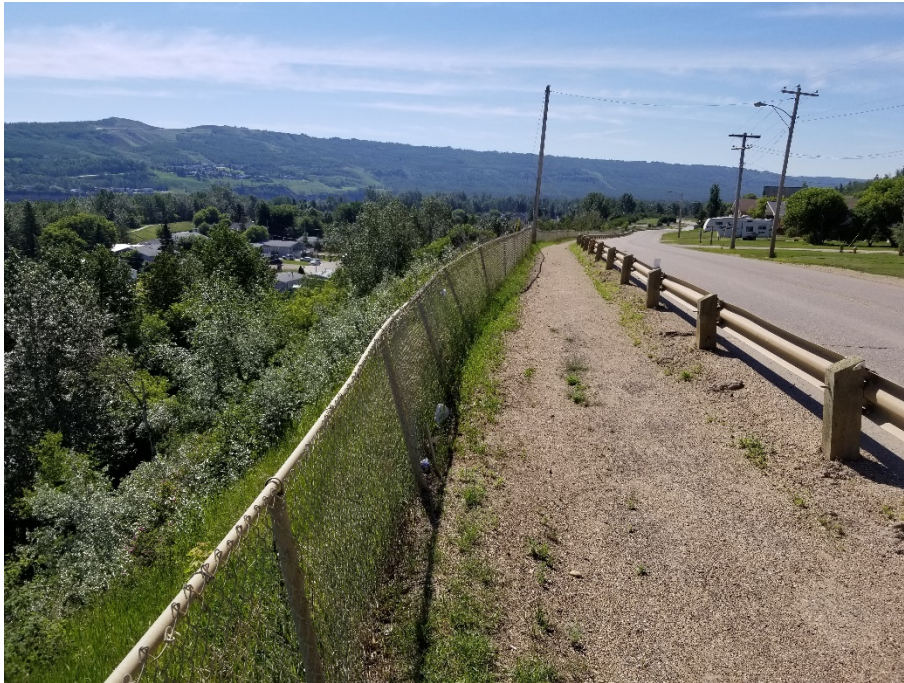
Photo 3: Looking south along pathway at the bow in chain link fence

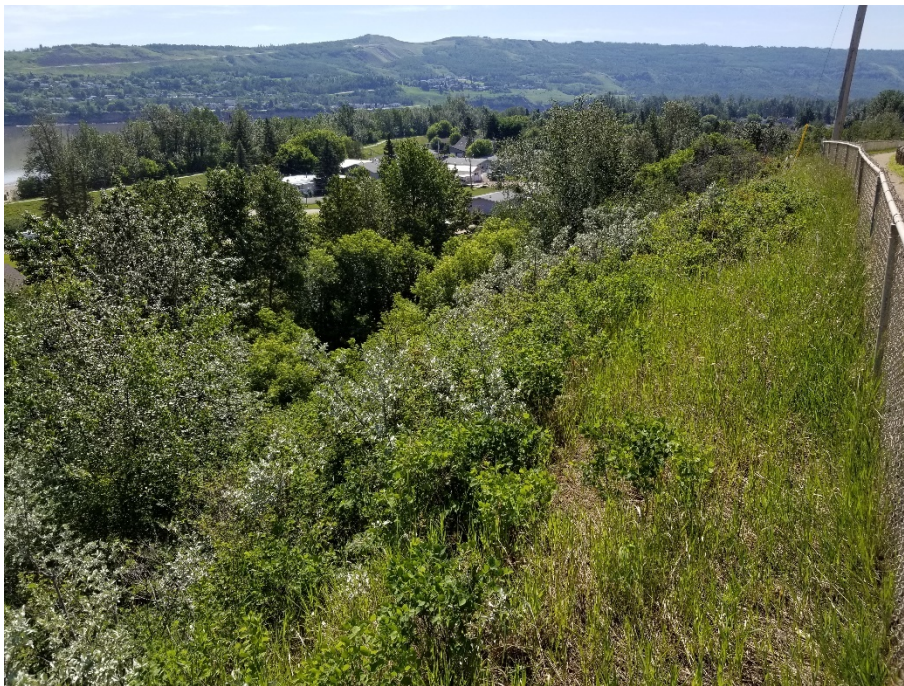
Photo 4: Looking southeast from chain link fence at the landslide

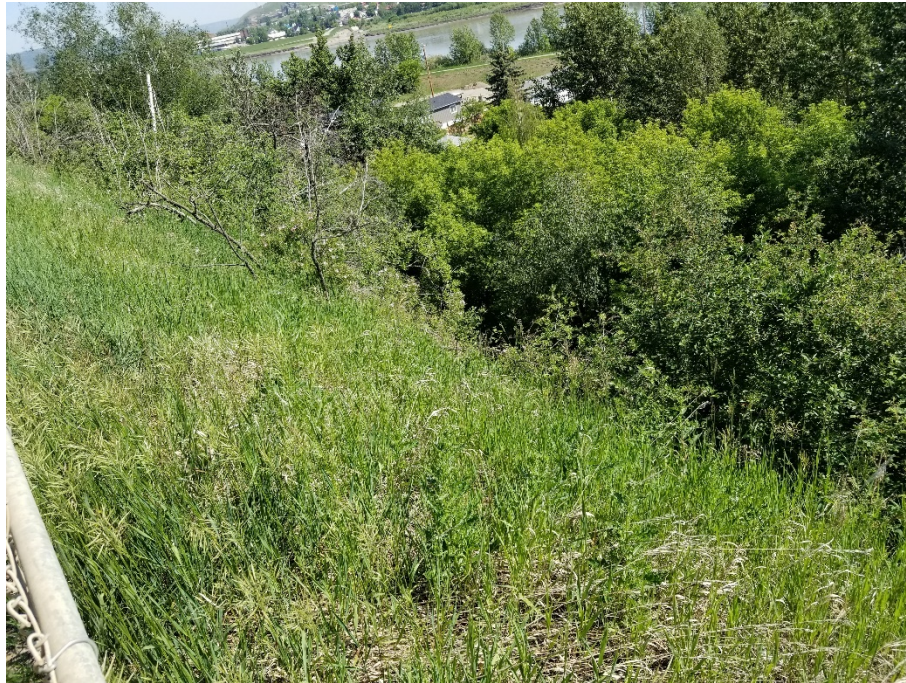
Photo 5: Looking northeast from chain link fence at the landslide

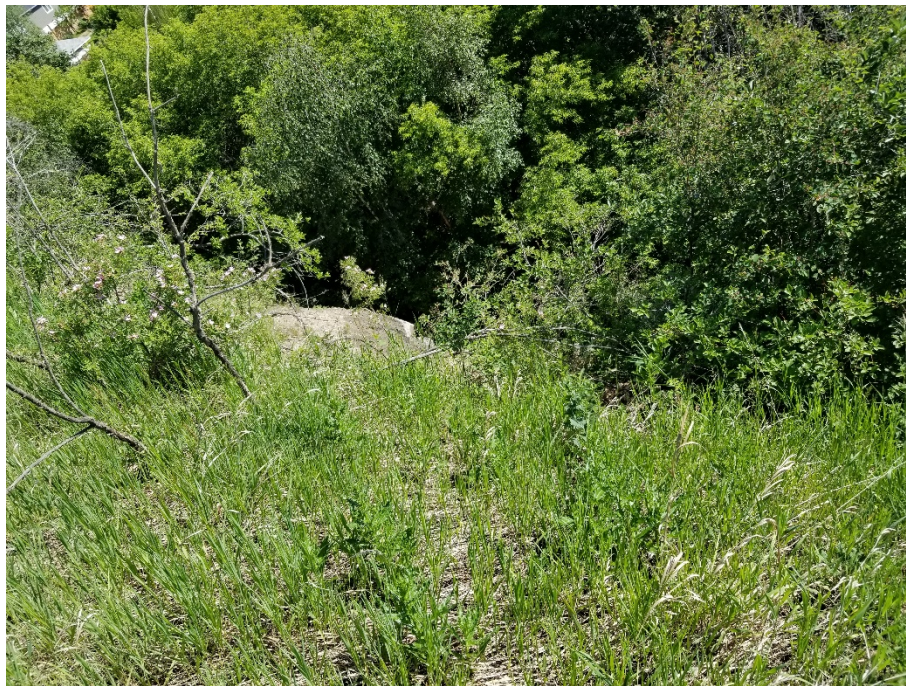
Photo 6: Looking east from chain link fence at the landslide scarp

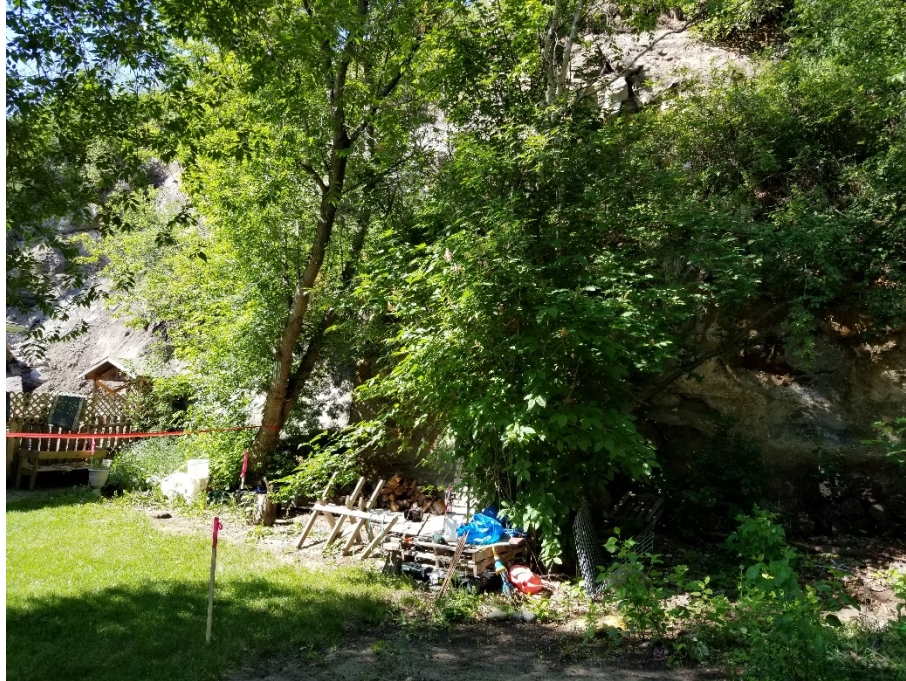
Photo 7: Looking southwest towards the toe of the slide

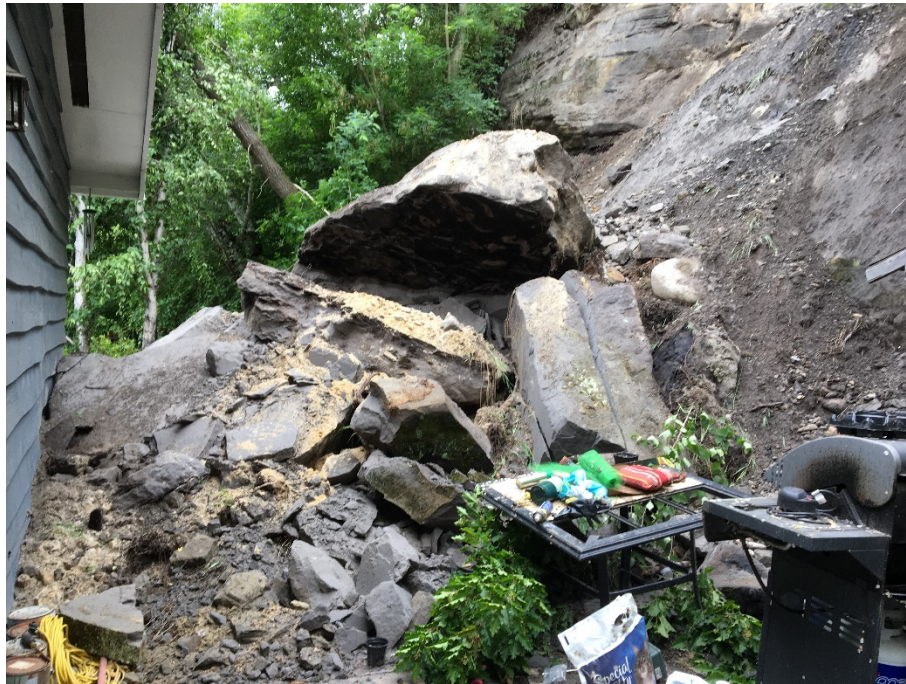
The debris accumulated at the toe of the slope consisted of a mix of clay, silt, sand, peat, dislodged trees in addition several slabs of poorly cemented and weathered sandstone that littered the base of the slope. The size of the sandstone slabs varied in thickness from 300 mm to 600 mm with sizes ranging from 1 m to 3 m. Several large pieces of the upper weathered sandstone layer are partially undermined and still could also topple down onto the lower terrace. The slide extends about 15 m laterally along the toe of the valley slope.

Photo 8: Looking south at sandstone slabs at the toe of the slide.

Barriers should be installed at the toe of the slope to prevent sandstone slabs, cobbles and other debris from reaching the residence below the slope. Consideration should also be given to relocating the residence further away from the slope.

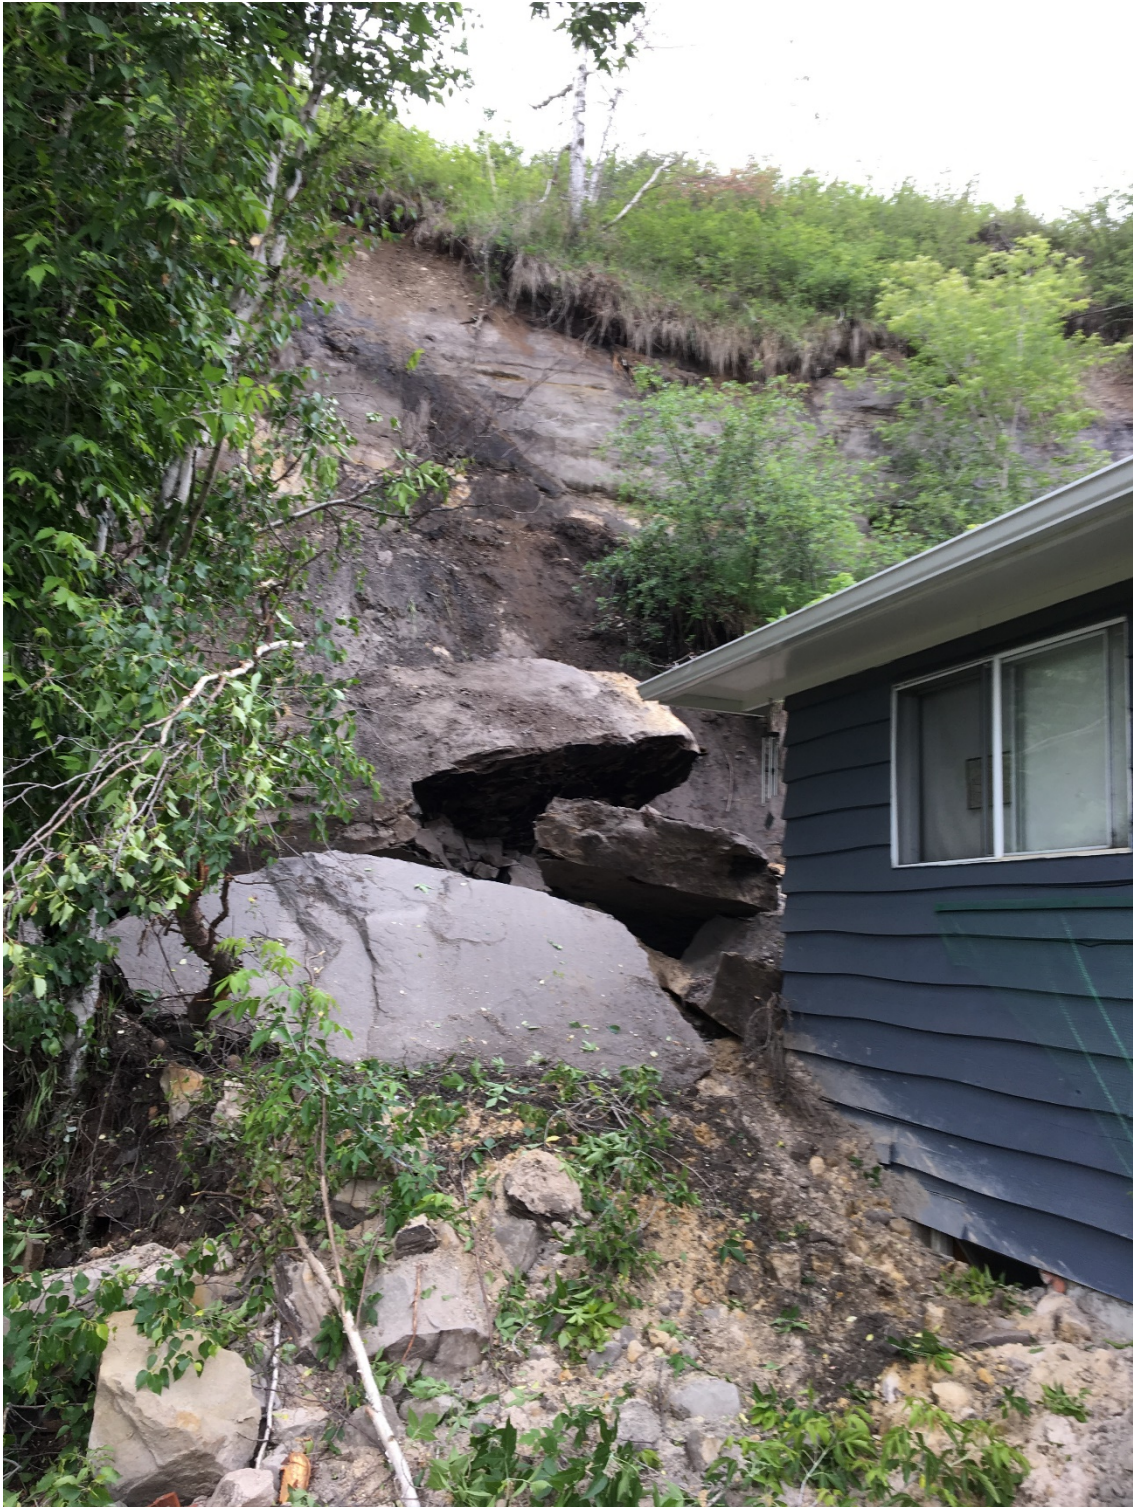
Photo 9: Looking northwest at the slide from the toe

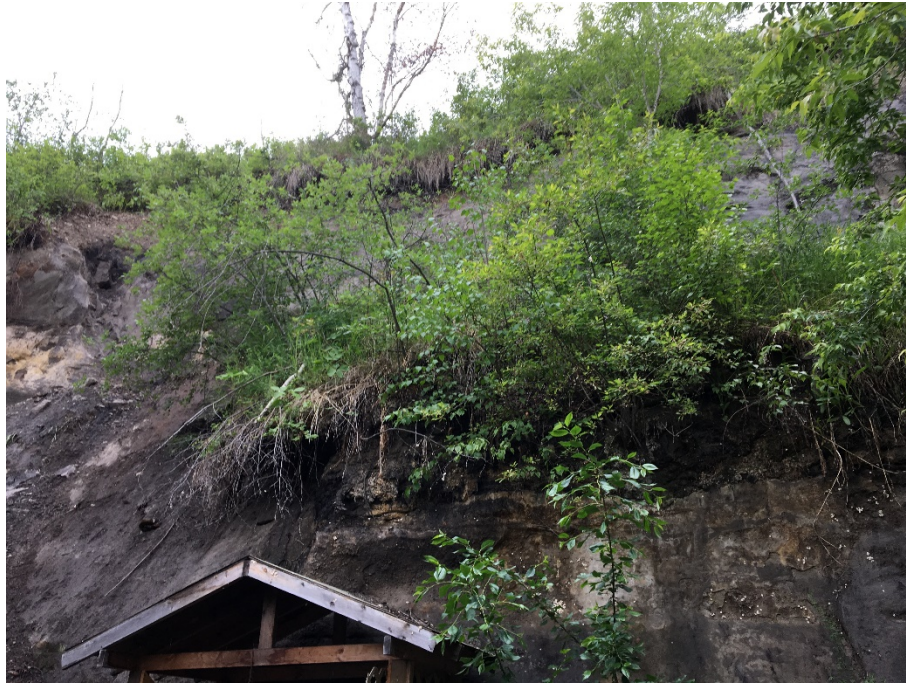
Photo 10: Looking west at upper weathered sandstone layer that did not shear and fall

The blocks and slabs of partially undermined weathered sandstone are still present and have the potential to shear and fall and should be dislodged as a matter of urgency prior to undertaking any other work at the site.

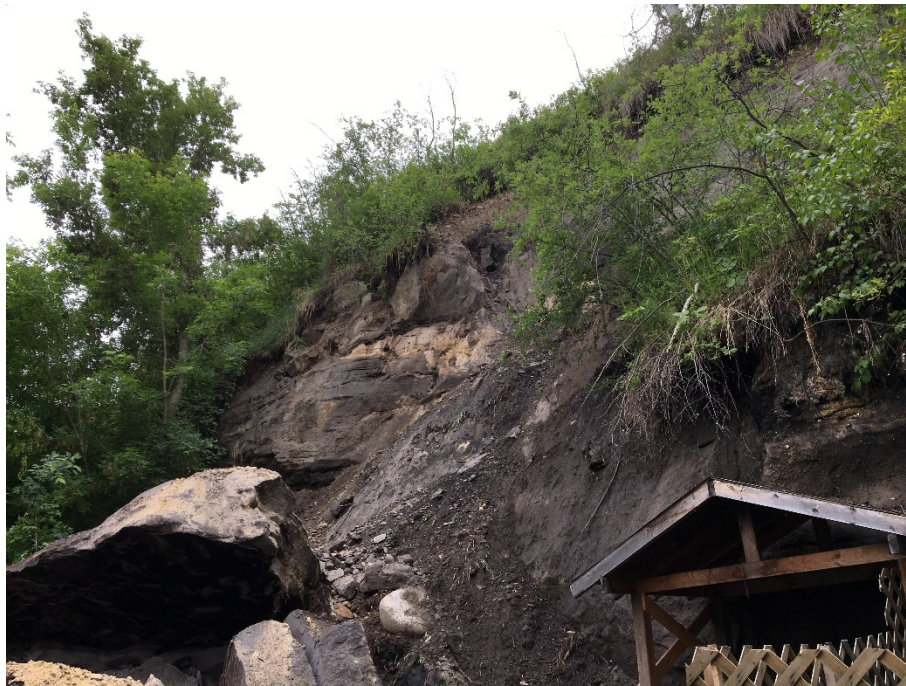
The overburden soil in the upper portion of the slope is comprised of about 0.2 m of organic soil cover followed by silty/cobbly clay-based colluvium soils to a depth of about 2 m with an overall sideslope angle of about 25 degrees from horizontal. The colluvium is underlain by a 0.5 m thick layer of silty fluvial sand and gravel. The overburden is underlain by about 500 mm of fractured poorly cemented weathered sandstone. The weathered sandstone is underlain by a clean fine to medium grained sand lens with a thickness varying up to 300 mm. The sand lens is underlain by more cemented competent sandstone.

Photo 11: Looking southwest at upper weathered sandstone layer underlain by sand lens
