August 10, 2007

File: 15-85-72

**PEACE REGION (PEACE – HIGH LEVEL AREA) GEOHAZARD ASSESSMENT
SHAFTSBURY TRAIL (SOUTH SITE)
2007 CALLOUT INSPECTION REPORT**

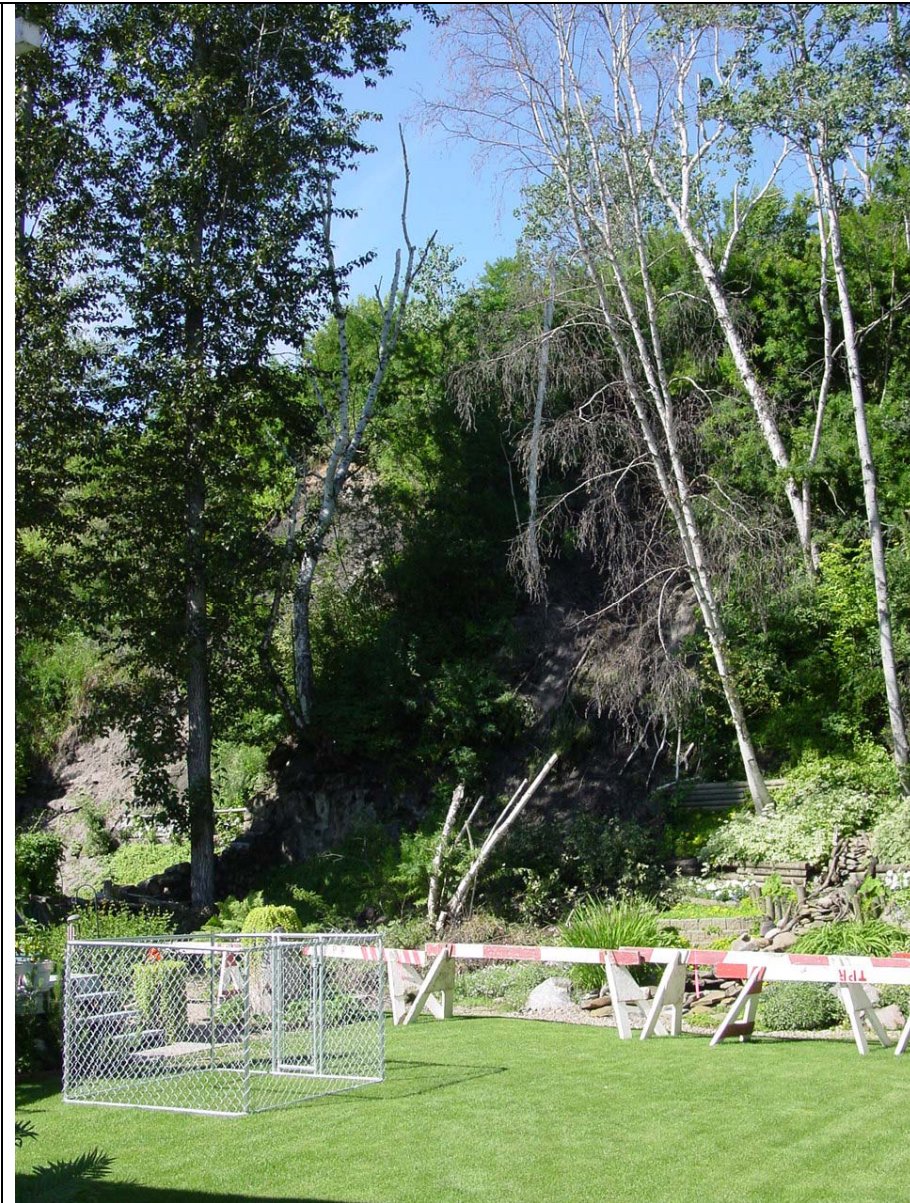
As shown in Photos 1 and 2, the failed materials have a relatively small volume, but appear to be very mobile, flowing from the slope to the terrace below. There does not appear to be a threat to the highway at this time.

These failures can be described as small debris flows. They would have been triggered by saturation of the colluvial soils by either an increase in groundwater or a concentration of surface water at this location. Either of these could have been caused by the reported heavy rainfall prior to the slides. The clay soils would have essentially liquefied and flowed down the slope. The sandstone appears to be relatively intact. The vegetation and soil on the slope flowed with the failures, but remains intact on adjacent portions of the slope.

Photo 1.
Cartier residence slide.
Debris from the slope has entered the developed area below. Note some apparently dead trees on the slope.

Managing the debris from potential future slides by construction of a berm along the toe of the slope to collect it should be feasible. Such a berm would have to be properly designed in terms of height and "storage" capacity. Note that periodic "cleaning out" of the berm would be required. As an initial estimate, we would expect the cost of such a berm to be in the order of \$50,000, but would depend on access, which may require the use of small equipment.

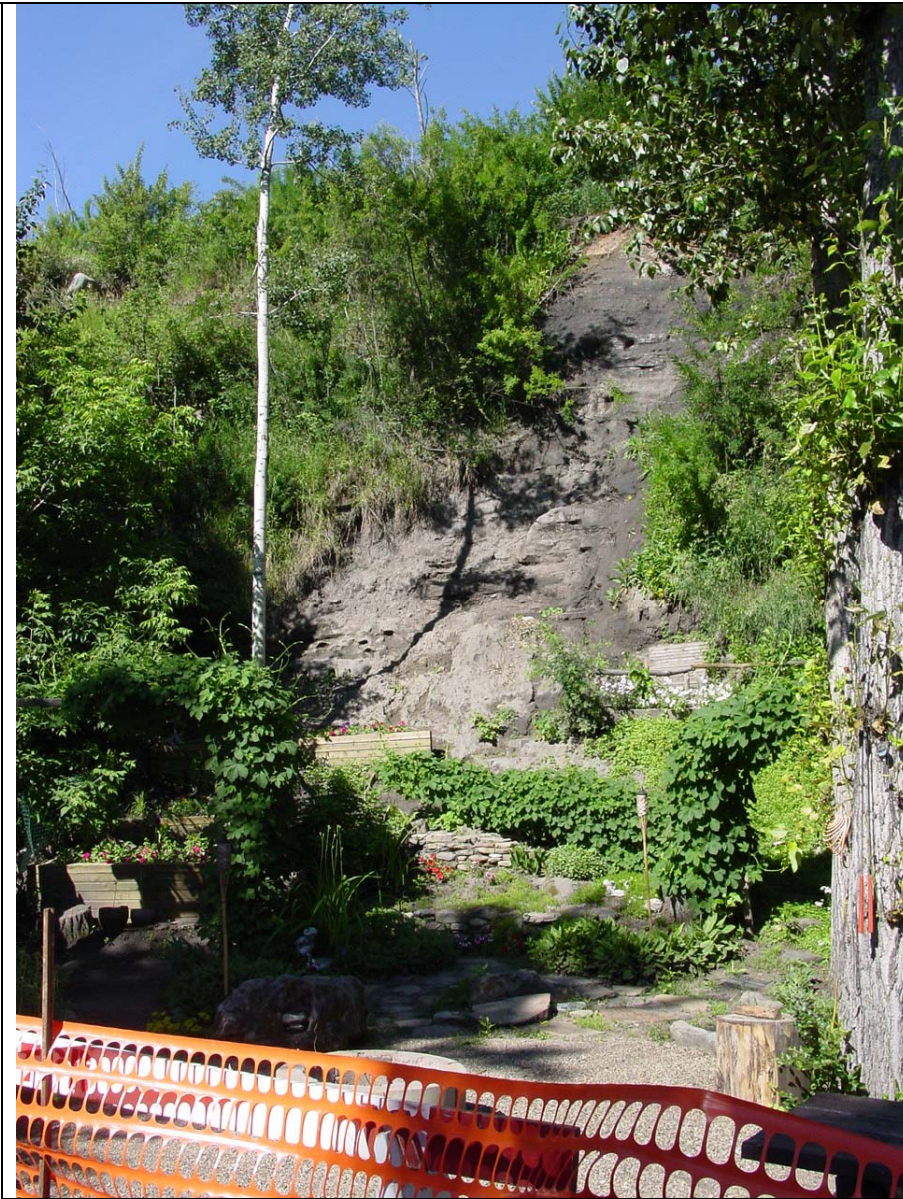
Photo 2.
Slide to the south of the
Cartier residence.

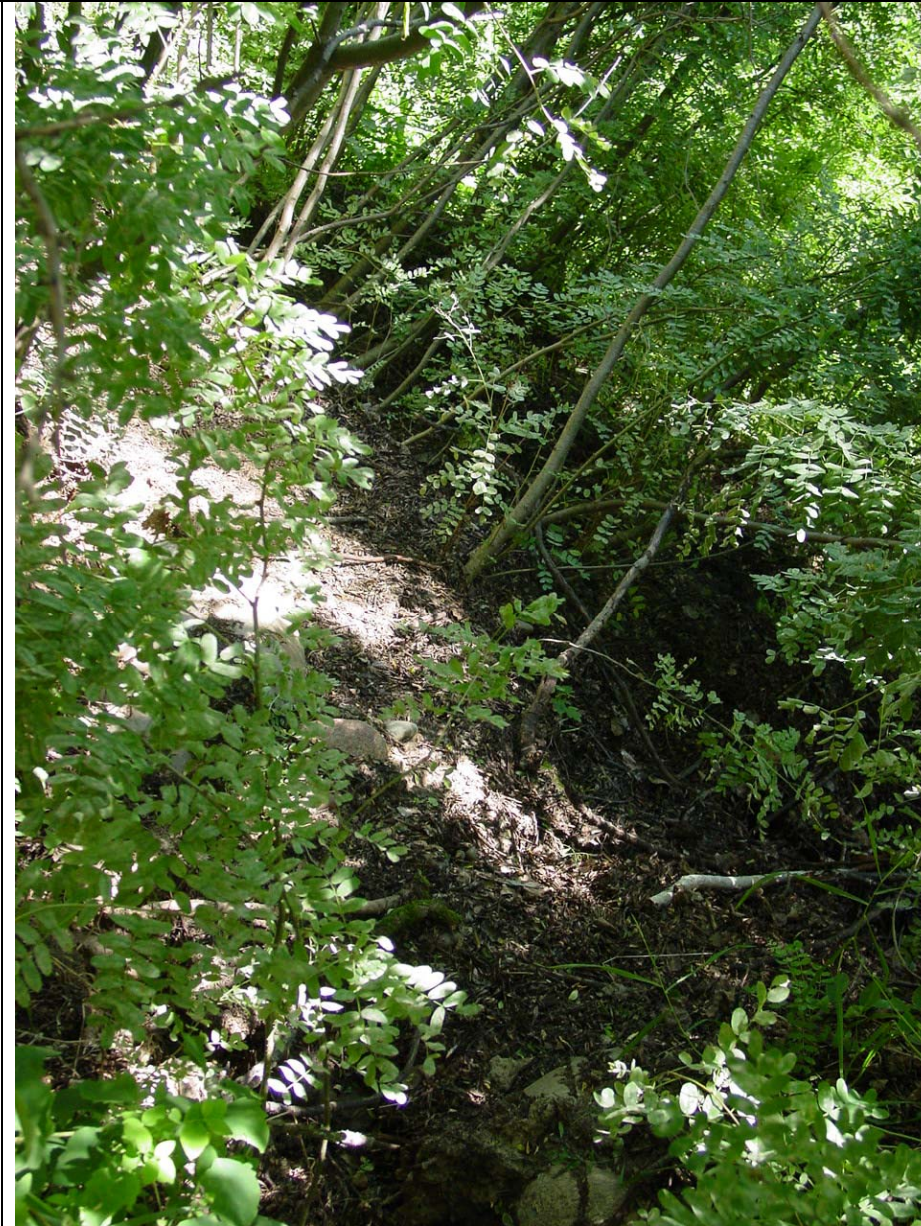
Photo 3.
Crest of the slope above the
Cartier residence slide.

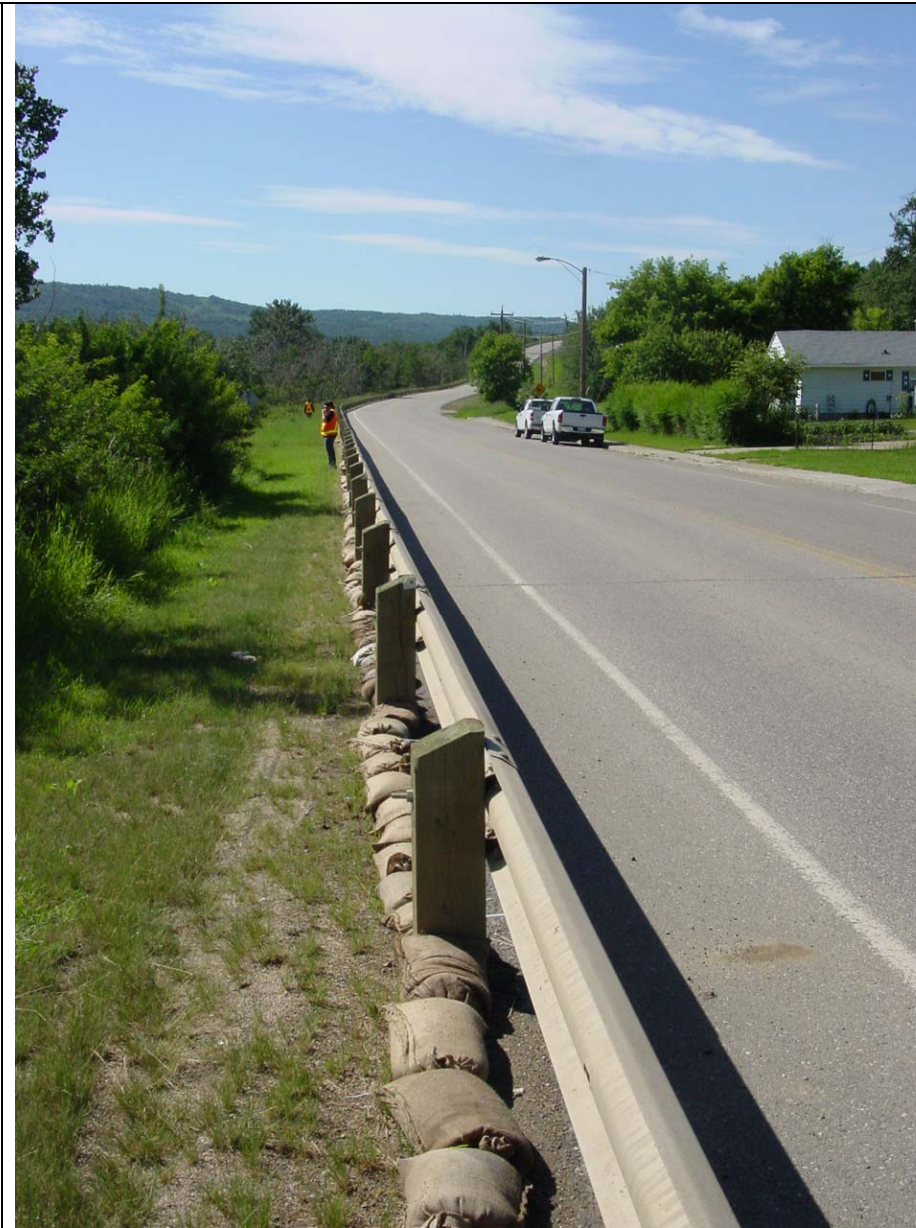
Photo 4.
Highway upslope of the failure area. The edge of pavement is roughly 10 m away from the crest of the slope.

Installation of a curb along the highway may be beneficial, to direct surface water to a controlled location. Note that surface water from the road is only considered as a possible contributor to the slide(s) and hence should not be relied upon as the sole solution. A catch basin is located 150 m south of the site, which may be an appropriate point to direct surface water – grades and elevations should be checked to confirm this. The estimated cost of constructing a 200 m long asphalt curb in this area is \$10,000.
