**THURBER ENGINEERING LTD.**

File: 15-16-213A

**PEACE REGION (PEACE – HIGH LEVEL AREA) GEOHAZARD ASSESSMENT  
HWY 688:02 PAT'S CREEK (PH50)**

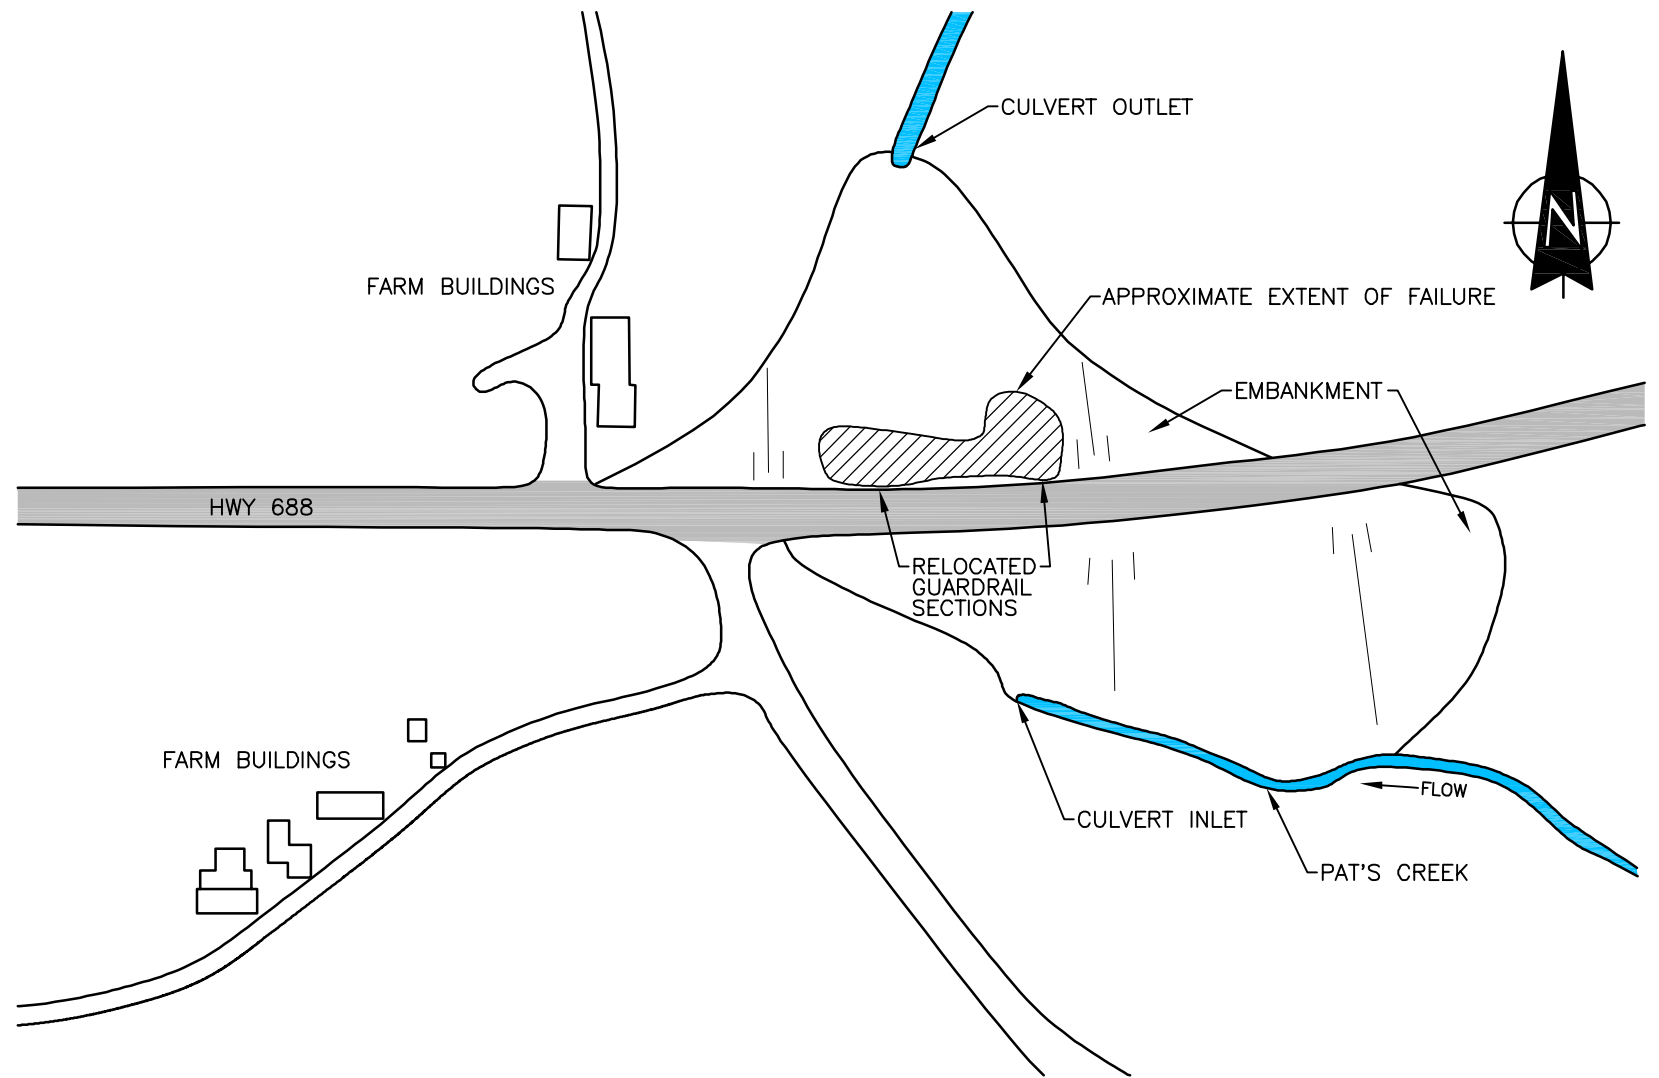
**FIGURE PH50-1**

At the time of the May 2008 inspection, the slope instability on the upper portion of the embankment was approximately 60 m long and up to 25 m wide, centered within the north side of the embankment over Pat's Creek (Figure 50-1). Conditions within the slide area were relatively unchanged from 2007, with the exception of site grading undertaken to access the slope as part of the geotechnical investigation undertaken by UMA (Photos 50-01 to 50-04).

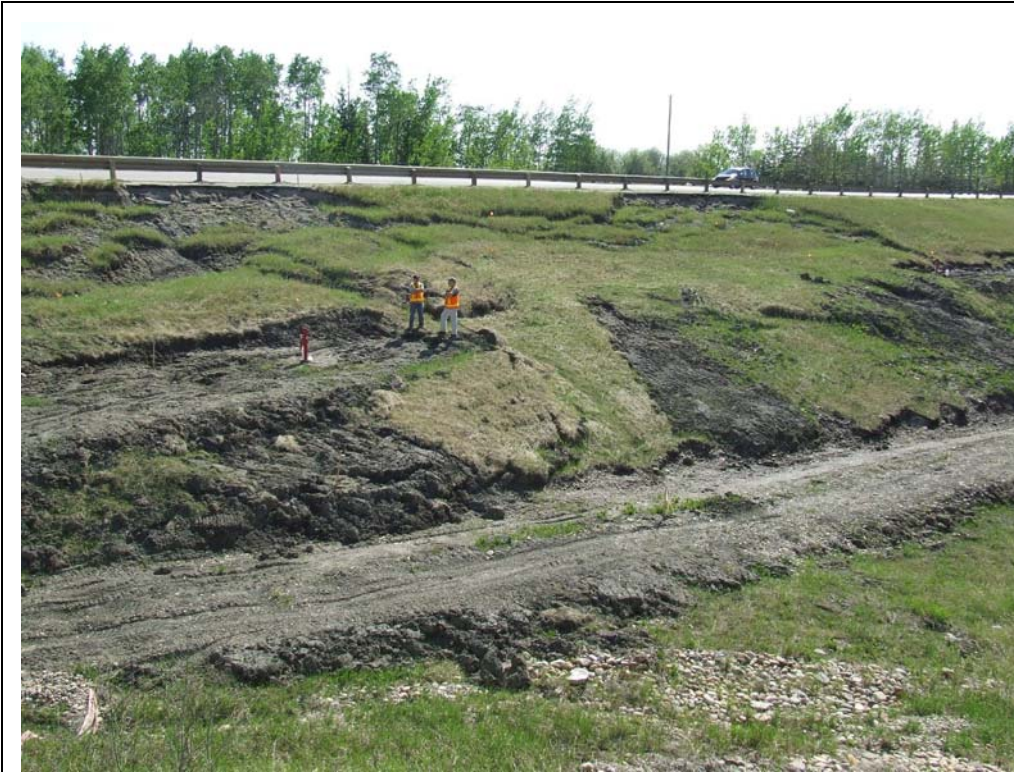
**Photo 50-01**

View looking southwest at unstable fill slope below roadway.

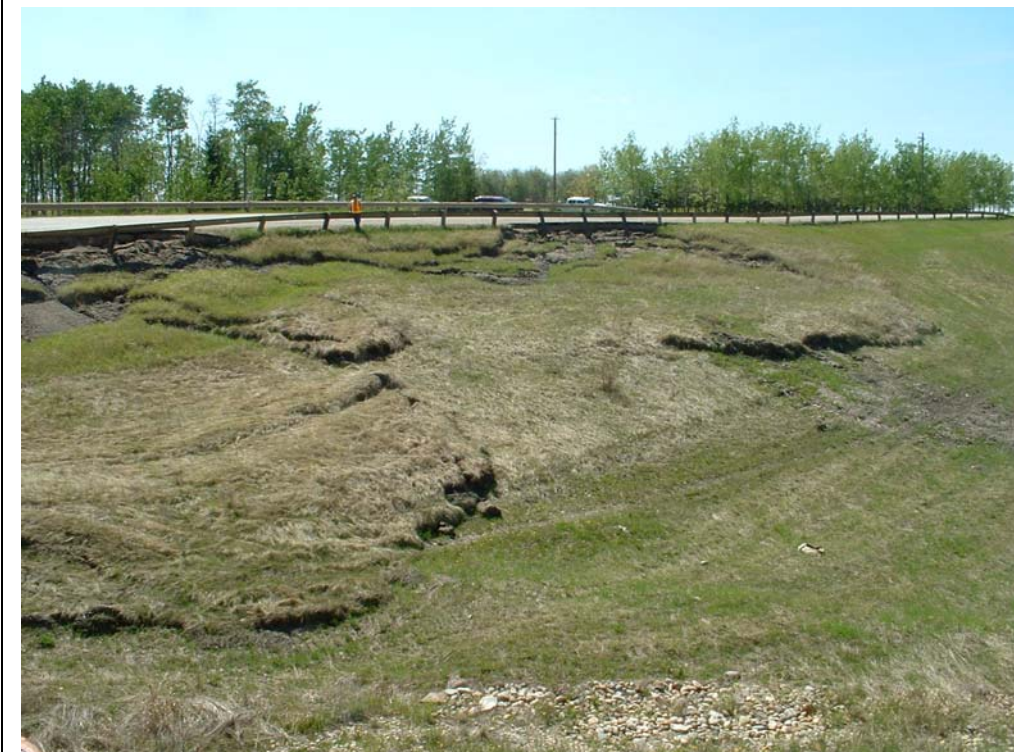
**Photo 50-02**

Similar view as Photo 50-01 above taken in 2007. Slide is relatively unchanged with the exception of access grading undertaken for recently installed instrumentation.

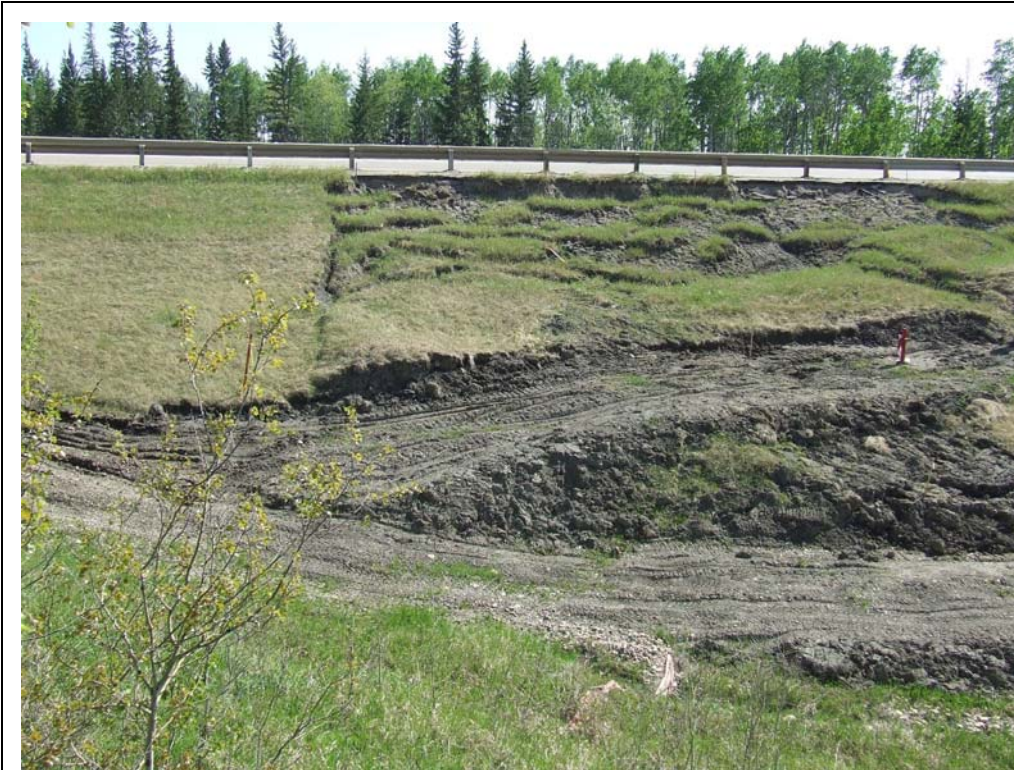
**Photo 50-03**

The slide was observed to be confined to the upper third of the slope. The upper portion of the embankment slope had a gradient of about 18° and the lower (stable portion) had a gradient of about 15°. Since 2007, the eastern end of the slide complex appears to be more defined (Photos 50-03 and 50-04).

View looking at east end of slide complex.

Until remediation measures can be completed, surface runoff should be directed away from the two scarp features at either end of the slide area. If possible, runoff should be intercepted at the ends of the embankment and directed down the slope outside of the slide area.

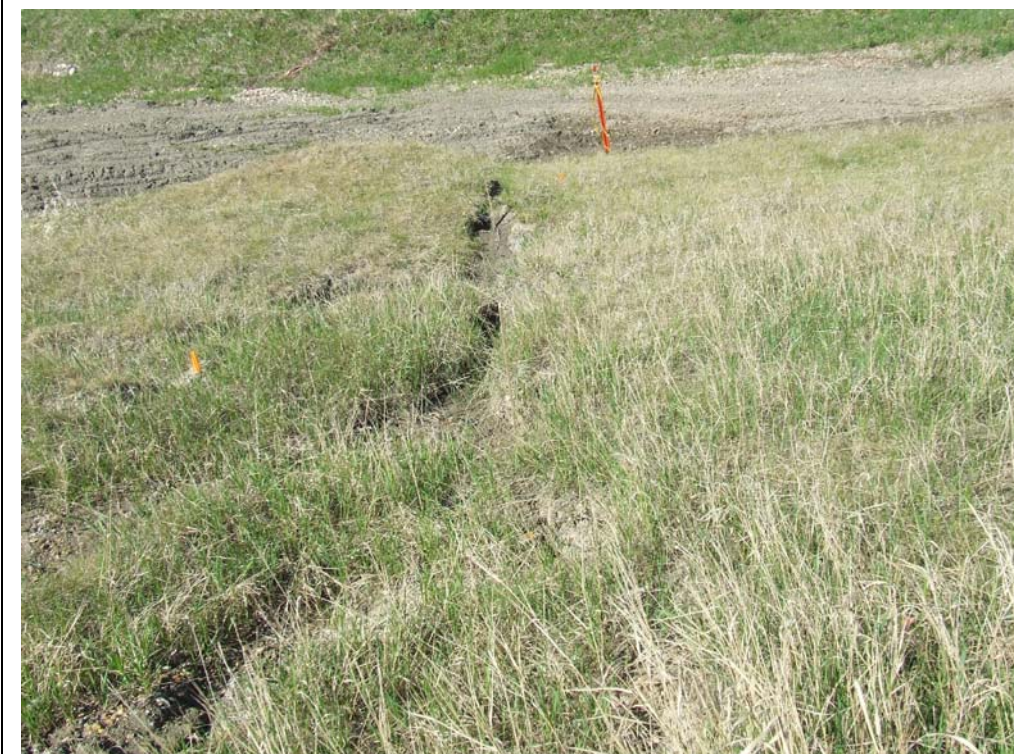
**Photo 50-04**

View looking downslope eastern flank of slide complex shown in Photo 50-03

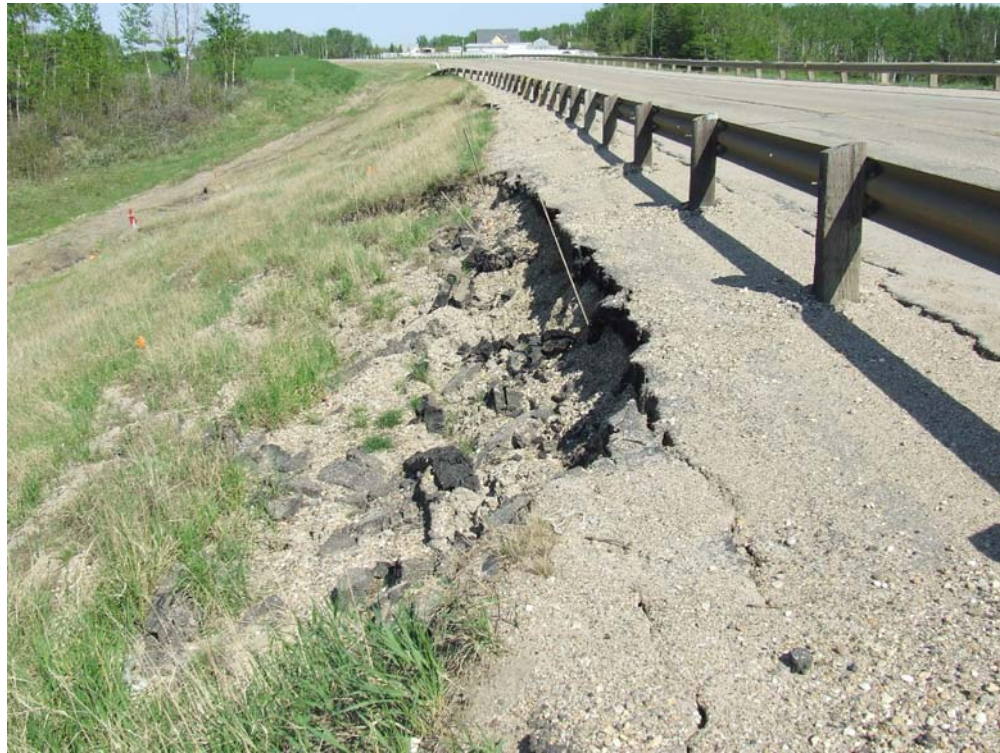
**Photo 50-05**

The headscarp of the slide extended to the shoulder of the westbound lane. The guardrail that had been undermined at the west and east ends of the slide in 2007 has since be relocated upslope closer to the westbound driving lane (Photos 50-05 to 50-07).

Looking east  
along headscarp  
of western end of  
slide complex

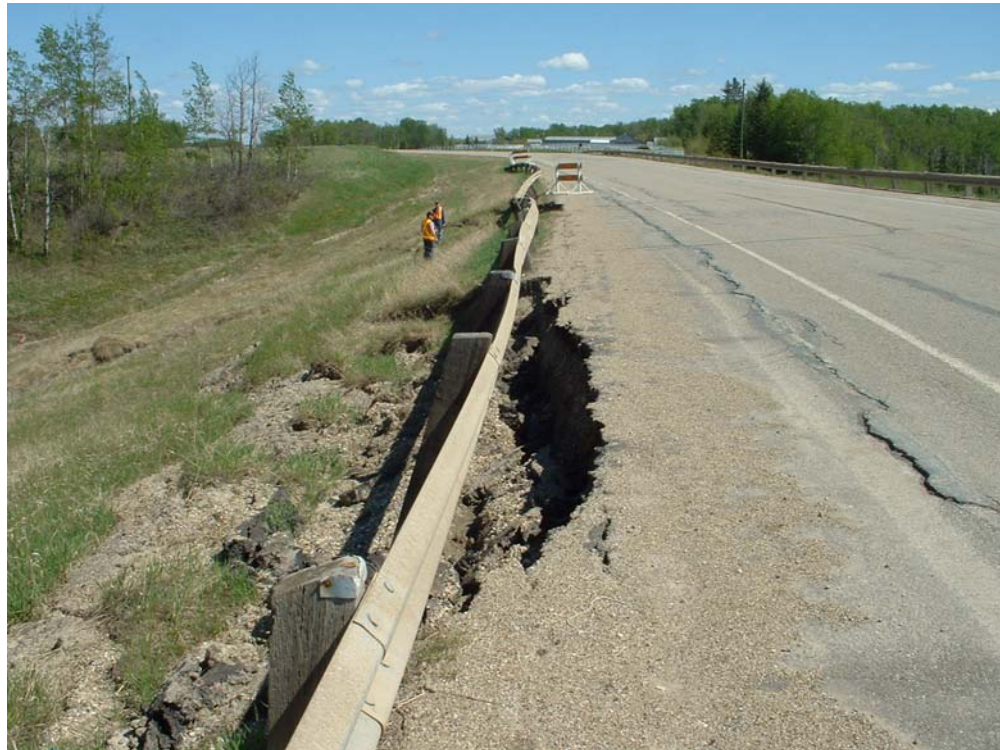
**Photo 50-06**

Similar view to  
Photo 50-05 taken  
in 2007.  
Headscarp  
relatively  
unchanged but  
guardrail moved  
upslope in 2008.

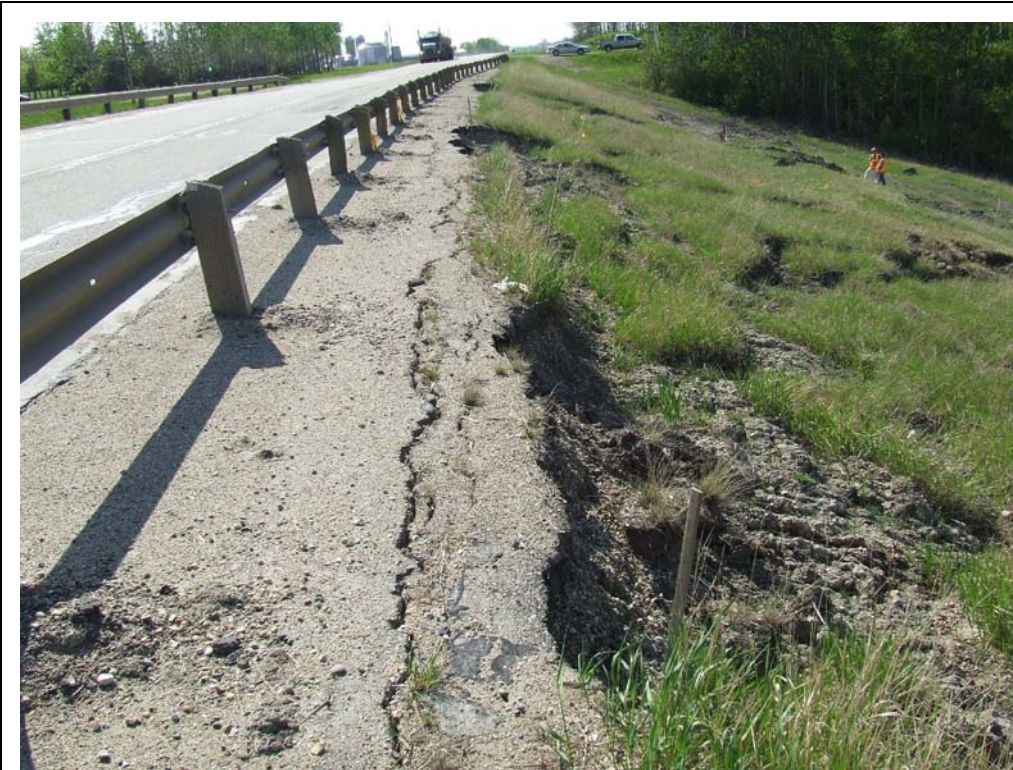
**Photo 50-07**

View looking west along headscarp of eastern end of slide complex.

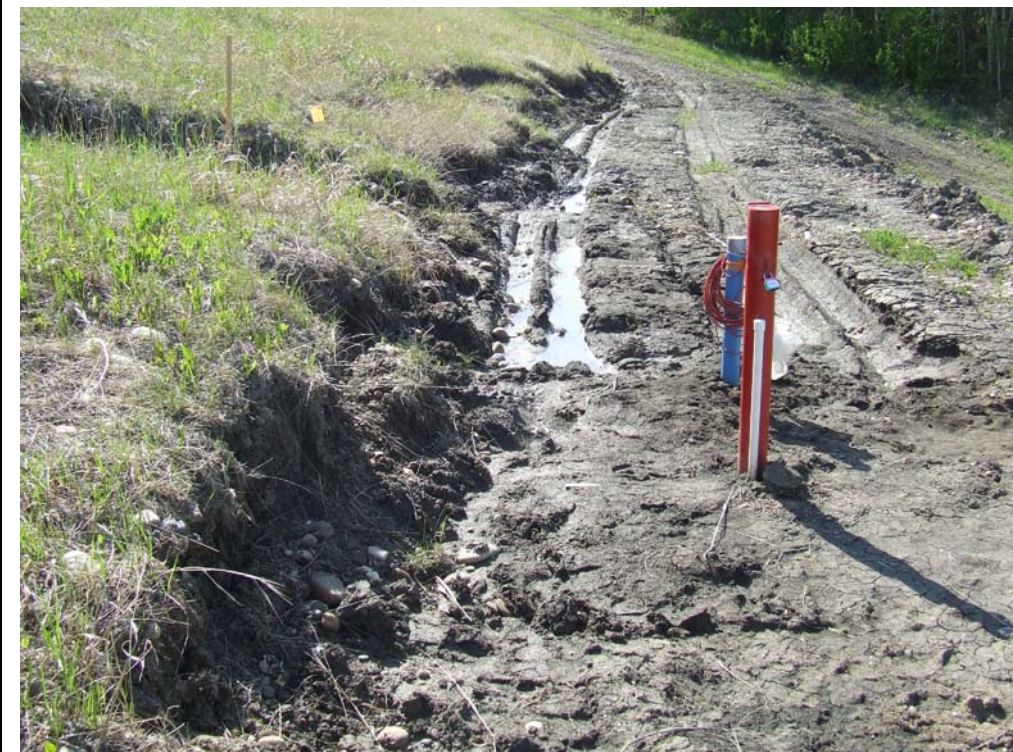
**Photo 50-08**

In the vicinity of the mid-slope instrumentation installed by UMA at the western end of the slide complex, seepage and ponding water were noted during the 2008 inspection that did not appear to be related to surface runoff (Photo 50-08).

Close-up of instrumentation cluster installed mid-slope in western portion of slide complex. Note the seepage and ponding water believed to reflect groundwater discharge.
