September 8, 2009

File: 15-16-229

**PEACE REGION (PEACE – HIGH LEVEL AREA) GEOHAZARD ASSESSMENT
HWY 688:02 PAT'S CREEK (PH50)
2009 ANNUAL INSPECTION REPORT**

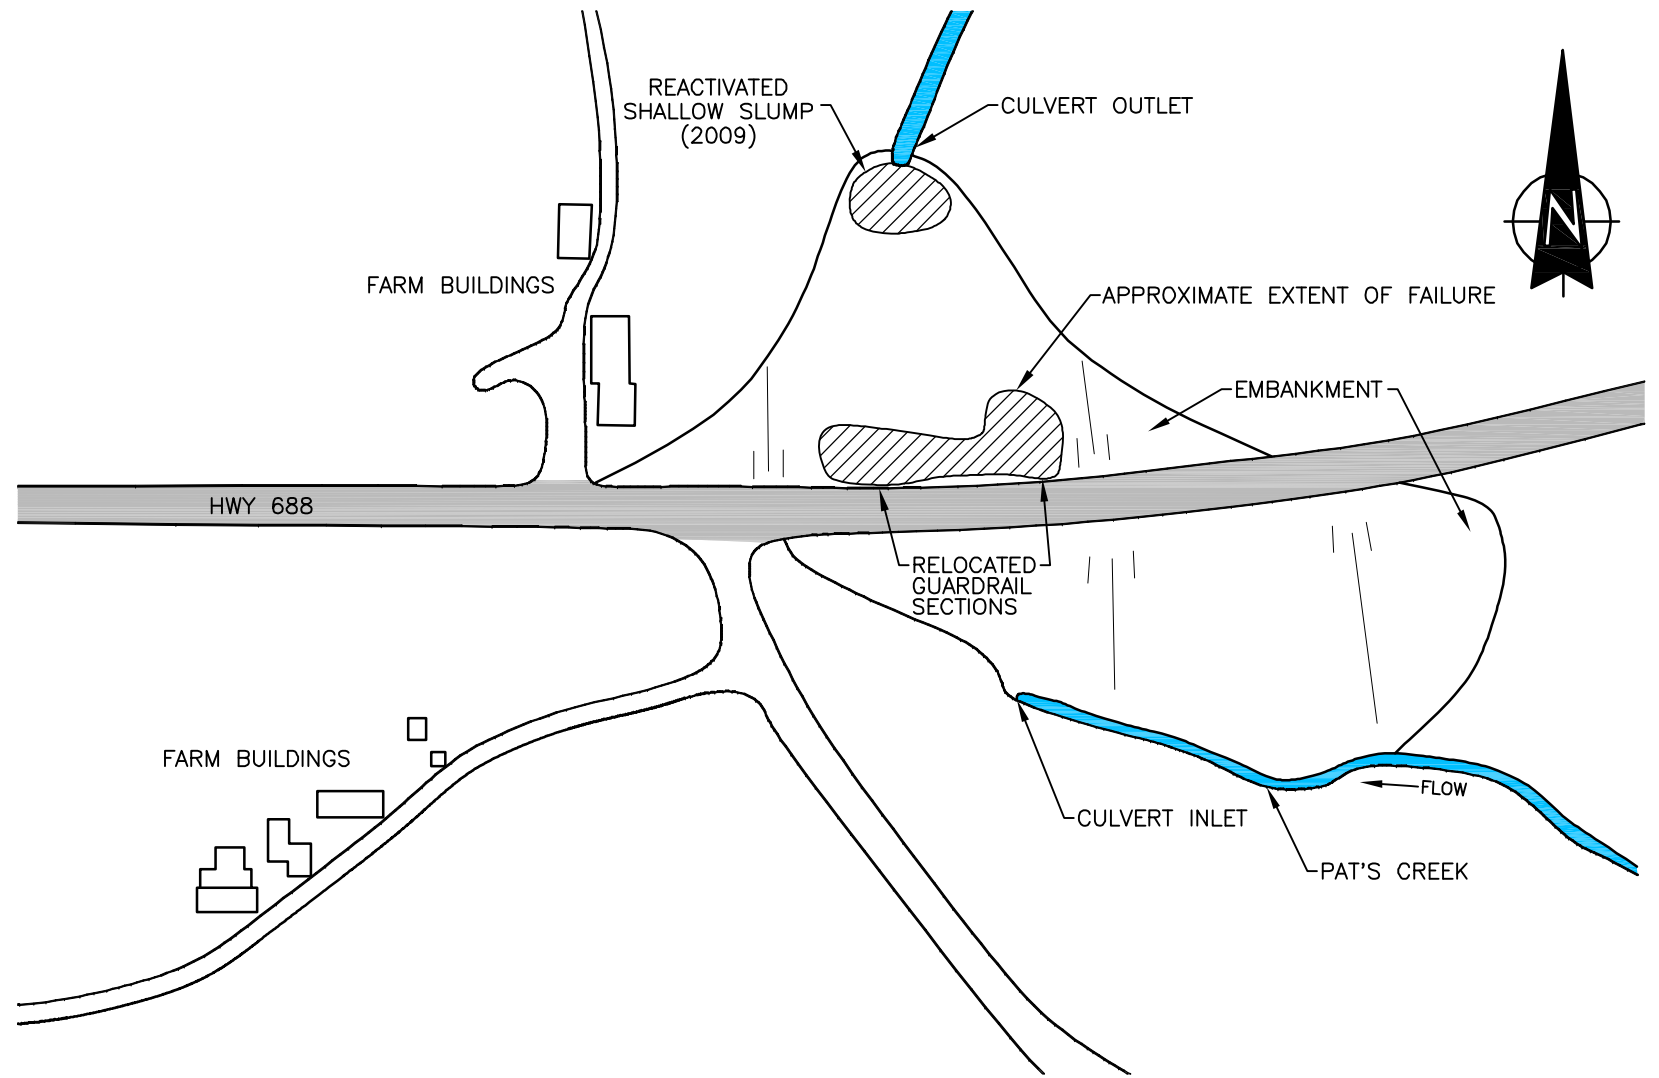
FIGURE PH50-1

At the time of the May 2009 inspection, the slope instability on the upper portion of the embankment was approximately 60 m long and up to 25 m wide, centered within the north side of the embankment over Pat's Creek (Figure 50-1). Conditions within the slide area were relatively unchanged from 2008 (Photos 50-01 to 50-04).

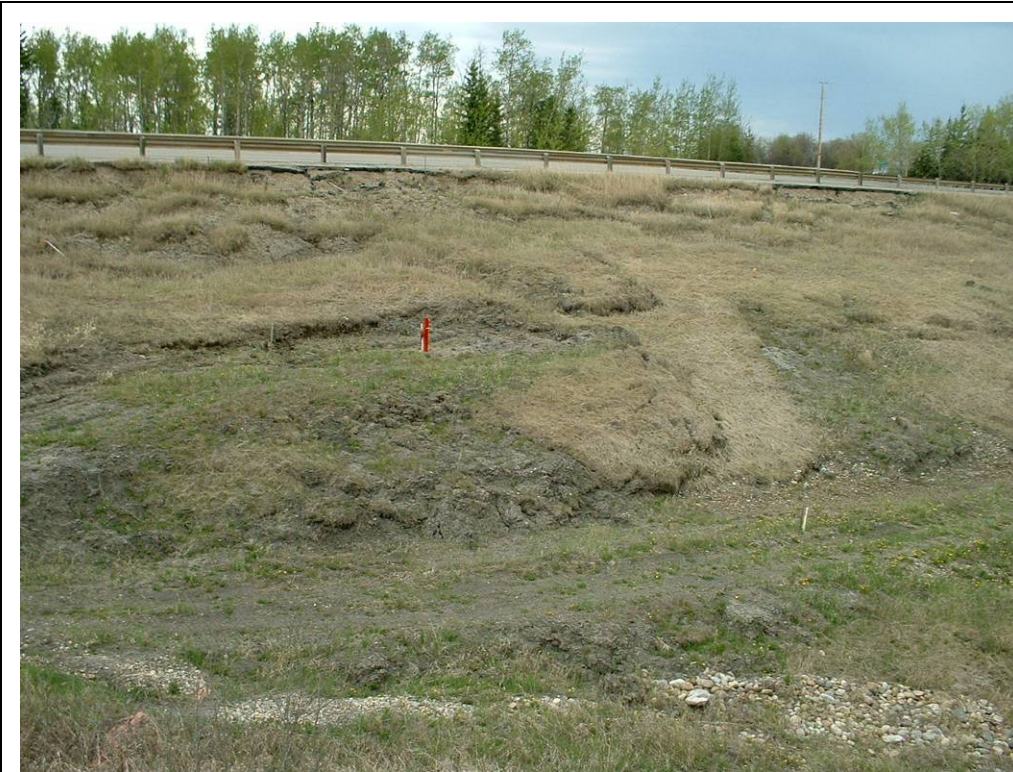
Photo 50-01

Based on the preliminary geotechnical assessment completed for the site, the cause of the slumping was determined to be a result of weathering and a loss of strength within the clay fill (i.e. loss of cohesion) over time. The trigger mechanism for the slide was likely a heavy precipitation event.

Looking southwest at unstable fill slope below roadway.

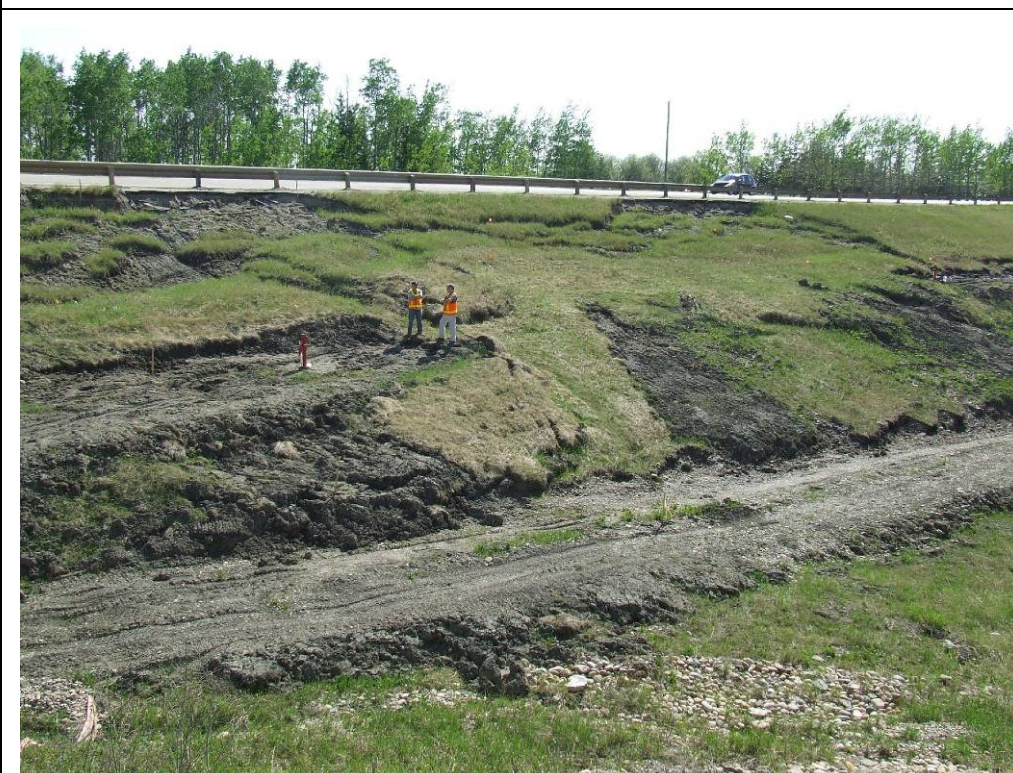
Photo 50-02

Similar view as Photo 50-01 above taken in 2008. Main slide is relatively unchanged in this time period.

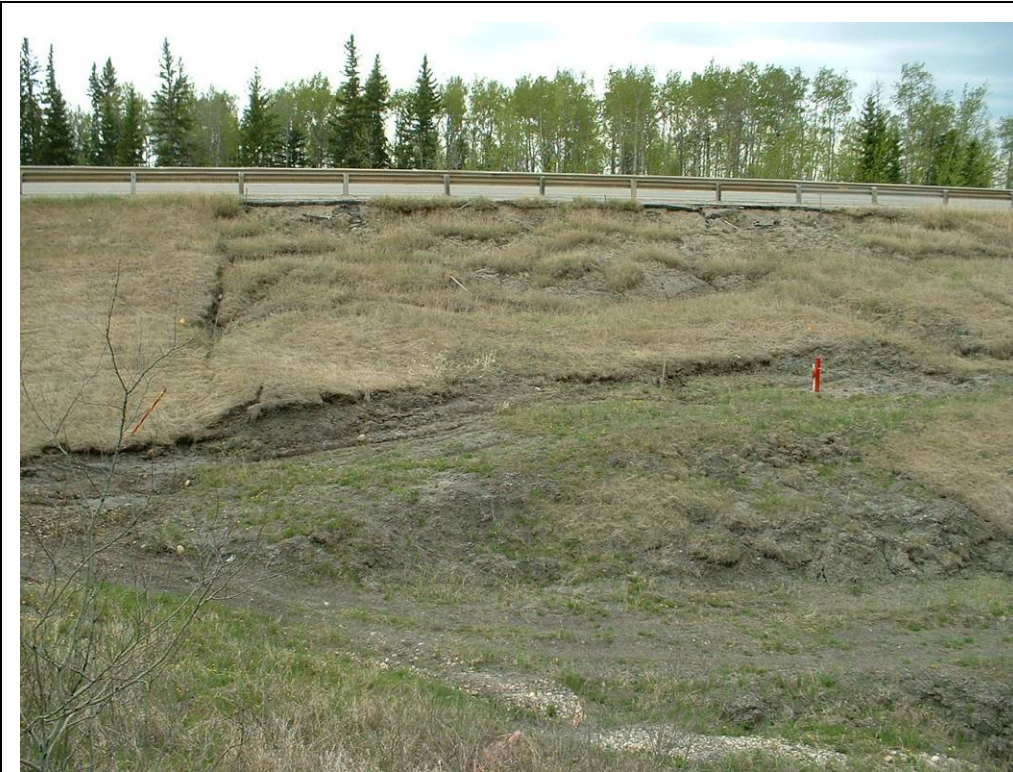
Photo 50-03

The main slide was observed to be confined to the upper third of the slope. The upper portion of the embankment slope had a gradient of about 18° and the lower (stable portion) had a gradient of about 15°. Since 2007, the eastern end of the slide complex became more defined; however it does not appear to have changed significantly since 2008 (Photos 50-03 and 50-04).

Looking south at east end of slide complex.

Until remediation measures can be completed, surface runoff should be directed away from the two scarp features at either end of the slide area. If possible, runoff should be intercepted at the ends of the embankment and directed down the slope outside of the slide area.

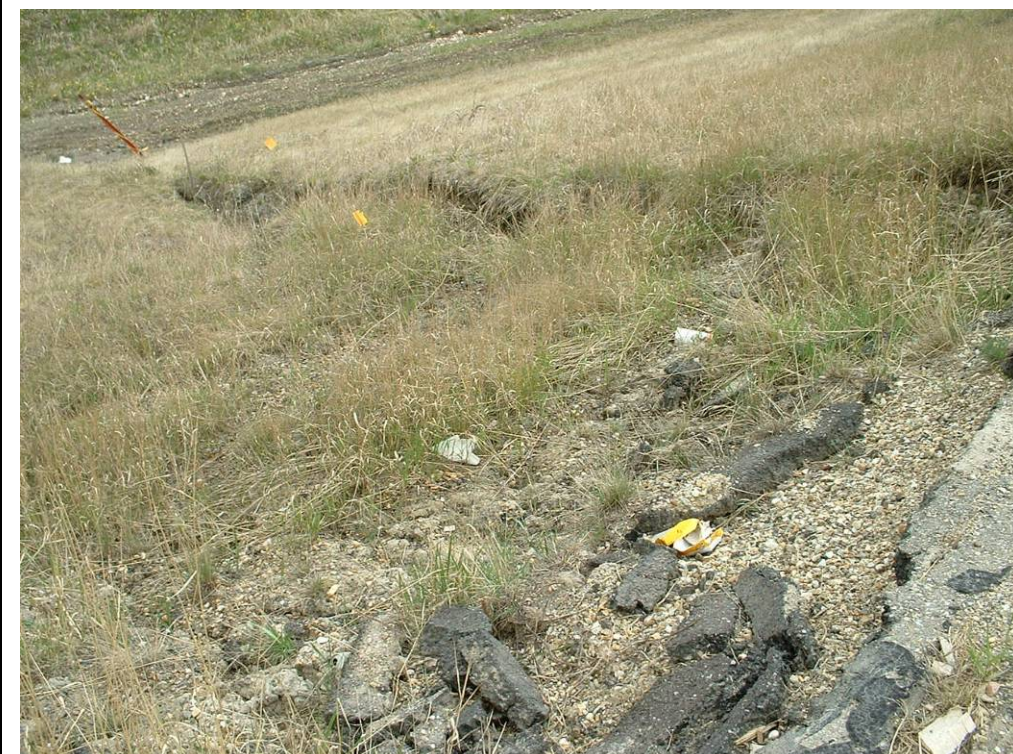
Photo 50-04

Looking downslope at eastern flank of slide complex shown in Photo 50-03.

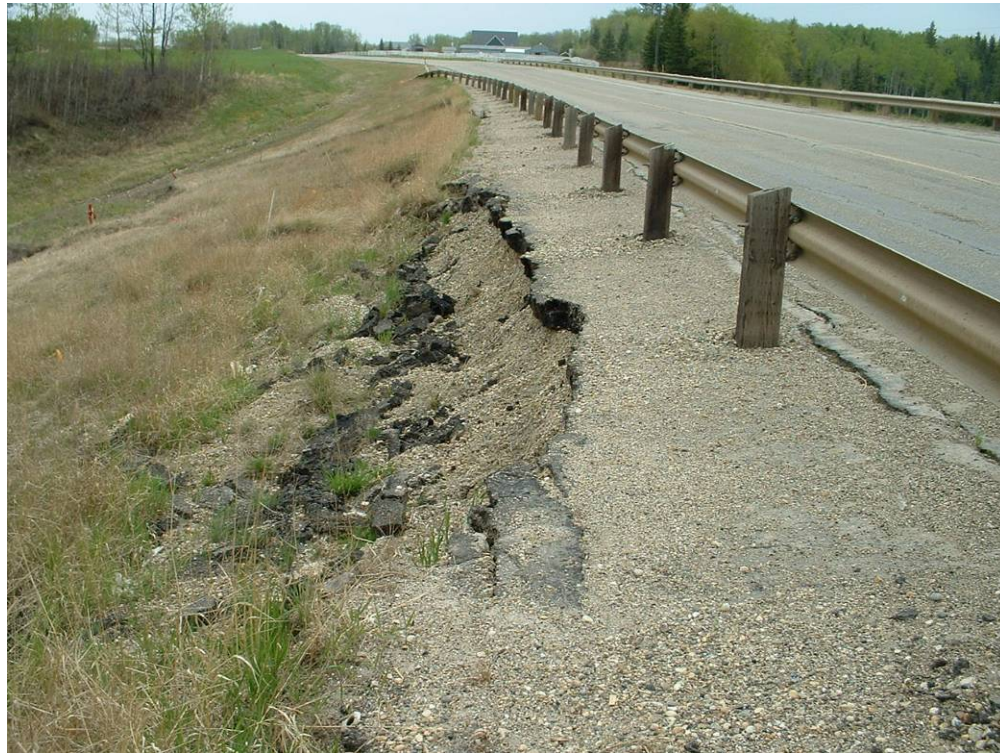
Photo 50-05

The headscarp of the slide originally extended to the shoulder of the westbound lane. The guardrail was relocated in 2007/8 closer to the westbound driving lane as shown in Photos 50-05 to 50-07. The headscarp appears to have become a bit steeper and higher since 2008 but has not retrogressed further laterally.

Looking east along headscarp of western end of slide complex.

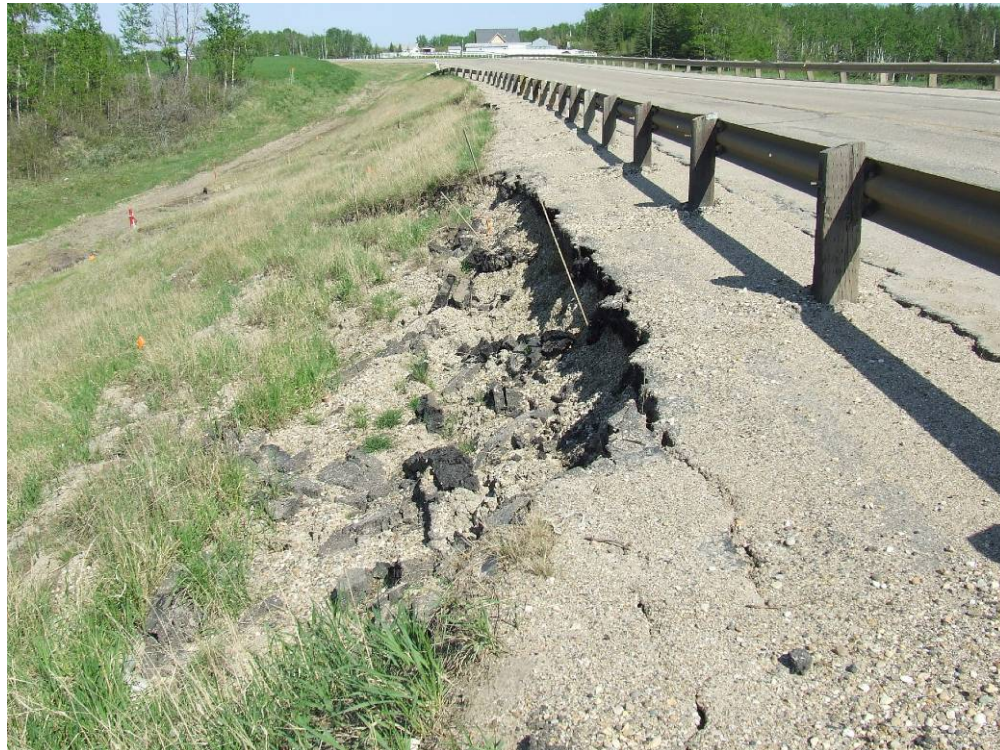
Photo 50-06

Similar view to Photo 50-05 taken in 2008. Headscarp has become a bit steeper and higher since 2008.

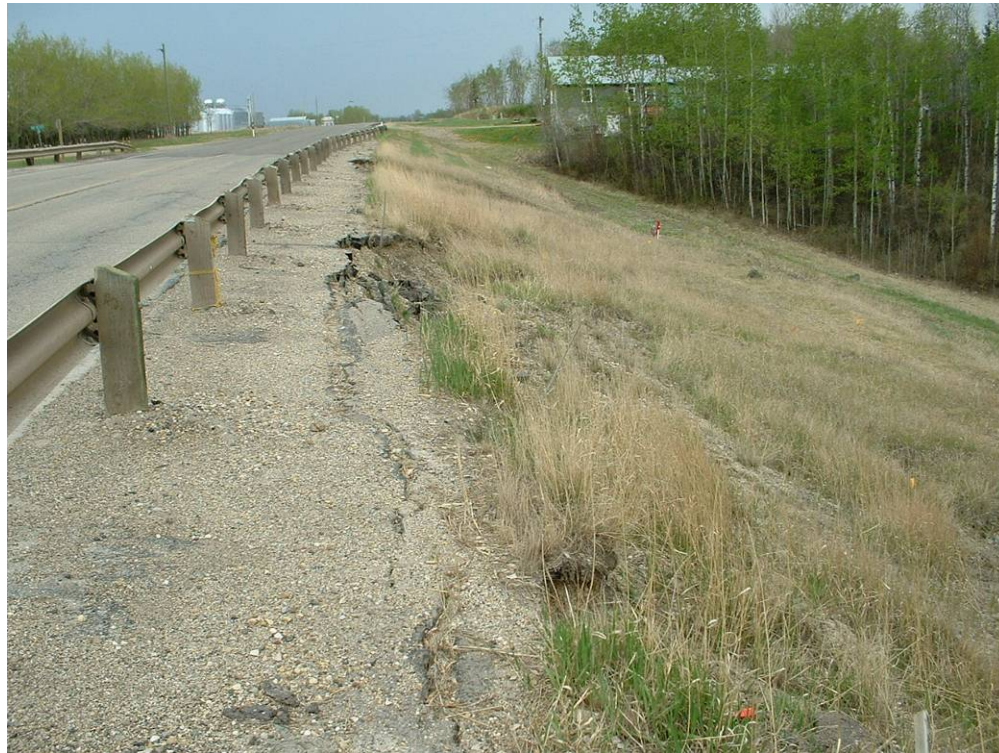
Photo 50-07

View looking west along headscarp of eastern end of slide complex.

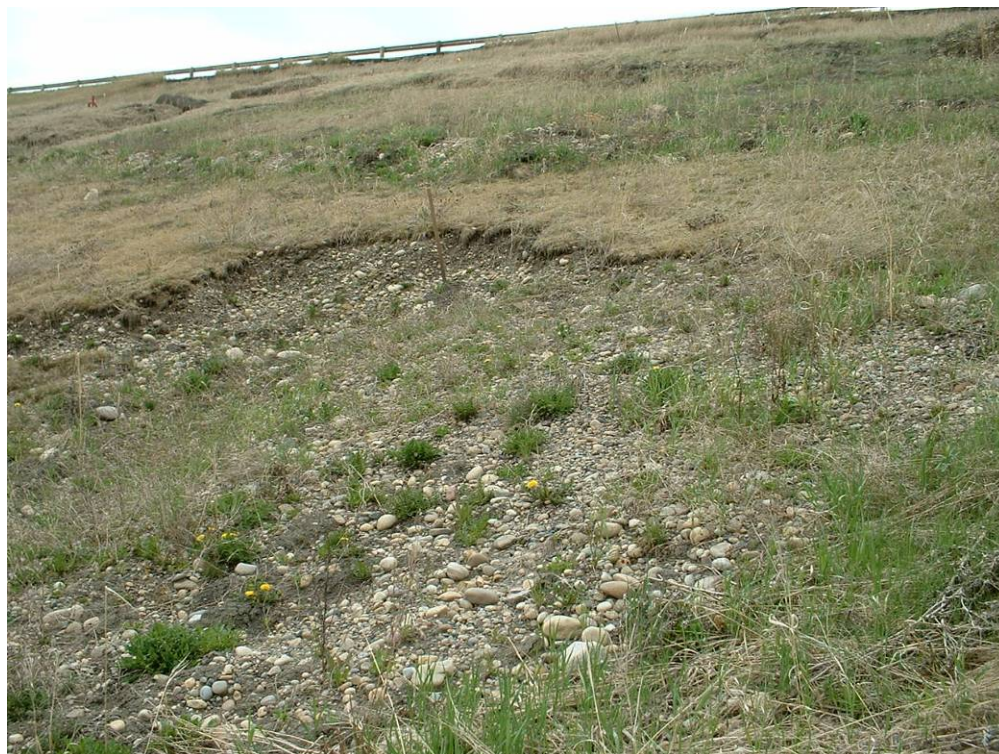
Photo 50-08

Since the 2008 site inspection, shallow slumping on the lower portion of the embankment, below the 2006 slide, appears to have re-developed in the vicinity of the 2001 slide as shown in Photo 50-08.

Shallow slump re-developing on lower portion of embankment below main slide, just above culvert.

It is understood long-term remediation measures are currently being designed by UMA. These measures should be reviewed in light of the renewed slumping observed just about the culvert outlet and, if required, modified to incorporate this area as well.
