GEOHAZARD ASSESSMENT PROGRAM

PEACE RIVER / HIGH LEVEL AREA

2015 INSPECTION

Site Number	Location	Name	Hwy	km
PH68	North of Town of Peace River	Bogey and Double Bogey Landslides	743:02	Approx. 3.6
Legal Description		UTM Co-ordinates		
12-84-22-5		11V N 6235659		E 478510

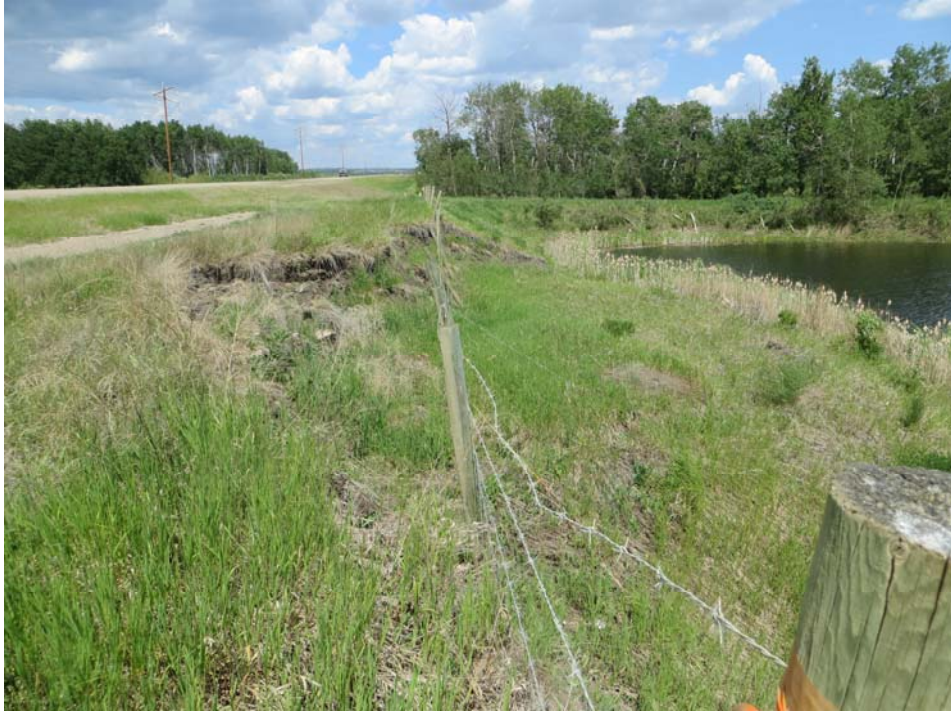
Photo 1 – Looking north at the backscarp of the pond slope failure of the Double Bogey Slide. Hwy 743 is on the left side of the photo.

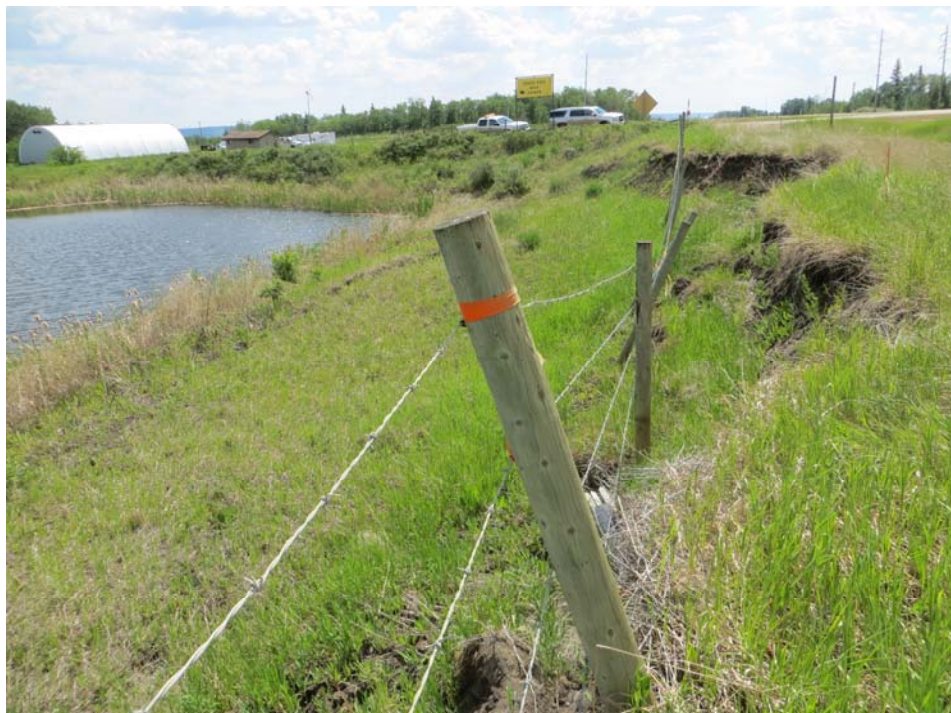
Photo 2 - Looking south at the failed pond slope (Double Bogey Slide).

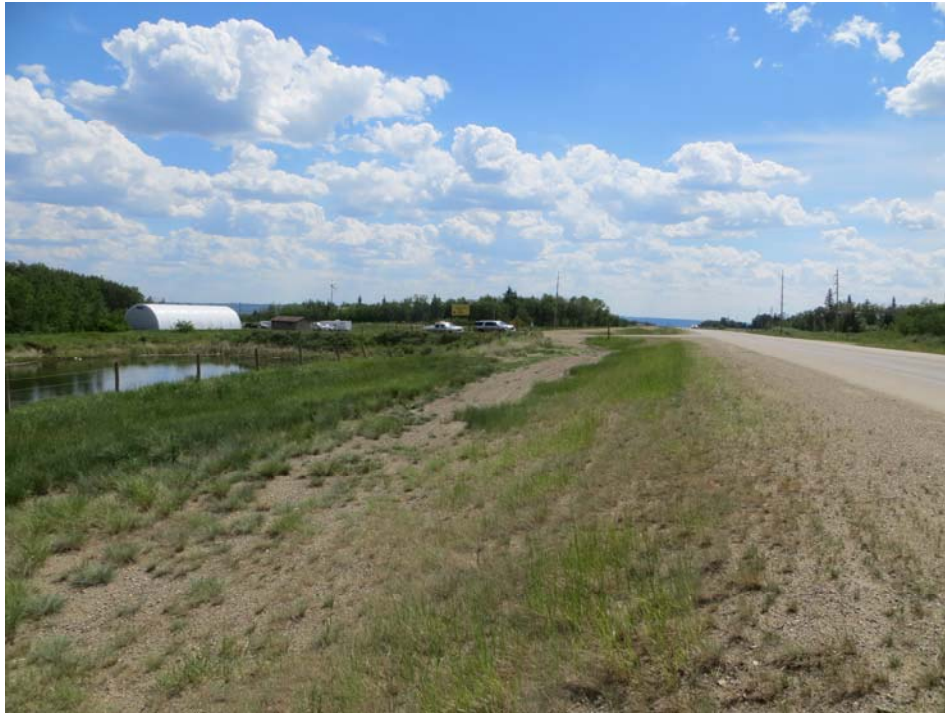
Photo 3 - Looking south at the highway and pond area.

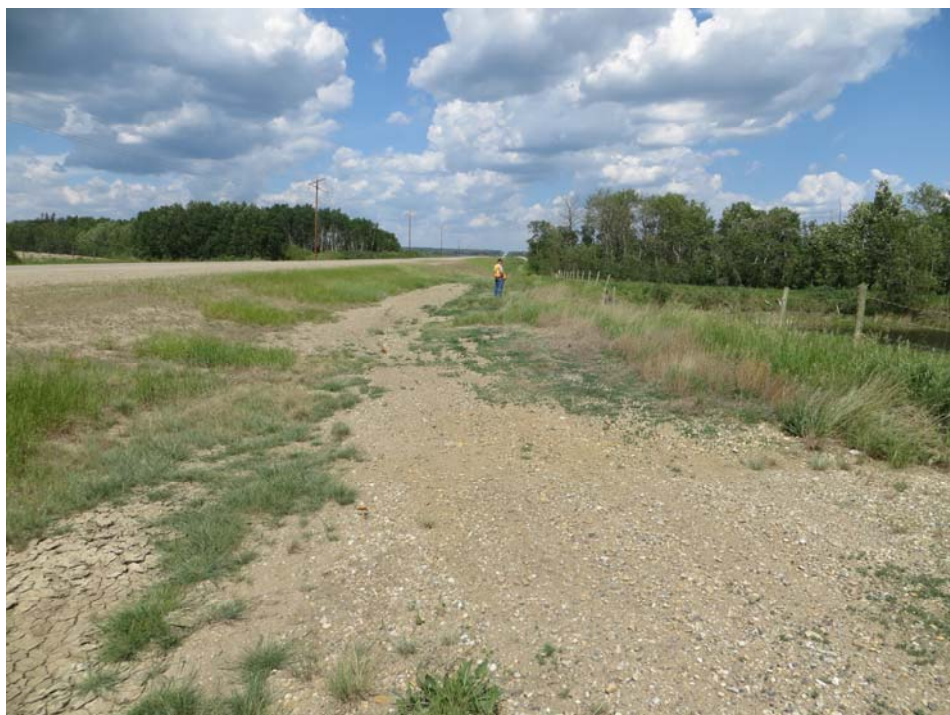
Photo 4 - Looking north at the bench between the highway and failed pond slope (Double Bogey Slide).

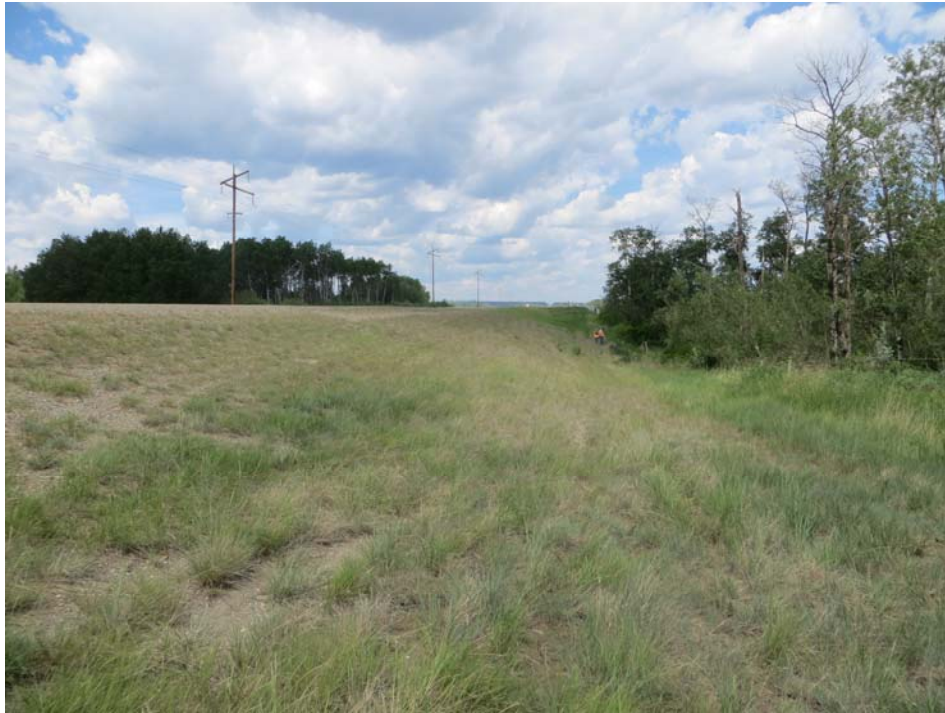
Photo 5 - Looking north at the sideslope of the highway embankment at the former Bogey Slide

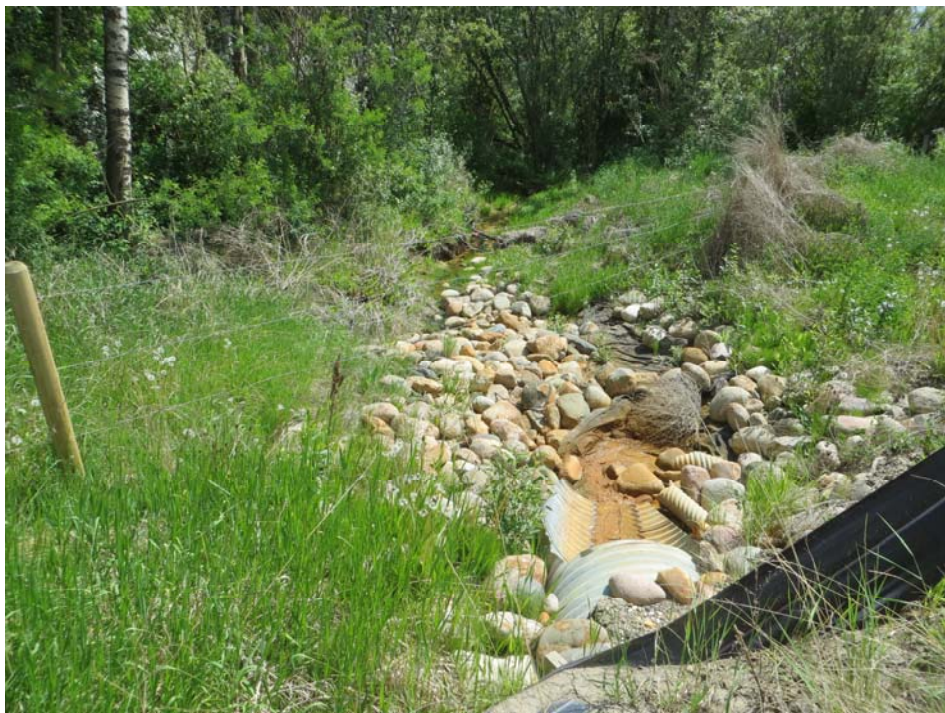
Photo 6 - Looking east at the culvert and subdrain outlets at the Bogey Slide Repair

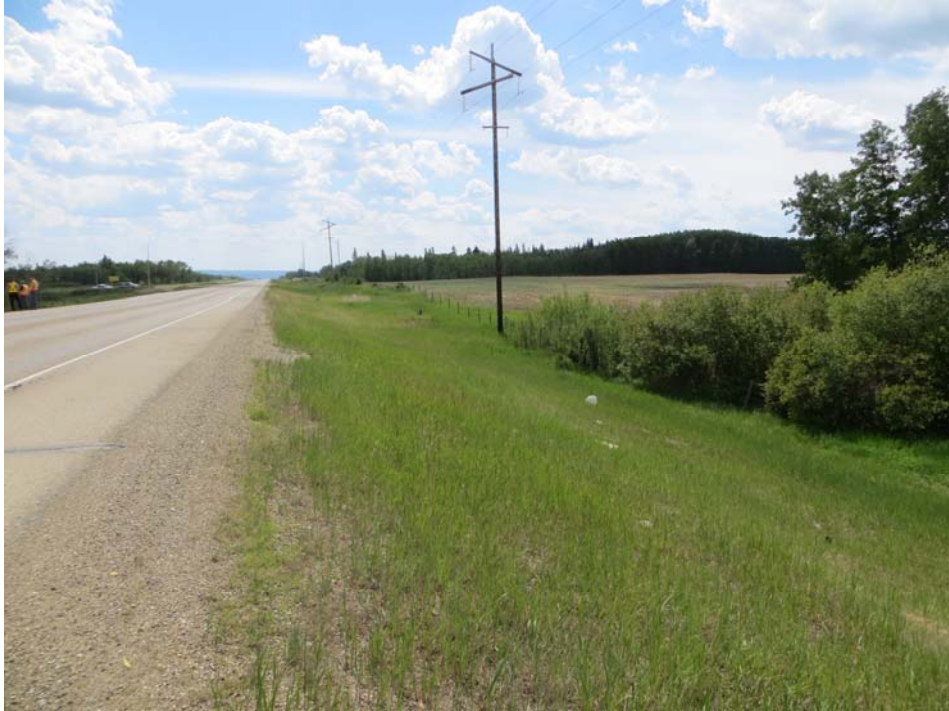
Photo 7 - Looking south along the east side of the highway at the former Bogey Slide area.
