**THURBER ENGINEERING LTD.**

December 11, 2006

**PEACE REGION (SWAN HILLS AREA) GEOHAZARD ASSESSMENT  
HWY 744:02 LITTLE SMOKY RIVER SOUTH OF BRIDGE (SH 21, SITE #2)  
2006 ANNUAL INSPECTION REPORT**

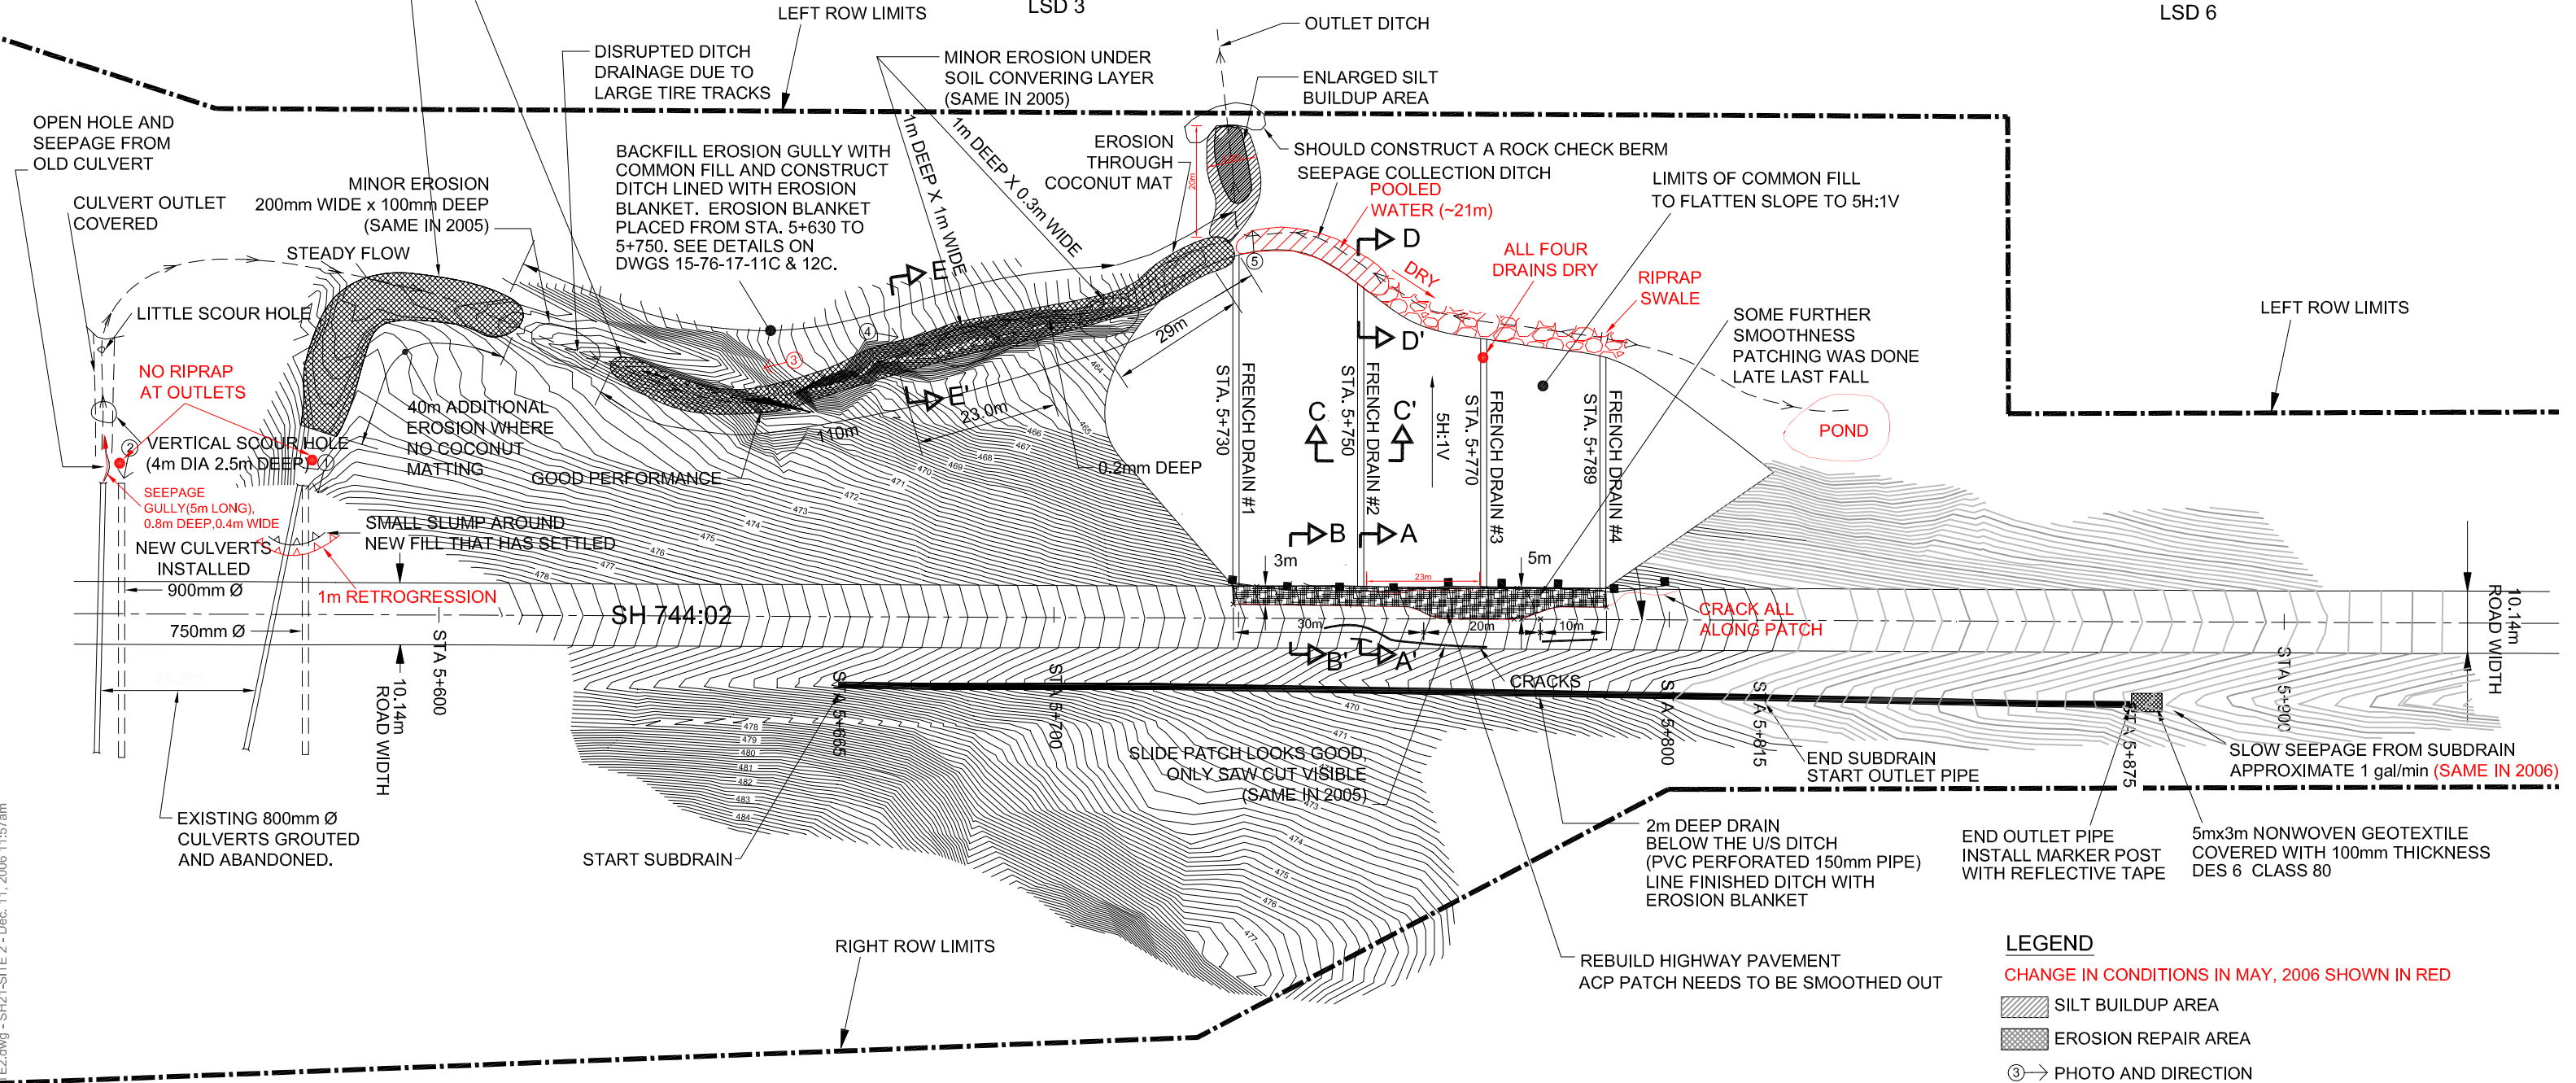
**FIGURE SH21-1 SITE #2 PLAN**  
HWY 744:02 LITTLE SMOKY RIVER VALLEY

The changes in condition since last year are shown on the attached site plan. Selected photographs taken during the visit are also attached.

SHOULD REPAIR GULLY & COCONUT EROSION MATTING (110m LENGTH, EXTEND 10m INTO SILT BUILDUP AND 40m DOWN STREAM OF CULVERT OUTLET WHERE NO MATTING EXISTS)

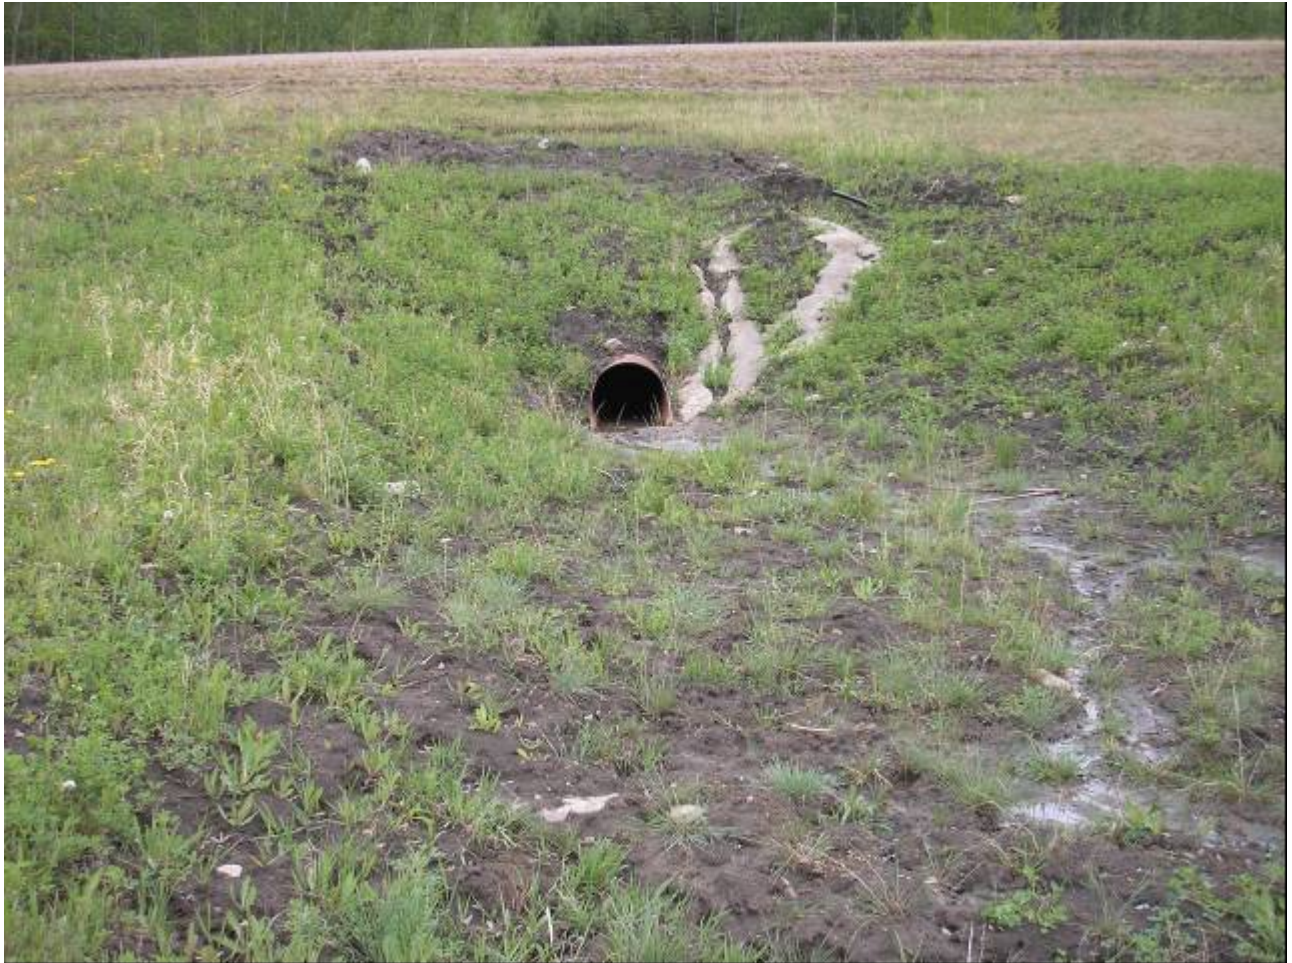
The two 800 mm diameter centreline culverts near the south end of this site that had been grouted and abandoned since last year, and replaced with new 750 mm diameter (north) and 900 mm diameter (south) culverts were inspected. Some seepage was observed emanating from the outlet of the old culvert to the south. An erosion gully had formed from the seepage coming out of the abandoned culvert and measured 5 m long x 0.8 m deep x 0.4 m wide. A small, shallow slump was observed above the outlet of the new culvert to the north in the highway embankment, coincident with the new fill that may have settled or was not compacted properly and had retrogressed back by 1 m since last year.

The backscarp of the shallow slump above the north culvert is due to settlement of the new fill, which was likely poorly compacted or not compacted at all. It will tend to degrade even more with time due to surface erosion of the backscarp face and loss of cohesion in the clay fill embankment material. At some point in time it could eventually begin to encroach into the paved shoulder. As no riprap was observed

to be present at the culvert outlets, there would be more erosion associated to high flow periods.

Photo 1 - Looking east at a small slump above the new 750 mm diameter culvert outlet area and minor erosion in unvegetated area further downslope, May 24, 2006.

RegROUT the south culvert where active seepage was observed emanating from the outlet. Place Class 1 riprap for up to 20 m length and 5 m width at the outlet of both culverts, over a non-woven geotextile membrane.

Excavate the small, shallow slumped area as required, and recompact the existing fill around the outlet of the north culvert.

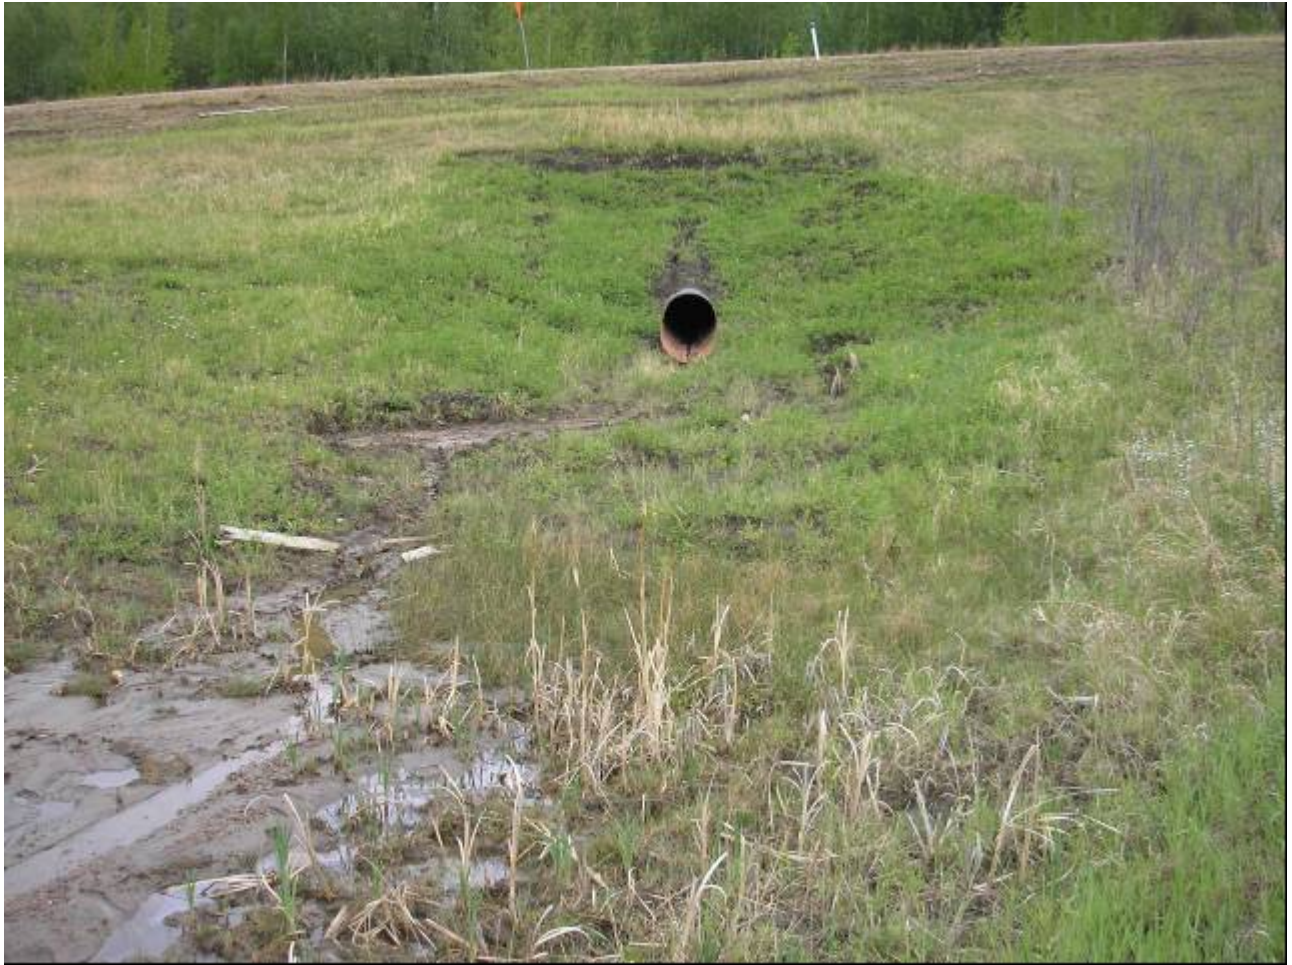
The seepage from the south old culvert is a result of insufficient grouting.

Photo 2 - Looking east at minor erosion in downslope of the new 900 mm dia. culvert outlet area. Note the open hole to right of culvert that marks improperly grouted old culvert (seepage emanating from open hole), May 24, 2006.

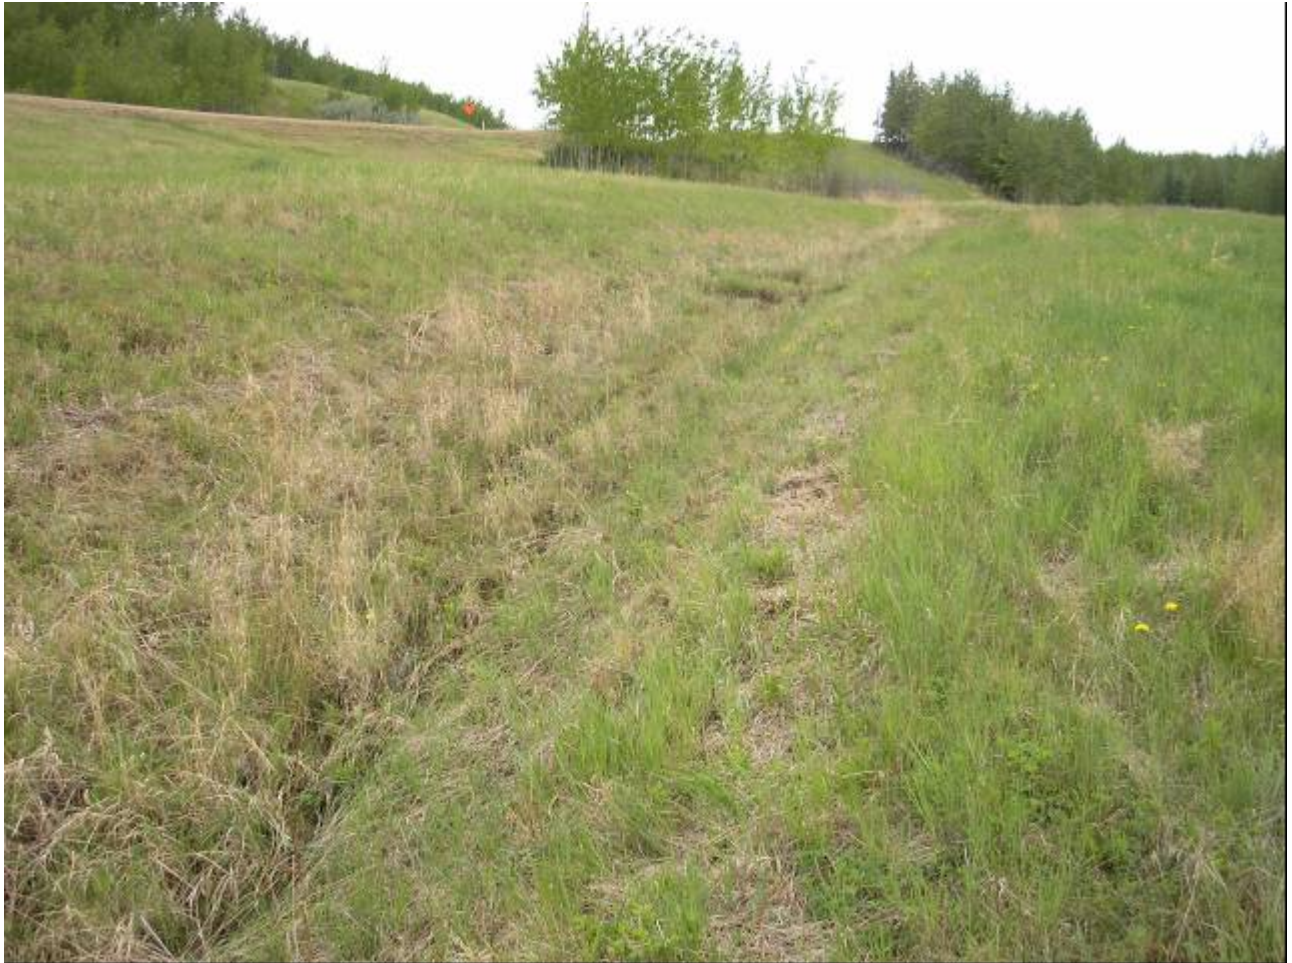
The erosion under the soil-covering layer in the D/S ditch appeared to be about the same as observed last year, as shown on the site plan. The segment near the south end, which had large tire tracks last year, had vegetation cover over it (Photo 3). The silt build-up in the outlet ditch noted last year has enlarged somewhat this year, as shown on the site plan and measures about 20 m long and 3 m wide. A 21 m long pooled water zone was present close to the silt build up area.

Photo 3 - Looking southwest at rutted ditch area with ponded water, May 24, 2006.

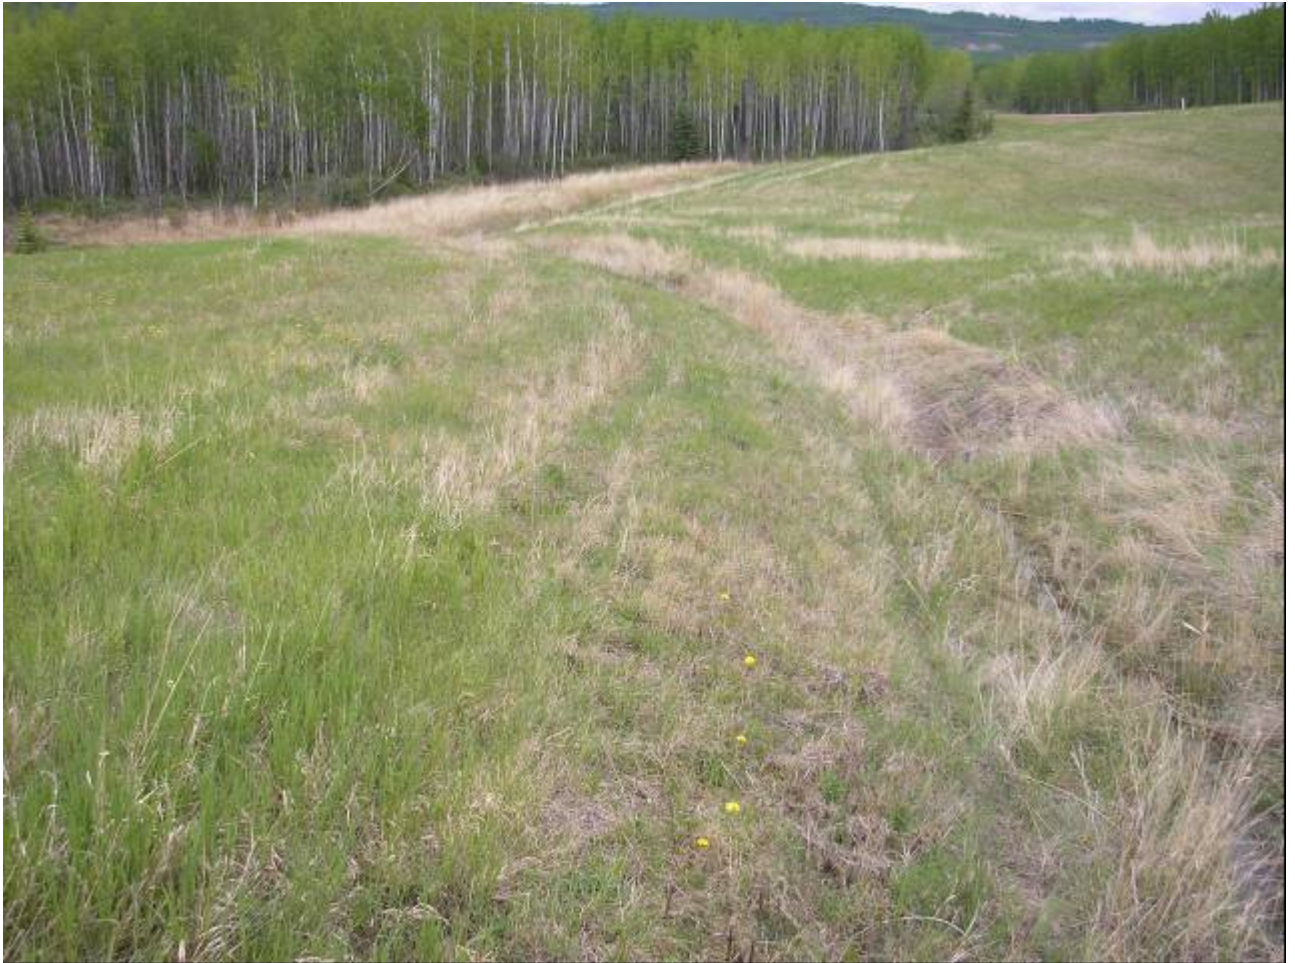
The erosion along the west drainage ditch was caused by previous high flows through the culverts further upstream to the south where previous scour holes had been created at the outlet, and associated slumping along the channel sideslopes a significant distance downstream within the bush/trees.

Photo 4 - Looking northeast along eroded channel, May 24, 2006.

Cover all ditch sections of >4% gradient with 300 mm of Class 1 riprap, filling the eroded voids in the base of the ditch with granular pitrun, over non-woven geotextile. During pitrun placement, pull up the ends of the existing non-woven geotextile at 2 m intervals to act as filters, and fill the gully to ditch level taking care not to mound the fill. Use low pressure wheel load equipment (such as a bobcat to transport the materials and an articulated backhoe to remotely place the granular materials. Cover the remaining sections with high flow soil covering. The total length was estimated to be about 150 m with about 55 m where more advanced erosion is present.

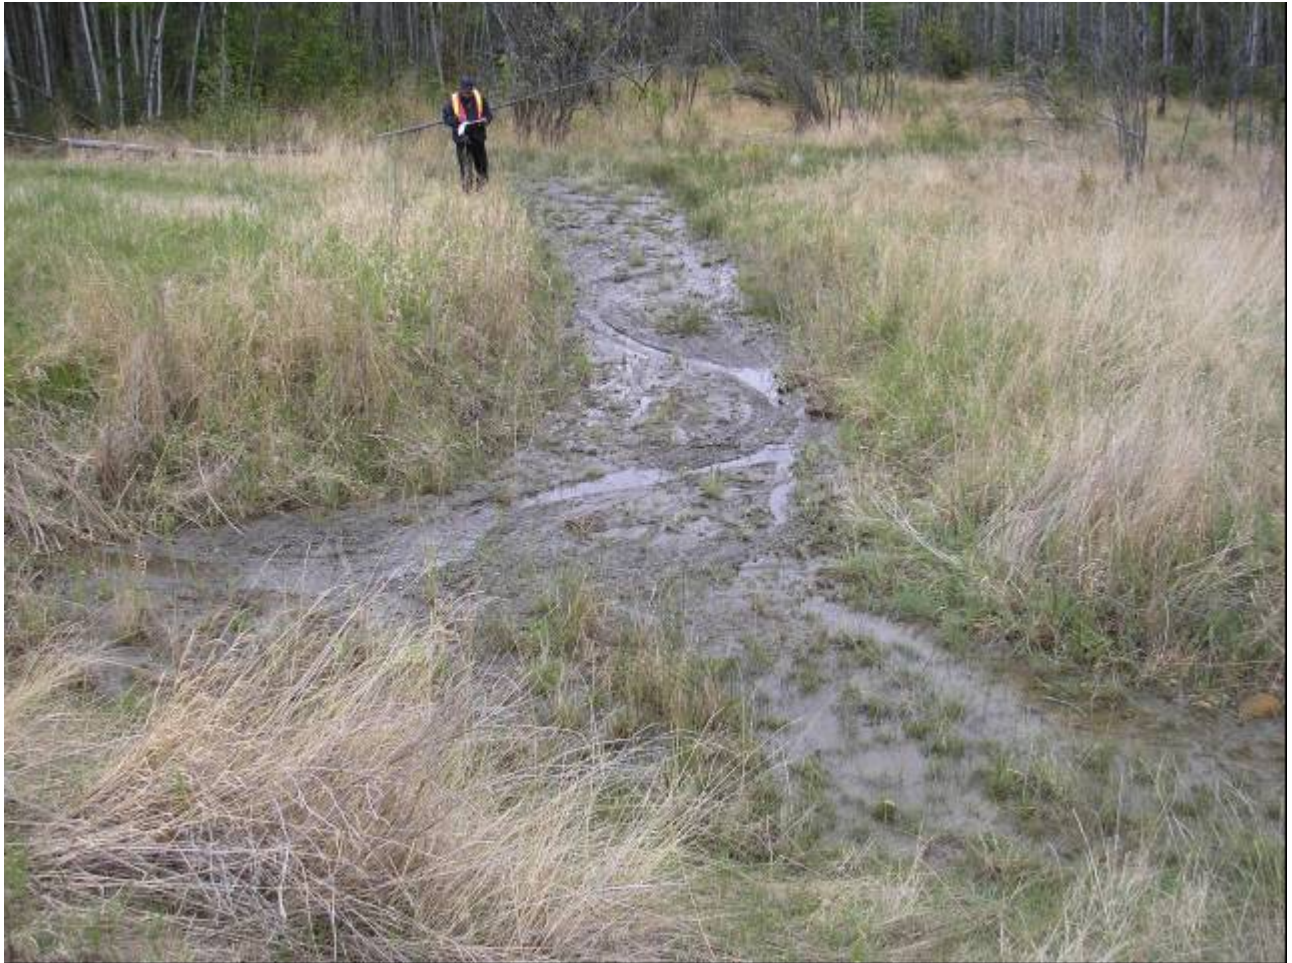
Photo 5 - Looking west at enlarged silt buildup area, May 24, 2006.

A rock check berm should be built at the downstream end of the ditch to reduce silt migration into the bog area.
