January 17, 2008

File: 15-85-73

**PEACE REGION (SWAN HILLS AREA) GEOHAZARD ASSESSMENT
HWY 744:02 LITTLE SMOKY RIVER SOUTH OF BRIDGE (SH 21, SITE #2)
2007 ANNUAL INSPECTION REPORT**

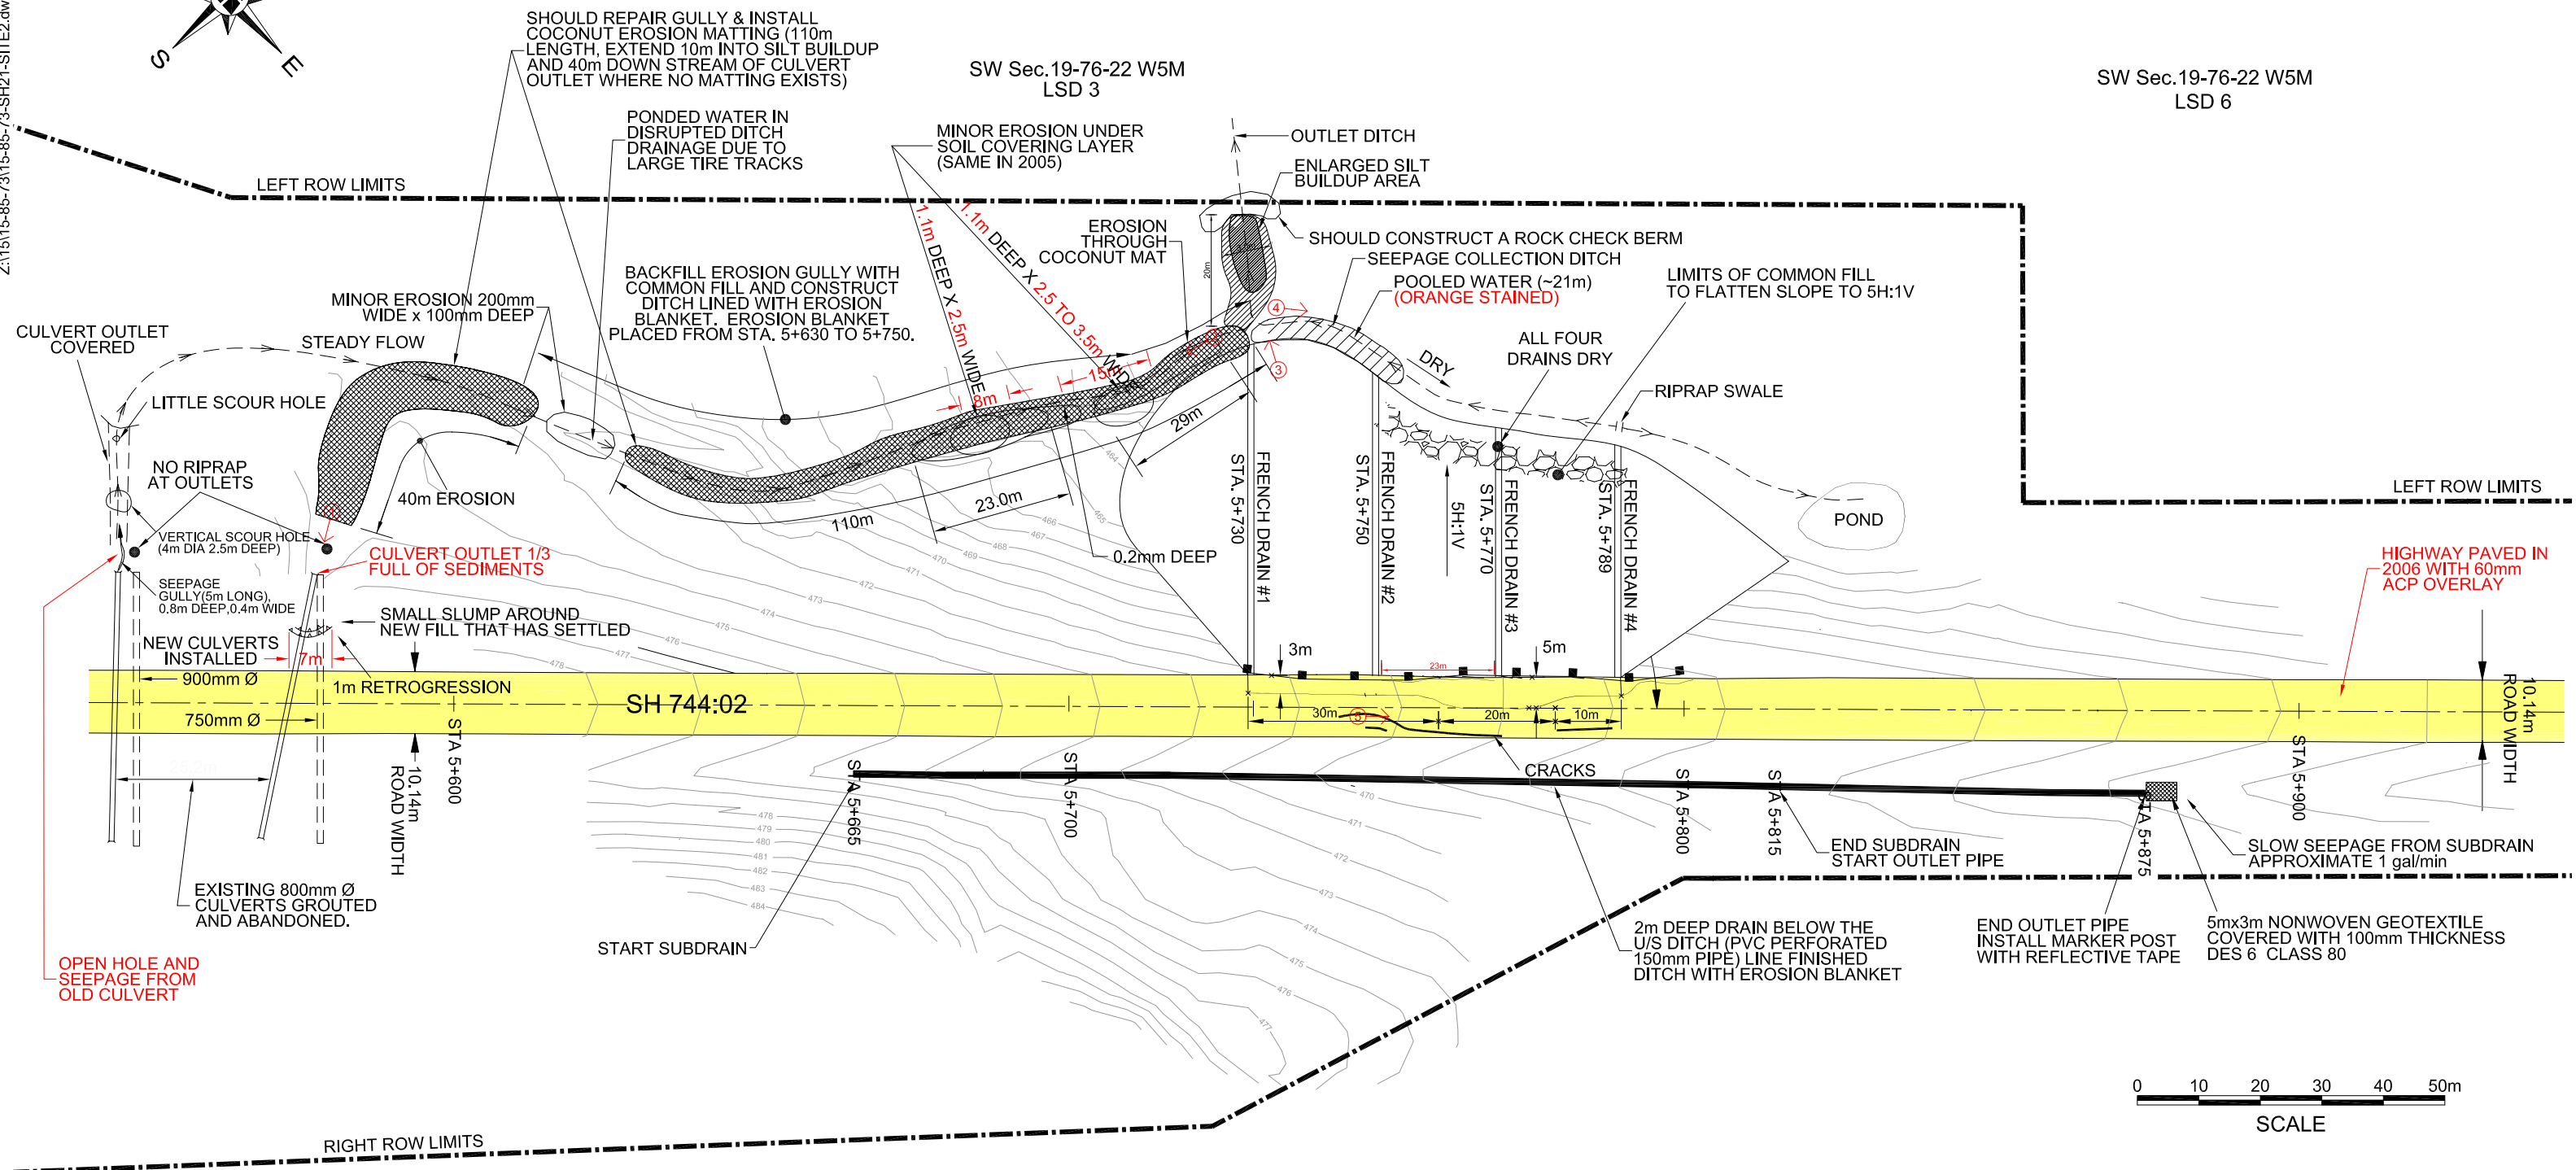
FIGURE SH21-1 SITE #2 PLAN
 HWY 744:02 LITTLE SMOKY RIVER VALLEY
 SCALE 1:1000
 JUNE 14, 2007
 THURBER PROJECT #15-85-73
THURBER ENGINEERING LTD.
 GEOTECHNICAL • ENVIRONMENTAL • MATERIALS

MINOR EROSION UNDER SOIL COVERING LAYER (SAME IN 2005)

40m EROSION

1.1m DEEP X 2.5 TO 3.5m WIDE

EROSION THROUGH COCONUT MAT

NO RIPRAP AT OUTLETS

VERTICAL SCOUR HOLE (4m DIA 2.5m DEEP)

SEEPAGE GULLY (5m LONG), 0.8m DEEP, 0.4m WIDE

CULVERT OUTLET 1/3 FULL OF SEDIMENTS

SMALL SLUMP AROUND NEW FILL THAT HAS SETTLED

OPEN HOLE AND SEEPAGE FROM OLD CULVERT

SHOULD REPAIR GULLY & INSTALL COCONUT EROSION MATTING (110m LENGTH, EXTEND 10m INTO SILT BUILDUP AND 40m DOWN STREAM OF CULVERT OUTLET WHERE NO MATTING EXISTS)

BACKFILL EROSION GULLY WITH COMMON FILL AND CONSTRUCT DITCH LINED WITH EROSION BLANKET. EROSION BLANKET PLACED FROM STA. 5+630 TO 5+750.

SHOULD CONSTRUCT A ROCK CHECK BERM SEEPAGE COLLECTION DITCH

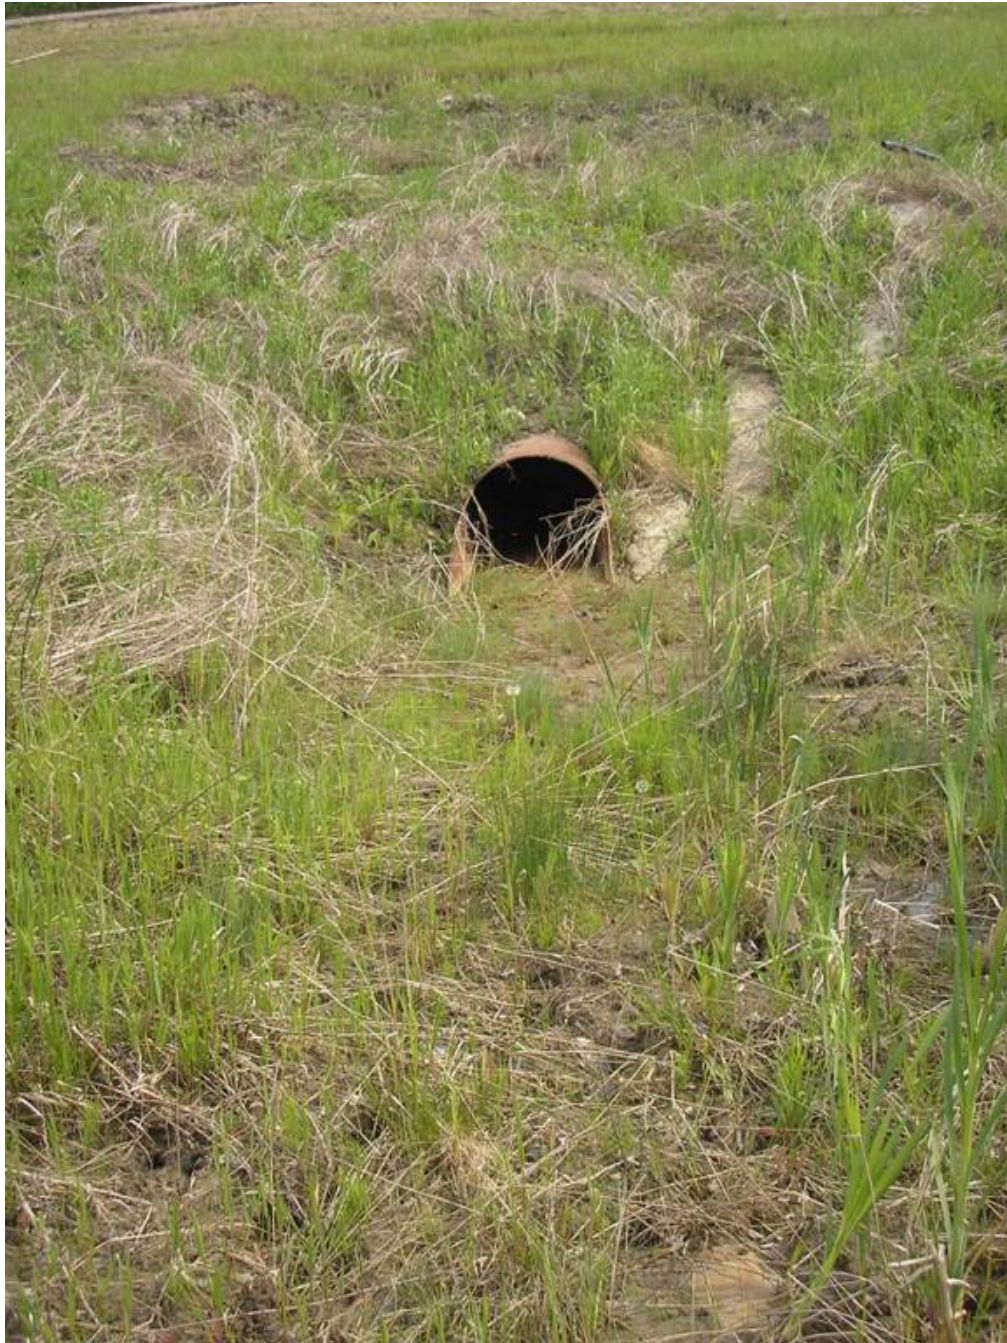
Some seepage was observed emanating through an erosion hole in the grout of the old culvert at the south end of the site. The new 750 mm diameter CSP was 1/3 full of sediment and there are still subtle signs of a small, shallow slump above the outlet of the culvert.

The backscarp of the shallow slump above the new north culvert is due to settlement of the new fill, which was likely poorly compacted or not compacted at all. As no riprap was observed to be present at the outlets of the new culverts, there erosion could develop at the outlets following a period of high flows.

Photo 1 - Looking southeast at a small slump above the new 750 mm diameter culvert outlet area, June 14, 2007.

Excavate the small, shallow slumped area as required, and recompact the existing fill around the outlet of the north culvert.

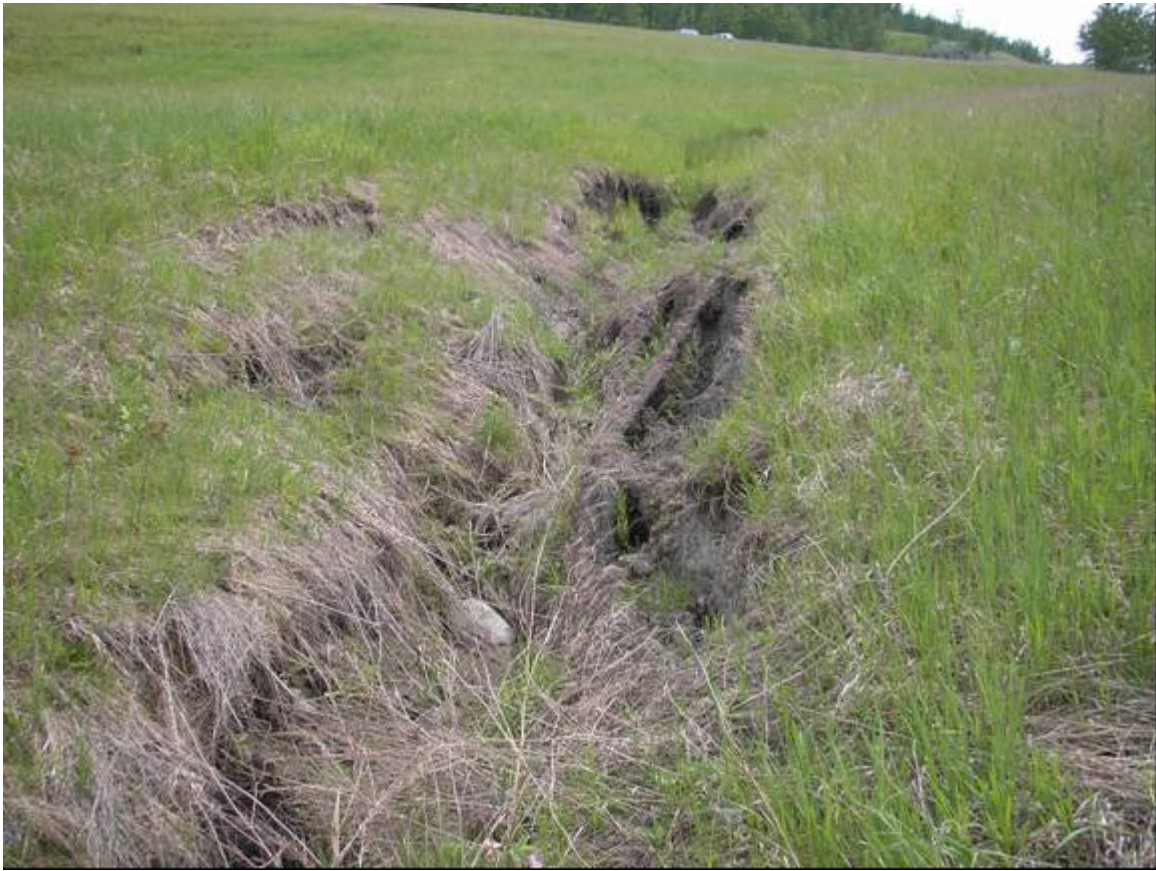
The erosion under the soil-covering layer in the D/S ditch appeared to have increased in size and depth a bit (Photo 2) and there was still some silt accumulating in the outlet ditch.

The erosion along the west drainage ditch might have been caused by previous high flows through the culverts further upstream to the south. The seepage from the south old culvert is a result of insufficient grouting.

Photo 2 - Looking southwest at erosion gully.

Cover all ditch sections of >4% gradient with 300 mm of Class 1 riprap, filling the eroded voids in the base of the ditch with granular pitrun, over non-woven geotextile. During pitrun placement, pull up the ends of the existing non-woven geotextile at 2 m intervals to act as filters, and fill the gully to ditch level taking care not to mound the fill. Use low pressure wheel load equipment (such as a bobcat to transport the materials and an articulated backhoe to remotely place the granular materials. Cover the remaining sections with high flow soil covering. The total length was estimated to be about 150 m with about 55 m where more advanced erosion is present.

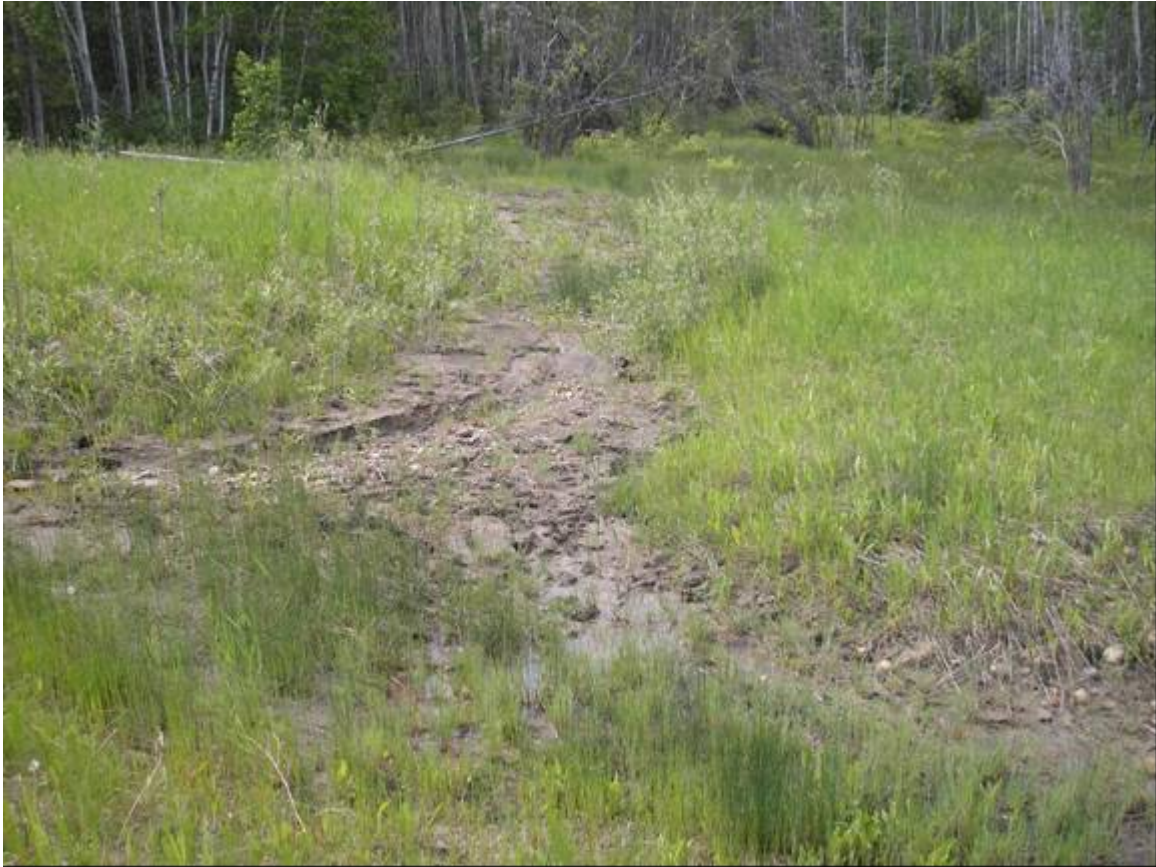
Photo 3 - Looking northwest at discharge area, June 14, 2007.

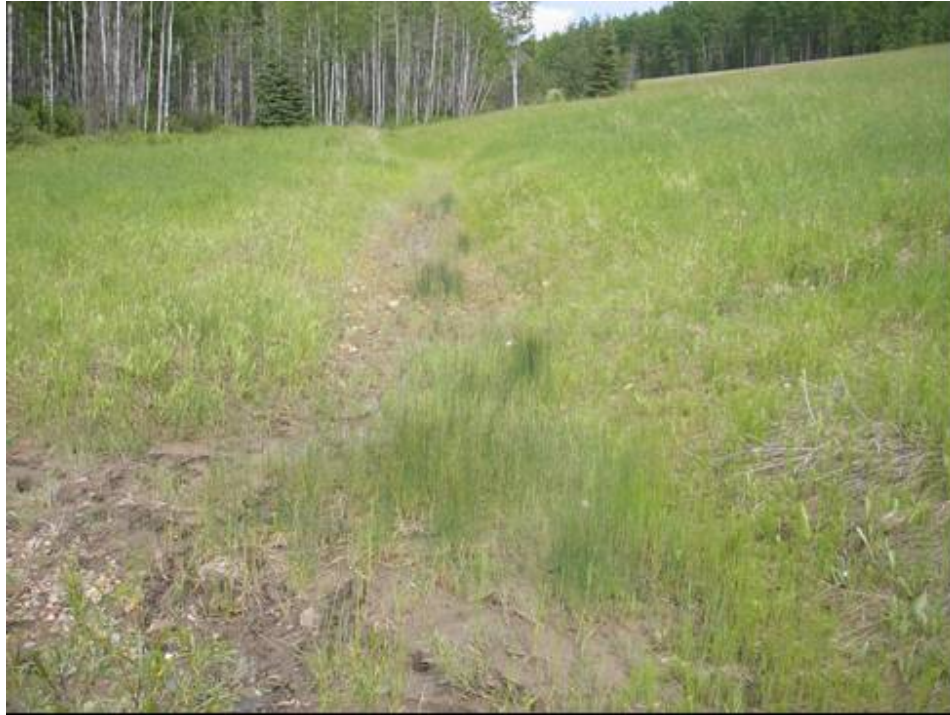
Photo 4 - Looking northeast along seepage collection ditch, June 14, 2007.

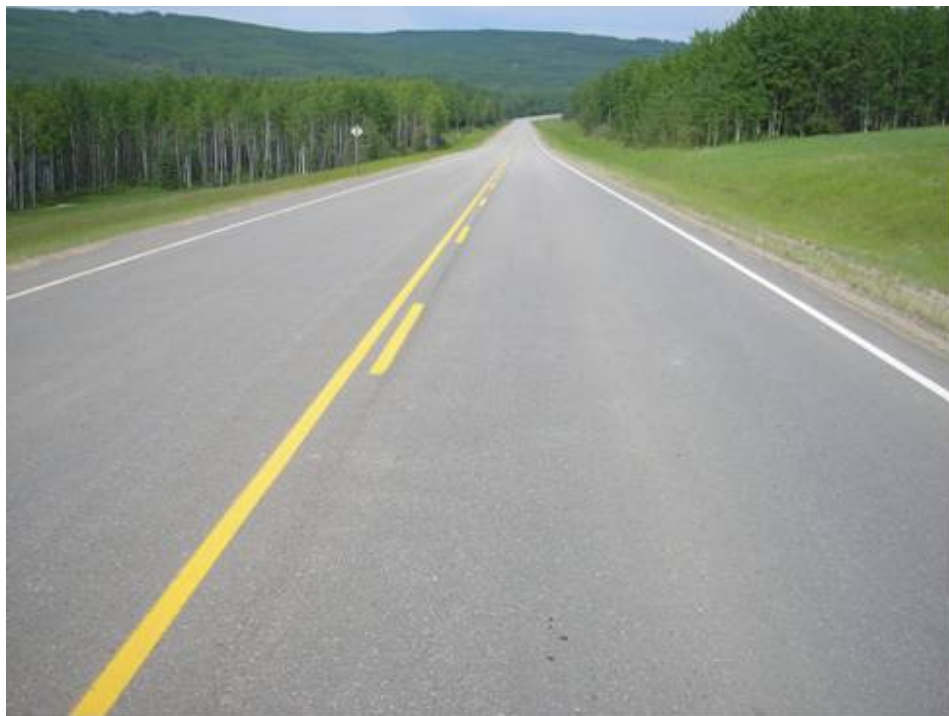
An asphalt overlay was placed in the highway through the site last year and none of the earlier cracks were observed on it.

Photo 5 - Northeast view along highway at Site # 2.
