July 2, 2009

File: 15-16-229

**PEACE REGION (PEACE RIVER/HIGH LEVEL) GEOHAZARD ASSESSMENT  
HWY 744:04 PH62 MARIE-REINE  
2009 INSPECTION REPORT**

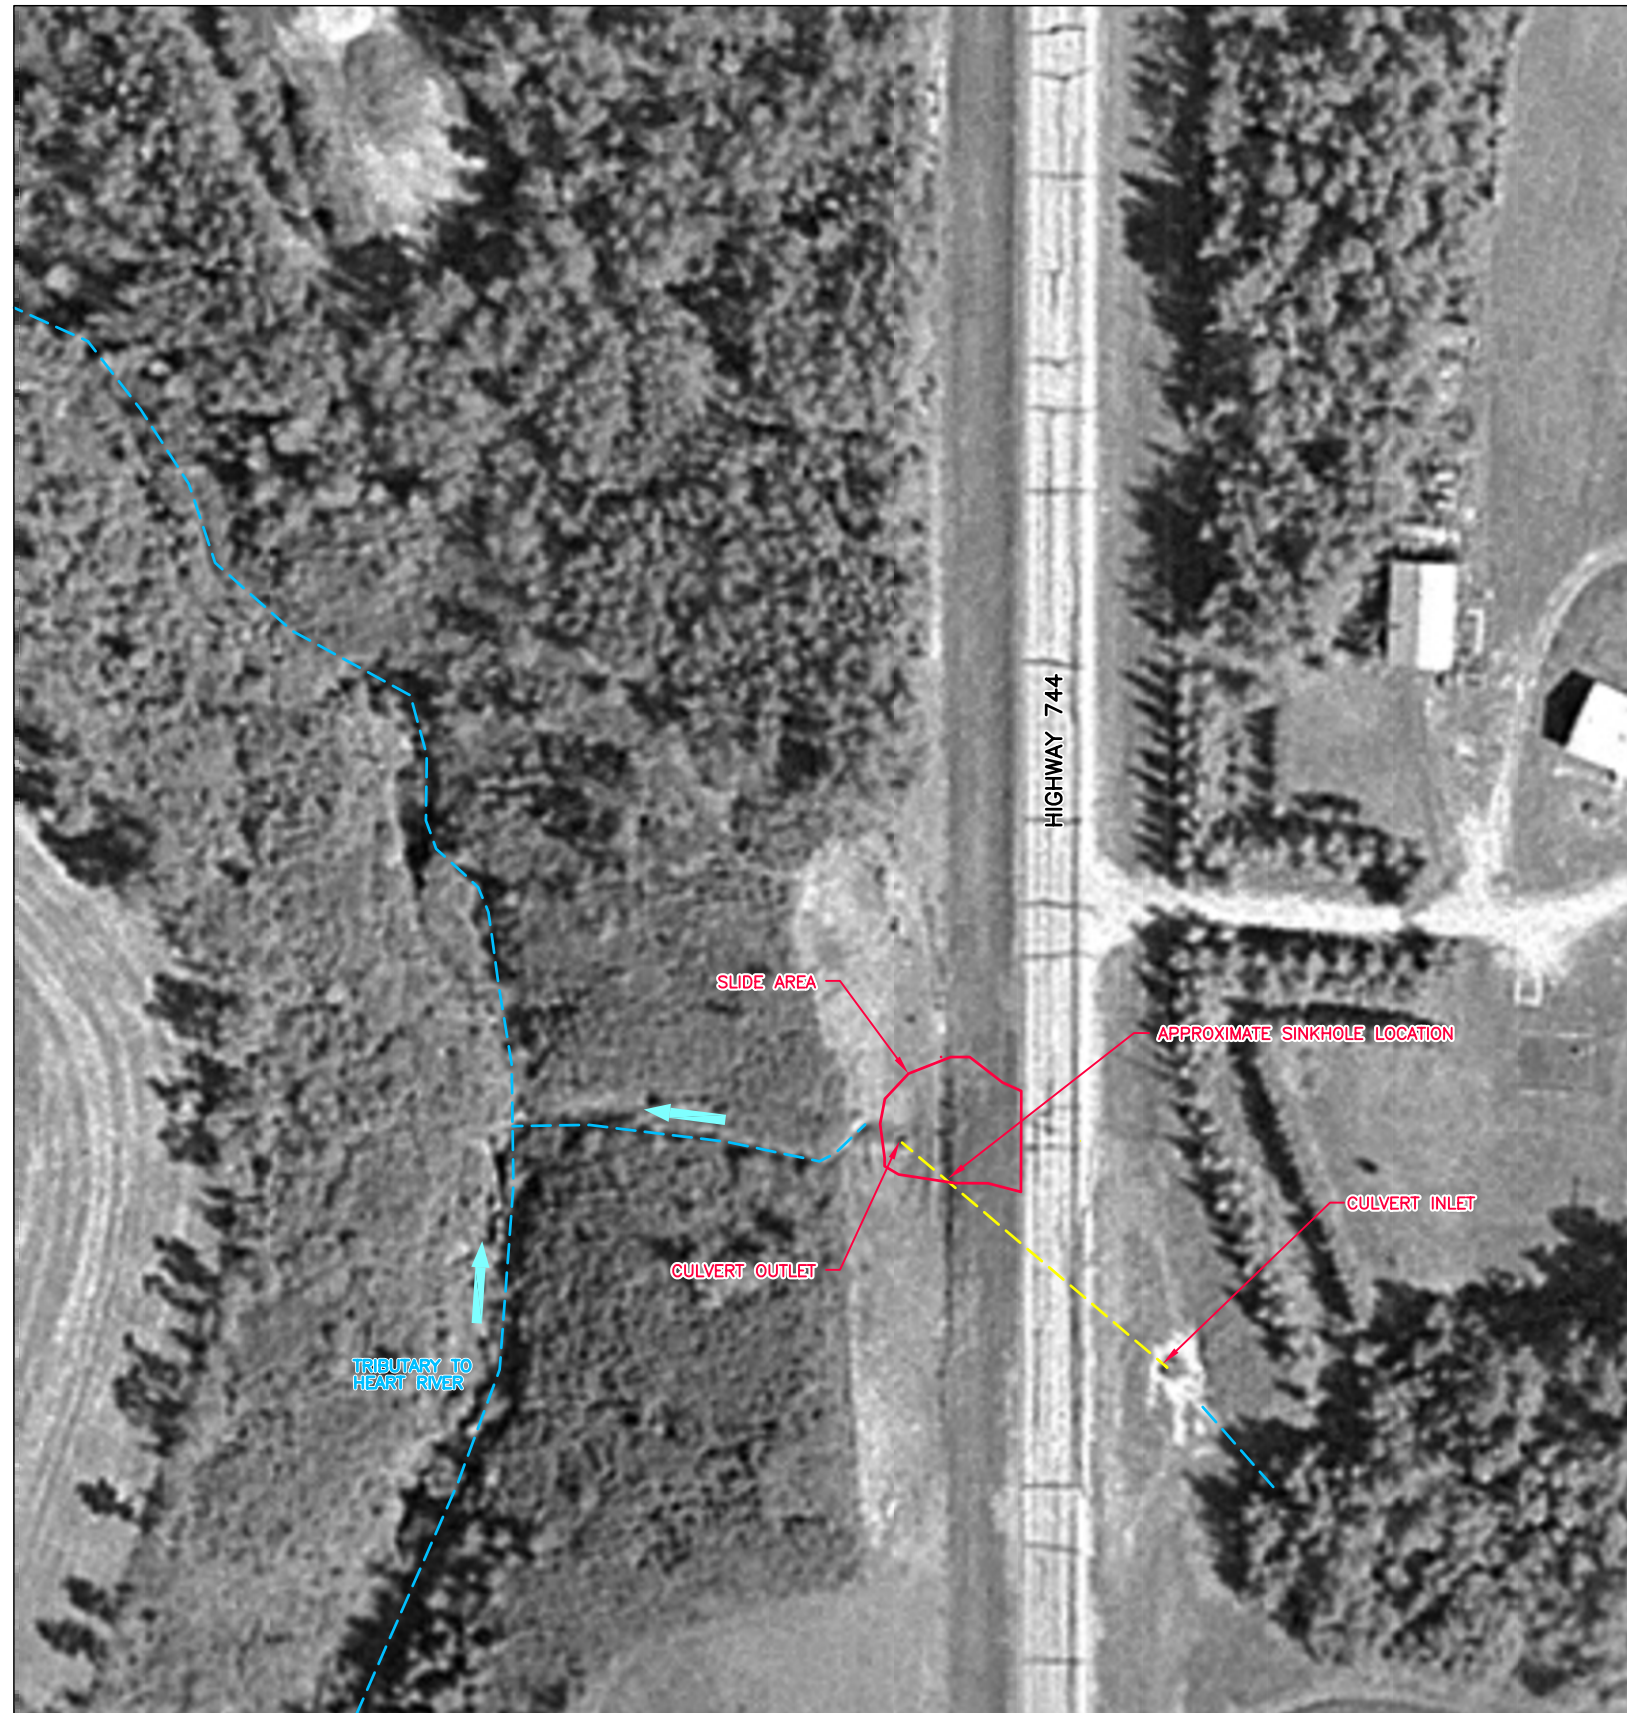
**FIGURE 1**

A 1200 mm diameter Corrugated Steel Plate (CSP) culvert runs in a southeast to northwest direction through the embankment as shown in Figure 1. The toe of the slide was noted to be well-defined near the culvert outlet (Photo 62-05). The outlet of the culvert appeared to be tilted upward slightly and a sinkhole was noted over the culvert part way up the slope (Photo 62-06), suggesting it has likely separated within the embankment.

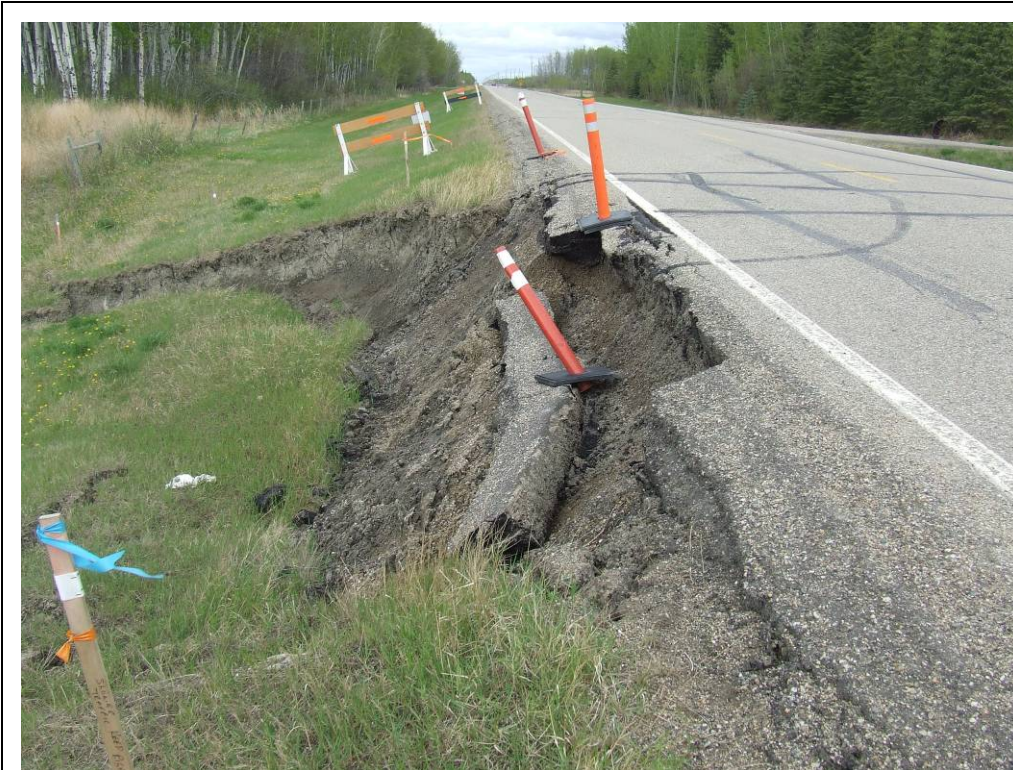
**Photo 62-01**

At the time of the May 2009 inspection, the slope instability on the west side of the road embankment was observed to be perpendicular to the roadway with a 1.8 m high vertical headscarp running along the shoulder of the southbound lane of Highway 744 as shown in Photos 62-01 to 62-04 and Figure 1, attached. The length of the headscarp along the roadway was about 13 m, with the overall width of the slide at its widest point being in the order of 20 m. The downslope length of the slide was estimated to be about 20 m.

Comparing photos taken in October 2008 and May 2009, it appears that some minor retrogression of the landslide has occurred. The headscarp appears to have encroached slightly from the edge of the asphalt in 2008 to near the white-line of

the shoulder in 2009. Also, the headscarp was reported to be about 1.5 m high in 2008 compared to about 1.8 m high in 2009.

Looking north at headscarp encroaching into shoulder of southbound lane.

Until a site investigation and remediation measures can be undertaken, the site should be regularly inspected by the MCI to ensure the southbound travel lane does not become undermined and fail further into the roadway.

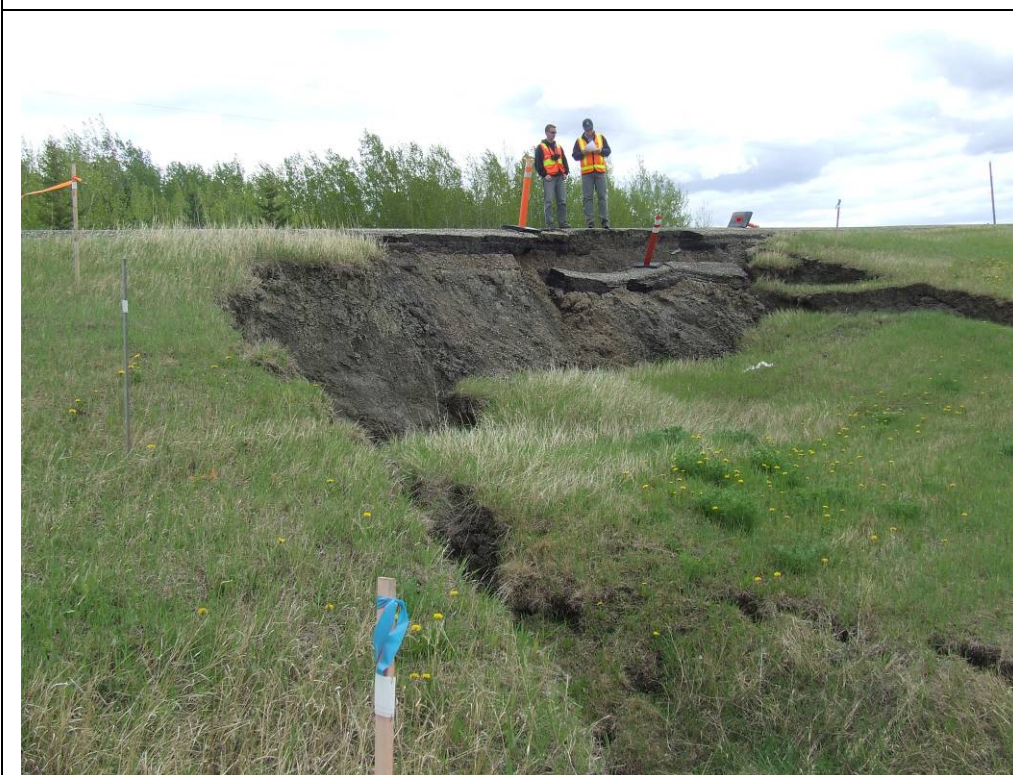
**Photo 62-02**

Looking upslope (southeast) at headscarp at edge of southbound lane.

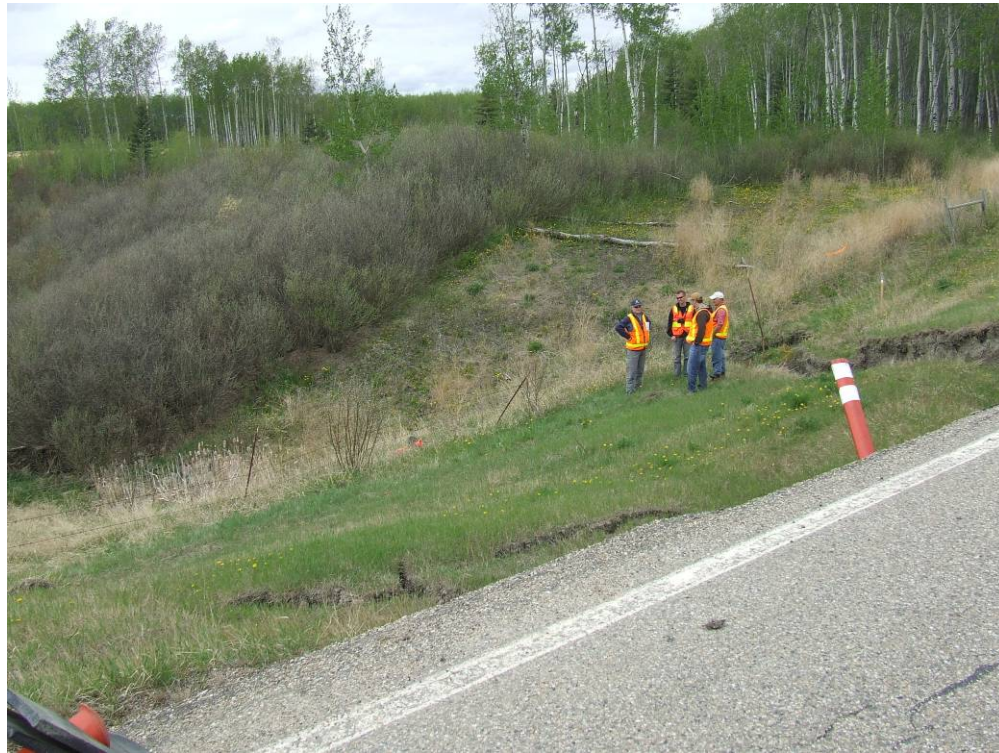
**Photo 62-03**

Looking downslope (northwest) at slide area from southbound lane.

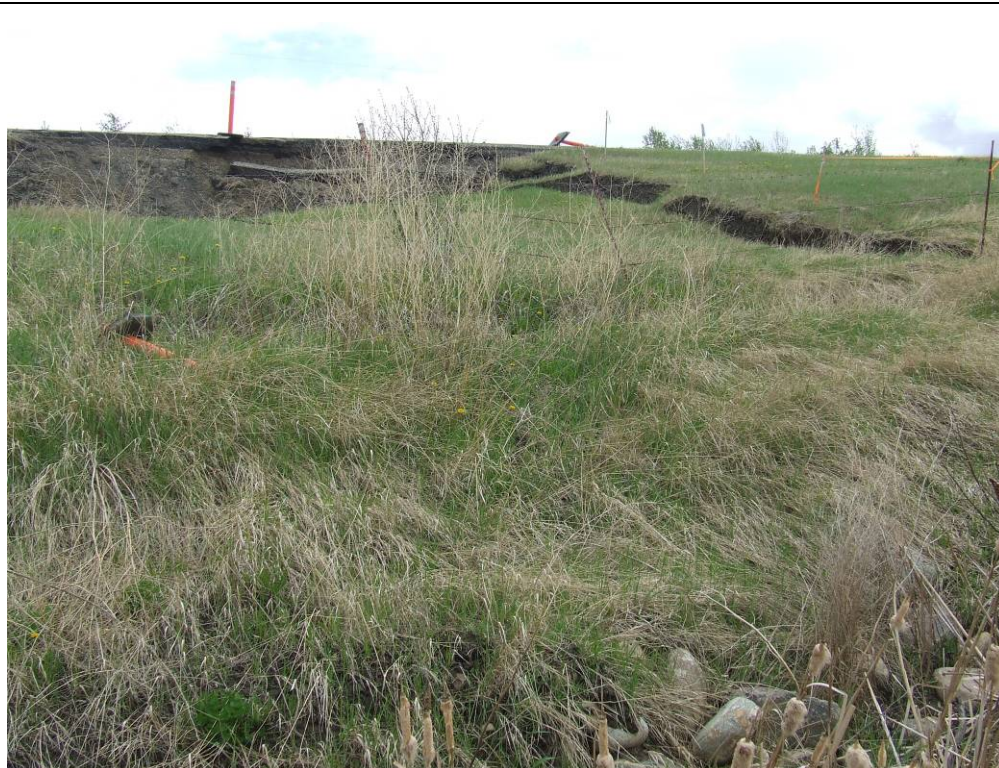
**Photo 62-04**

Looking upslope (southeast) at slide from toe area.

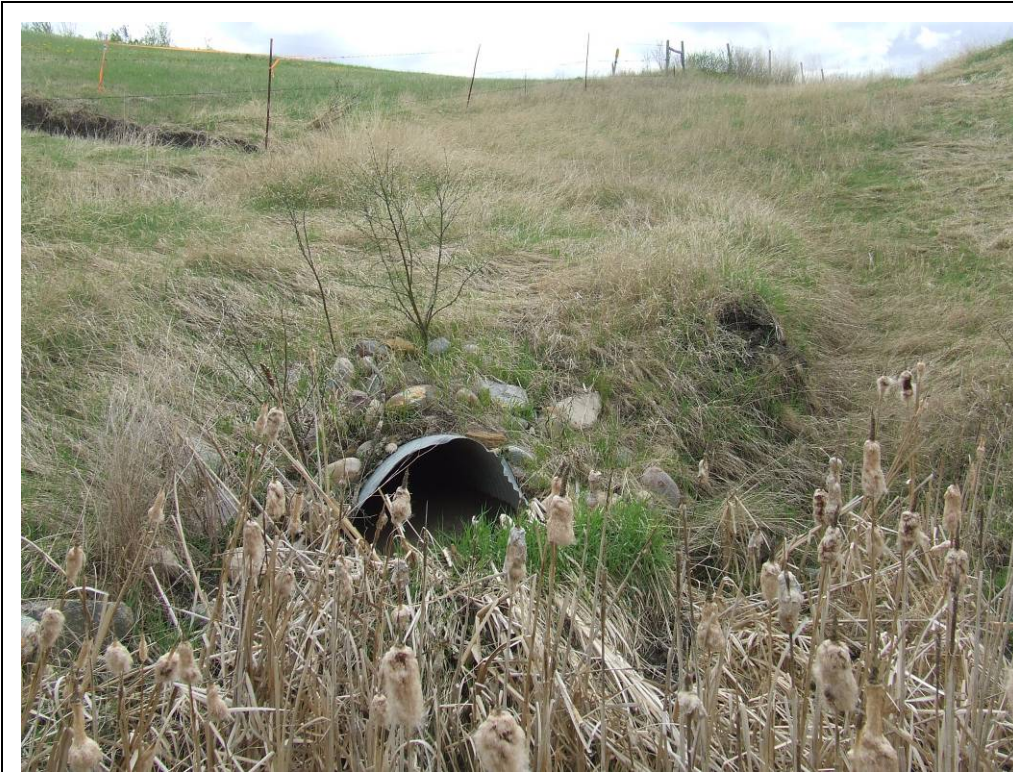
**Photo 62-05**

Looking south along west ditch at toe of slide and culvert outlet.

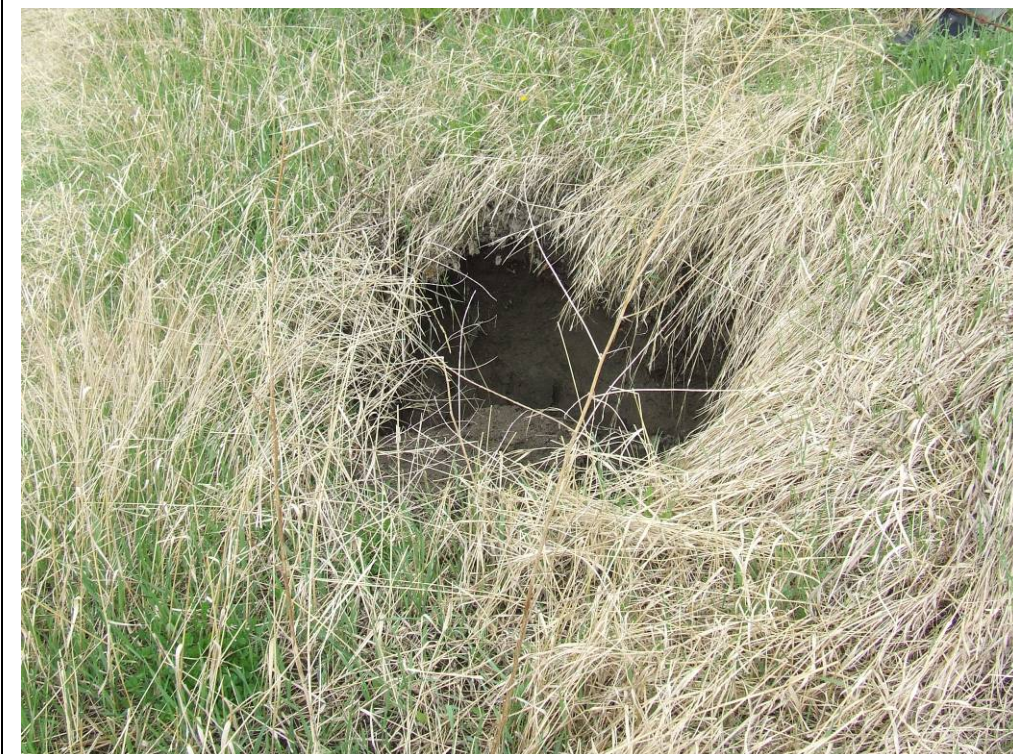
**Photo 62-06**

Close-up of sinkhole over culvert on lower third point of slope within slide area.

- Removal of all weak saturated high plastic clay fill material from the toe and slide area.
- Repair/replacement of all broken sections of the CSP culvert and extension to account for proposed flatter fill slopes.
- Placement of a granular berm and/or blanket at the toe and lower portion of the slope prior to placement of new fill.
- Reconstruction of the embankment fill to a flatter slope angle (anticipated to be in the range of 4H:1V to 5H:1V).
