June 21, 2007

File: 15-85-73

**PEACE REGION – SWAN HILLS AREA - GEOHAZARD ASSESSMENT
(CE047/2004)
CALL-OUT FOR EMBANKMENT FAILURE (SH 25)
ON HWY 744:04 ~KM 45, 3 KM NORTH OF MARIE REINE, ALBERTA**

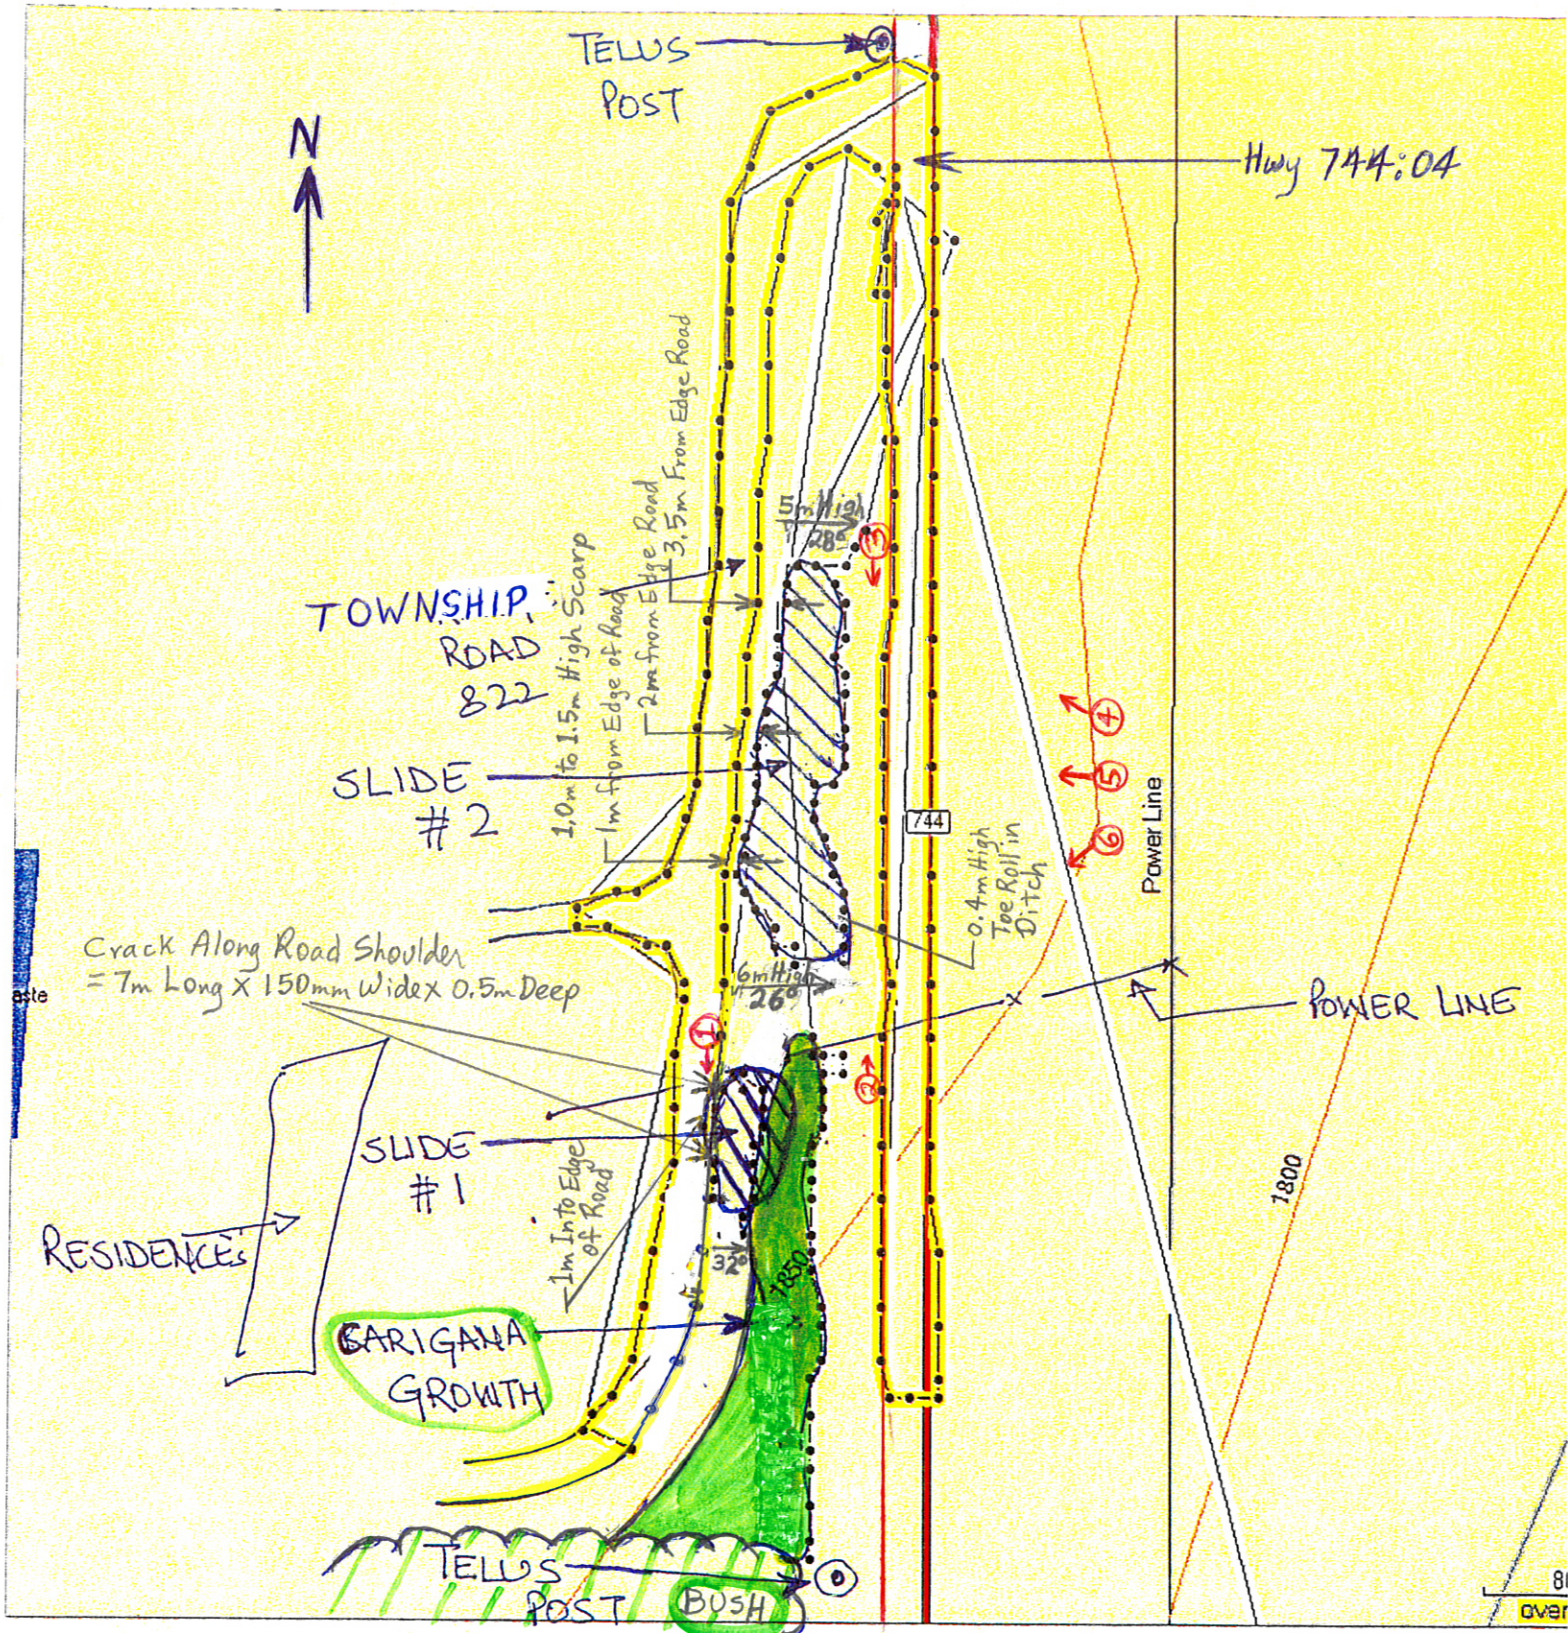
ALBERTA INFRASTRUCTURE AND TRANSPORTATION	
SITE PLAN SHOWING MARIE-REINE SLIDE	
THURBER ENGINEERING LTD.	
CALL OUT JUNE 14, 2007	HWY 744:04 3 KM NORTH-MARIE REINE JUNE, 2007 15-85-73 FIGURE 2

A sketch plan showing the limits and extent of the slides labelled as Slides 1 and 2 on June 14, 2007, is provided on Figure 2. Selected photographs taken during the site reconnaissance are also attached.

The slides were located on common ground forming the west highway backslope and the east township road embankment. Slide 1 is located further south (centered about 25 m north of the beginning of the curve). Slide 2 is further north (separated from Slide 1 by about 15 m), and is presently contained entirely within the common ground area.

No seepage or surface water was observed within the slide outlines, in the highway ditches or on the west side of the township road. The slope and highway ditch was grassed, except for the caraganas that are approximately shown on Figure 2. Bush existed south of the caraganas and adjacent to the south side of the township road. The west highway ditch sloped downwards to the south at an approximate 4% slope.

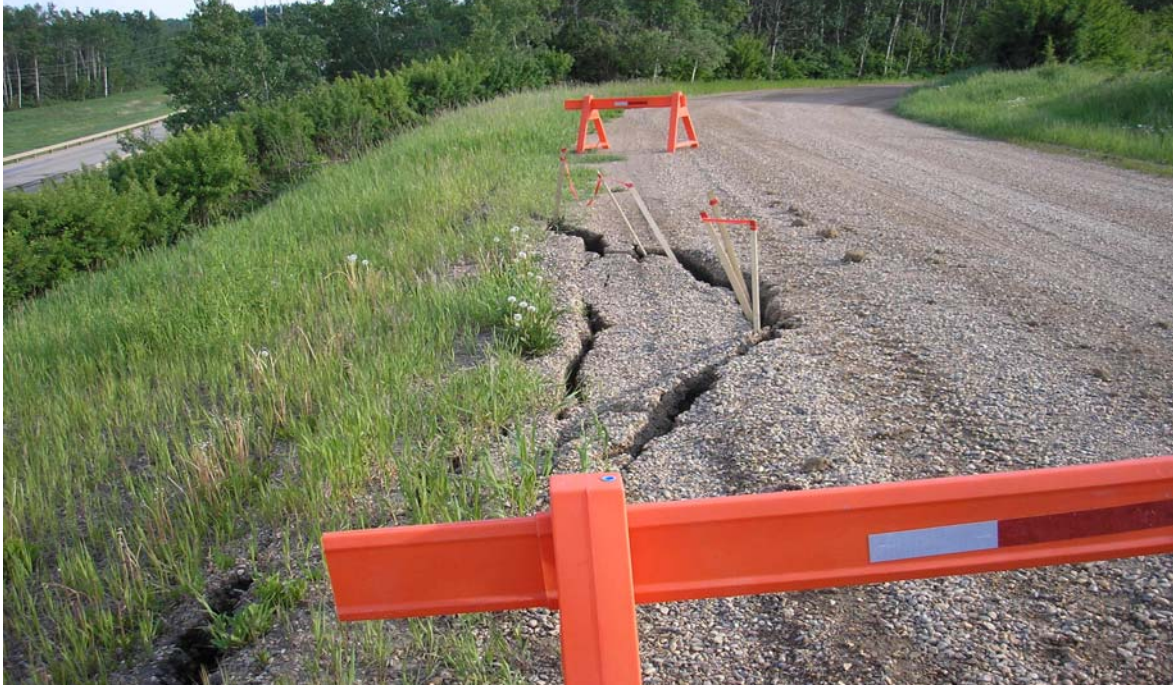
Slide 1 is about 20 m wide and extends about 12 m long down the slope. The scarp extends about 1 m into the east shoulder edge of the Township Road, and appears to toe out inside the caragana thicket (although the toe push was not readily apparent). The scarp is identified by a crack about 18 m in total length, although the portion that intersects the road is 7 m long by 150 mm wide by 0.5 m deep. The township road embankment was approximately 7.5 m high, and inclined at approximately 30° to 32° above the caraganas. The west edge of the highway was separated from the east edge of the road by about 22 m horizontally.

Photo 1 – Looking south at Slide 1 along edge of Twp. Road 822.

Slide #1 is currently affecting the township roadway and both slides could continue to retrogress further into the road. The barricades that are currently erected should be maintained around the slide area to warn motorists of the hazard and the slide should be inspected on a regular basis so that barricades can be moved and traffic signs or signals set up, or a detour constructed if the slides worsen.

For the short term, it is recommended that the gravel surface and the top edge of the slide areas should be regularly inspected and filled/graded to bridge the open cracks and scarp to reduce water infiltration into the slide cracks, and to taper runoff off of the graveled surface onto the sideslope.

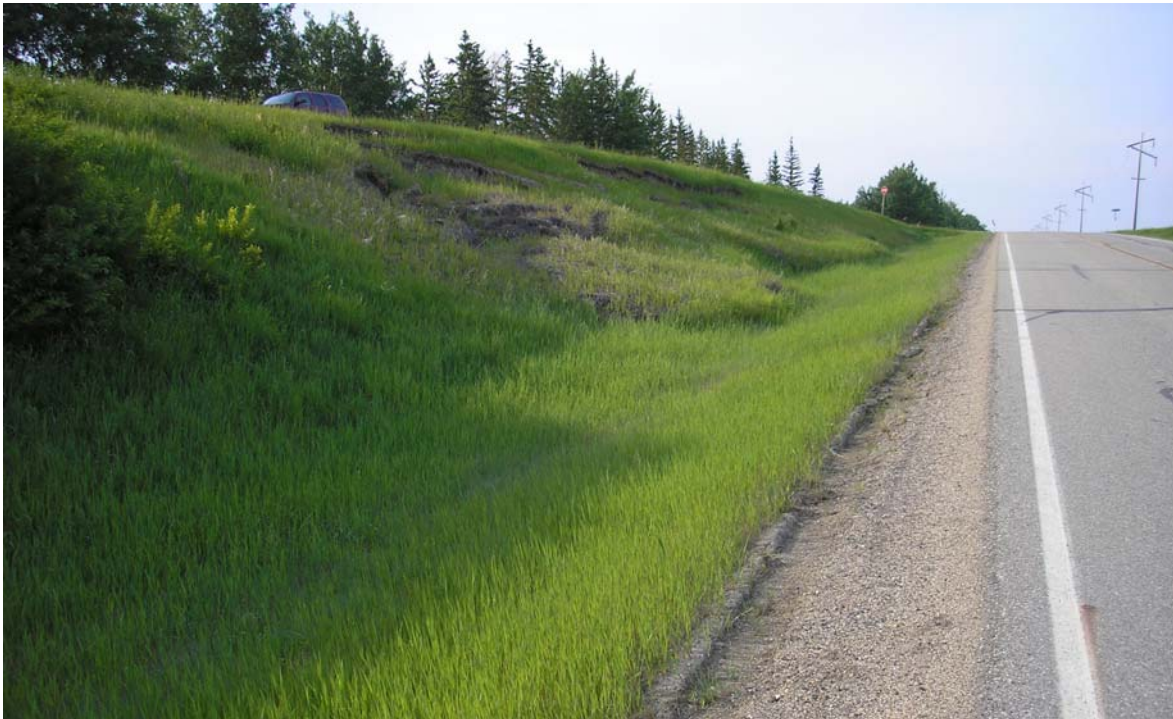
Slide 2 had overall dimensions in plan view of about 50 m by 12 m. The scarp was about 1.0 to 1.5 m high, and was located in the embankment between 1 m to 3.5 m from the east edge of the township road. The soil exposed in the scarp appeared to be silty, medium to high plastic clay fill. The toe pushed into the center of the west highway ditch at a couple of locations, and was as high as 0.4 m. The total height of the embankment varied from 5 m at the north end to about 6 m at the south end of the slide on an approximate 26° to 28° slope.

Photo 2 – Looking north along highway ditch and toe of Slide 2.

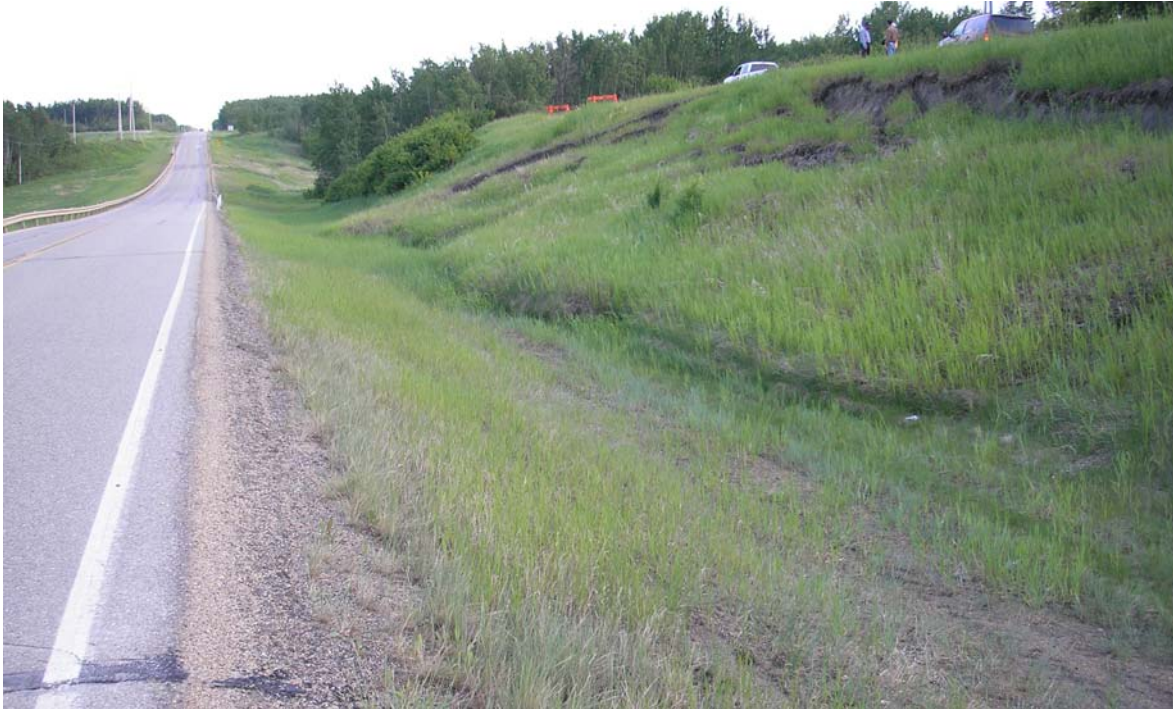
Photo 3 – Looking south along highway ditch at slide area.

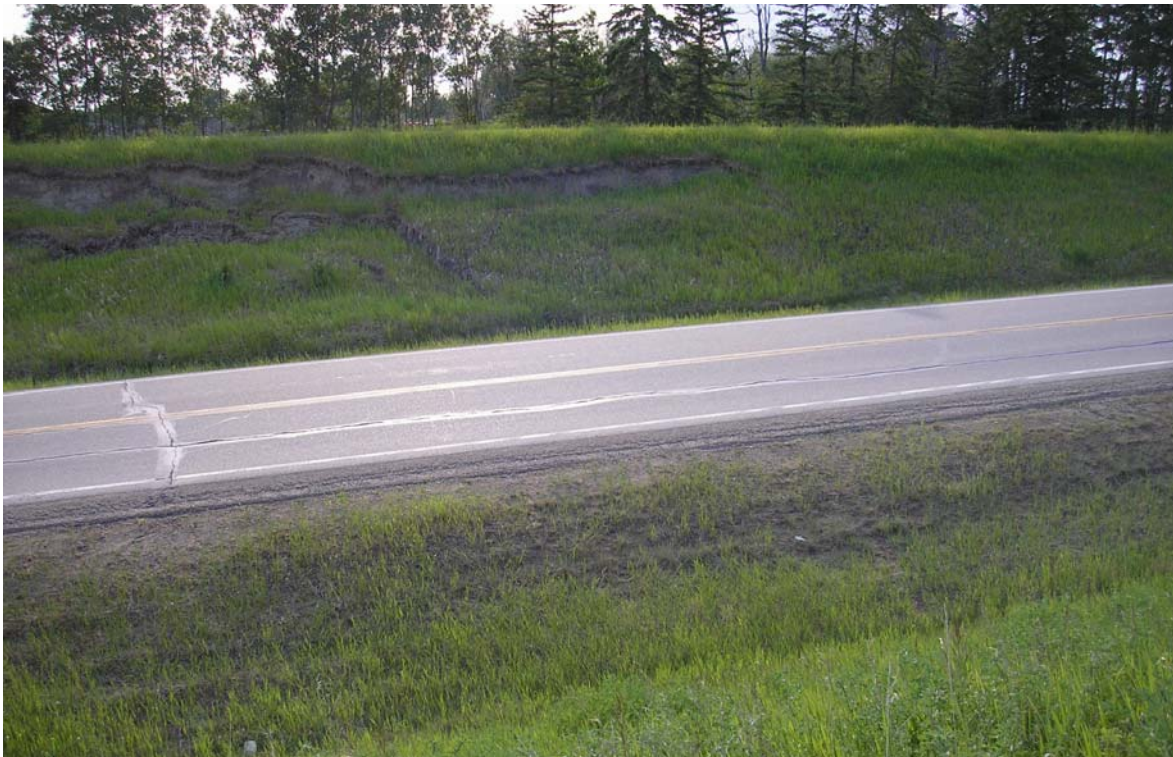
Photo 4 – Looking west at north end of Slide 2.

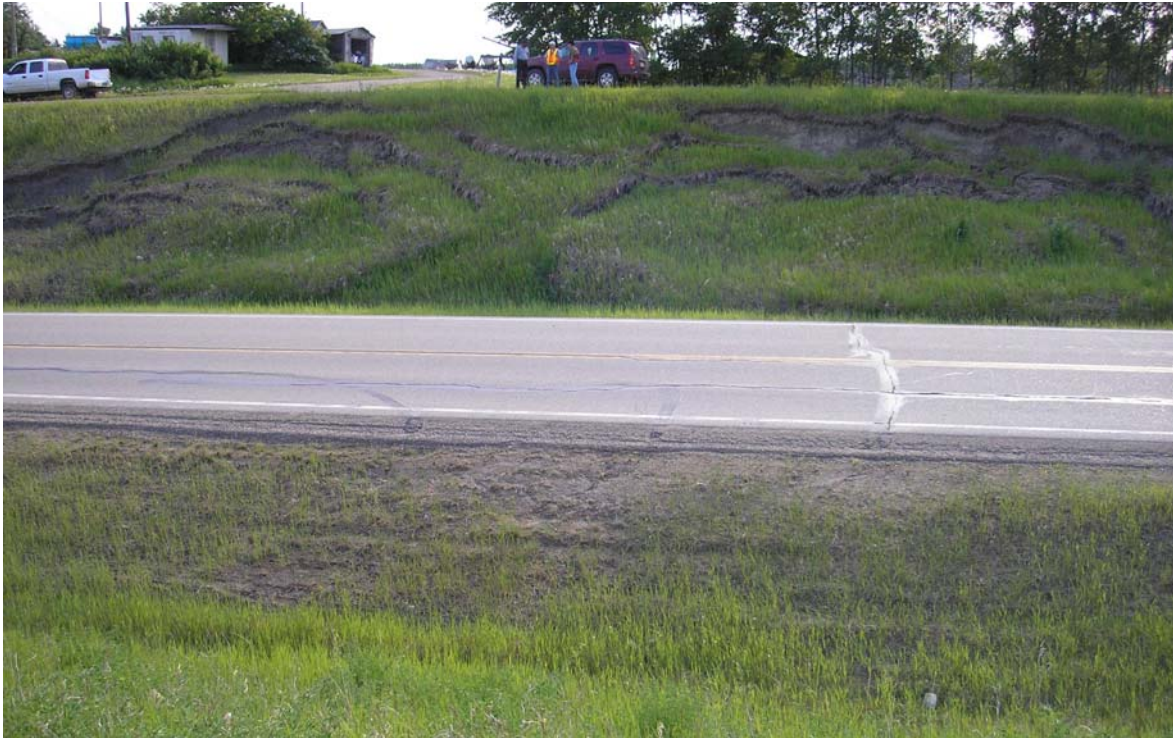
Photo 5 – Looking west at south end of Slide 2.

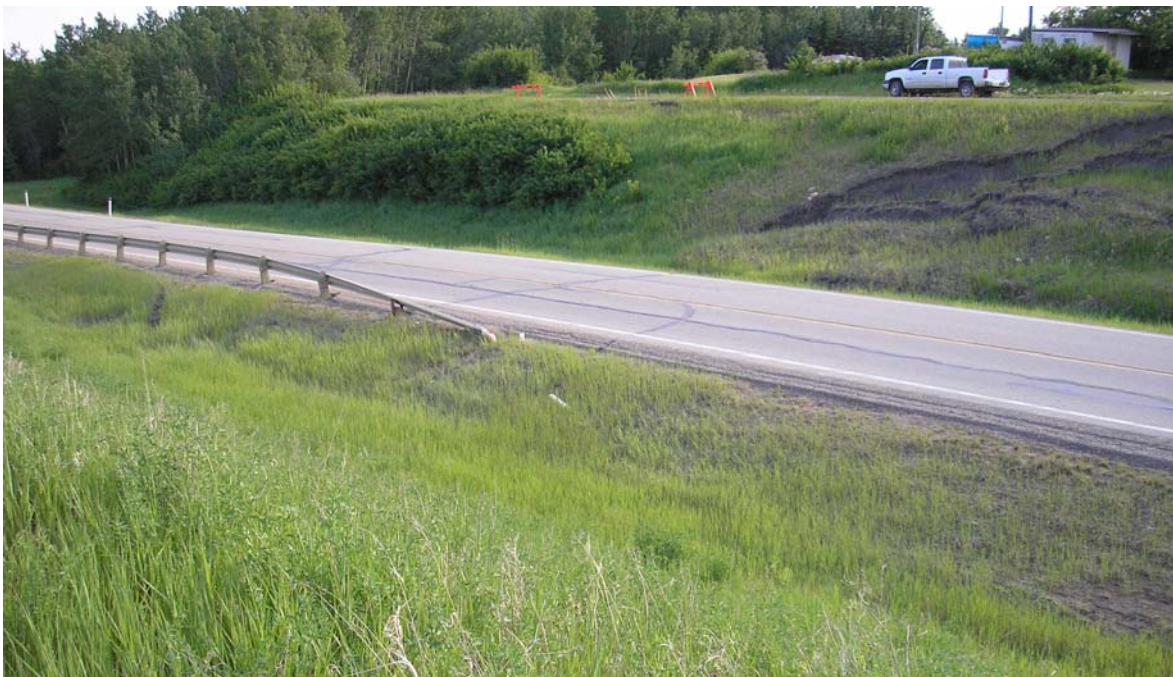
Photo 6 – Looking west at Slide 1.
