December 19, 2005

File: 15-85-12

**PEACE REGION (SWAN HILLS AREA) GEOHAZARD ASSESSMENT
EMBANKMENT FAILURE
ON HWY 749:02, Km 16.10, BANANA BELT – SH 19
2005 ANNUAL INSPECTION REPORT**

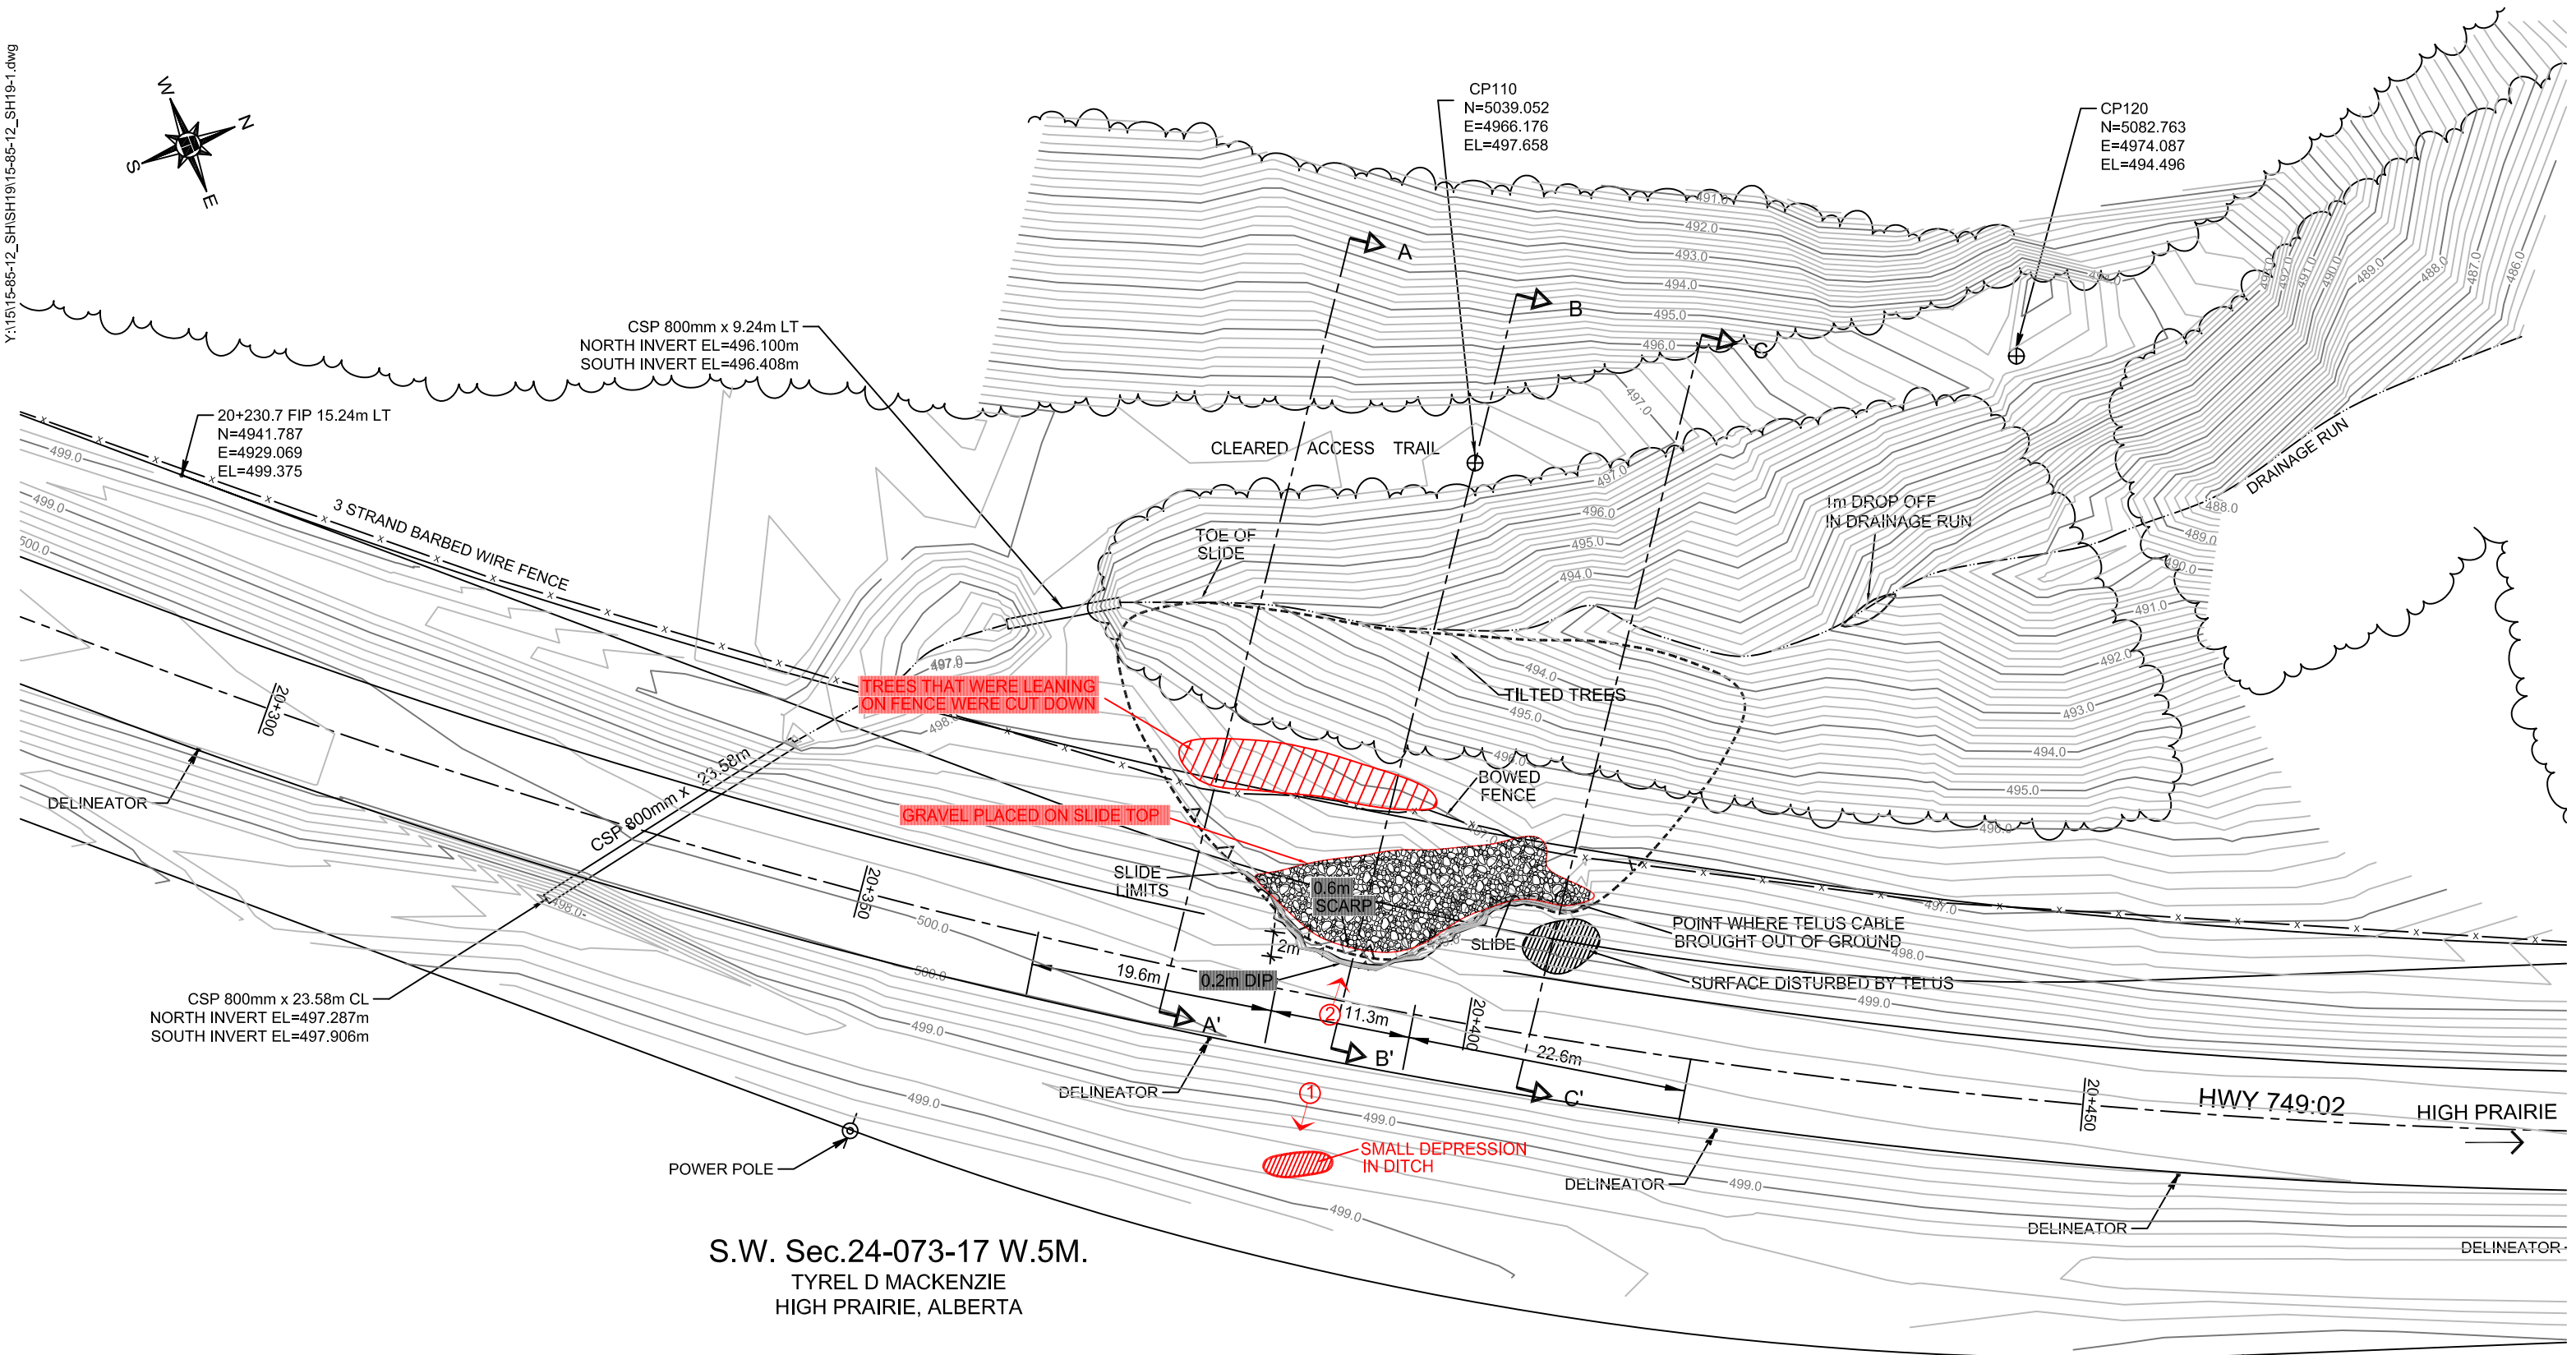
**FIGURE SH19-1, HWY 749:02 km 16.10
SOUTH OF HIGH PRAIRIE, AB
BANANA BELT SLIDE - SH19, SITE PLAN (JUNE 9, 2005)**

The slide occurred on the west side of the highway. The backscarp of the slide was located about 2 m into the paved road surface and the slip surface extended below the side slope to toe out in a natural drainage run. The slope varies in height from about 3.5 m at the south end of the slide to about 7 m at the north end. The upper part of the slope (embankment sideslope) was inclined at about 4.5H:1V while the lower portion which was covered with natural bush varying from about 5H:1V at the south end to 3.8 H:1V at the north end. The slide has a total length of about 53.5 m. As was previously recommended, gravel had been placed on the top portion of the slide including the highway shoulder to lessen the sharp drop-off.

At the time of the visit, no water was flowing in the drainage run and it is believed to be an intermittent drainage course. However, there were a few locations where running water had scoured out parts of the base of the drainage run, the most prominent of which is shown on the site plan. There was an 800 mm diameter centerline CSP that crossed at a skew under the highway to drain water through another shorter pipe located south of the slide under the farmer's access road and into the natural drainage run.

Some erosion protection will be required in the base of the drainage run at the existing scour hole location, and just downstream of the end of the new dissipation bowl downstream of the culvert which co-oincides with the end of an existing approach at the north end.

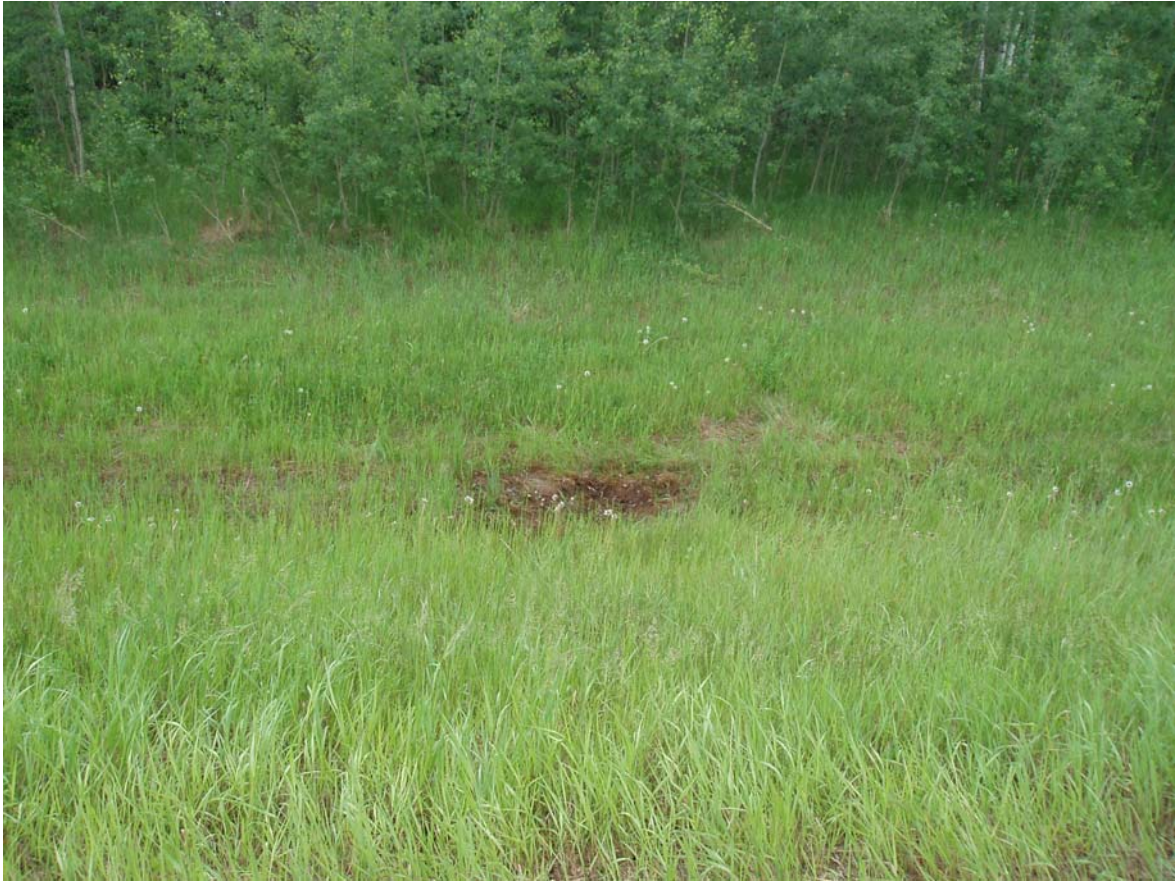
A small depression was observed in the east ditch directly across from the slide, and water may pond in this area during periods of precipitation.

The highway embankment failure appears to be mainly due to saturation of the slope as a result of a prolonged period of rainy weather. The low, saturated area in the east ditch directly across from the slide may also be a source of water feeding the slide. The subsurface conditions below the slope appeared to consist mainly of high plastic clay. Over time, the clay may have become desiccated and weakened by freeze thaw and wet dry cycles which resulted in fissures and /or softened soil into which the rain could permeate. There were no signs of significant erosion at the toe of the slope that could have triggered the slope movement.

Photo 1: Looking southeast at small depression in ditch opposite the slide area.

The small depression area in the east ditch directly across from the slide should be filled with compacted clay to reduce the probability of water ponding and surcharging the slide with water.

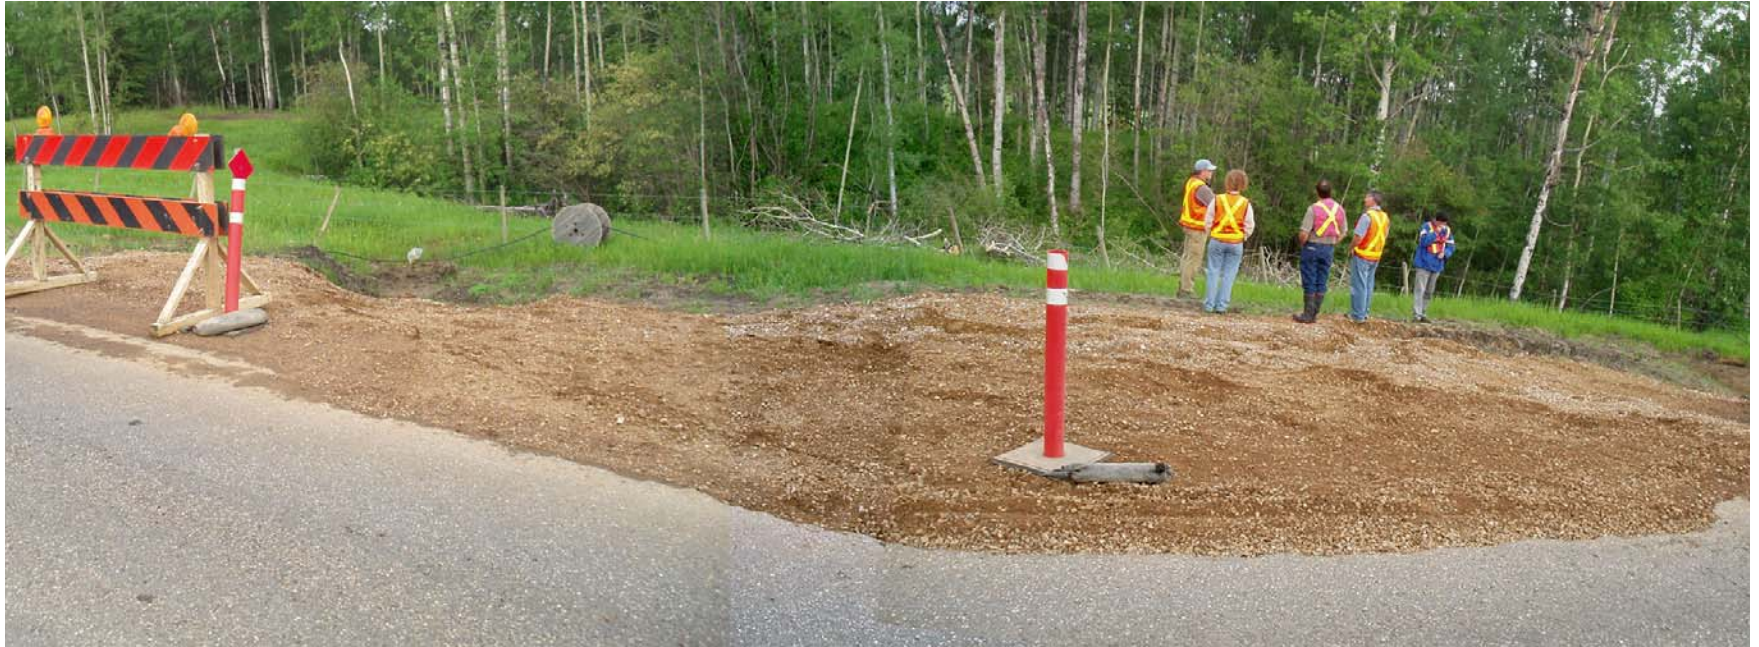
The backscarp of the slide was well defined with a total height of about 0.6 m. The exposed pavement structure consisted of 250 mm of asphalt concrete over 200 mm of soil cement over high plastic clay. The slope area in the vicinity of the slide was very soft and saturated with water at the time of the visit. Some water was present pooled along the base of the backscarp crack. The location where Telus pulled out the cable from the slope was badly rutted by the equipment. The slide movement had bowed out the barbed wire fence located at the west edge of the highway right-of-way. Tilted trees were present at the toe of the slope where the slide toe roll was present. The trees that were leaning on the fence were cut down by someone prior to this visit.

Photo 2: Looking northwest at slumped area from edge of highway embankment.

The slide is currently affecting the roadway and could continue to retrogress into the pavement due to the relatively high backscarp. Barricades and warning signs should be maintained around the slide area to warn motorists of the hazard and the slide should be inspected on a daily basis so that signs can be moved, or a detour constructed if the slide worsens.
