THURBER ENGINEERING LTD.

December 11, 2006

File: 15-85-38

**PEACE REGION (SWAN HILLS AREA) GEOHAZARD ASSESSMENT
EMBANKMENT FAILURE
ON HWY 749:02, Km 16.10, BANANA BELT – SH 19
2006 ANNUAL INSPECTION REPORT**

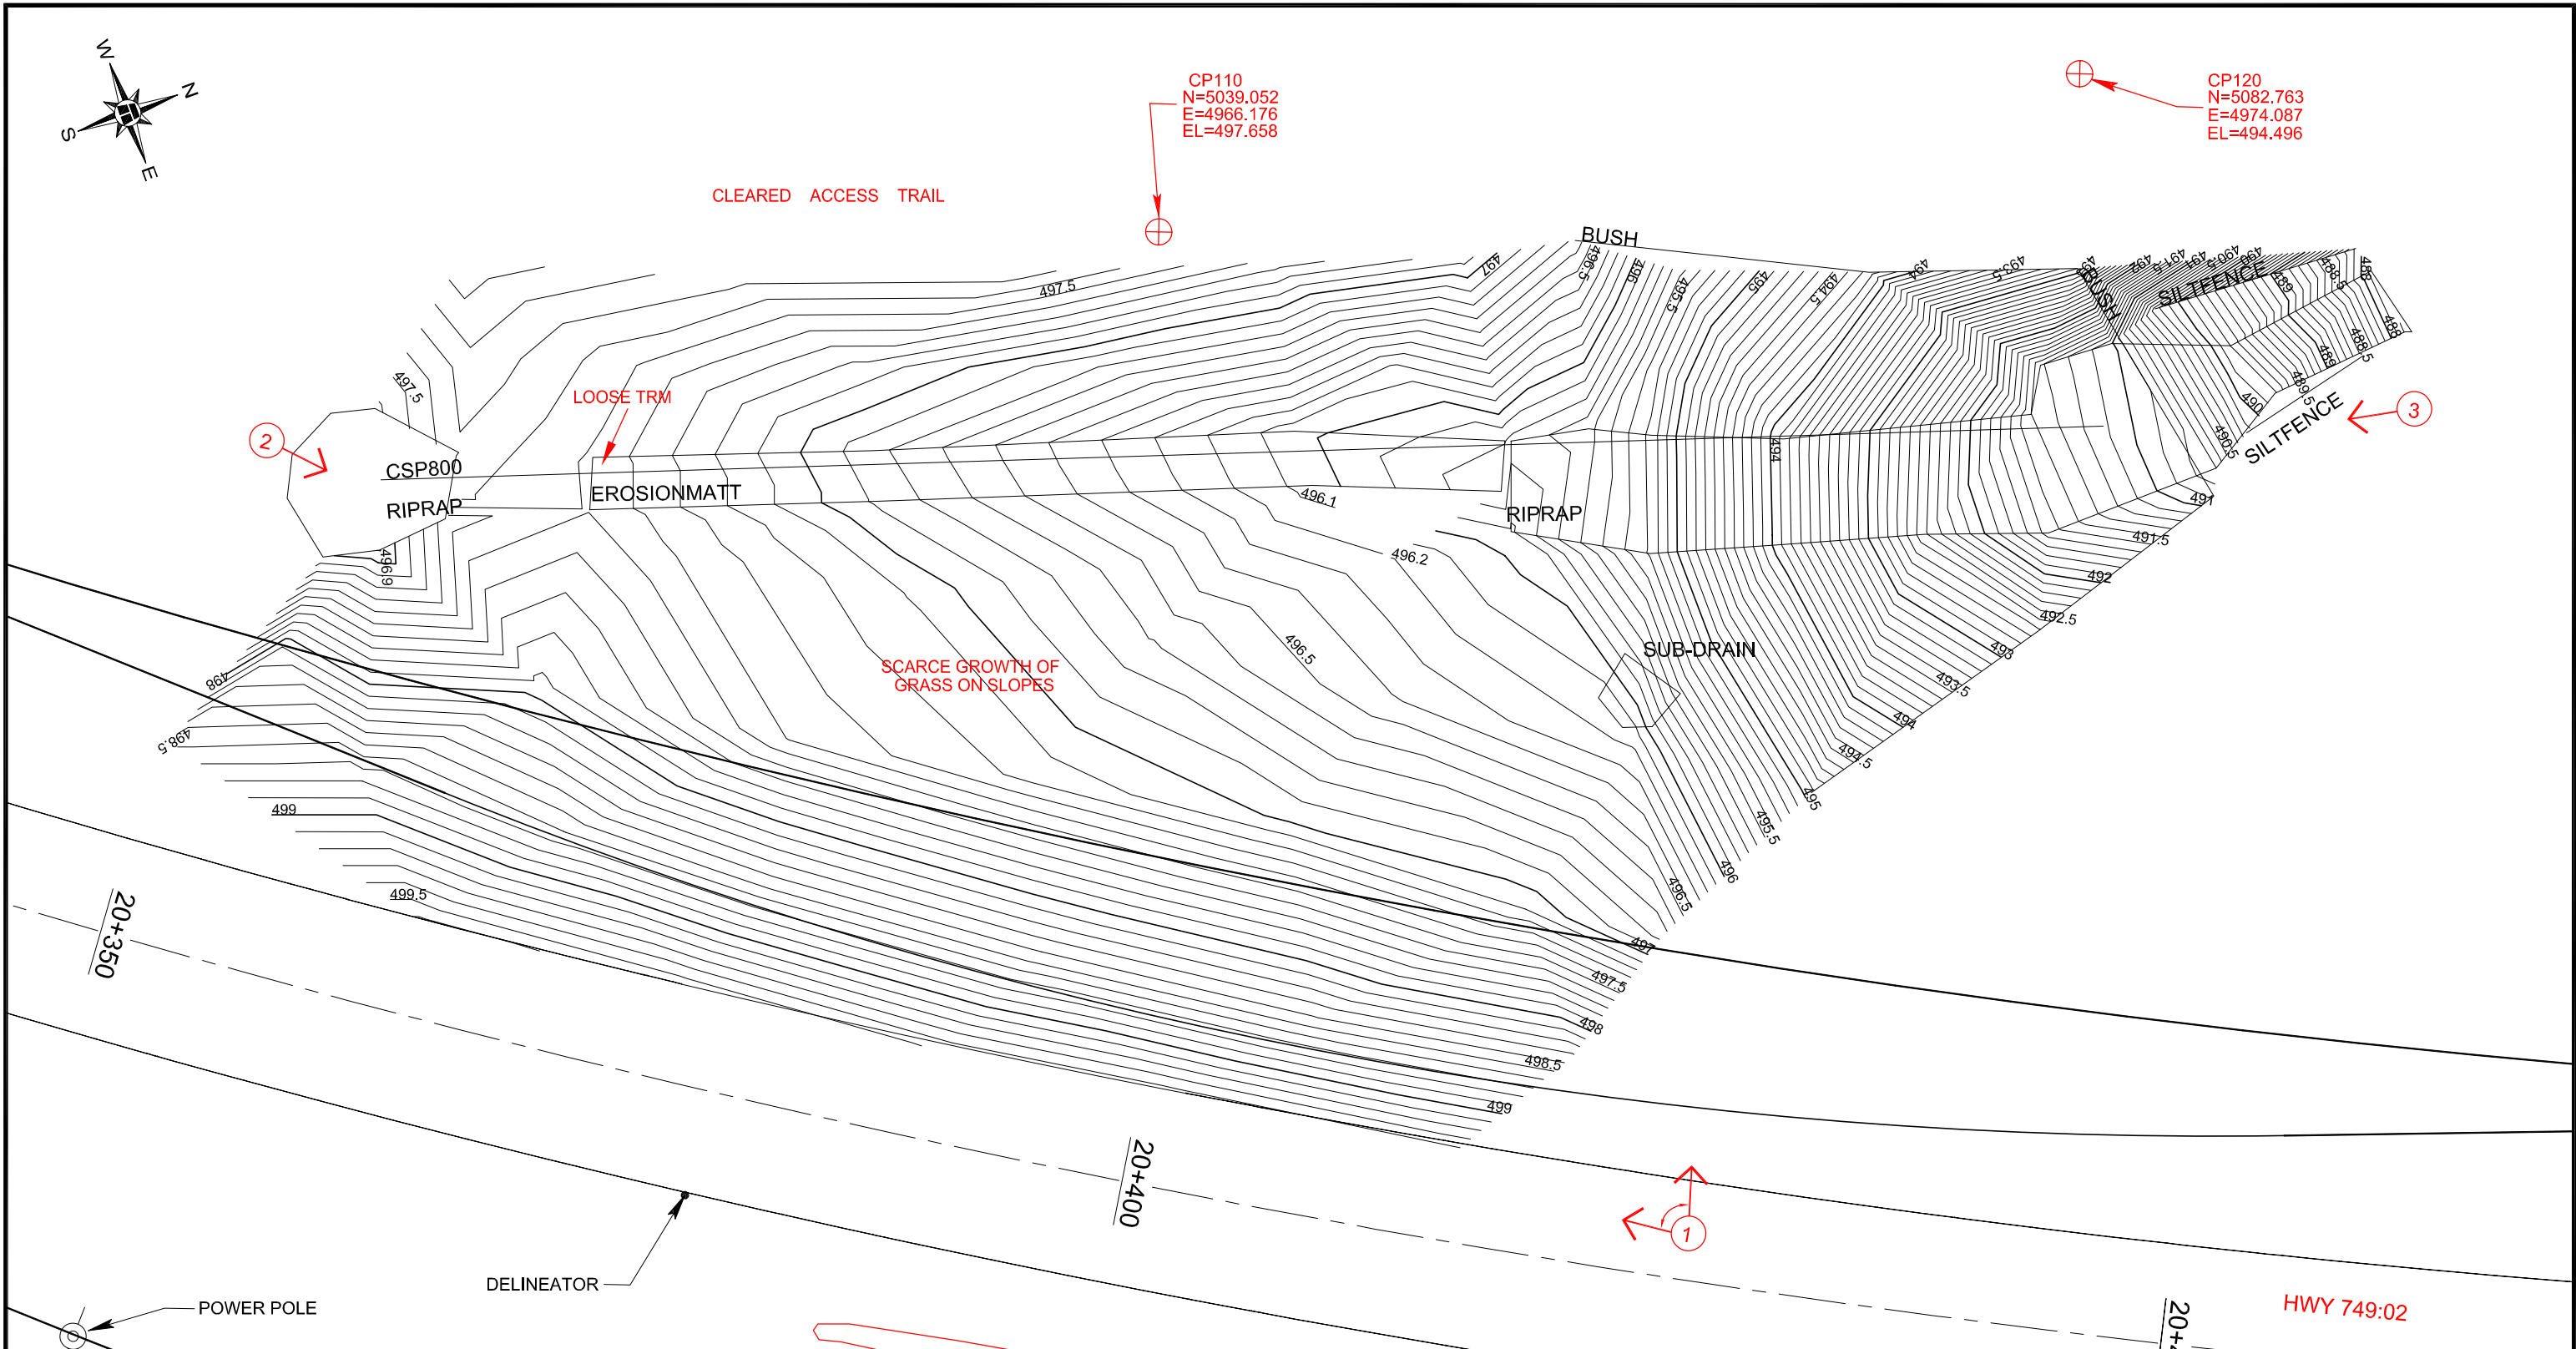
**FINAL AS-BUILT CONTOUR
PLAN OF SLIDE REPAIRS**

A few minor depressions were observed in the east ditch directly across from the slide, and water was ponding in them after periods of rain. The fence along the slide area was erected by the farmer on thin steel posts, which met one of the requirements of the former conditional construction completion certificate.

The low, saturated area in the east ditch directly across from the slide still collects storm water and may continue to be a source of water, feeding the repaired slide zone. A check should be kept on the amount of ponding within this section; it could still feed the slope and could eventually affect the repairs performed on the main slide area.

NOTE
X 2006 OBSERVATIONS
ARE SHOWN IN RED

POOLED WATER
IN EAST DITCH

The slide repair work undertaken is performing satisfactorily and it is recommended to undertake regular maintenance/cleaning of the culvert inlets and outlets along with a check on the pooling of water in the east ditch of the highway. It may be necessary to place some topsoil in the east ditch to correct the pooling issue.

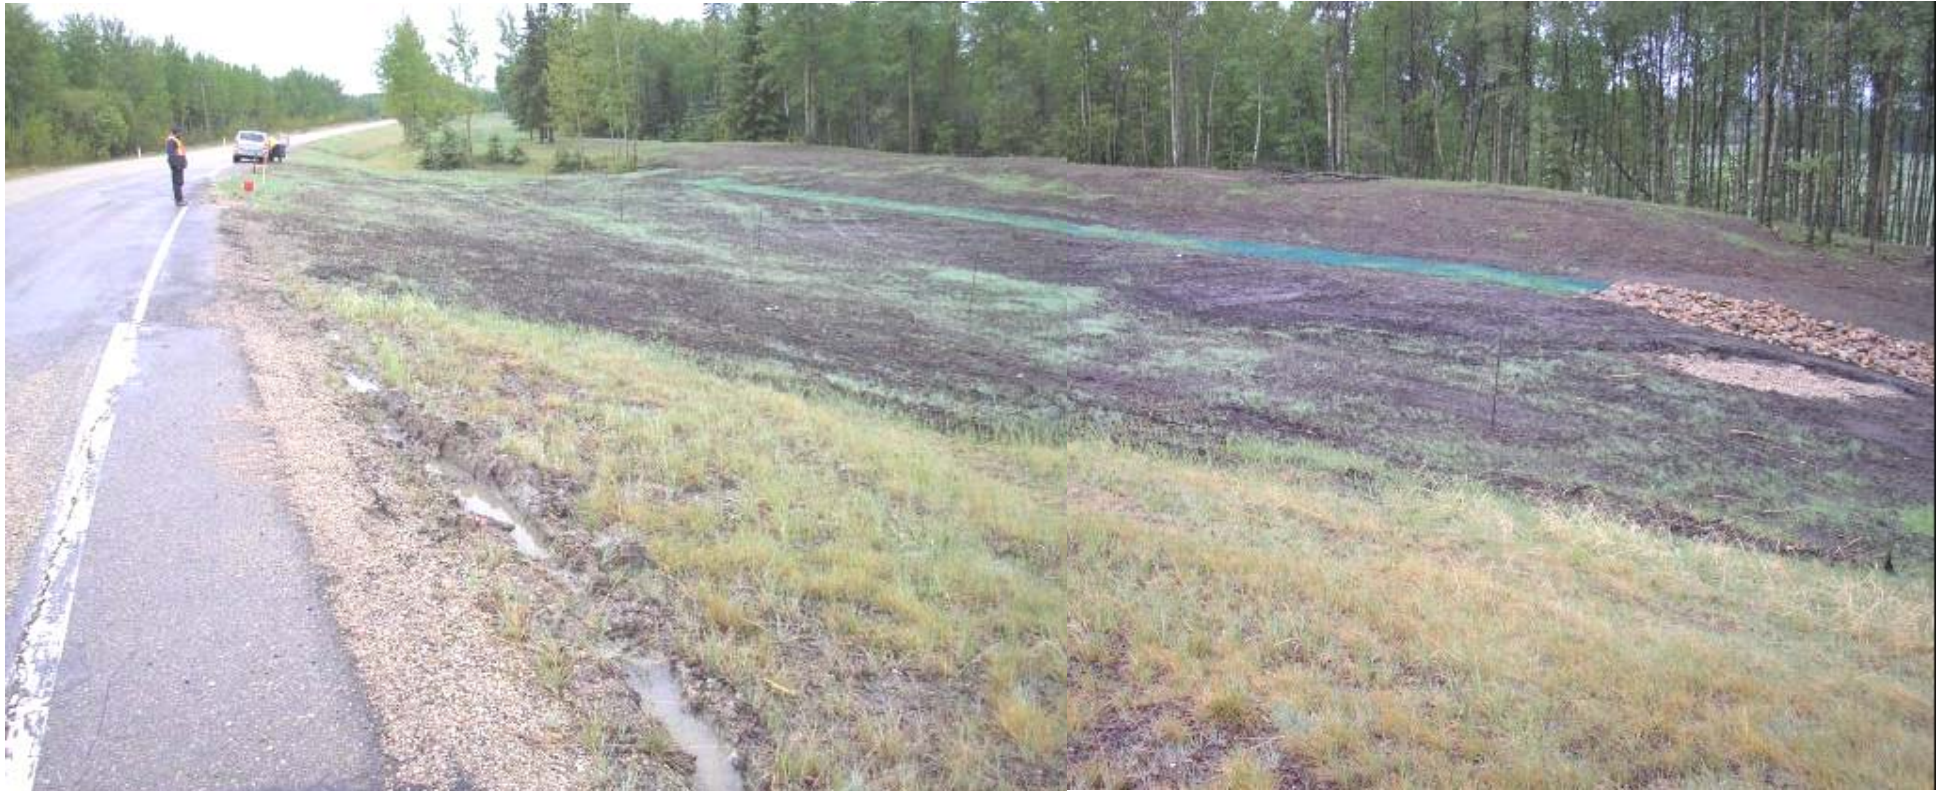
The main slide rehabilitation appears to be performing well at this stage.

Photo 1 - Panoramic view of the Banana Belt Slide Area, May 24, 2006.

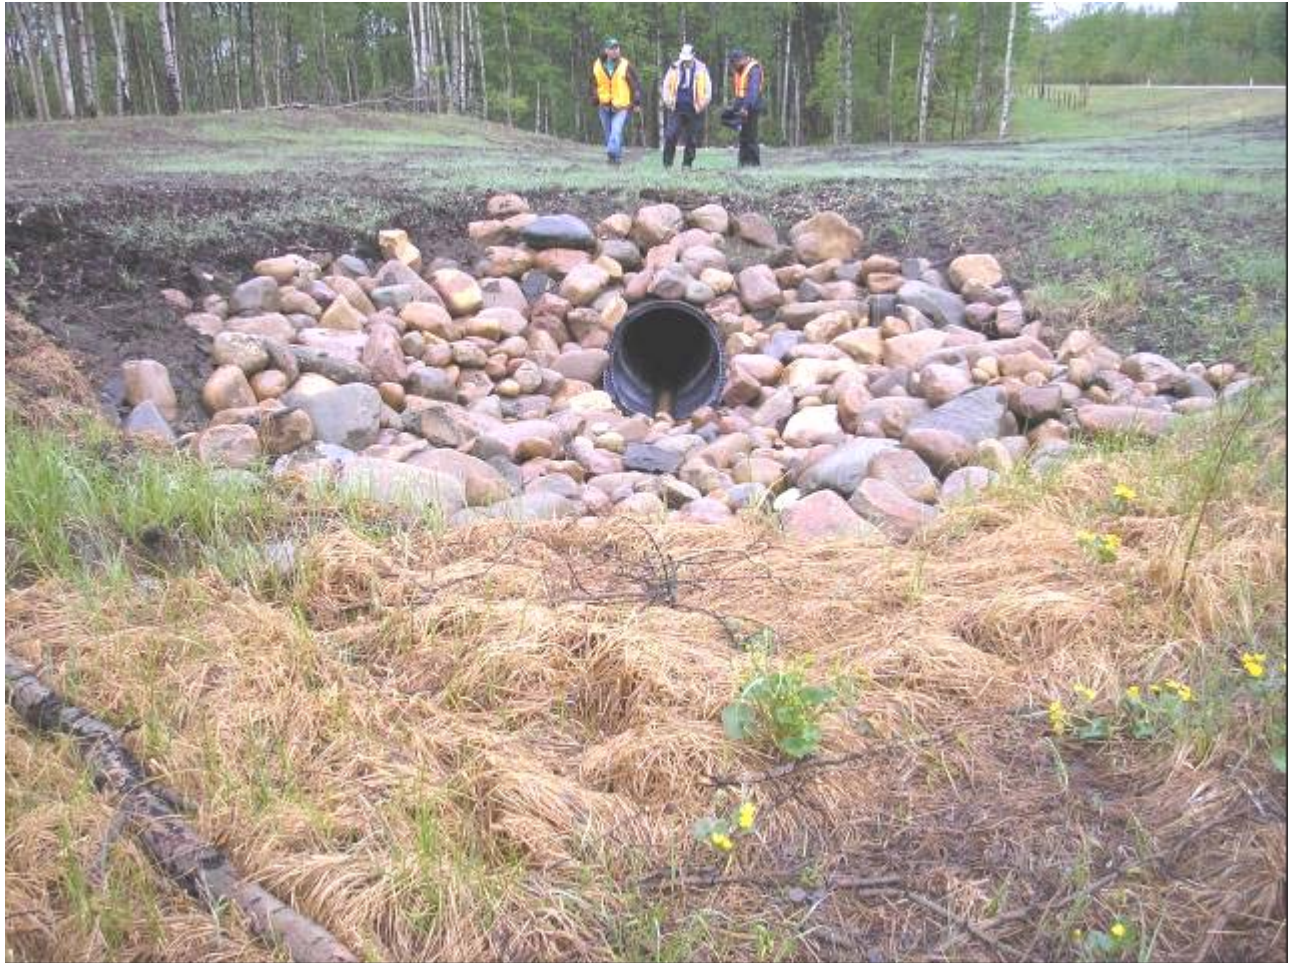
Photo 2 - Looking north at culvert inlet, May 24, 2006.

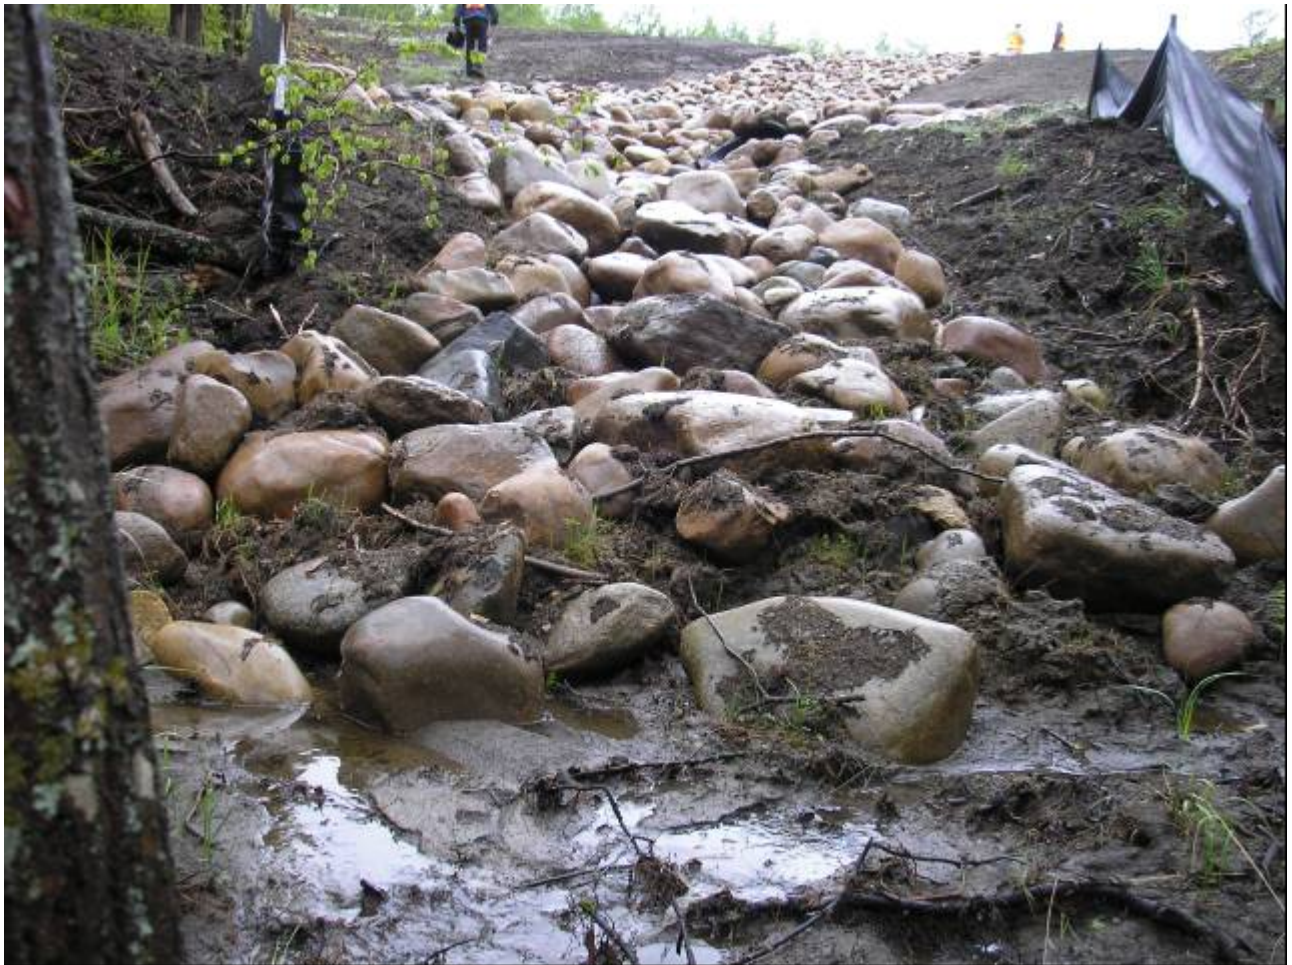
At the time of the visit, there was only a small amount of discharge from the culvert. There was an existing 800 mm diameter centerline CSP that crossed the highway at a skew south of the slide area draining into the natural drainage run

over which the berm had been constructed. The silt fences installed along the culvert outlet were erect and were performing to satisfaction.

Photo 3 - Looking south at culvert outlet, May 24, 2006.
