GEOHAZARD ASSESSMENT PROGRAM

PEACE RIVER / HIGH LEVEL AREA

2009 INSPECTION

FIGURE PH58-1
PH58 : CULVERT CROSSING ON HWY 986:02 WEST OF CADOTTE LAKE
PEACE REGION (PEACE RIVER / HIGH LEVEL) GEOHAZARD ASSESSMENT

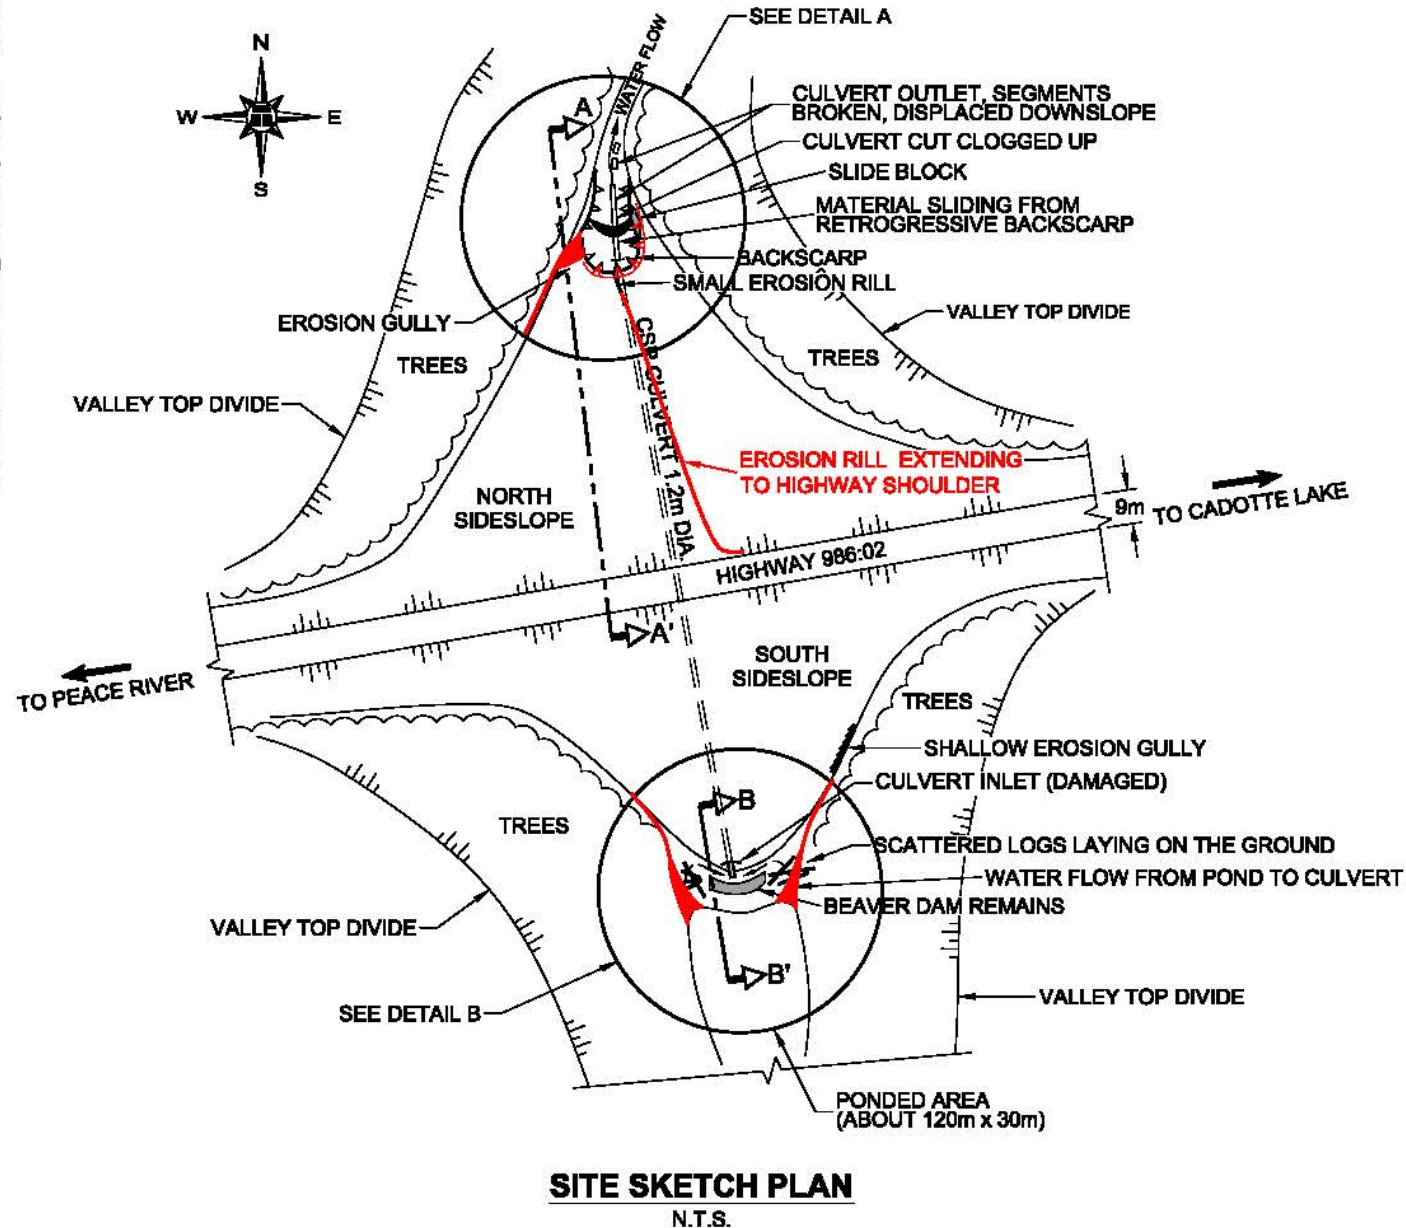
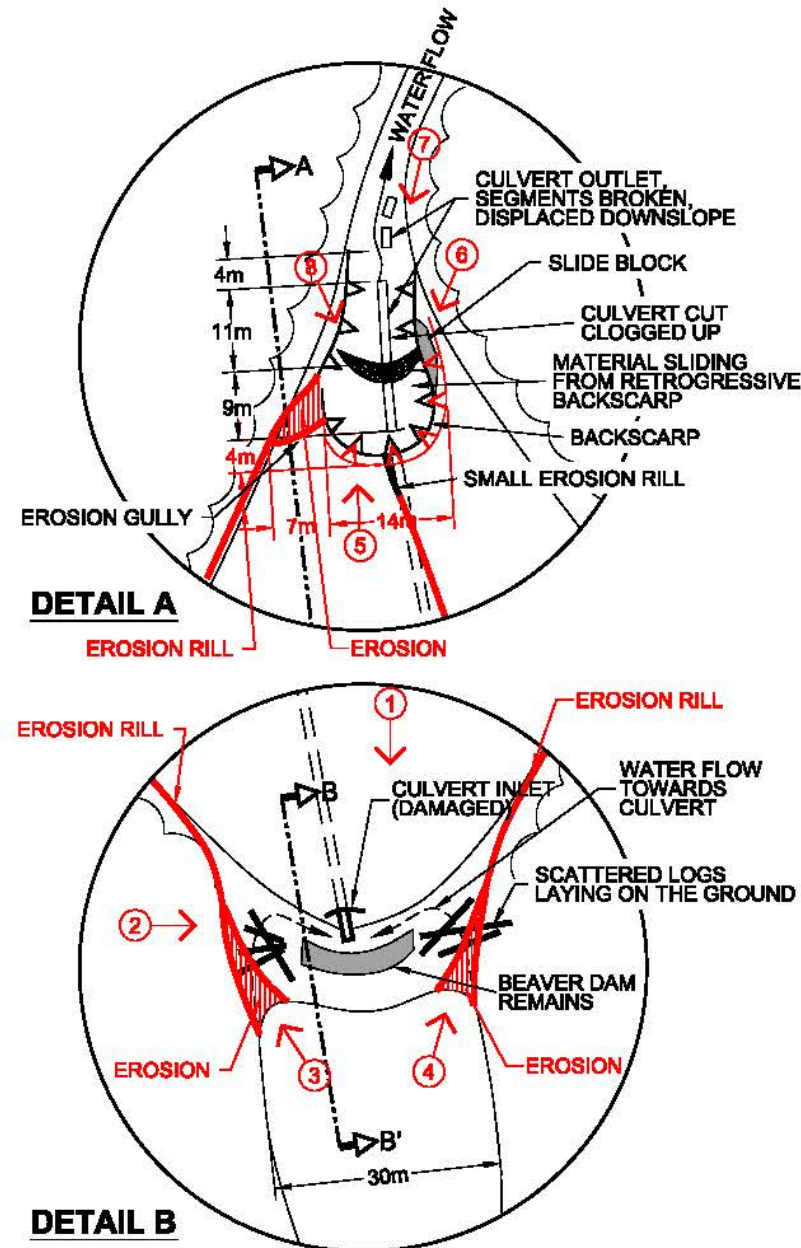
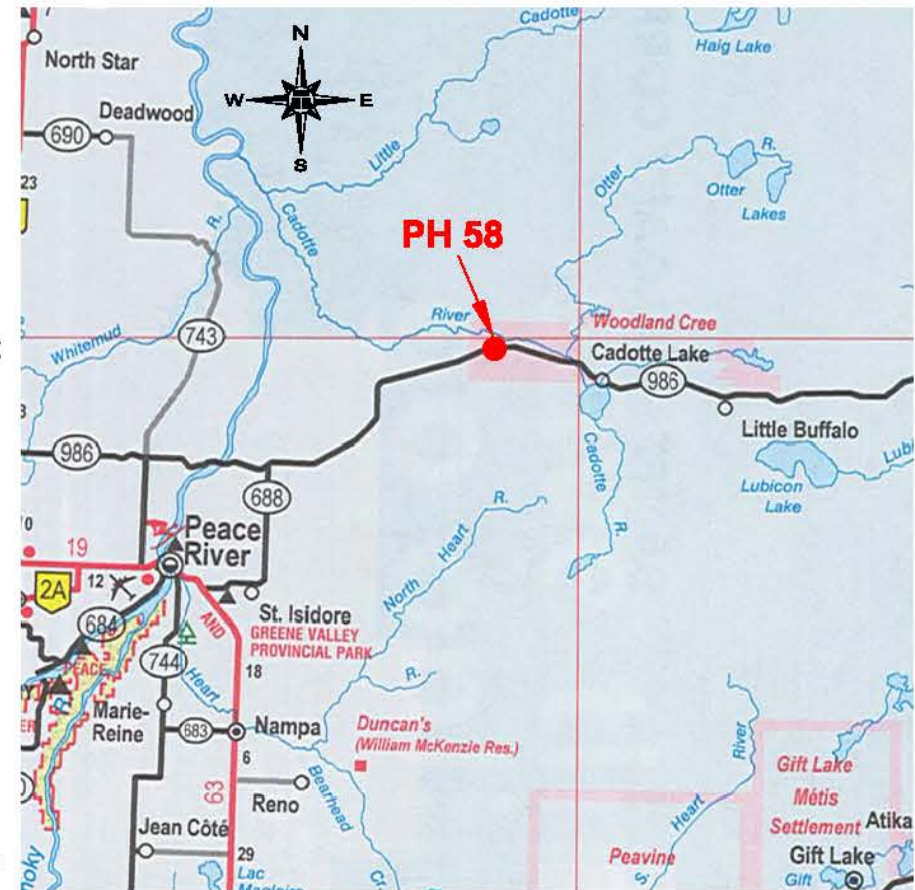
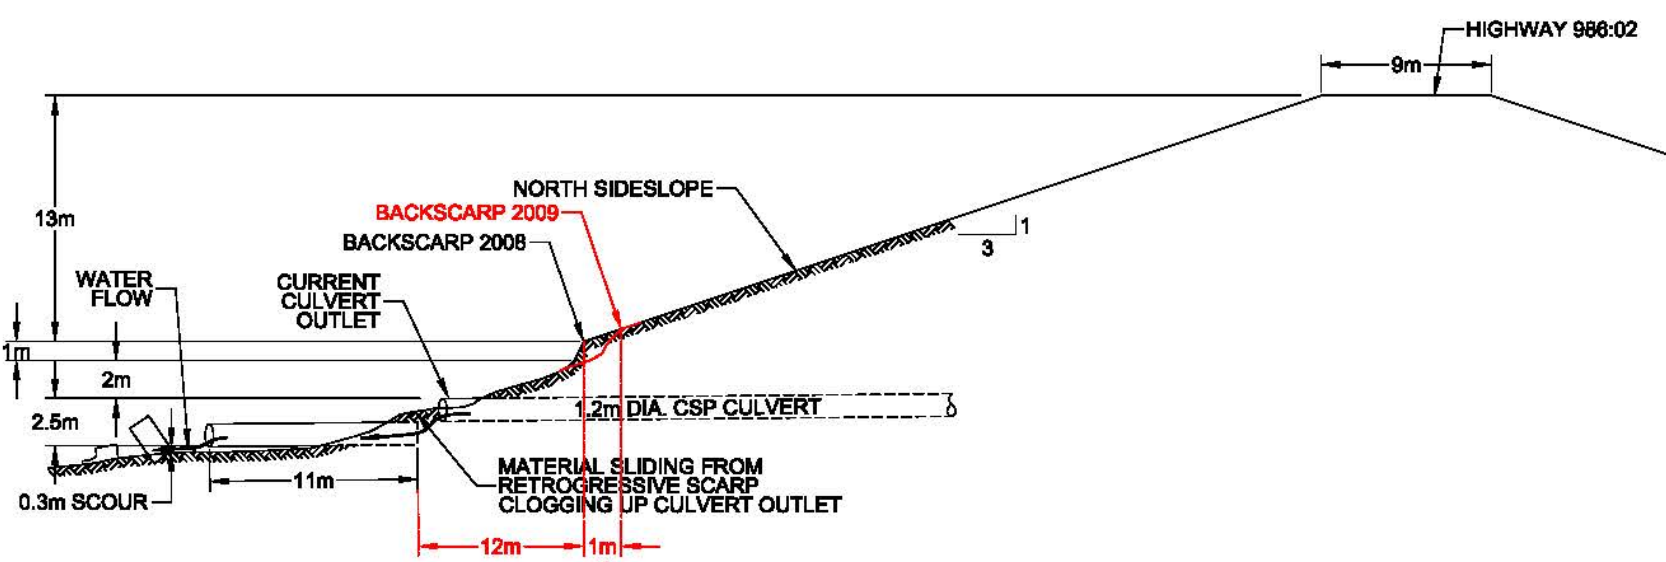
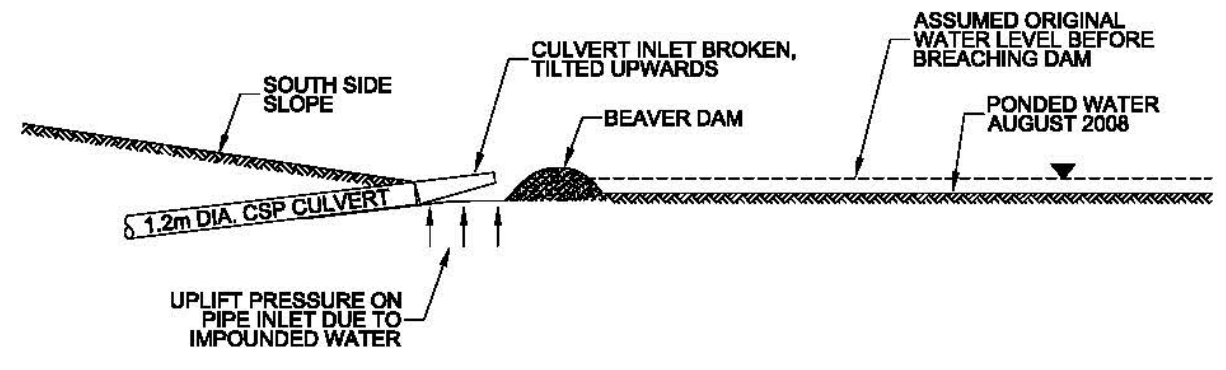
Culvert Inlet: The beaver dam appears to have blocked the creek flow and created a pond upstream of the culvert. Seepage under the beaver dam appears to have exerted uplift pressures that heaved the culvert inlet. The water level rising behind the dam kept pushing the culvert inlet upwards, breaking it.

Culvert Outlet: The slump may have been triggered by erosion / scour at the outlet of the culvert. Seepage from the highway embankment may have been a contributing factor. The

slumped soil is partially blocking culvert flow and becoming saturated. The slump is expected to continue to retrogress towards the highway if repairs are not carried out. Based on the length of the broken CSP segments located downslope of the slump, location of the slip failure was roughly about 15 m inside the body of the embankment, measured from the culvert outlet.

Repairs to the culvert inlet are required. The damaged pipe section needs to be removed and a small excavation of the embankment toe near the culvert inlet is required to provide access for repairs. A new pipe section needs to be installed.

The recommended repair at the outlet is to excavate the slumped material to undisturbed soil below and behind the slide surface and to dispose of the wet clay and broken culvert pieces. A blanket of free draining granular material should then be draped over the lower 1/3 of the excavation, separated from the native soil by a non-woven geotextile. The culvert should be extended to a longer length than the original to allow a berm to be constructed to flatten the overall inclination of the sideslope. A rip rap lined flow dissipation bowl should be constructed beyond the outlet of the extended pipe.

A topographic survey, stability analysis and fisheries assessment should be carried out to complete the design.

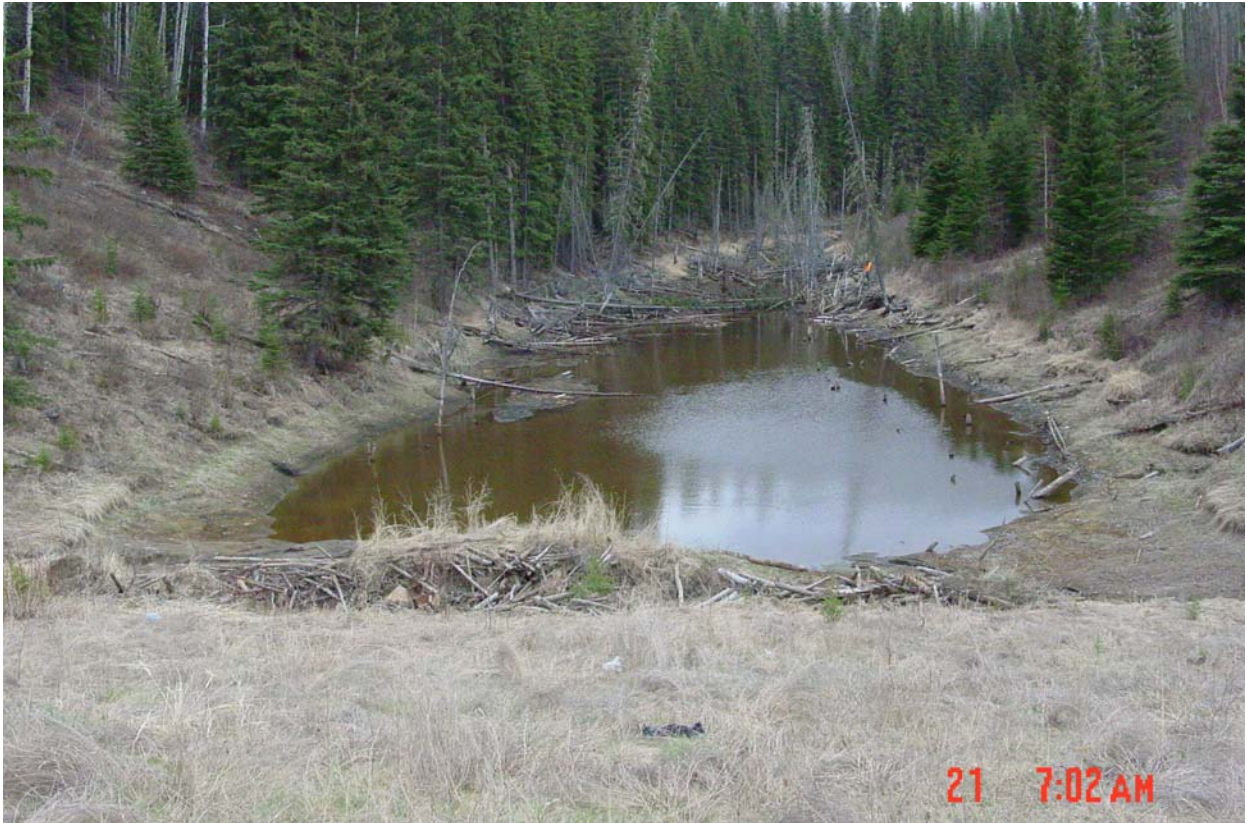
Photo 1: View of south sideslope, beaver dam remains with ponded water south of culvert inlet.

The remains of the beaver dam should be excavated down to the original ground level to drain as much water as possible and the logs scattered near the culvert inlet need to be removed to avoid drift from blocking the culvert. Measures have to be taken to prevent beavers from building a new dam.

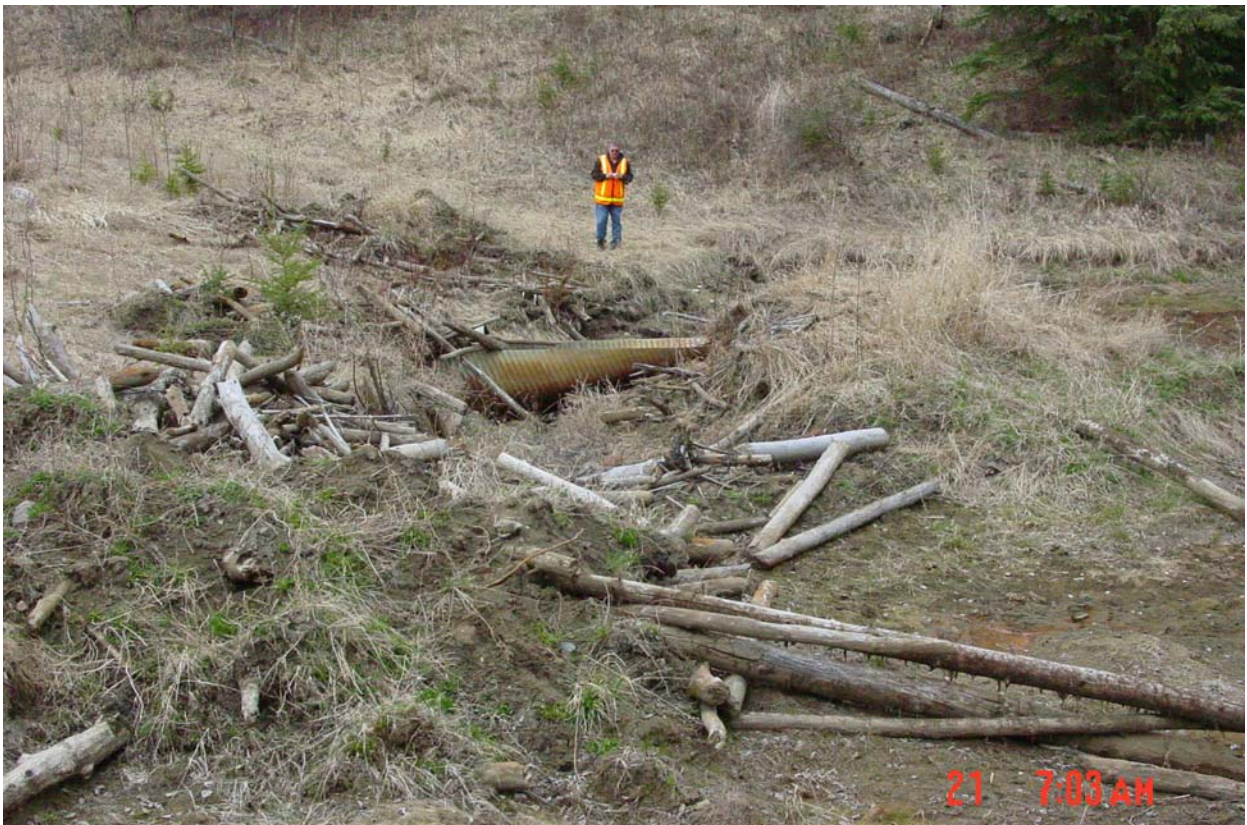
Photo 2: Damaged culvert inlet tilted upwards, looking east.

To repair the inlet, it should be backfilled with well compacted medium plastic clay to re-establish a plug. Rip rap erosion protection should be placed around the inlet in accordance with AT standards.

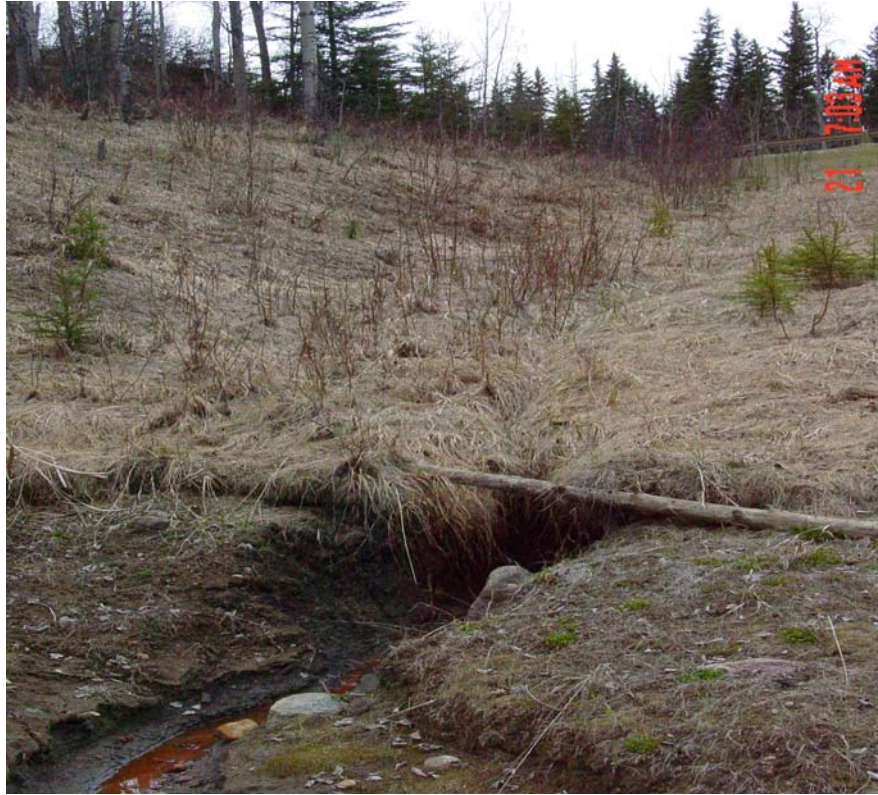
Photo 3: Erosion rill extending from highway, west of culvert inlet, looking northwest.

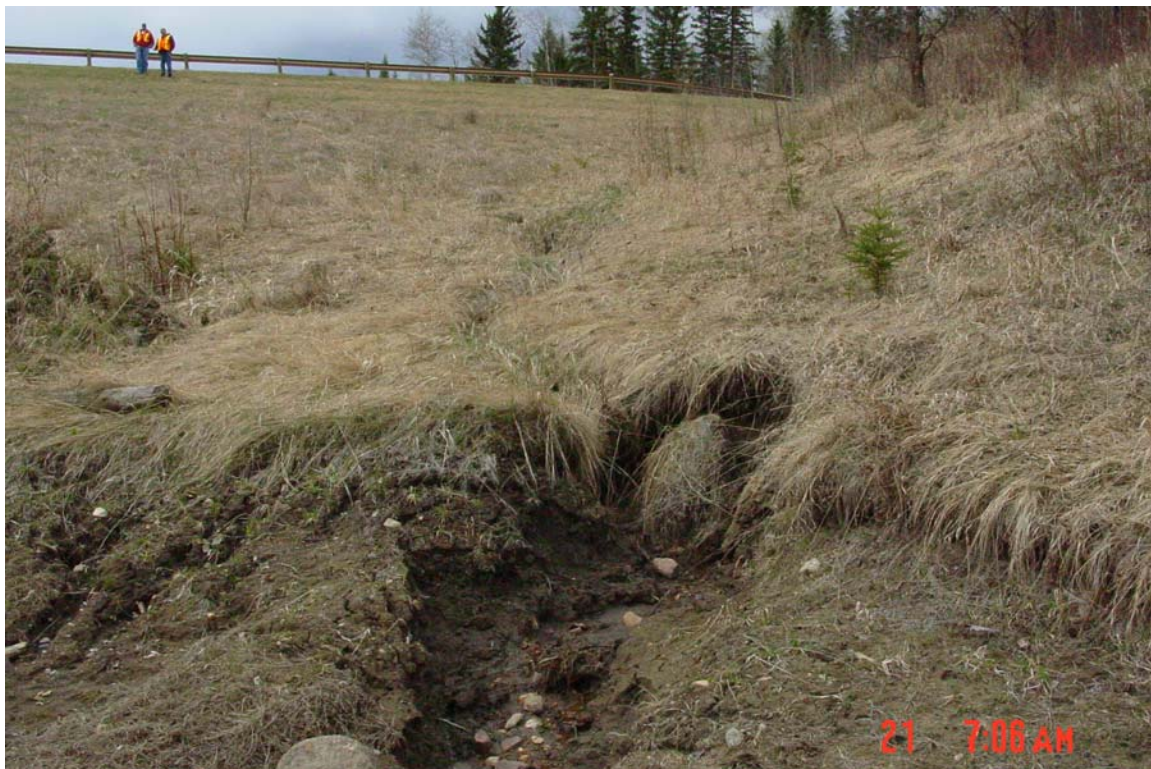
Photo 4: Erosion rill extending from highway, east of culvert inlet, looking northeast.

The erosion rill east of the culvert inlet should be backfilled with clay, topsoil, seeded and covered with high flow soil covering (RECP). A flat-bottom swale should be formed at this repair to avoid concentration of runoff.

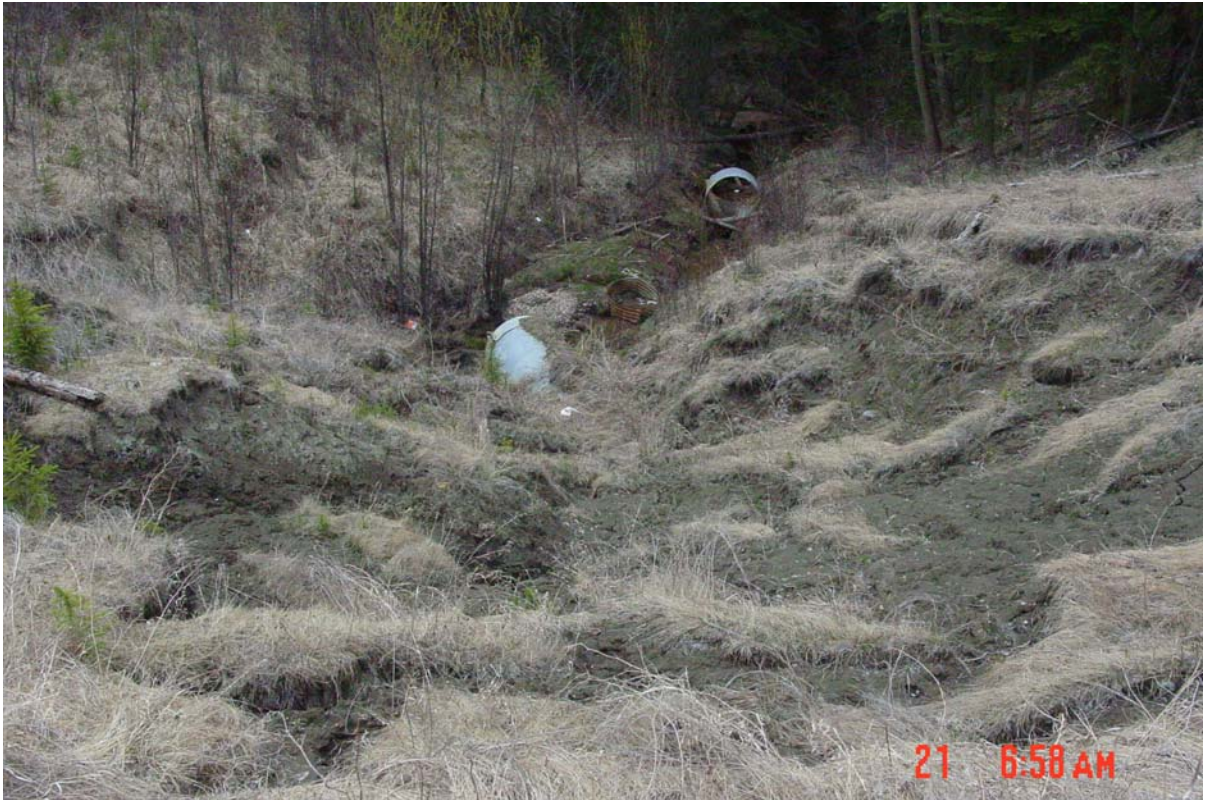
Photo 5: View of slope failure at culvert outlet location looking north.

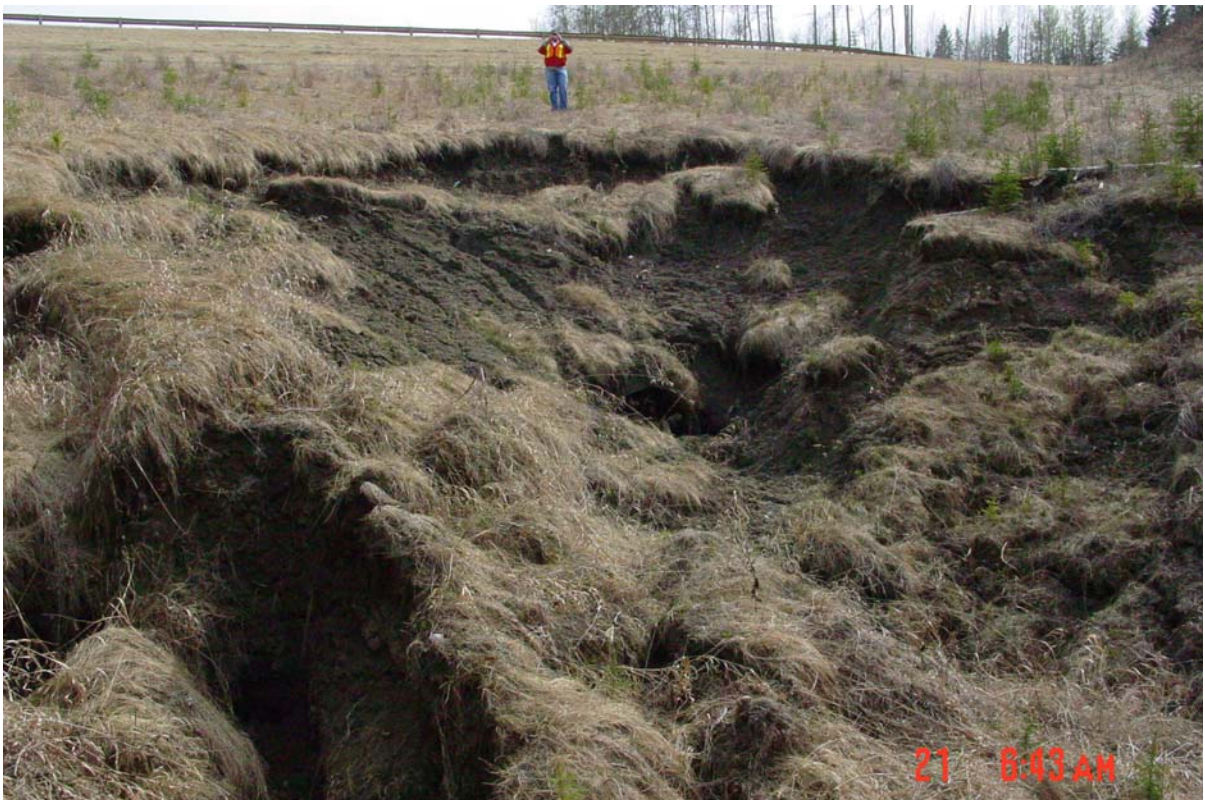
Photo 6: View of pipe severed by slope failure a few meters above the culvert outlet location, looking south.

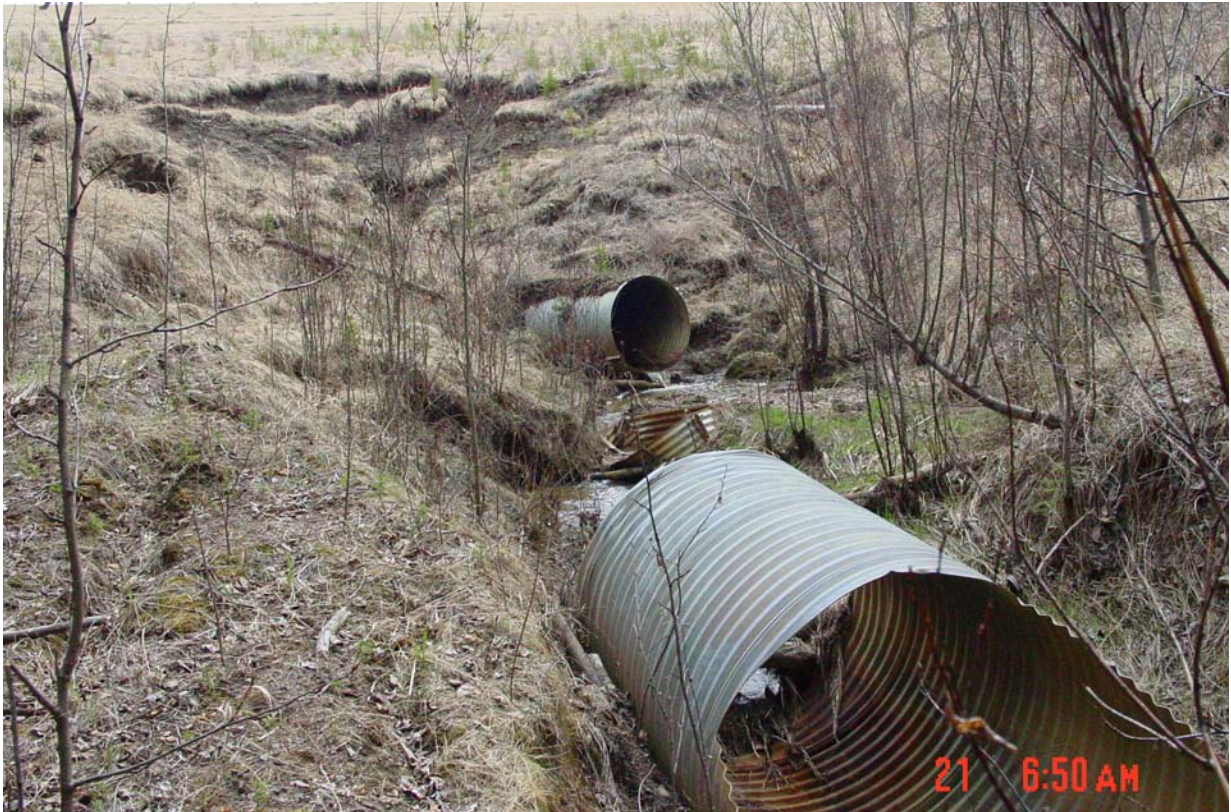
Photo 7: Pipe destroyed at culvert outlet location, looking south.

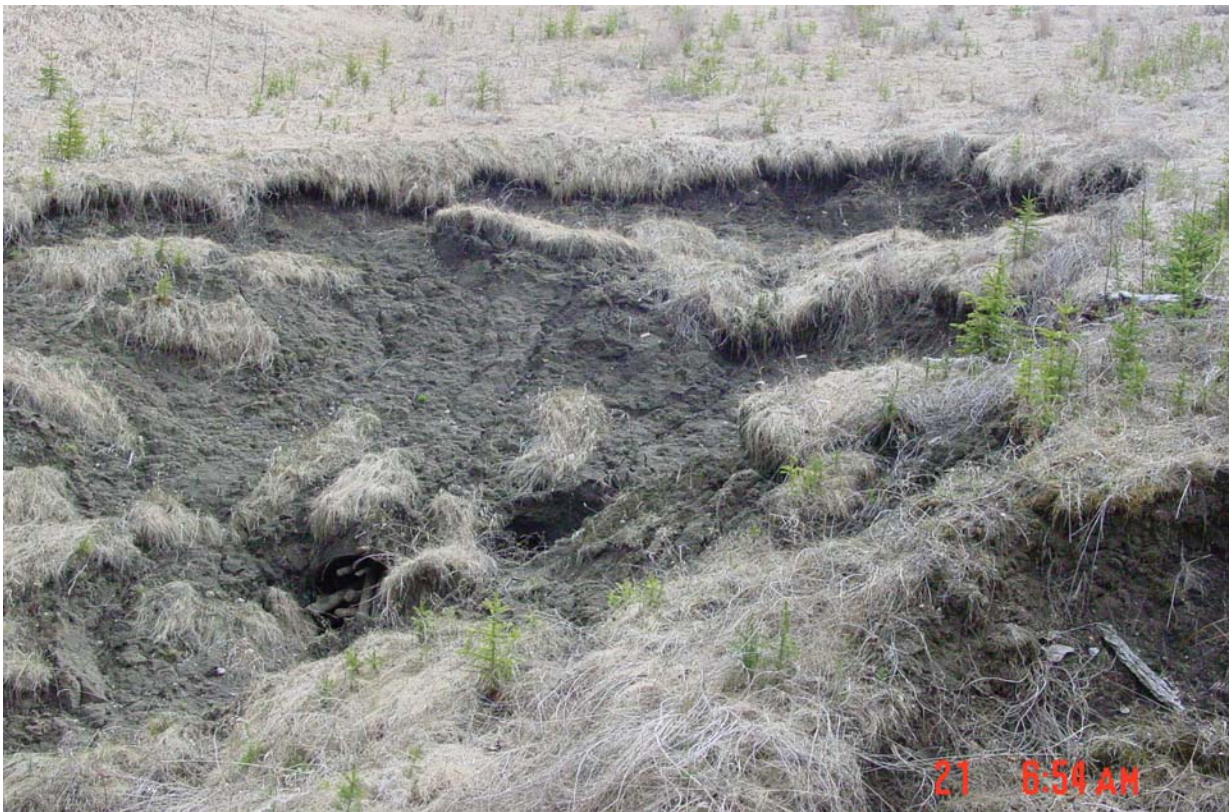
Photo 8: View of backscarp and clogged pipe above the culvert outlet location, looking northwest.
