GEOHAZARD ASSESSMENT PROGRAM

PEACE RIVER / HIGH LEVEL AREA

2010 INSPECTION

Site Number	Location	Name	Hwy	km
PH58	Northeast of Town of Peace River, AB	Cadotte Lake	986:02	Approx. 41
Legal Description		UTM Co-ordinates		
NW1/4 35-86-17-W4M		11V N 6262615	E 526085

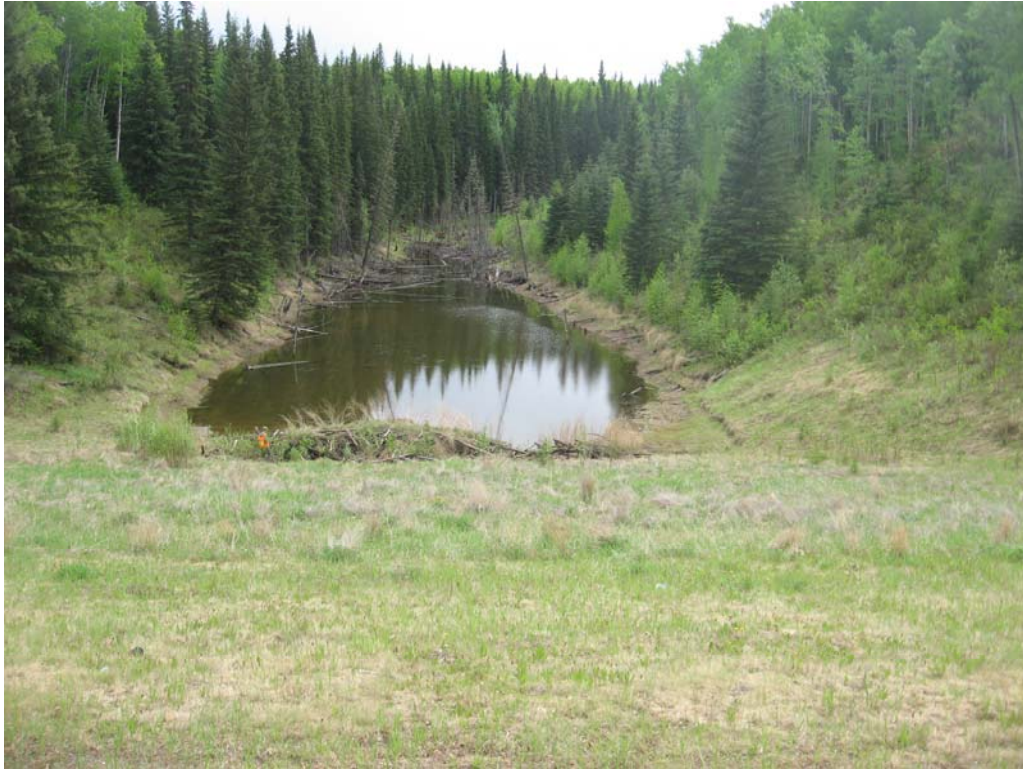
Photo 1: View of south sideslope, beaver dam remains and ponded water, south of culvert inlet.

The remains of the beaver dam should be excavated down to the original ground level to drain as much water as possible and the logs scattered near the culvert inlet need to be removed to avoid drift from blocking the culvert. Measures have to be taken to prevent beavers from building a new dam.

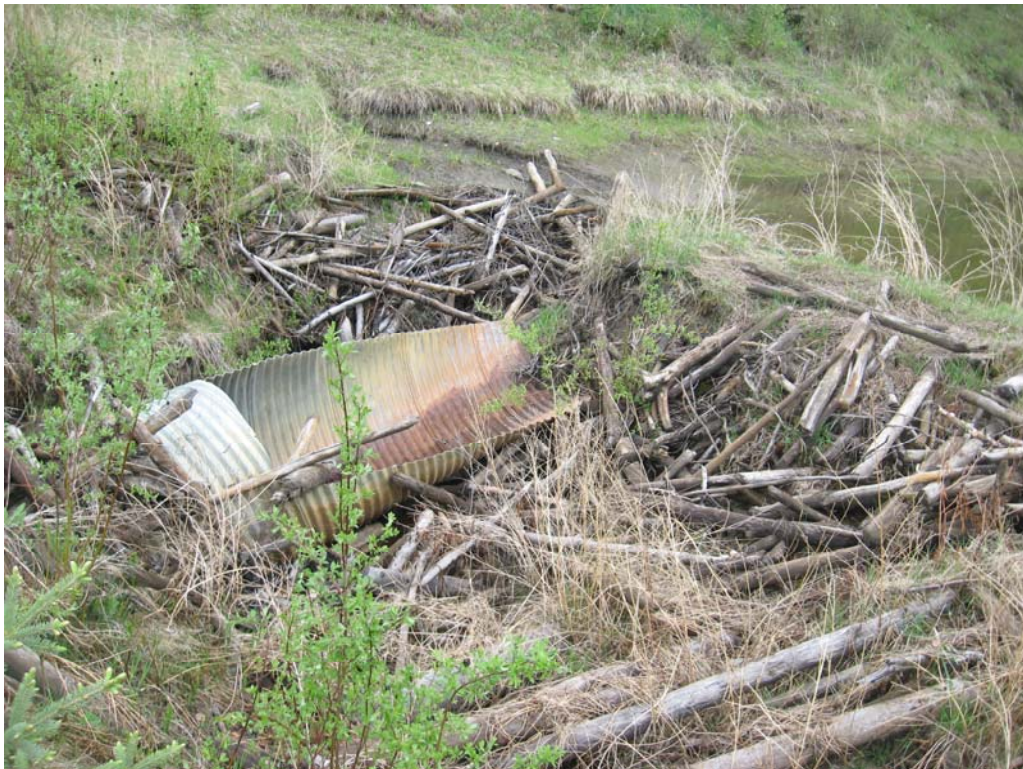
<input checked="" type="checkbox"/> Culvert Distress	- Culvert inlet heaved and broken by water uplift pressures created by beaver dam built in front of inlet - Culvert outlet destroyed by slope failure	<input checked="" type="checkbox"/>	<input type="checkbox"/>
<input type="checkbox"/> Other		<input type="checkbox"/>	<input type="checkbox"/>
Instrumentation:			
None			
Assessment (Refer to Figure PH57-1):			
Culvert Inlet: The beaver dam appears to have blocked the creek flow and created a pond upstream of the culvert. Seepage under the beaver dam appears to have exerted uplift pressures that heaved the culvert inlet. The water level rising behind the dam kept pushing the culvert inlet upwards, breaking it.

Photo 2: View of beaver dam and culvert inlet, broken and tilted upwards, looking east.

Repairs to the culvert inlet are required. The damaged pipe section needs to be removed and a small excavation of the embankment toe near the culvert inlet is required to provide access for repairs. A new pipe section needs to be installed.

To repair the inlet, it should be backfilled with well compacted medium plastic clay to re-establish a plug. Rip rap erosion protection should be placed around the inlet in accordance with AT standards.

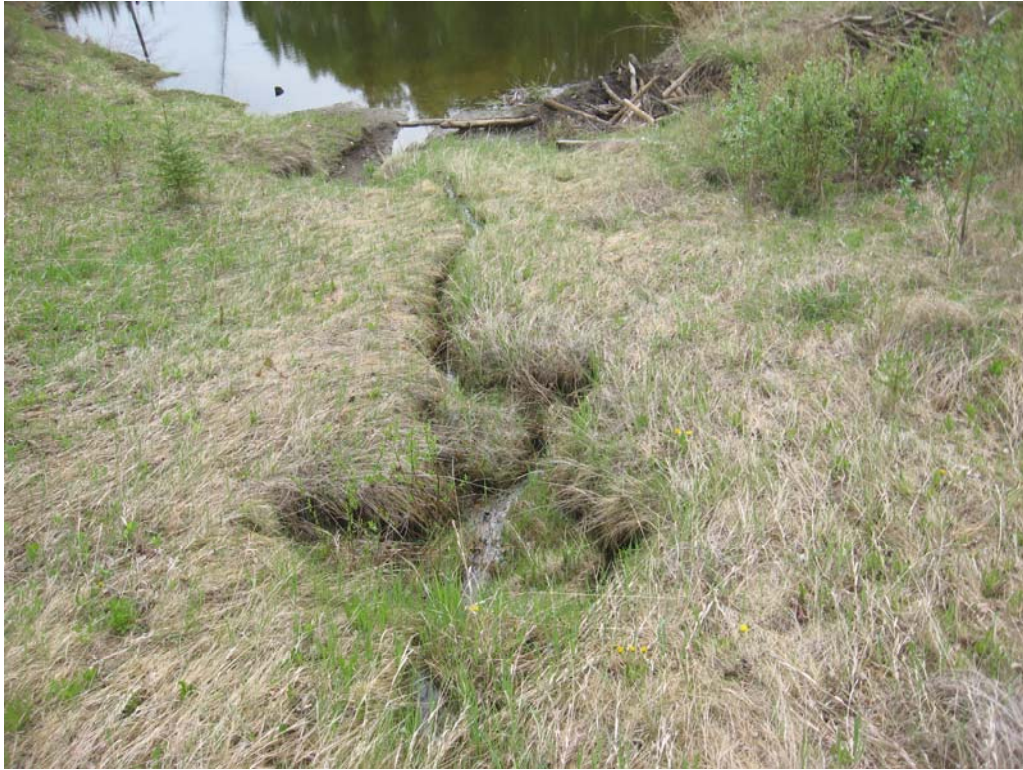
Photo 3: Increased erosion in rill located east of culvert inlet.

The erosion rill east of the culvert inlet should be backfilled with clay, topsoiled, seeded and covered with high flow soil covering (RECP). A flat-bottom swale should be formed at this repair to avoid concentration of runoff.

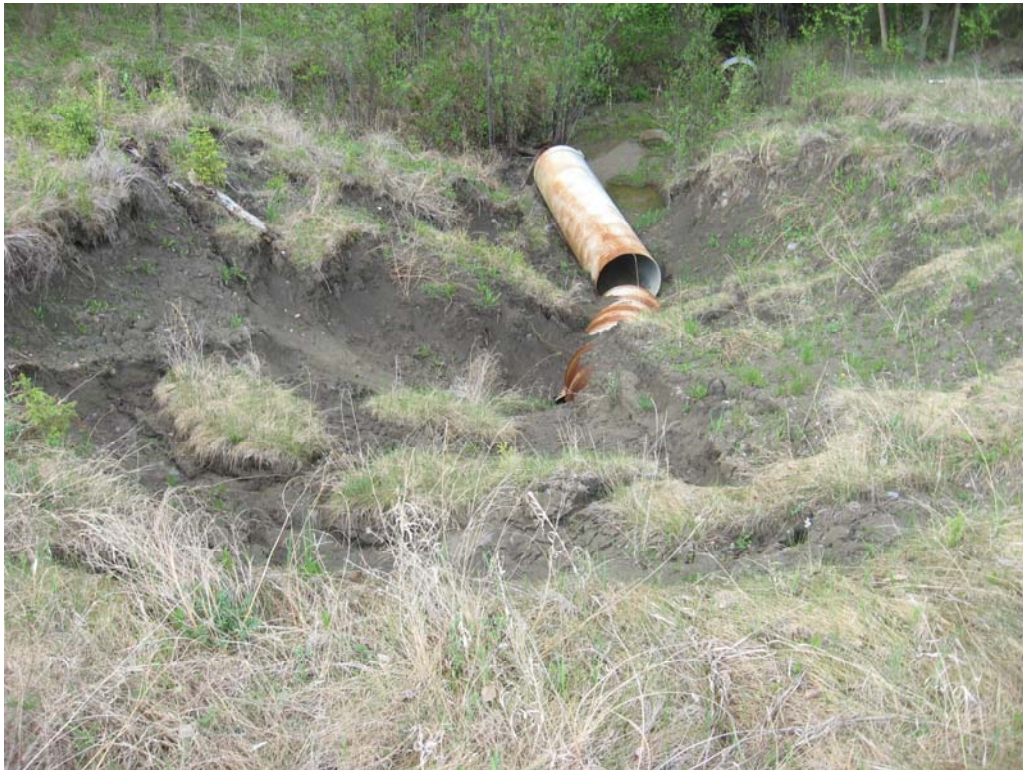
Culvert Outlet: Retrogressive slope failure possibly triggered by erosion / scour at the outlet of the culvert. Seepage from the highway embankment may have been a contributing factor. Due to the continued retrogressive movement, a 6 m length CSP segment has sheared off and now the effective outlet starts deeper into the embankment. The slumped soil is partially blocking culvert flow and becoming saturated. The slump is expected to continue to retrogress towards the highway if repairs are not carried out. Based on the length of the broken CSP segments located downslope of the slump, it appears that the original culvert outlet was located roughly 21 m further north than the present sheared outlet.

Photo 4: Broken culvert and increased slope movement at the outlet, looking north.

The recommended repair at the outlet is to excavate the slumped material to undisturbed soil below and behind the slide surface and to dispose of the wet clay and broken culvert pieces. A blanket of free draining granular material should then be draped over the lower 1/3 of the excavation, separated from the native soil by a non-woven geotextile. The culvert should be extended to a longer length than the original to allow a berm to be constructed to flatten the overall inclination of the sideslope. A rip rap lined flow dissipation bowl should be constructed beyond the outlet of the extended pipe.

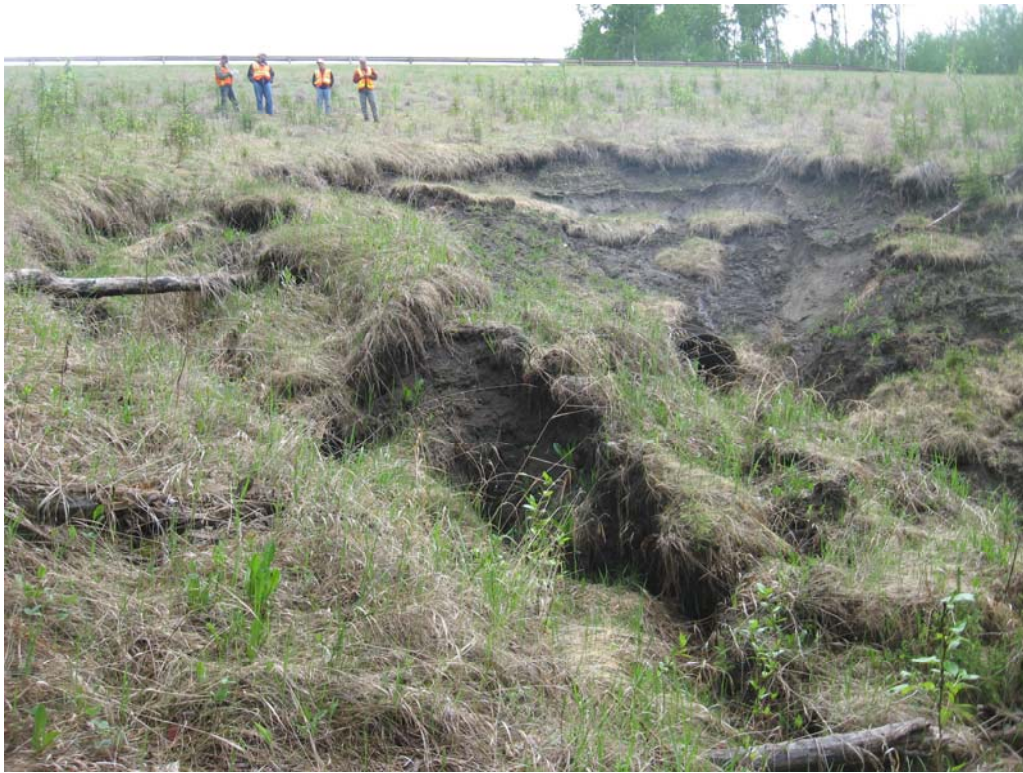
Photo 5: View of slope failure and broken culvert outlet, looking upslope.

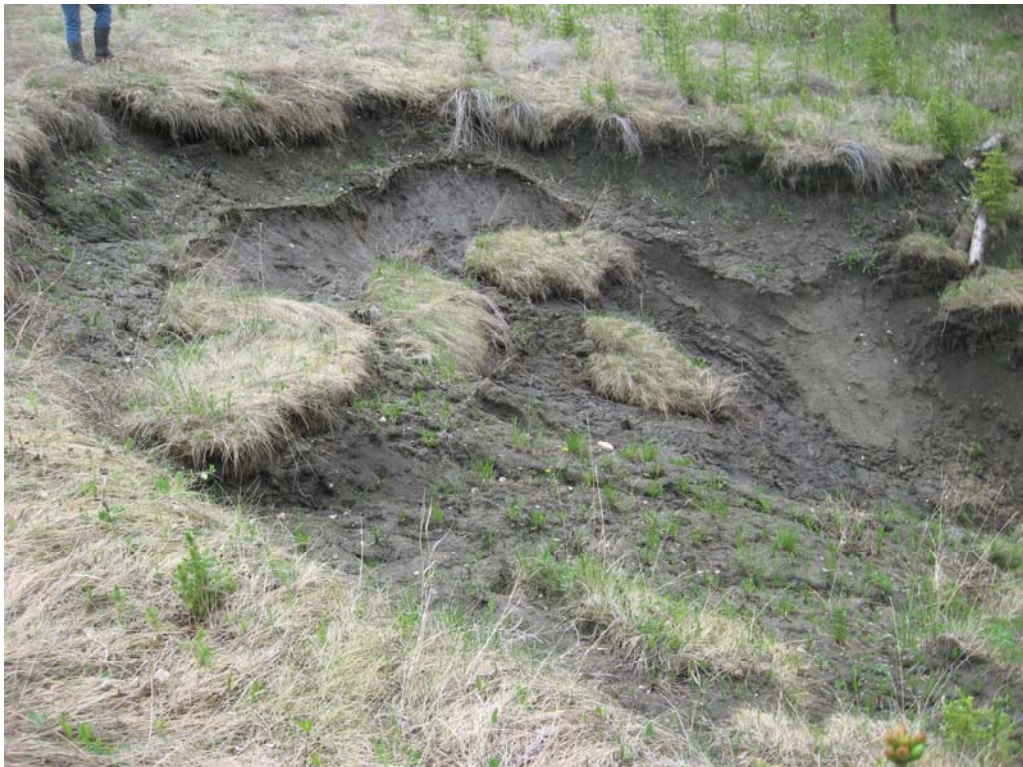
Photo 6: Increased backscarp retrogression at culvert outlet, looking west.

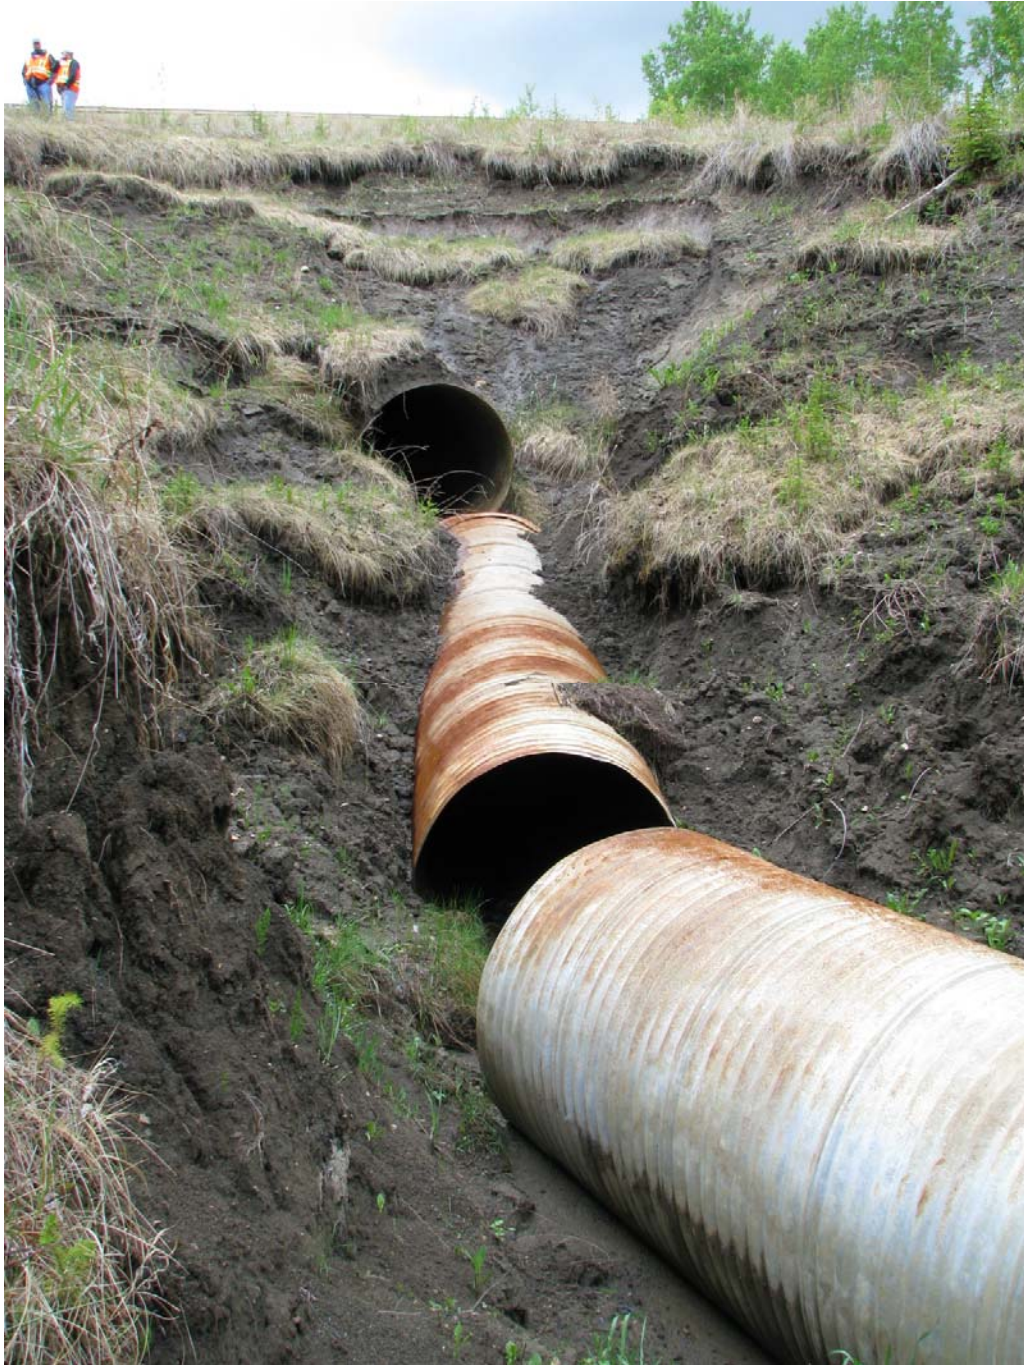
Photo 7: Pipe destroyed at culvert outlet location, looking upslope.
