**ALBERTA TRANSPORTATION
GEOHAZARD ASSESSMENT PROGRAM
PEACE REGION (PEACE RIVER DISTRICT)
2021 INSPECTION**

Site Number	Location	Name	Hwy	km
SH030-1	West of High Prairie	East of Gunns Creek	2A:54	17.56 – 17.82
Legal Description		UTM Co-ordinates		
NE&SE32-73-19-W5M		11U E 508,043		N 6,135,622

**SH030-1: HWY 2A:54 km 17.6 TO km 17.9
2021 SITE INSPECTION PLAN**

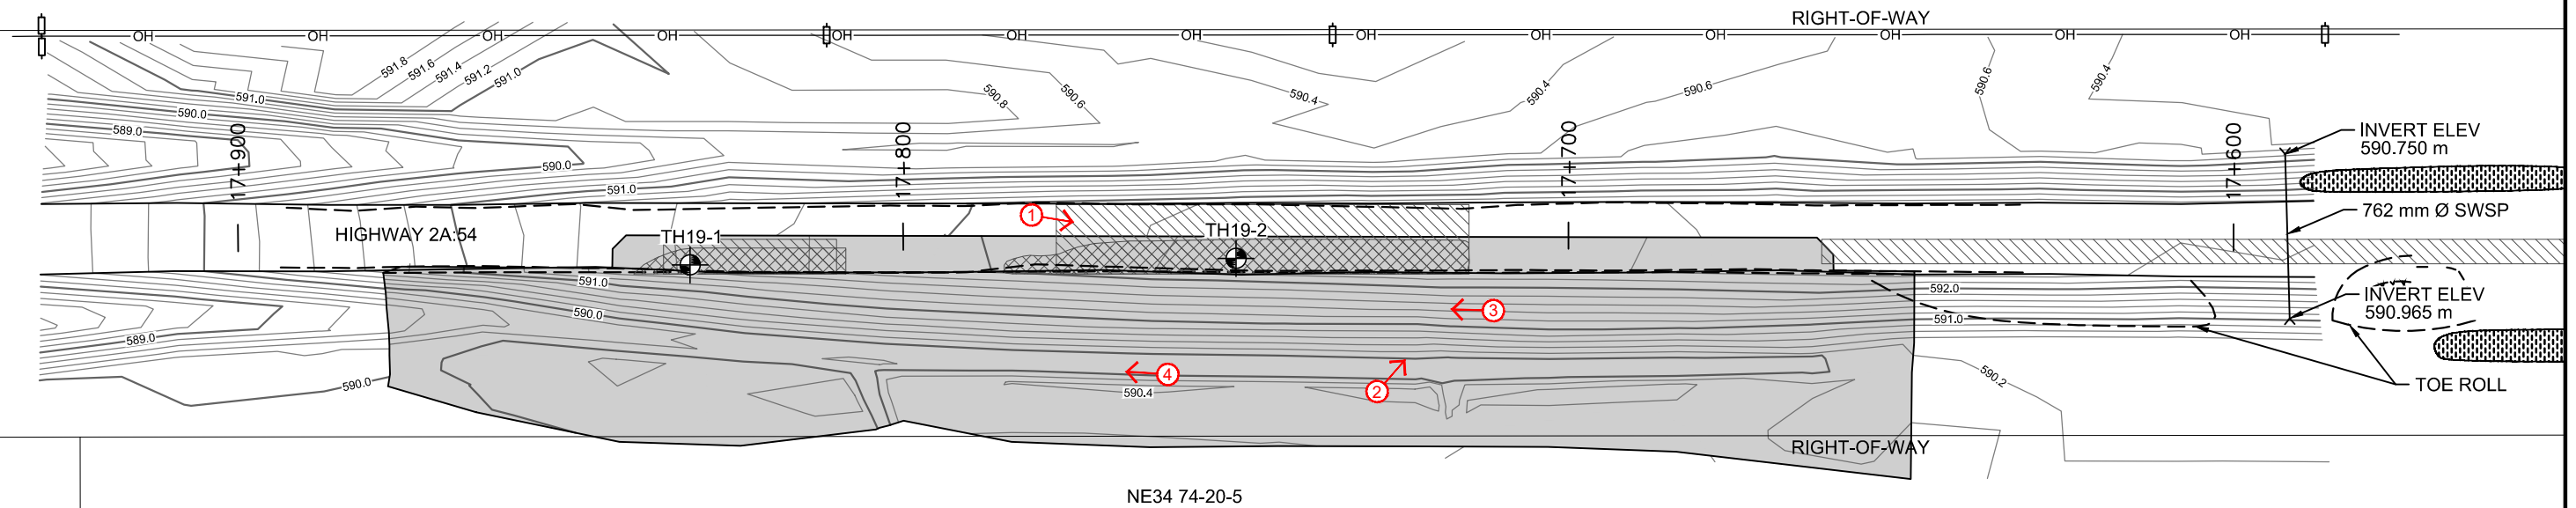
DWG No. 32121-SH030-1

1. ORIGINAL SURVEY COMPLETED BY WSP ON FEBRUARY 5, 2019
2. AS-BUILT SURVEY COMPLETED BY WSP ON JULY 25, 2020
3. SIDE SLOPES SLOPE TEXTURED
4. ALL DISTURBED AREAS COVERED WITH SALVAGED TOPSOIL AND SEEDED
5. TRM (TYPE A) PLACED ON DITCH BOTTOM AND CUT SLOPES
6. JUNE 2021 OBSERVATIONS SHOWN IN RED.

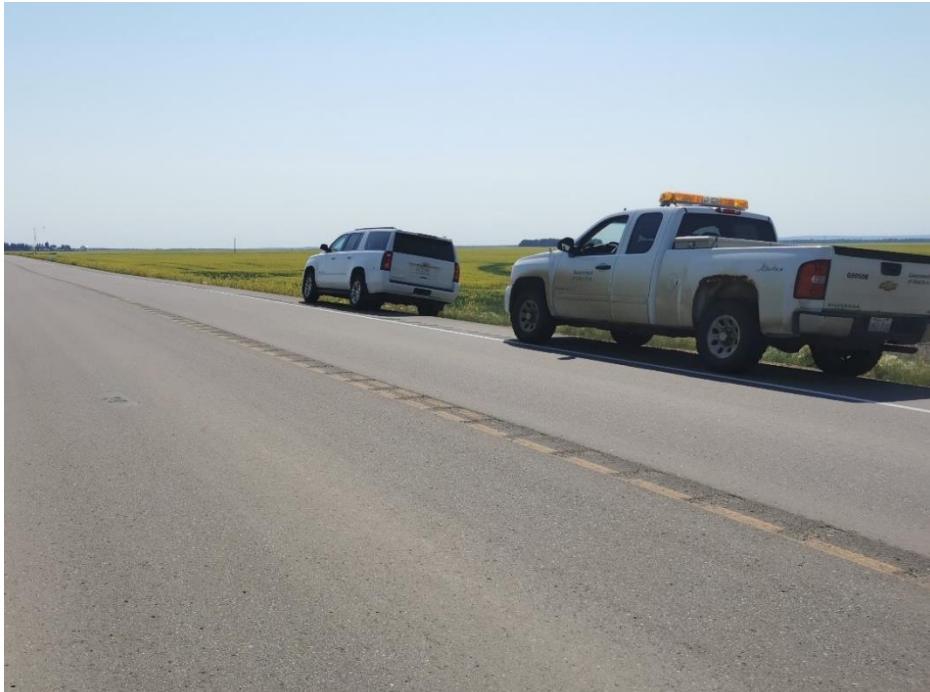
Photo 1 – Looking east from west end of newly-reconstructed portion of EBL.

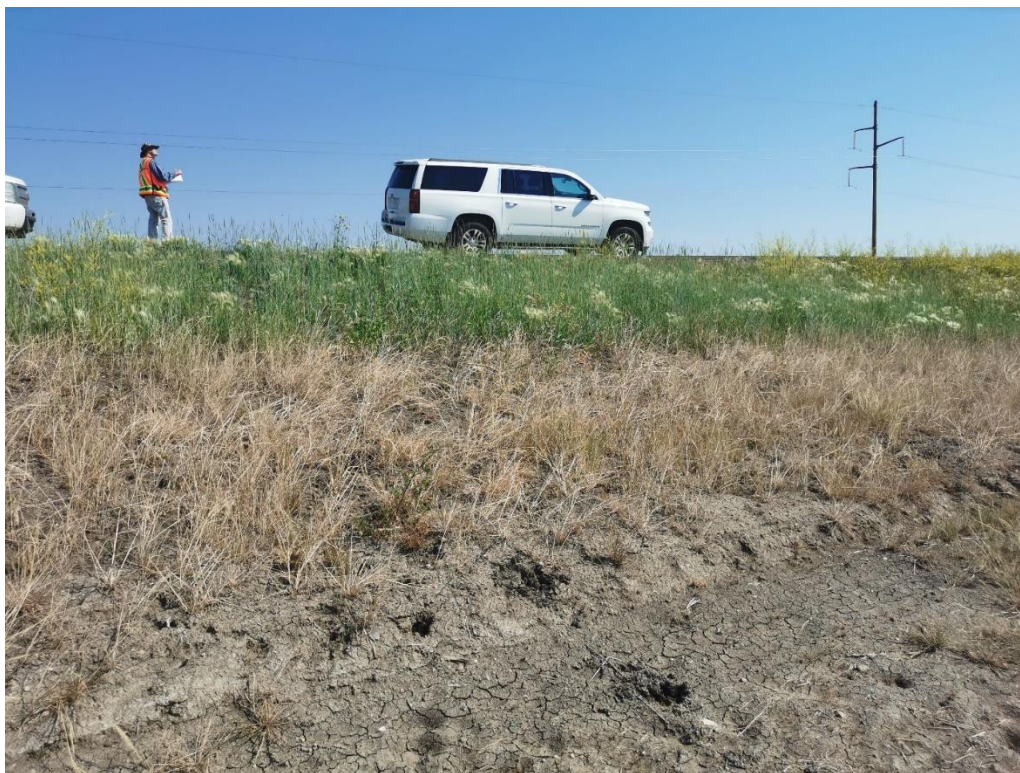
Photo 2 – Looking northeast at south slope of highway embankment from south ditch.

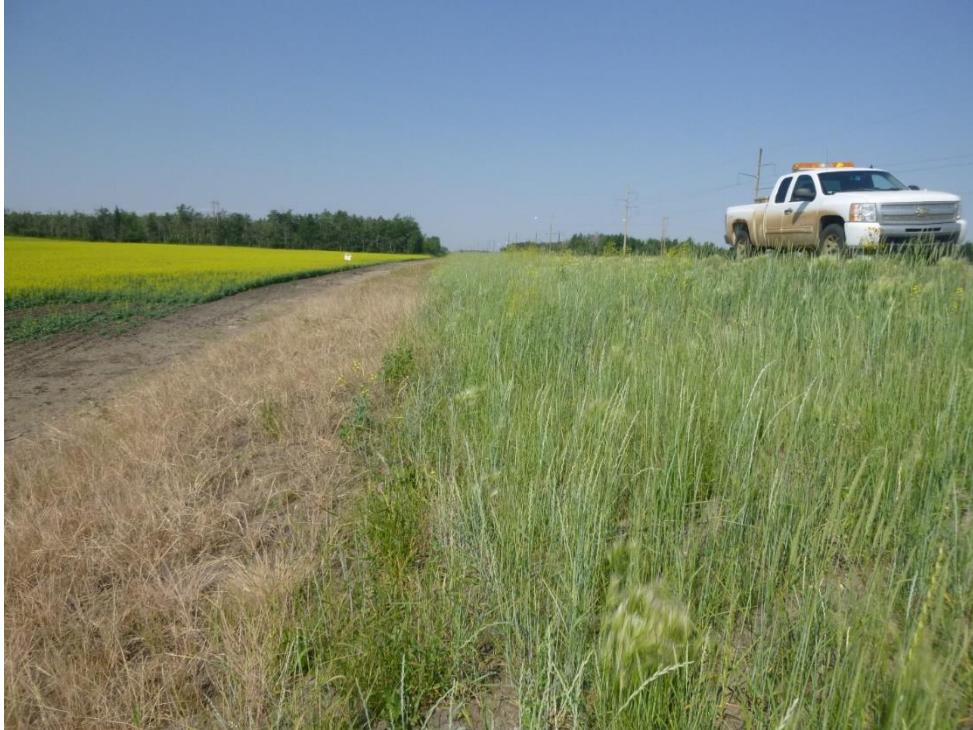
Photo 3 – Looking west along south side slope of highway embankment.

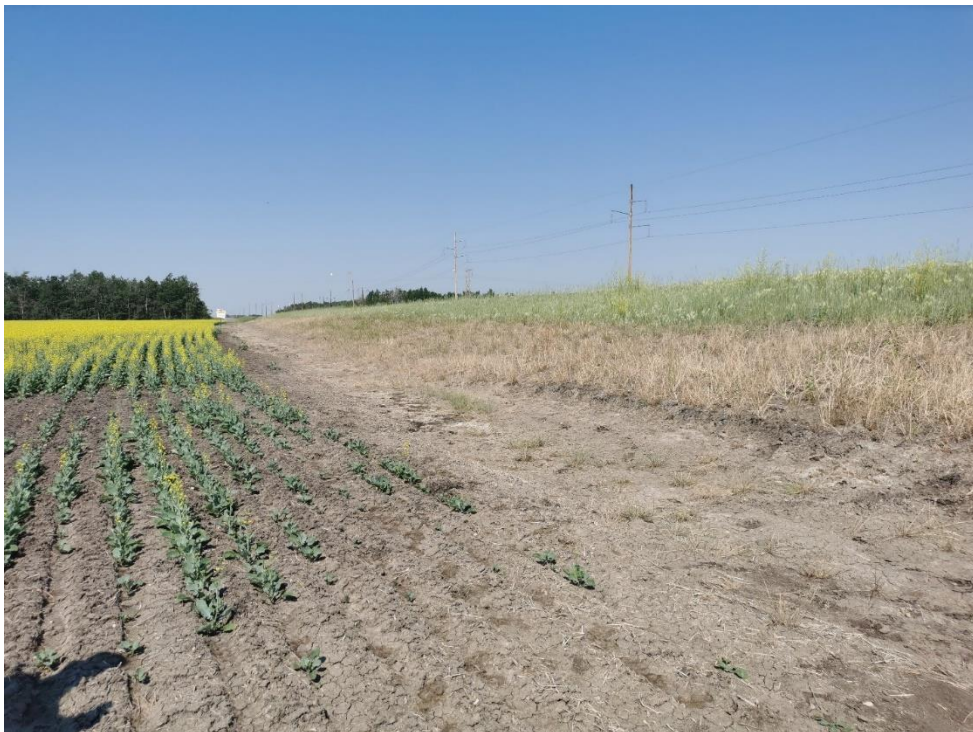
Photo 4: Looking west along south ditch where TRM was installed.
