**ALBERTA TRANSPORTATION
GEOHAZARD ASSESSMENT PROGRAM
PEACE REGION – SWAN HILLS
2020 CALLOUT**

Site Number	Location	Name	Hwy	km
Callout	East of Arcadia	Callout	2:50	44.42
Legal Description		UTM Co-ordinates		
NE9-74-14-W5		11V N 6,139,489	E 557,842

**PEACE REGION (SWAN HILLS)
HWY 2:50 KM 44.4, EAST OF ARCADIA**

JUNE 1, 2020 CALLOUT PLAN

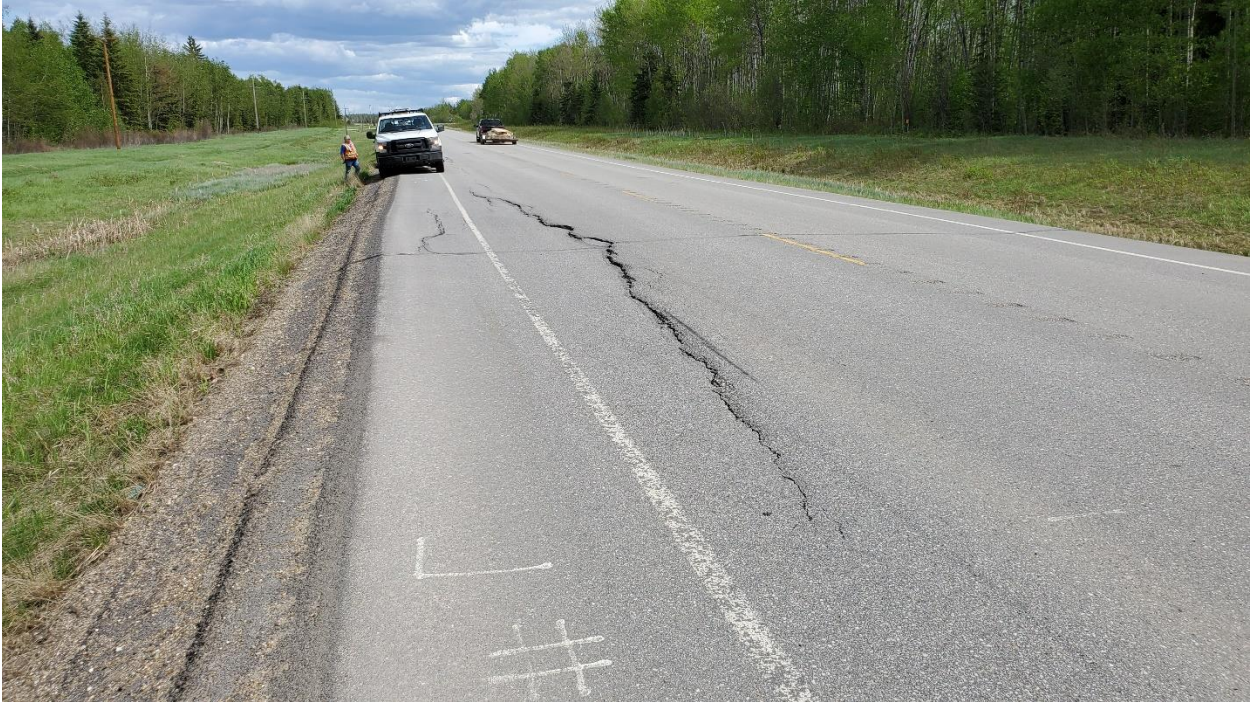
At the time of the callout inspection, approximately 21 m length of the east-bound lane (EBL) had an arch-shaped crack in the middle of the lane with a dip between the crack at the south shoulder. This main crack was up to 50 mm in width and 40 mm of height differential. There was a secondary crack near the shoulder on the south side of the dip which was up to 30 mm wide with 30 mm of differential. There appeared to be a toe roll in the lower part of the sideslope. The crack in the centre of the lane continued an additional 30 m west indicating that a great extent of movement is likely.

Photo 1 – Looking west along the EBL at the main crack and dip (at the fog line).

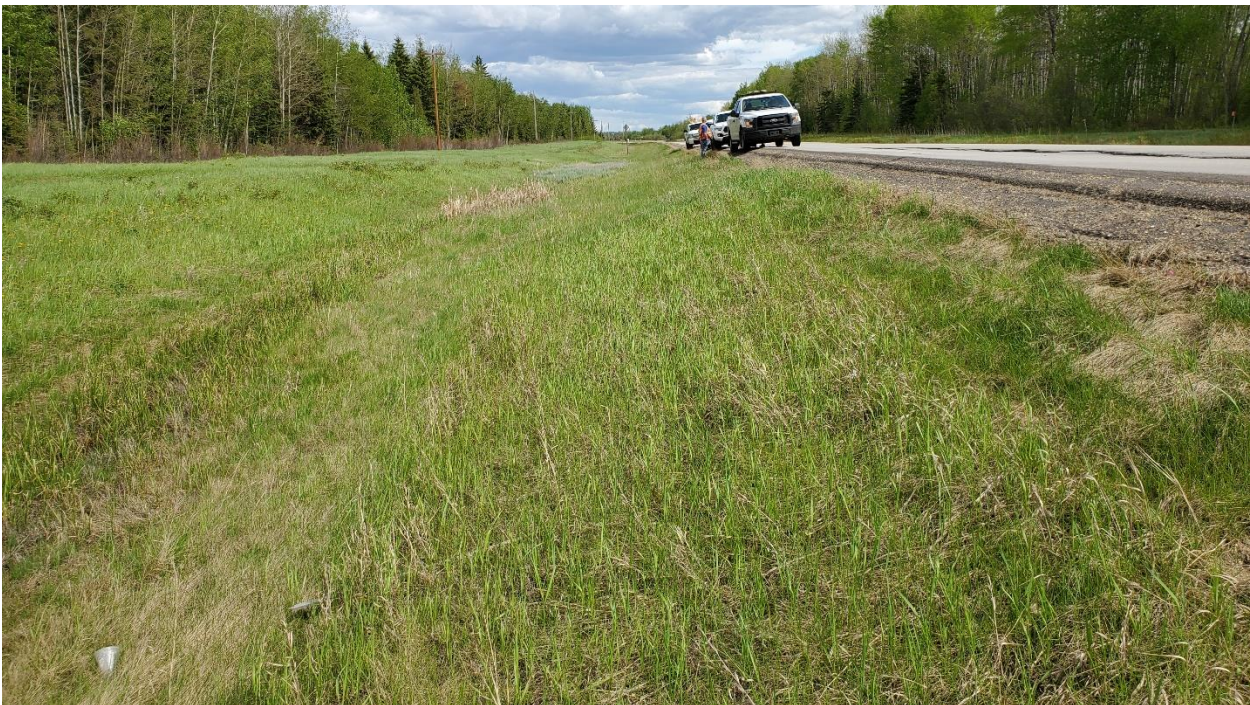
Photo 2 – Looking west at the sideslope below the main crack where there may be a toe roll.

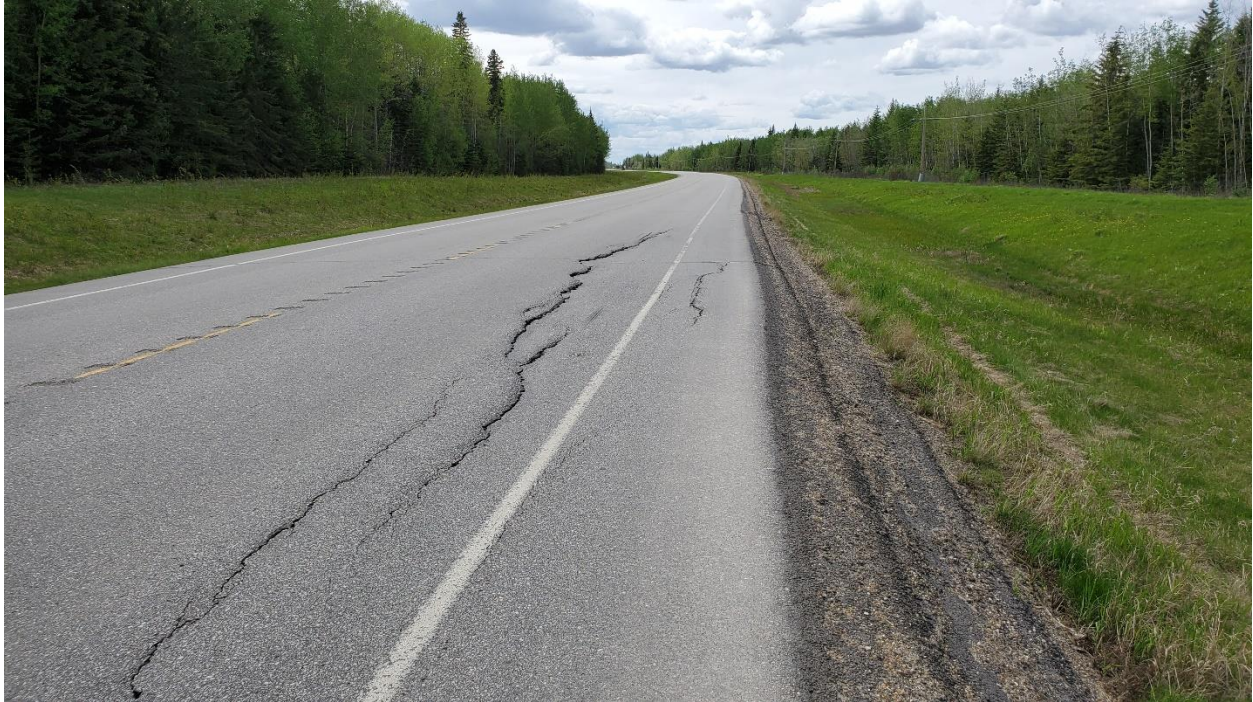
Photo 3 – Looking east at the main area of distress.

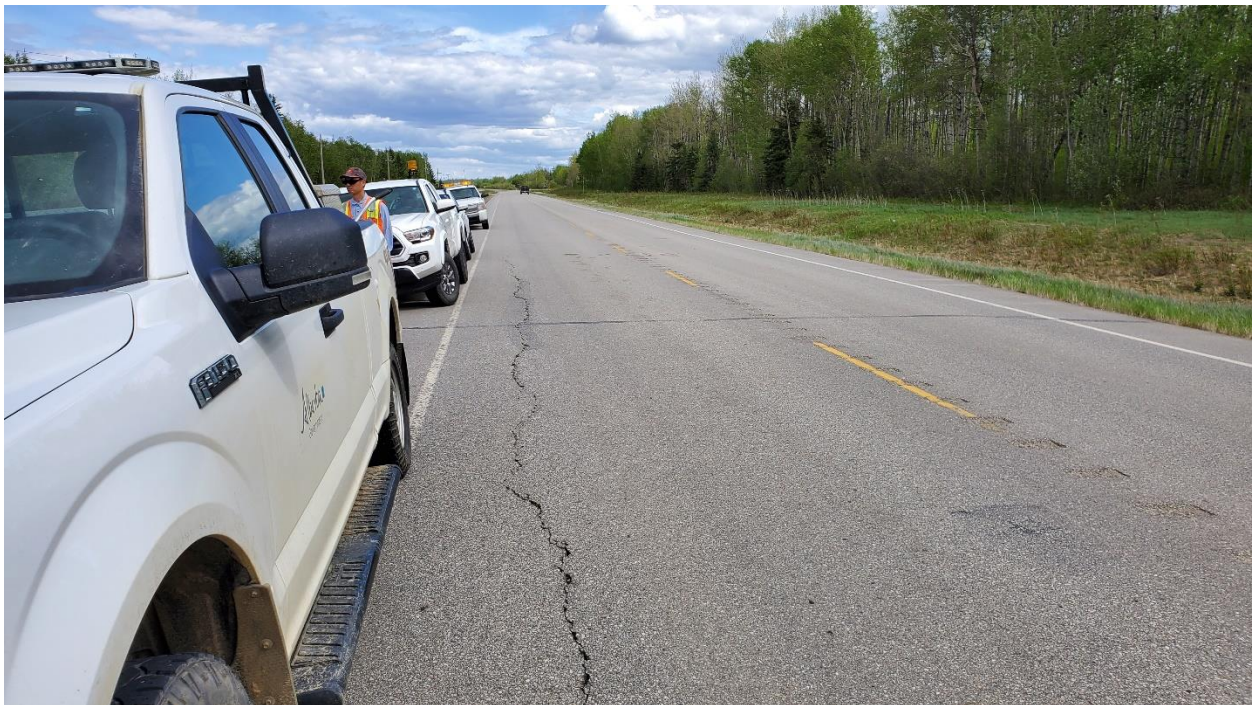
Photo 4 – Looking west at developing extension of the crack.
