**ALBERTA TRANSPORTATION
GEOHAZARD ASSESSMENT PROGRAM
PEACE REGION (PEACE RIVER DISTRICT)
2021 INSPECTION**

Site Number	Location	Name	Hwy	km
SH034	East of Arcadia	Near Arcadia Embankment Slide	2:50	44.42
Legal Description		UTM Co-ordinates		
NE9-74-14-W5		11U N 6,139,489	E 557,842

PH034-1 HWY 2:50 KM 44.4, EAST OF ARCADIA
2021 SITE INSPECTION PLAN

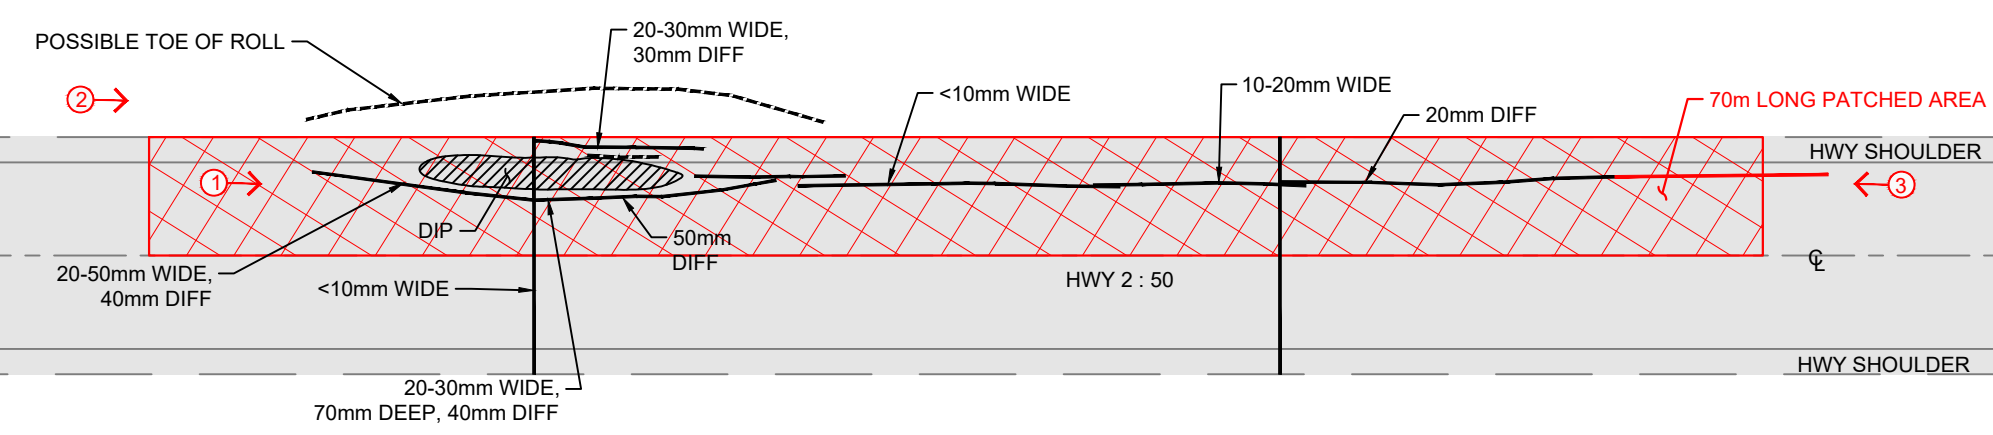
DWG No. 32121-PH034-1

POSSIBLE OLD HIGHWAY

DITCH - SOFT AND WET

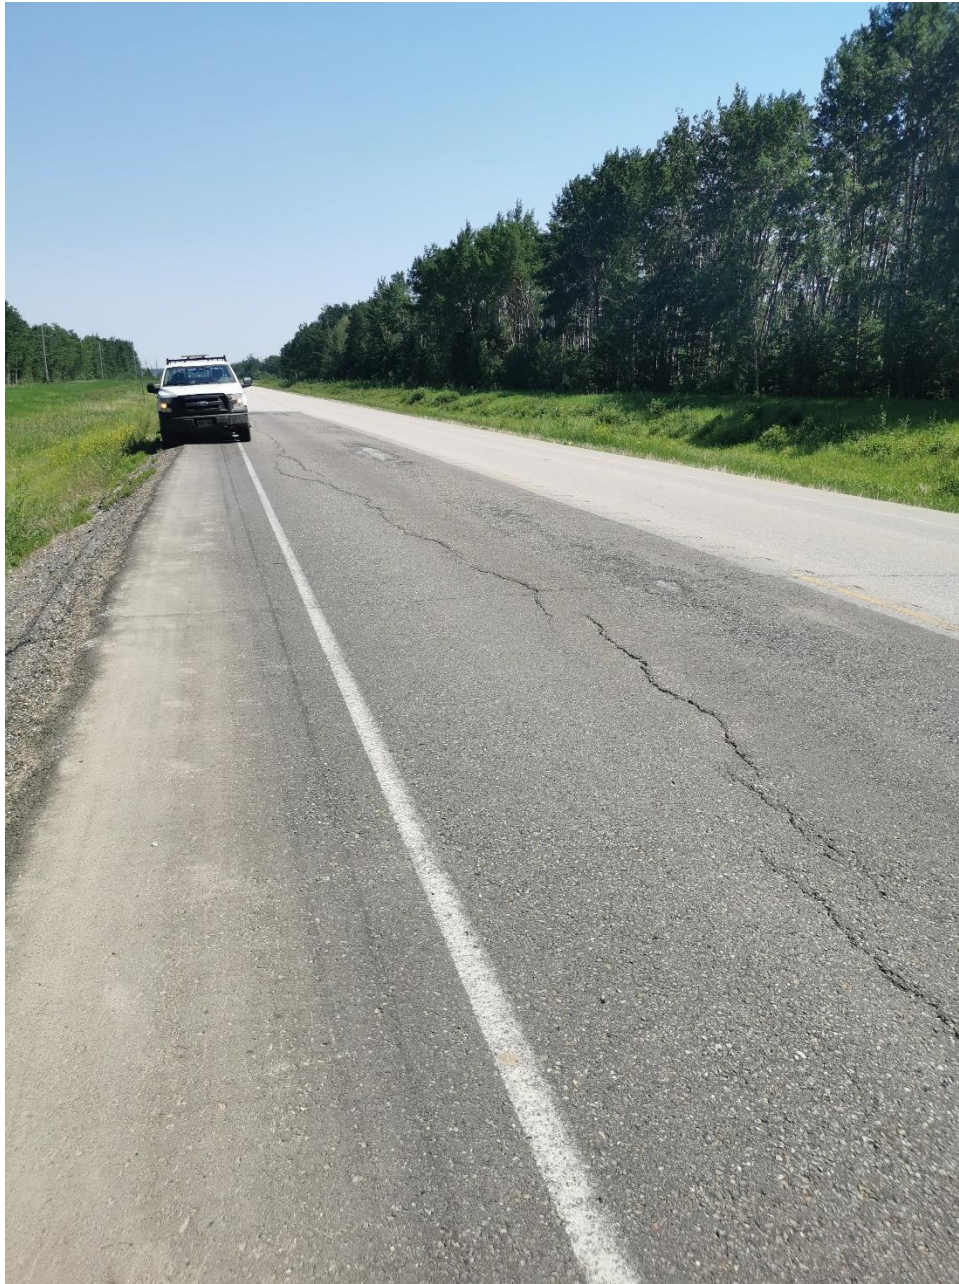
During the callout inspection last year, approximately 21 m length of the west-bound lane (WBL) had an arch-shaped crack in the middle of the lane with a dip between the crack at the south shoulder. This main crack was up to 50 mm in width and 40 mm of height differential. There was a secondary crack near the shoulder on the north side of the dip which was up to 30 mm wide with 30 mm of differential. There appeared to be a toe roll in the lower part of the sideslope. The crack in the centre of the lane continued an additional 30 m east indicating that a great extent of movement is likely.

Since the callout inspection, a 70 m long section of the WBL was patched. During this year's inspection, it appeared that the features observed during the callout inspection are starting to surface again. According to the MCI, the site has a long history of being patched (since 1995). The crack also continued east, past the area that was patched.

Photo 1 – Looking east along the WBL at the main crack and dip.

- Road maintenance should continue as necessary to maintain an even, safe roadway surface and may consist of milling, patching, and crack sealing of the pavement. The site was patched after the callout inspection in 2020, but the cracks are starting to surface again during the 2021 inspection.

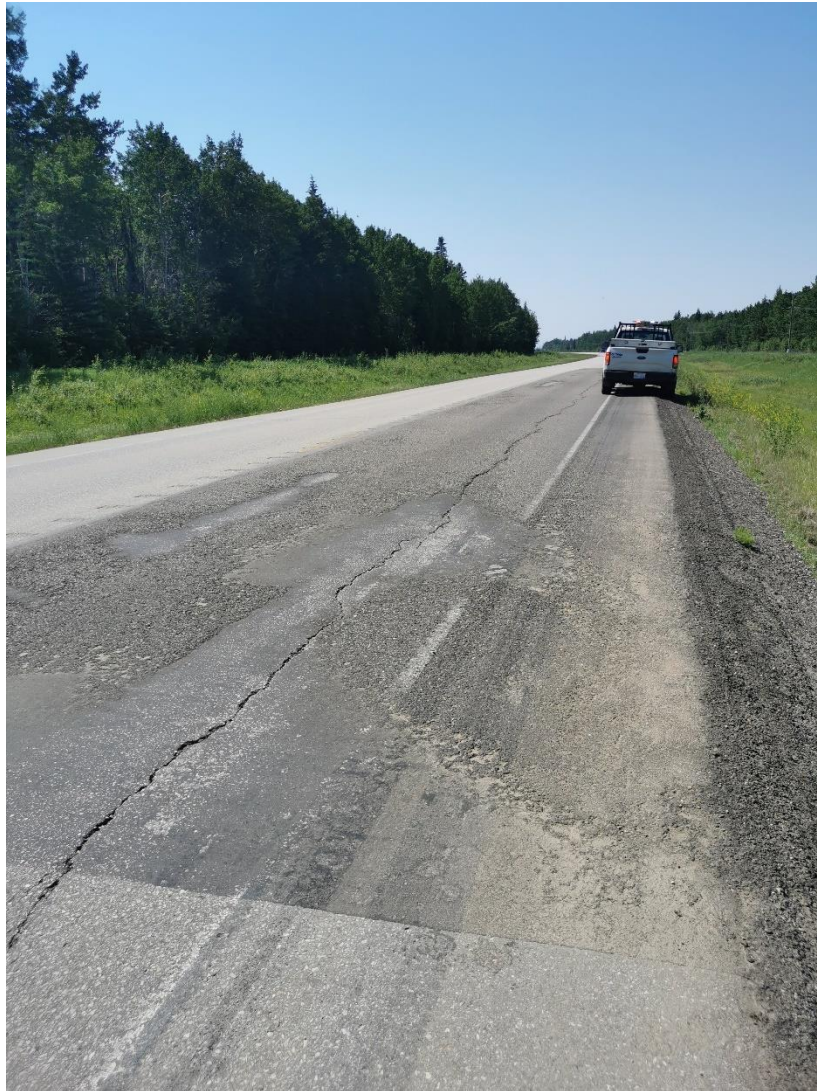
Photo 3 – Looking west at the main area of distress. Note the crack at bottom of photo extending past the patched area
