**ALBERTA TRANSPORTATION AND
ECONOMIC CORRIDORS
GEOHAZARD RISK MANAGEMENT PROGRAM
PEACE REGION (PEACE RIVER DISTRICT)
2025 INSPECTION**

Site Number	Location	Name	Hwy	km
SH034	East of Arcadia	Near Arcadia Embankment Slide	2:50	44.42
Legal Description		UTM Co-ordinates		
NE9-74-14-W5		11U N 6,139,489	E 557,842

SH034-1 HWY 2:50 KM 44.4, EAST OF ARCADIA
2025 SITE INSPECTION PLAN

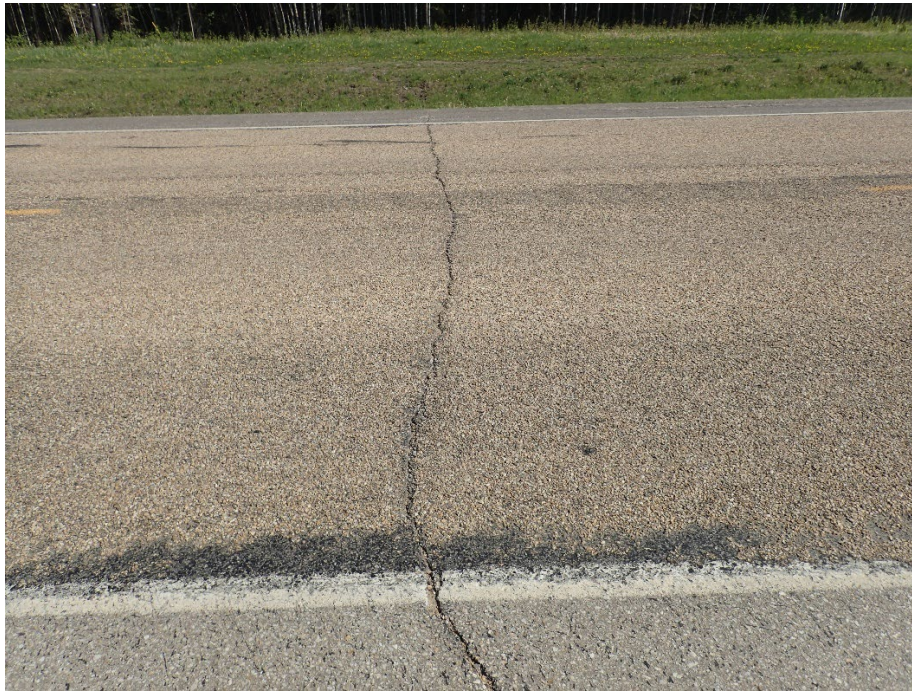
Photo 1 – Looking north at transverse crack that crosses the main landslide’s head scarp crack and highway dip.

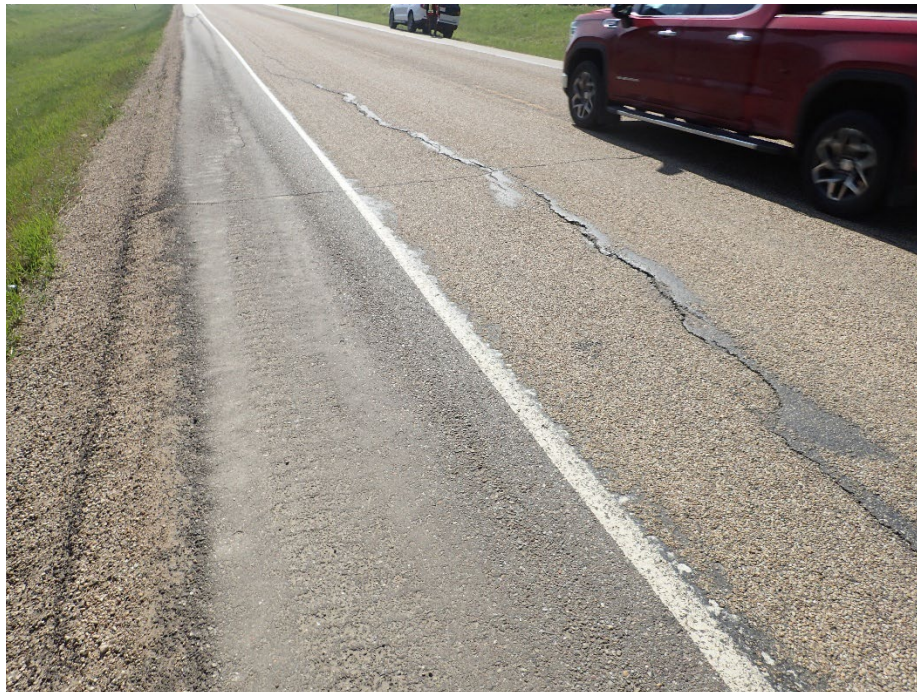
Photo 2 – Looking east along the WBL at longitudinal cracks that extends west from the main landslide crack.

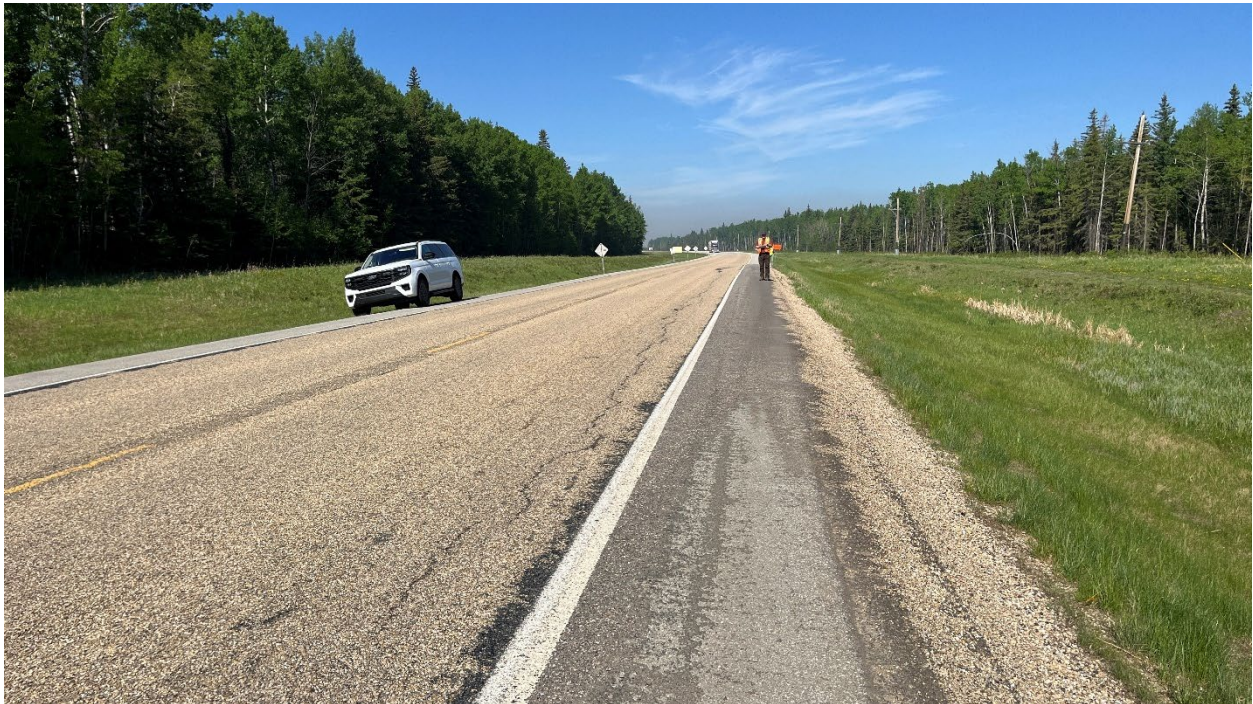
Photo 3 – Looking west at the extended longitudinal cracks that lead to the main landslide.

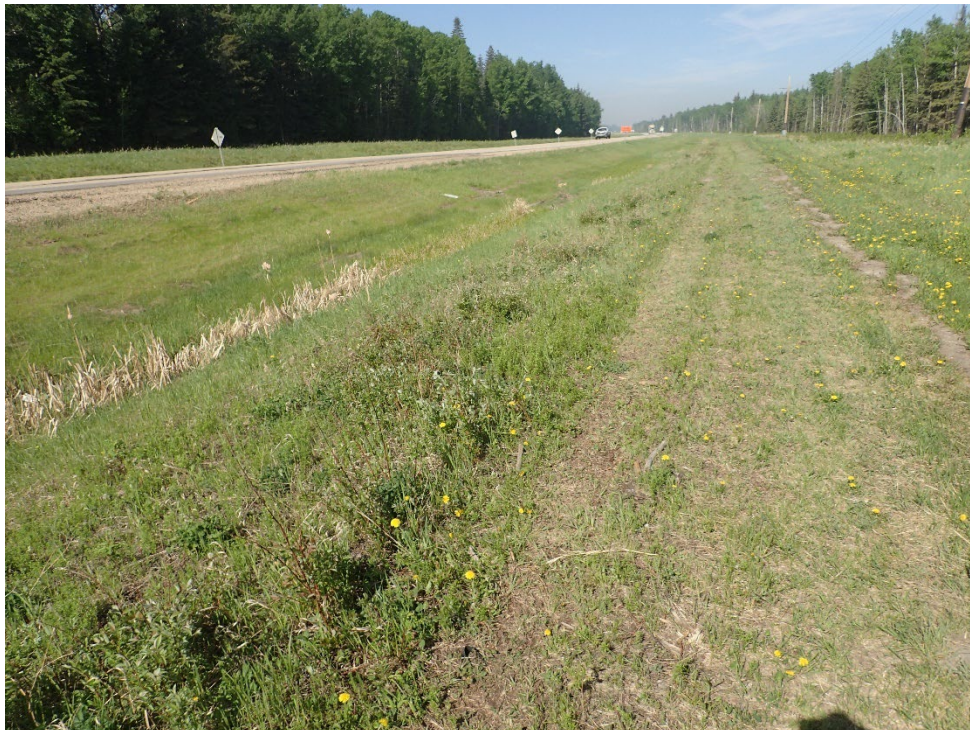
Photo 4 – Looking west at the highway sideslope from the north ditch.

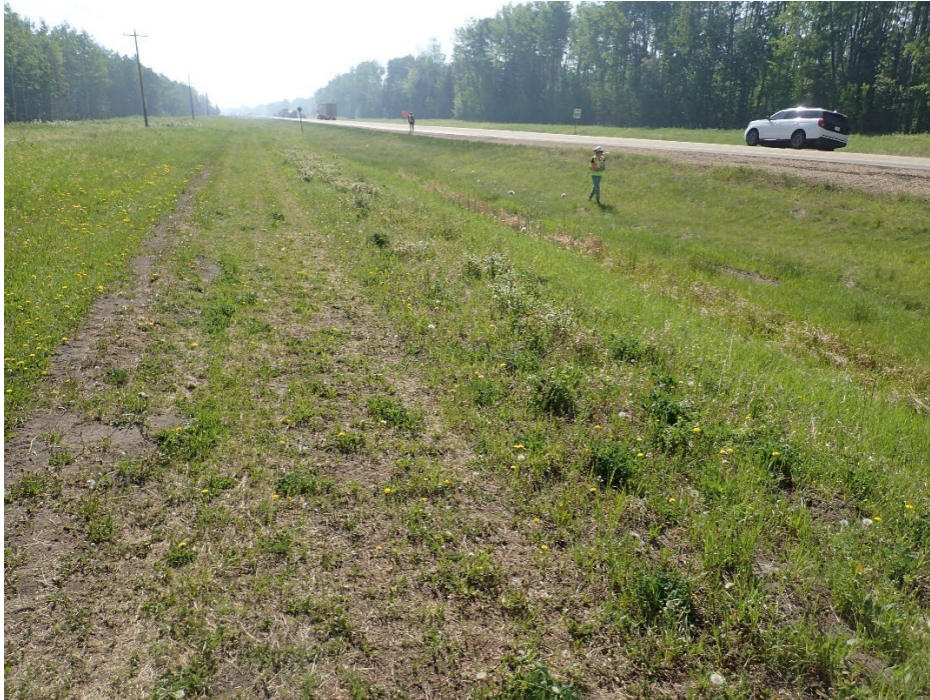
Photo 5 – Looking east at the highway sideslope from the north ditch.

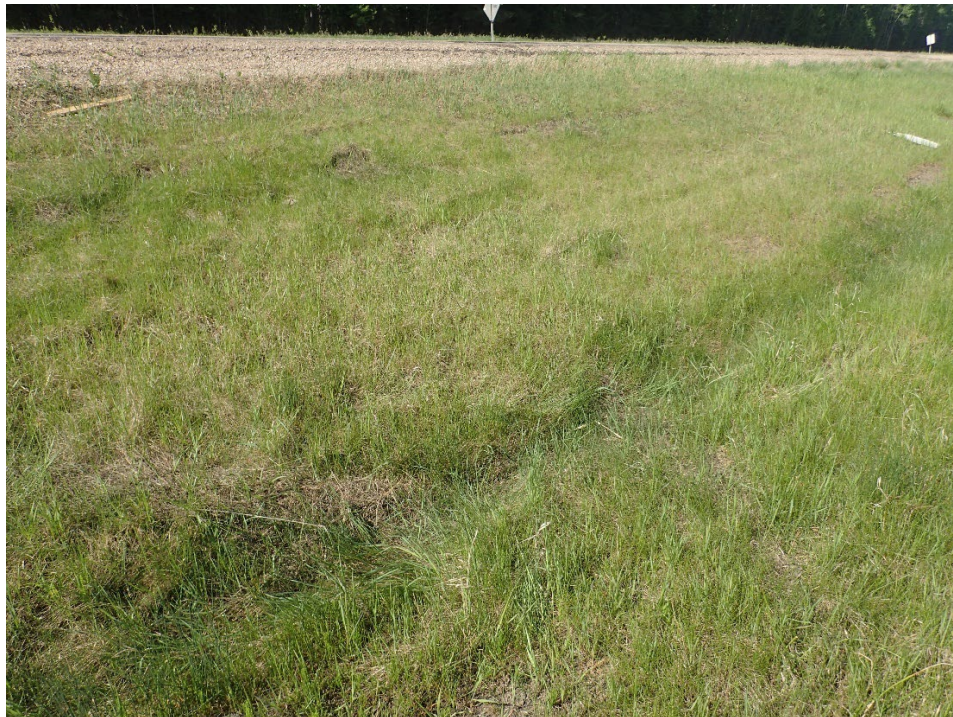
There appeared to be a toe roll in the lower part of the sideslope. The crack in the centre of the lane continued an additional 30 m east indicating that a greater extent of movement was likely.

Photo 6 – Looking southwest at the sideslope below the main crack where a toe roll is present in the ditch.

- Toe berm: stabilized the north sideslope with a 3 m to 4 m wide toe berm that extends halfway up the embankment. This option would also require imported fill and realigning the ditch. The long term performance would also be improved with full or partial excavation of the slide mass.
