**GEOHAZARD ASSESSMENT PROGRAM**

**PEACE RIVER/HIGH LEVEL AREA**

**CALLOUT (JANUARY 28, 2015)**

**HWY 2:60 NEW LANDSLIDE WEST OF EAST HILL PILE WALL (PH2) - PEACE RIVER, ALBERTA**

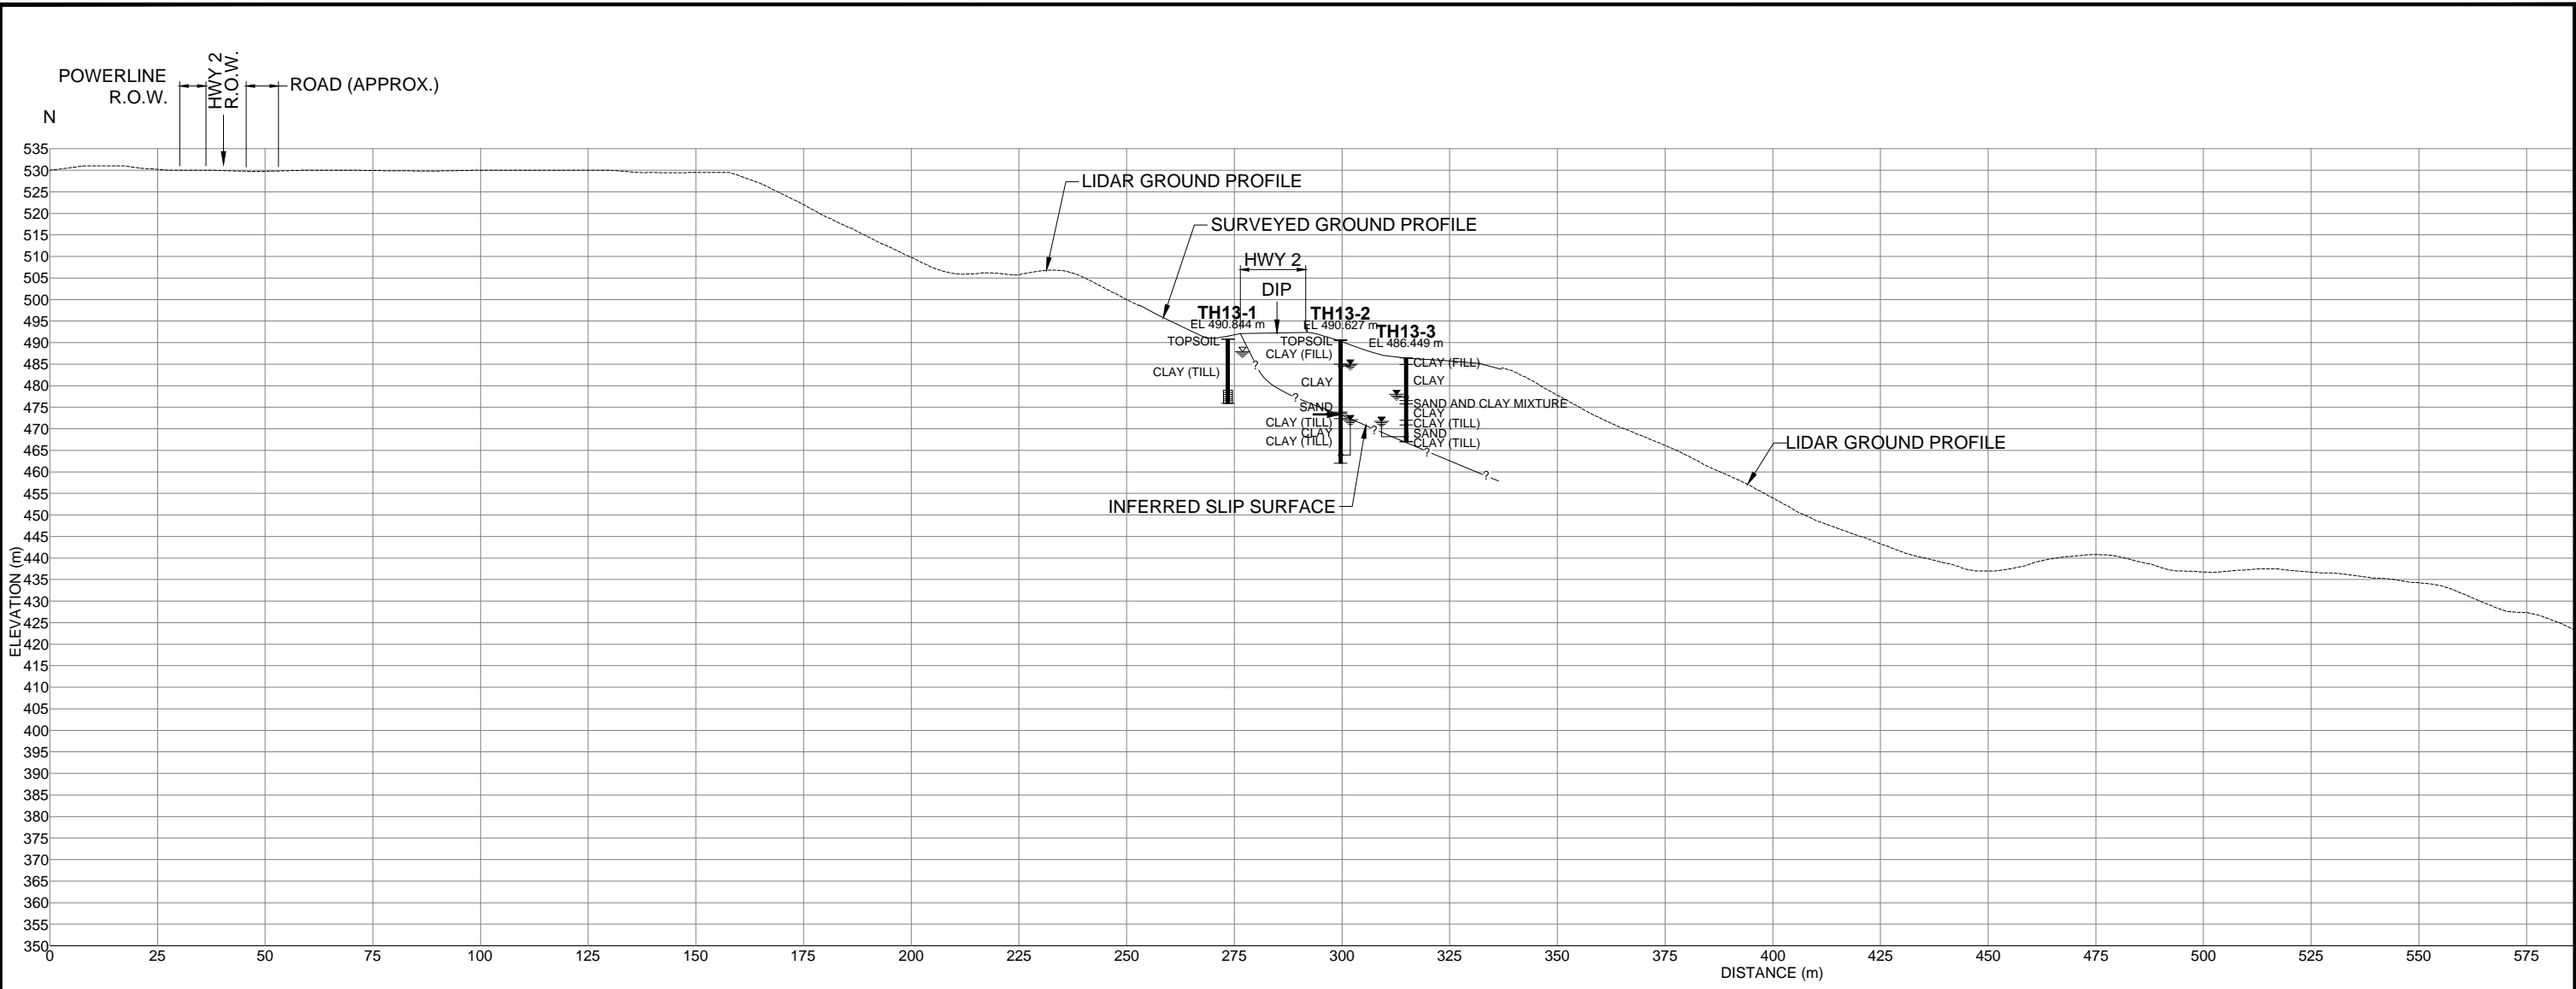
**DWG No. 15-16-357-PH2-2A**

SI13-2, located partway down the sideslope at the original landslide zone, shows a slip surface at 17.5 m depth and has a rate of movement of 12 mm/year as measured on January 28, 2015. The depth of movement in SI13-3, located further downslope, is not as well defined. It is possible that the slip surface extends below the bottom of the SI casing.

A deep-seated landslide is affecting the roadway and appears to be growing in lateral extent and rate of movement. The interpolated slip surface extends to about 18 m below the highway at the guard rail, as shown on the attached Dwg. 15-16-305-PH2-2A. The highway is located on a side hill alignment

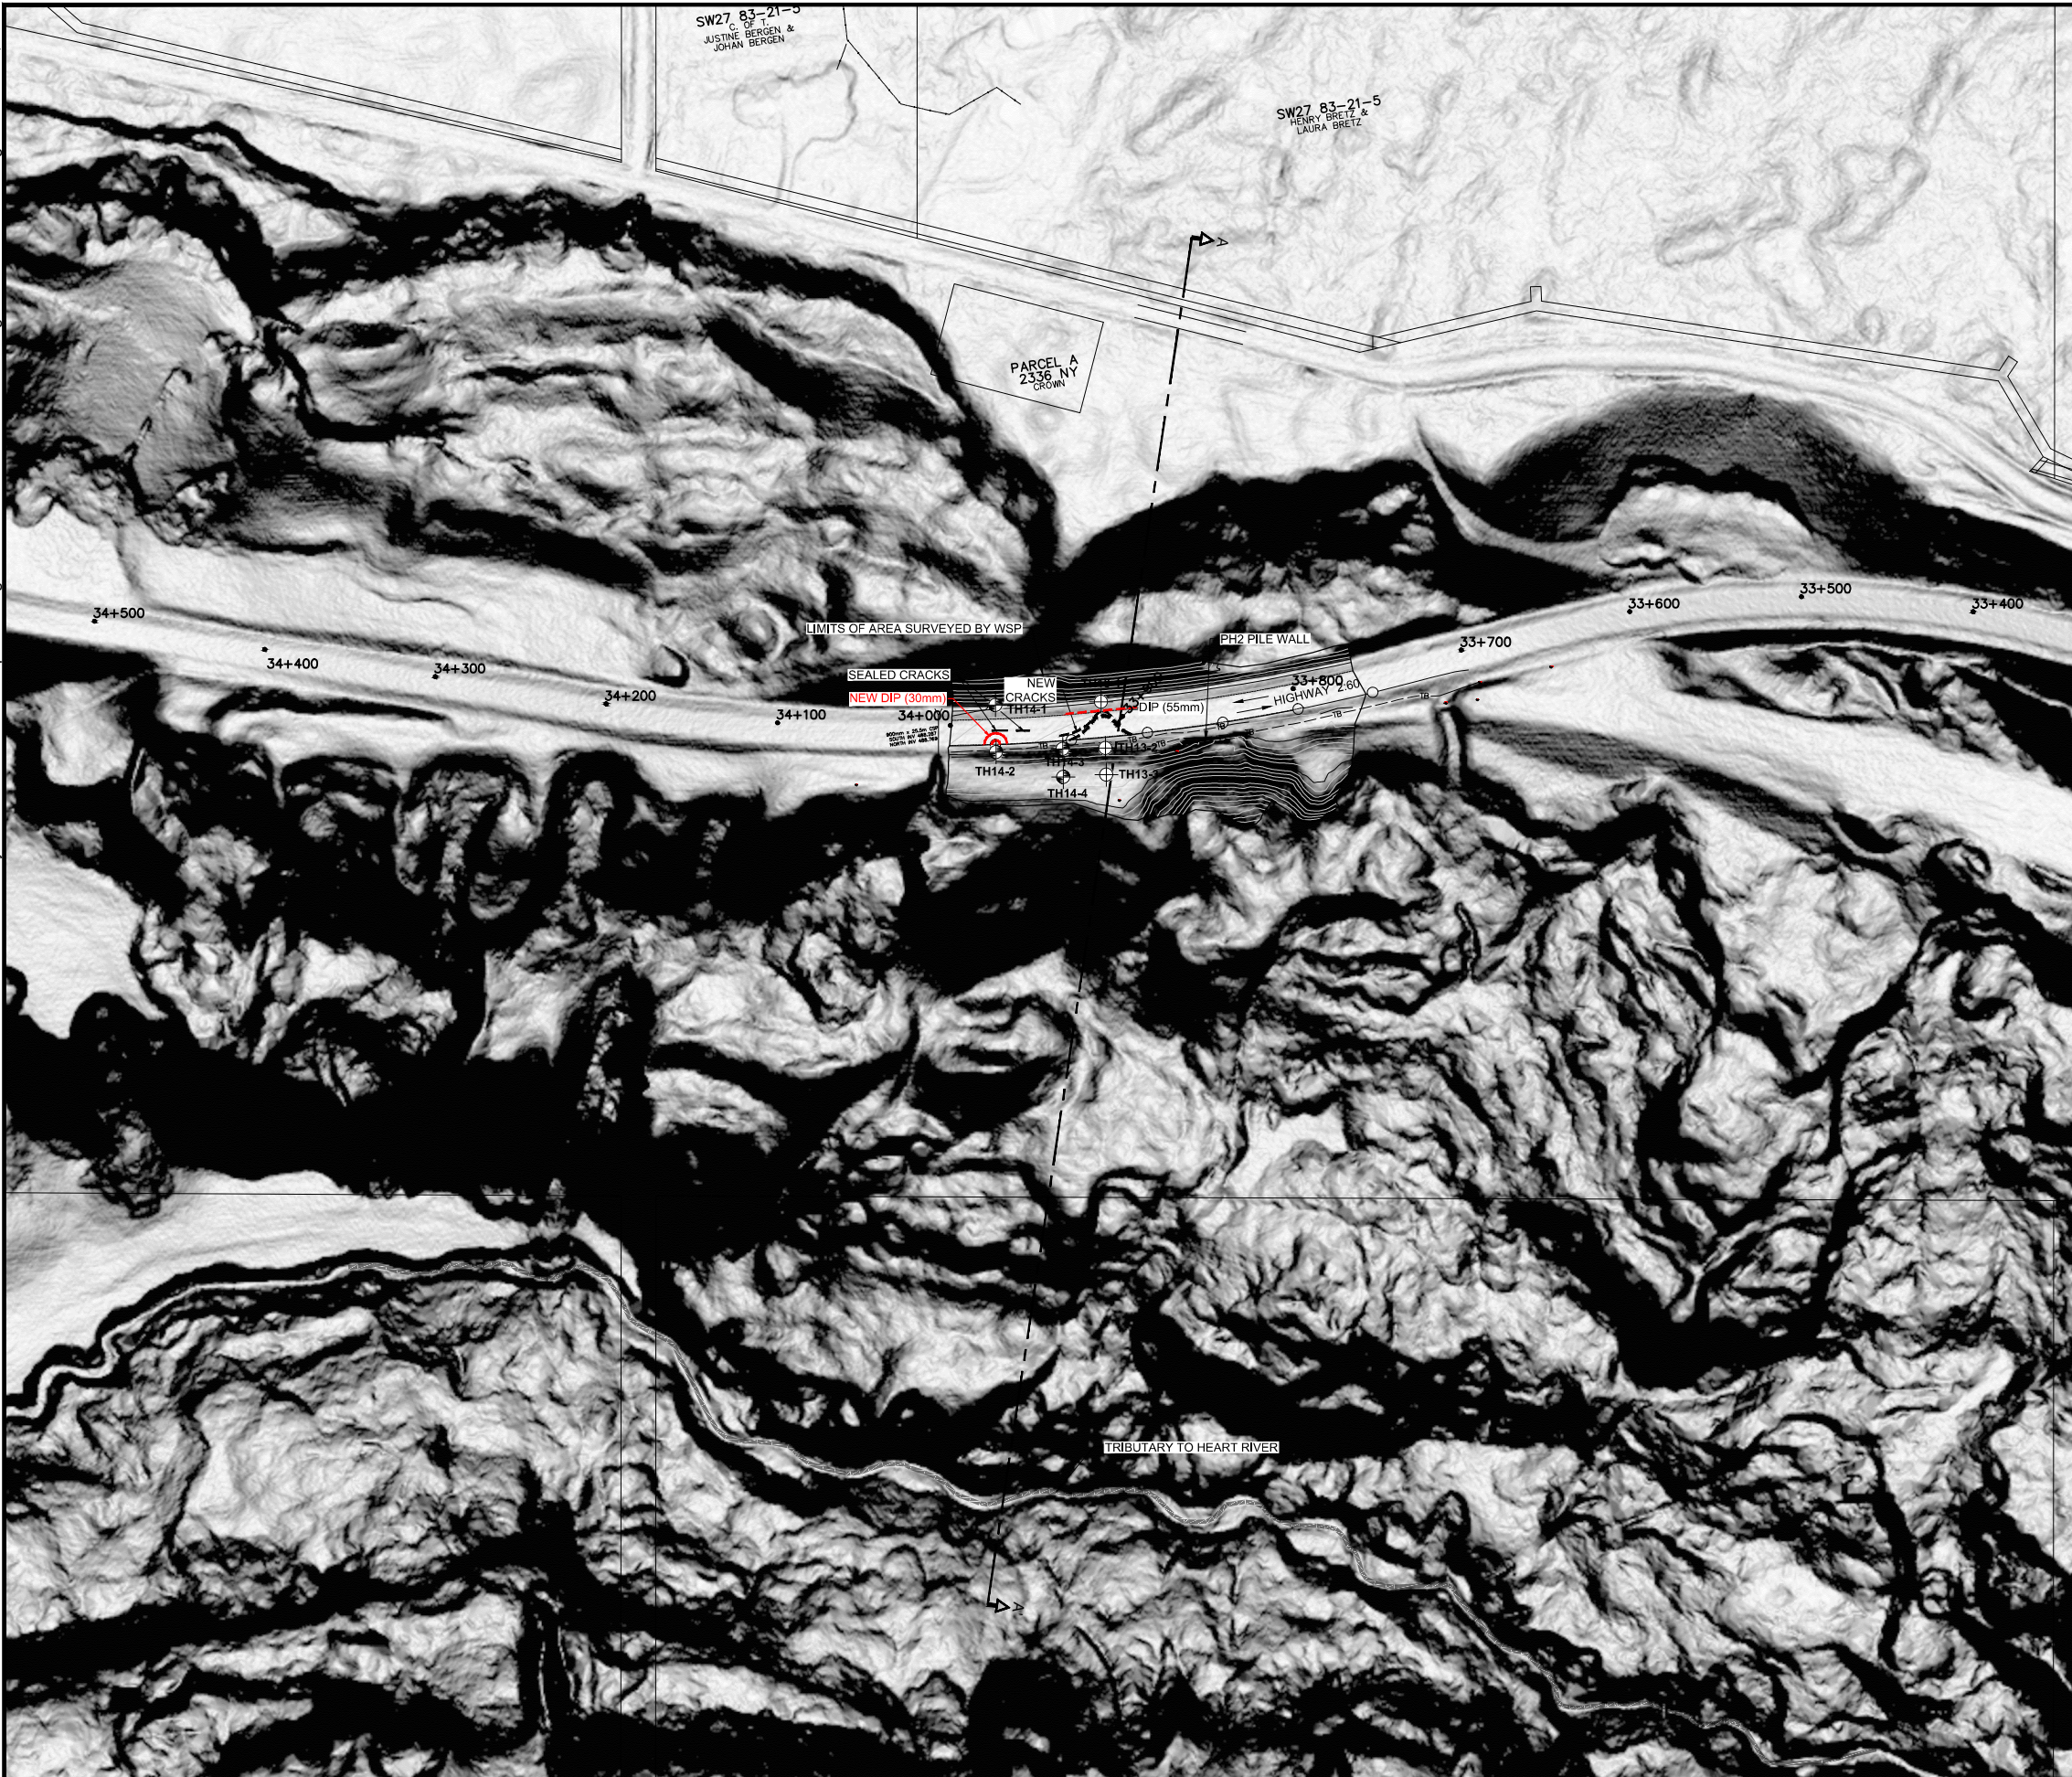
**DWG No. 15-16-357-PH2-3**

Based on LiDAR imagery (Refer to Dwg 15-16-357-PH2-3), the highway was constructed over a large ancient landslide and the current movement appears to be a local retrogression of a slide block within the old landslide into the highway fill, possibly due to progressive failure due to a gradual loss of cohesion or a change in groundwater conditions. The tributary to the Heart River is present 122 m below the highway surface. This landslide has the potential to close all three lanes of the highway, which is the main access route to the Town of Peace River and a part of the national transportation network.

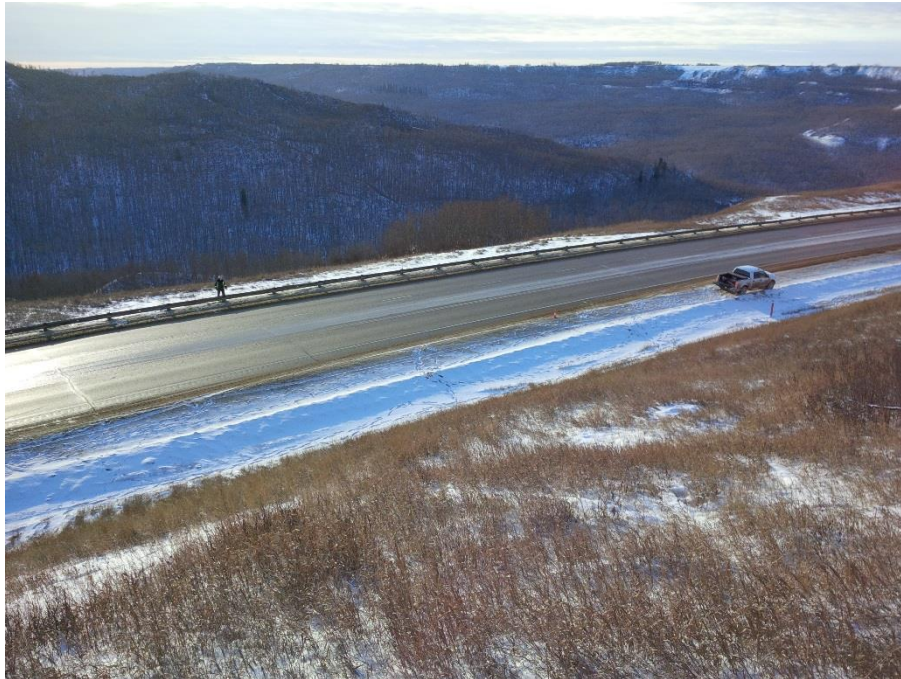
<b>Primary Site Issue:</b>	A landslide is affecting all three lanes of the highway, resulting in tension cracks and dips in the asphalt.		
<b>Dimensions:</b>	The original landslide was affecting about 40 m of highway, however new cracks and dips suggest that the total length of highway affected is now about 90 m (refer to Dwg. 15-16-305-PH2-1).		
<b>Maintenance:</b>	None since 2011	<b>Worsened?</b>	
<b>Observations:</b>	<b>Description</b>	<b>Yes</b>	<b>No</b>
<input checked="" type="checkbox"/> Pavement Distress	There are tension cracks and dips in the pavement.	<input checked="" type="checkbox"/>	<input type="checkbox"/>
<input checked="" type="checkbox"/> Slope Movement	Slope inclinometer 13-2 shows a distinct shear plane about 18 m below the d/s shoulder of the highway. The movement rate has increased.	<input checked="" type="checkbox"/>	<input type="checkbox"/>
<input checked="" type="checkbox"/> Erosion	Some erosion has occurred in the valley slope beyond the outlet of the centreline culvert located west of the distressed pavement area	<input type="checkbox"/>	<input checked="" type="checkbox"/>

Photo 1 – Looking southwest at section of highway that is affected by landslide (Jan. 28, 2015)

The highway should be patched as necessary to provide a safe riding surface. Landslide warning signs should be erected to warn the public in case of a sudden movement of the landslide.

A speed reduction through the area (The current gazetted speed is 100 km/hr) should also be considered. Based on the accentuation of the dipping in the asphalt pavement observed in December 2014 and January 2015 that the landslide is currently active and a failure of the highway embankment could be imminent.

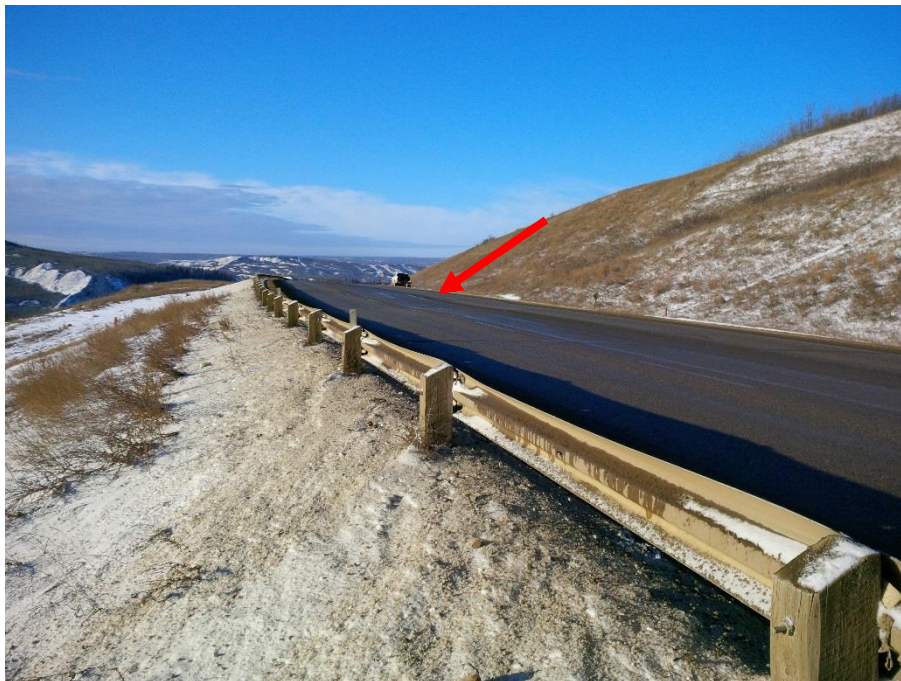
Photo 2 – Looking west at sideslope area between highway and valley slope and the main dip the roadway (January 28, 2015)

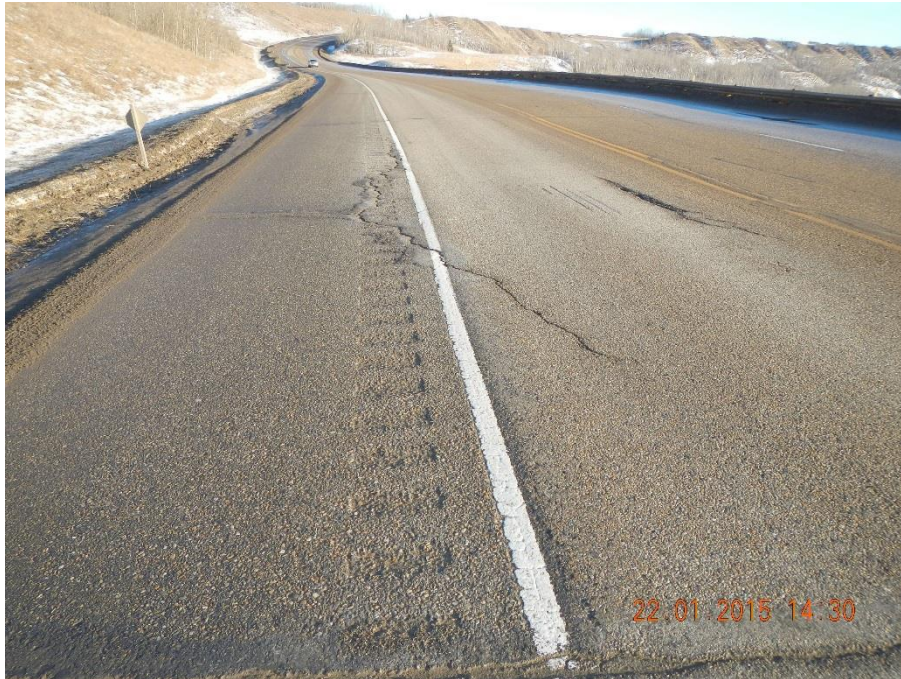
Recent observations made by the MCI and the Maintenance Contractor have indicated that both dips have worsened during the months of December 2014 and January 2015, which is typically a more dormant period for landslide activity. There is a significant risk that the rate of movement will increase in the Spring months, when the ground thaws and water tables are typically higher at which point a sudden failure, resulting in the closure of the highway, is more likely to occur.

Photo 3 – Looking east at dip and tension cracks near headscarp of landslide (Jan. 22, 2015)

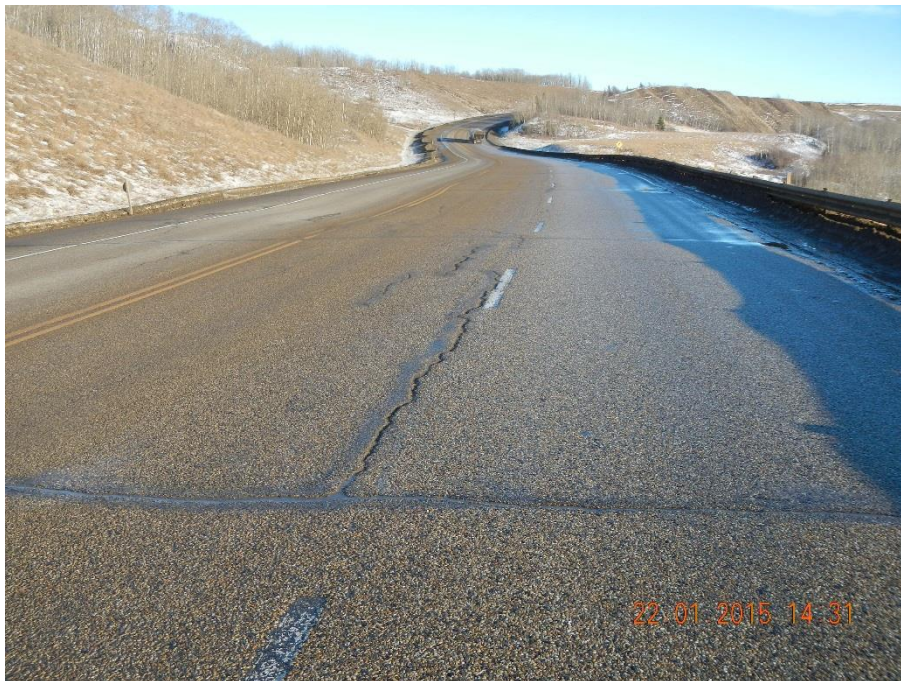
Photo 4 – Looking east at cracks propagating in EB lanes, from original landslide area. Water is ponding in dipped areas. (January 22, 2015)
