THURBER ENGINEERING LTD.

November 16, 2022

**ALBERTA TRANSPORTATION GRMP (CON0022164)
PEACE REGION (PEACE RIVER DISTRICT)
INSTRUMENTATION MONITORING RESULTS – FALL 2022**

SITE PH002: HWY 2:60, PEACE RIVER EAST HILL

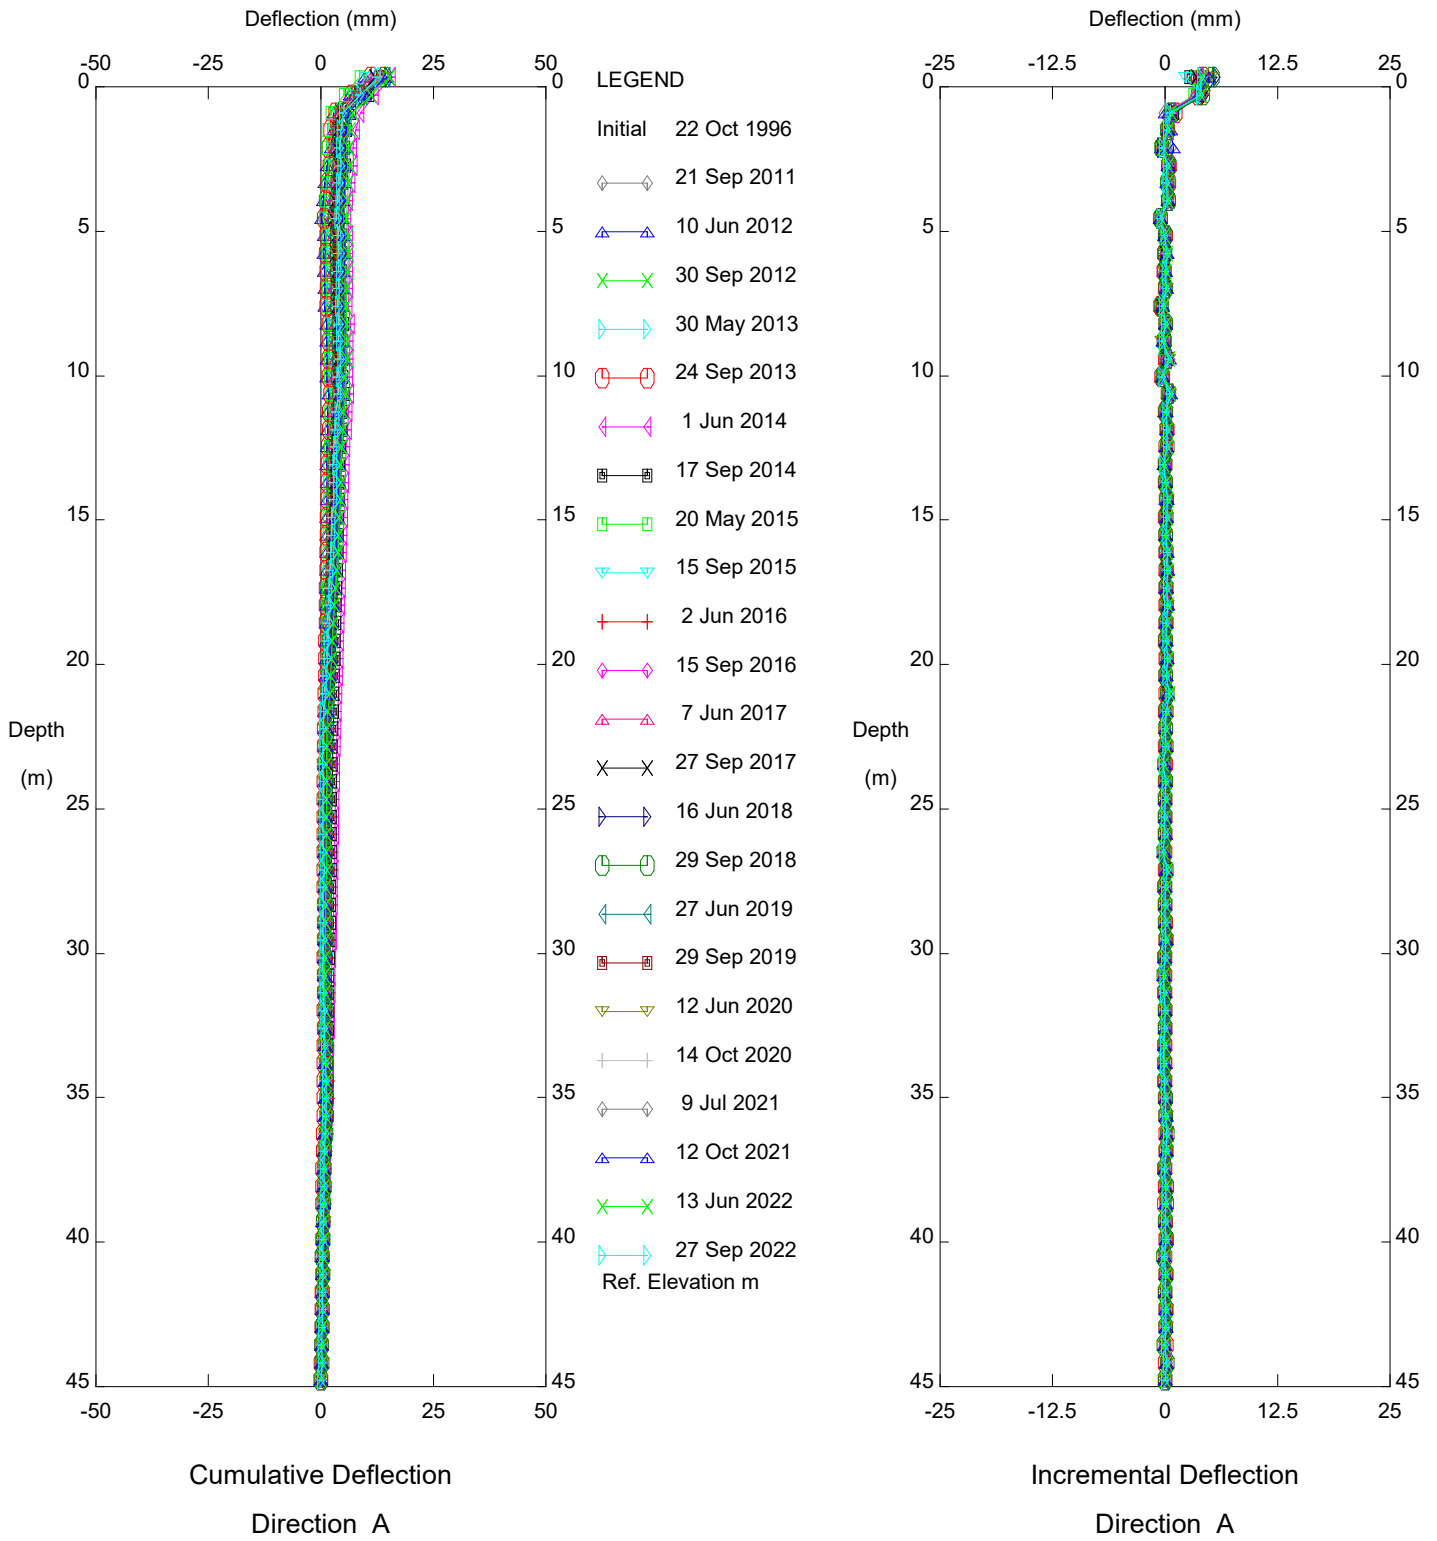
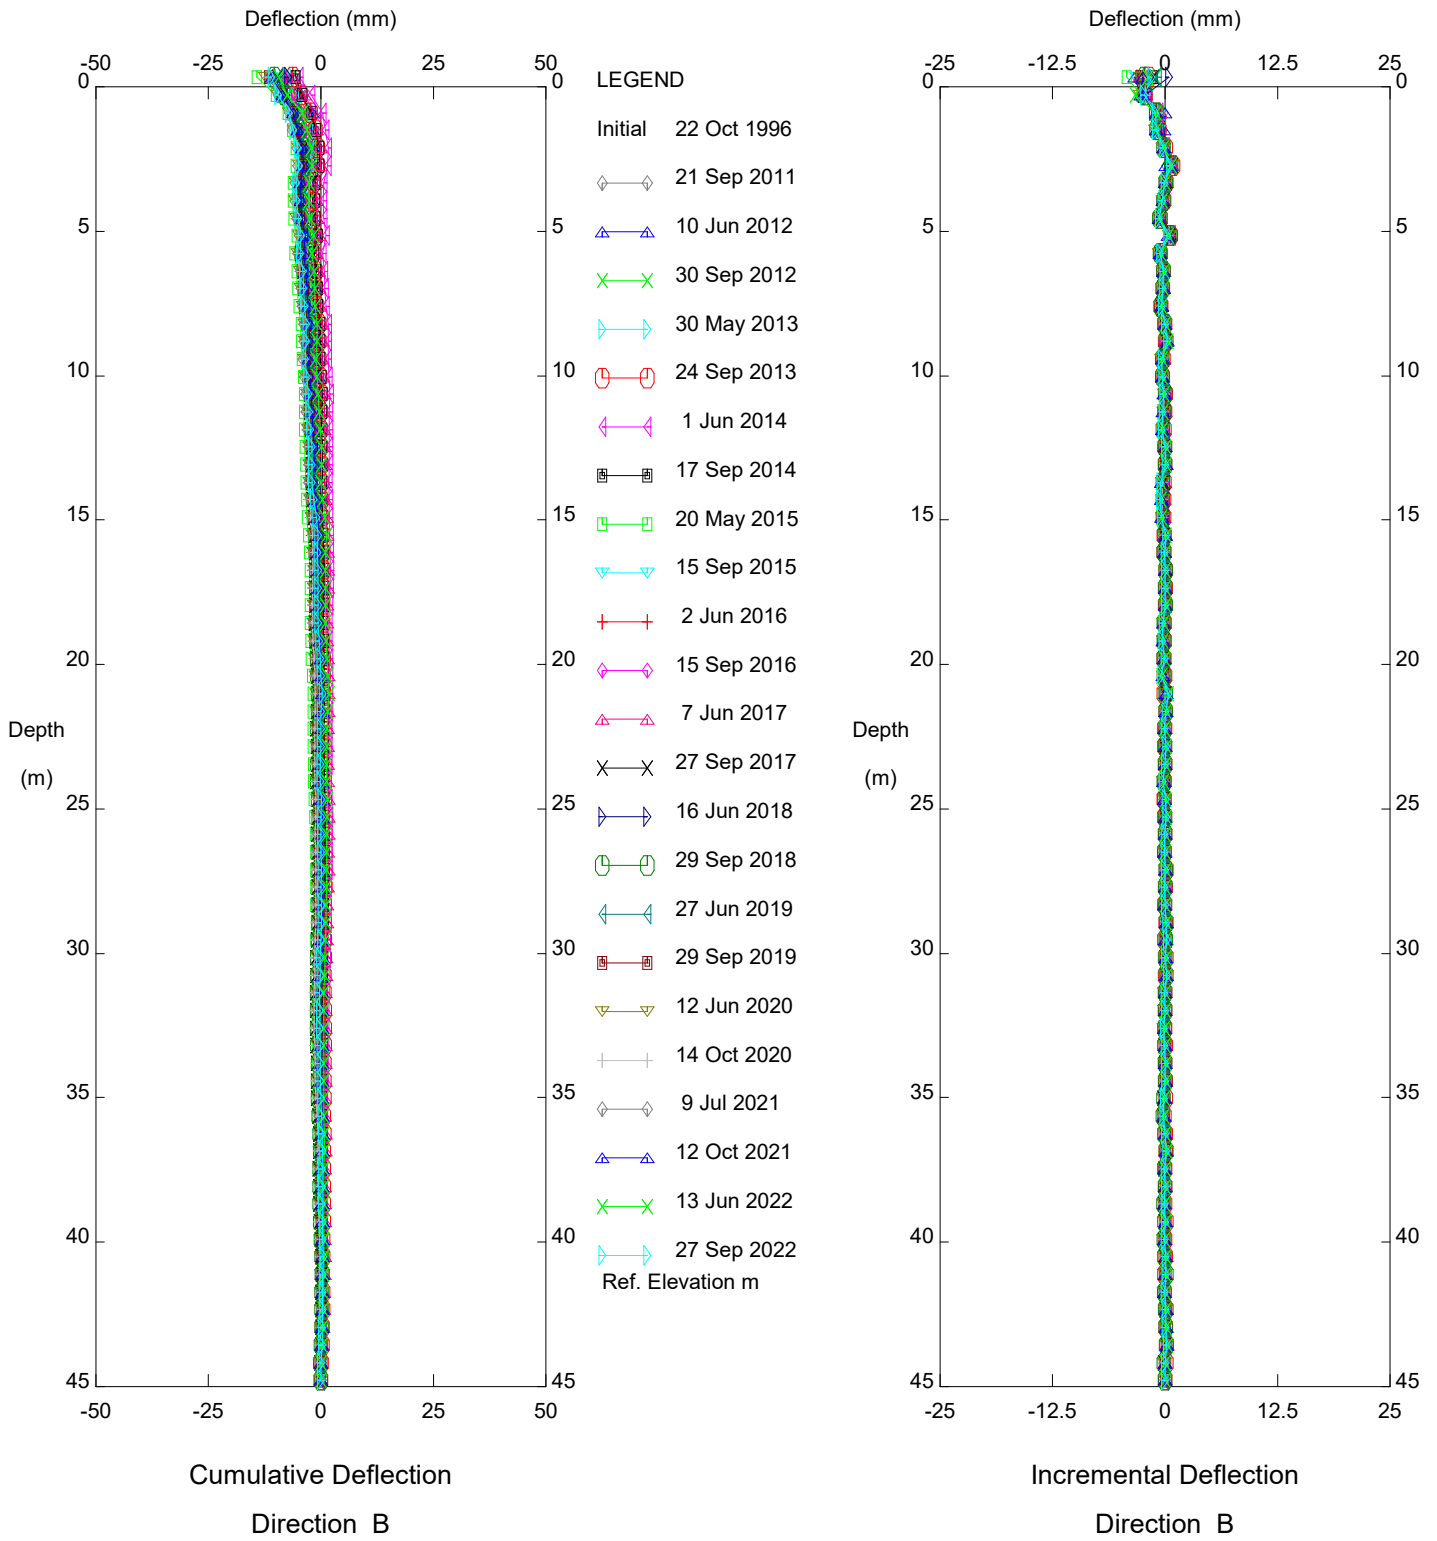
HWY. 2:60 - STA. 2+600, Inclinometer SI-63

Slope inclinometers SI-63 and SI10-3 continued to show no discernible movement. SI-64 showed a rate of movement of 6.6 mm/yr over 0.5 to 4.1 m depth since the spring of 2022 readings.

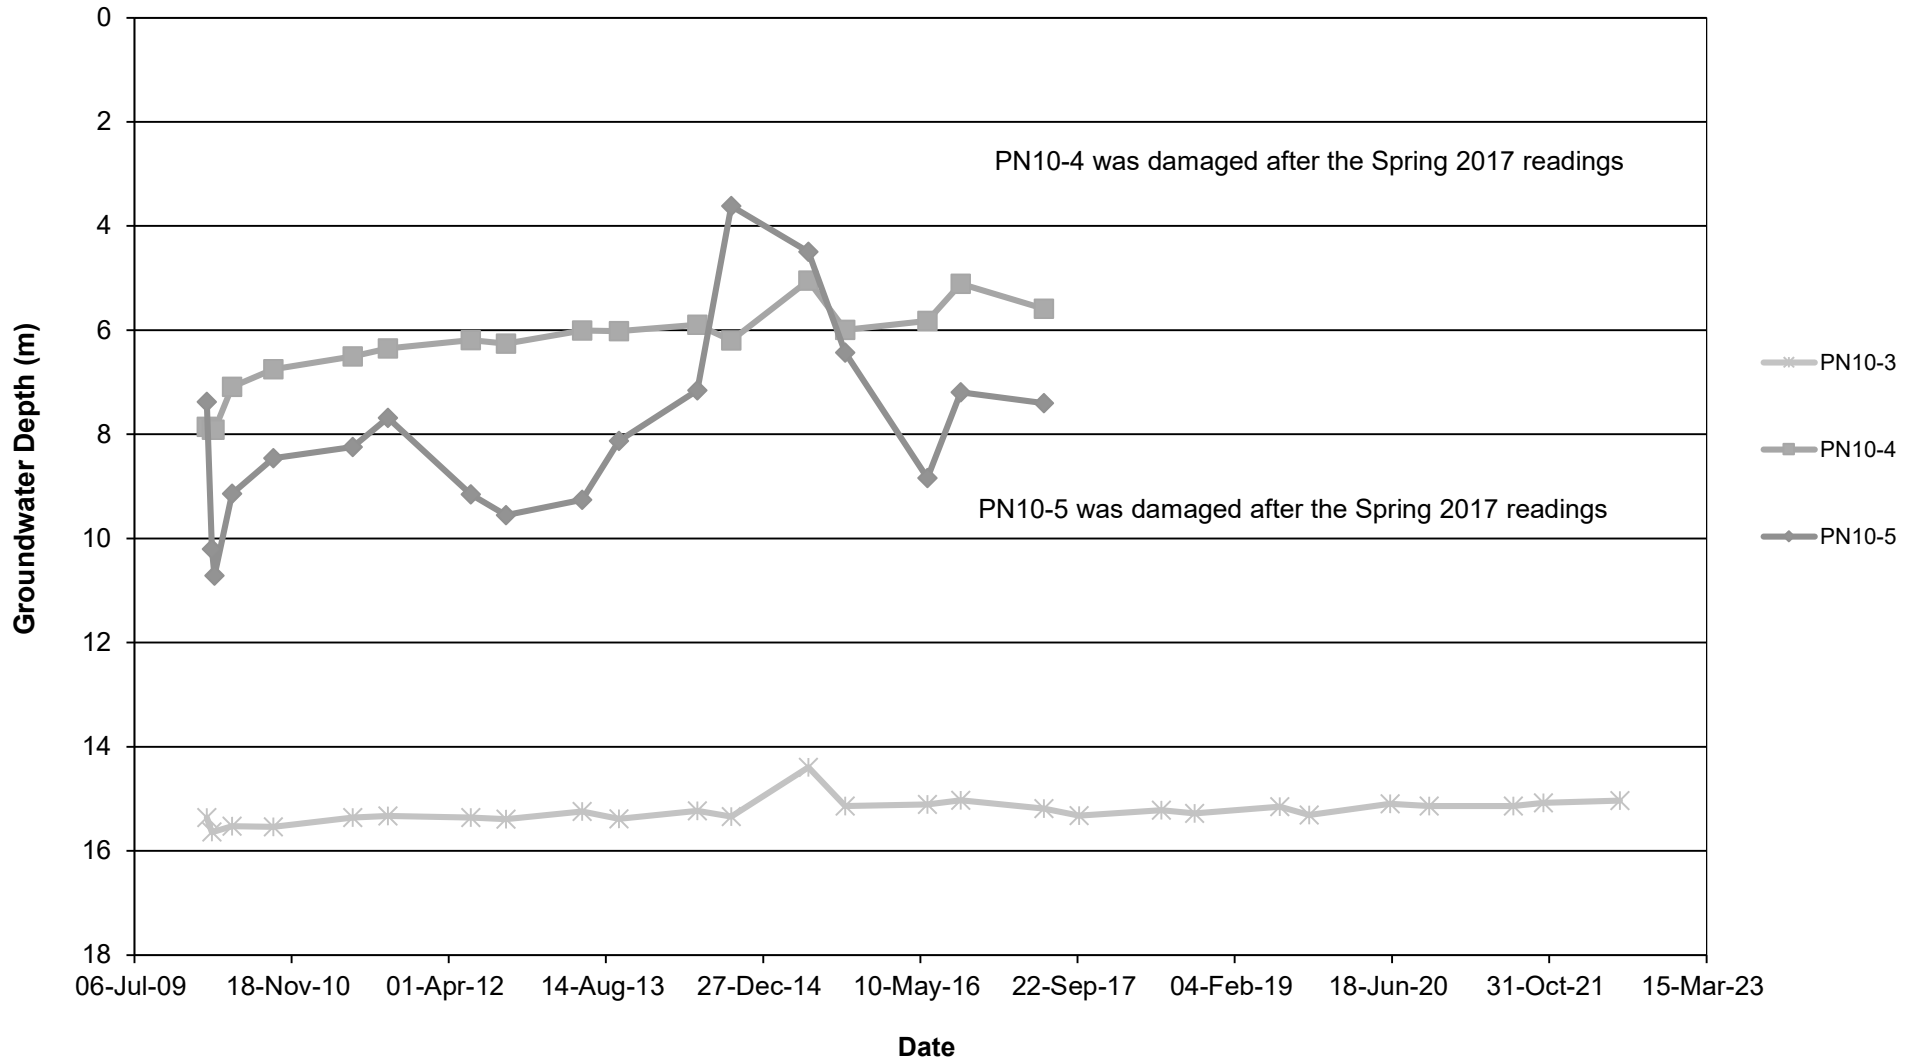
**FIGURE PH002-1
PIEZOMETRIC DEPTHS FOR HWY 2:60 PEACE RIVER EAST HILL**

Pneumatic piezometer PN10-3 showed a decrease in groundwater level of 0.08 m since the spring of 2022 readings. The pneumatic piezometer readings are summarized in Table PH002-2 above and are plotted on Figure PH002-1 in Appendix A.
