**ALBERTA TRANSPORTATION GEOHAZARD ASSESSMENT PROGRAM
PEACE REGION – PEACE-HIGH LEVEL
2020 INSPECTION**

Site Number	Location	Name	Hwy	km
PH59	East Hill	34+770 to 35+680 Site 2	2:60	35.20
Legal Description		UTM Co-ordinates		
S28-083-21 W5M		11V E 484105	N 6231090

**PEACE RIVER EAST HILL
HWY 2:60 (PH59) STA. 34+770 TO 35+680
LOCATION PLAN**

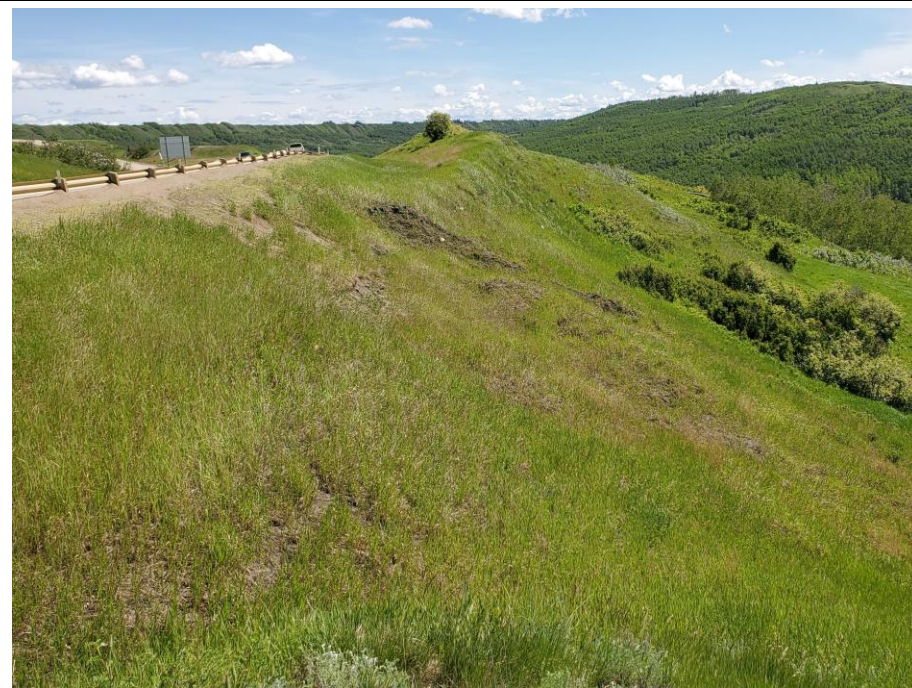
Photo 59-01.
Looking east at headscarp area of shallow landslide on downslope side of roadway. Small downslope movement within displaced slide mass but no major expansion at the main scarp since 2009 (34+850).

Drain pipe outlet needs to be cleared in gabion discharge structure at 35+480. Culvert at 35+480 under the highway needs to be repaired and north ditch regraded (using nearby borrow fill?) and armored with ECM or similar (from 35+275 to 35+650). Regrading of the slope or fill placement at 34+850 may be required in the future if the guardrail becomes undermined due to erosion or movement at the slide scarp.

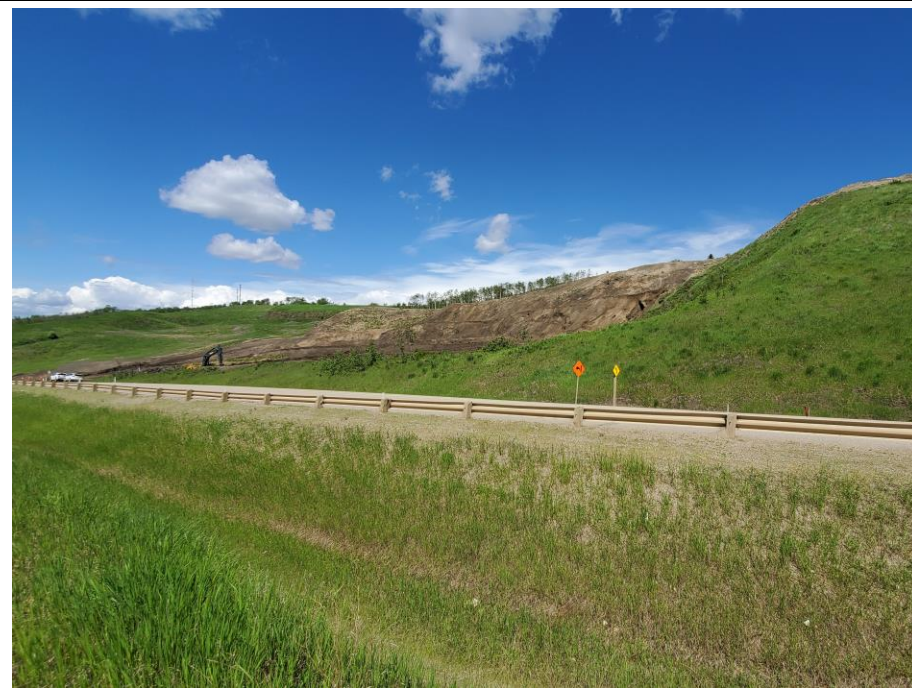
Photo 59-02.
Looking northwest towards the slope above the highway that was excavated for borrow fill for other highway work (35+000).

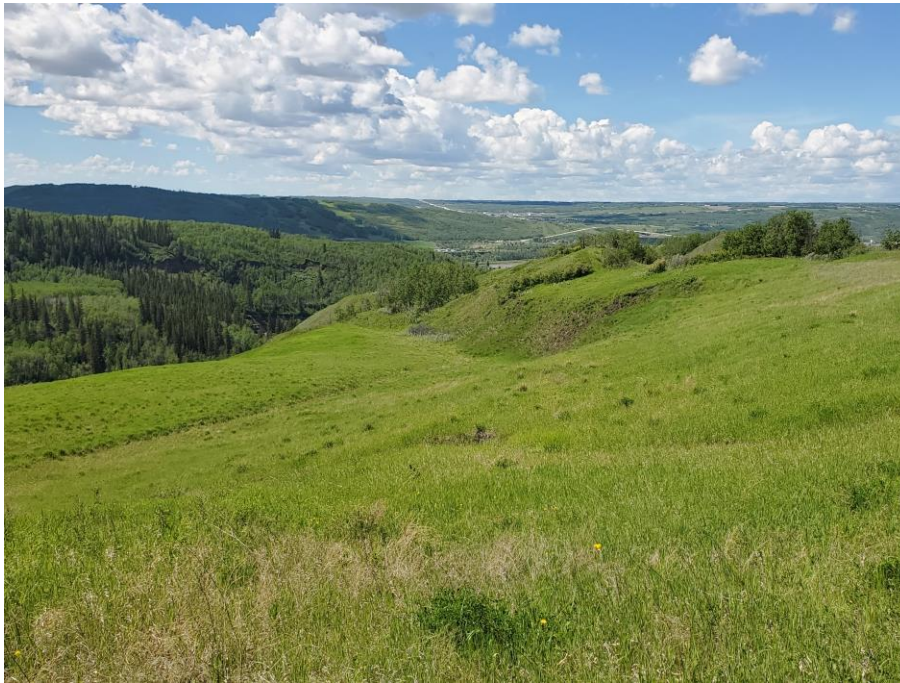
condition. Flank of scarp near 35+300 has no change from 2019 condition (Photo 59-03).	
<input checked="" type="checkbox"/> Erosion	<p>Erosion gully is active near 35+450, approximately 125 m downslope from highway (Photo 59-05). Overgrown erosion gully downstream of gabion culvert outlet near 35+500 has minor ongoing erosion/expansion at the flanks but no major retrogression since previous inspection (Photo 59-08).</p> <p>Active ditch erosion (up to 1.5 m deep) and associated gully erosion occurring at 35+100, 35+200, and 35+475 (Photo 59-06 and 59-09) from uncontrolled runoff from roadway ditch.</p> <p>Significant silt buildup was noted within ditch fences on the north side of the highway near 35+200.</p>	<input checked="" type="checkbox"/>
<input type="checkbox"/> Seepage		<input type="checkbox"/>
<input checked="" type="checkbox"/> Bridge/Culvert Distress	Culvert at 35+100 and 35+480 under the highway corroded and the inlet is blocked (Photo 59-04 and 59-06).	<input checked="" type="checkbox"/>

Photo 59-03.
Looking west across
the berm below the
road embankment
(35+250).

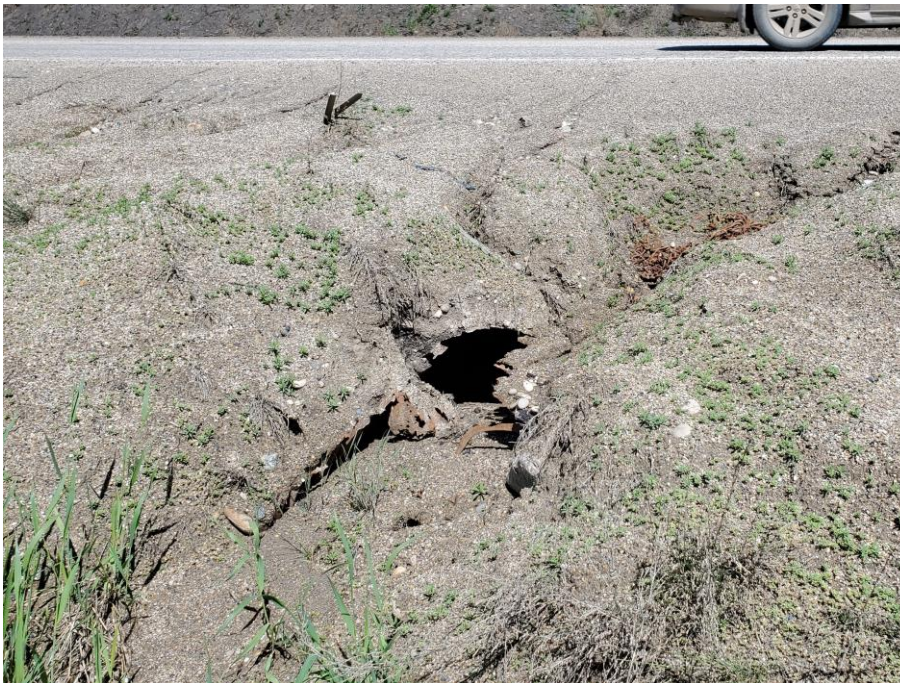
Photo 59-04.
Looking at damaged
culvert outlet
(35+100).

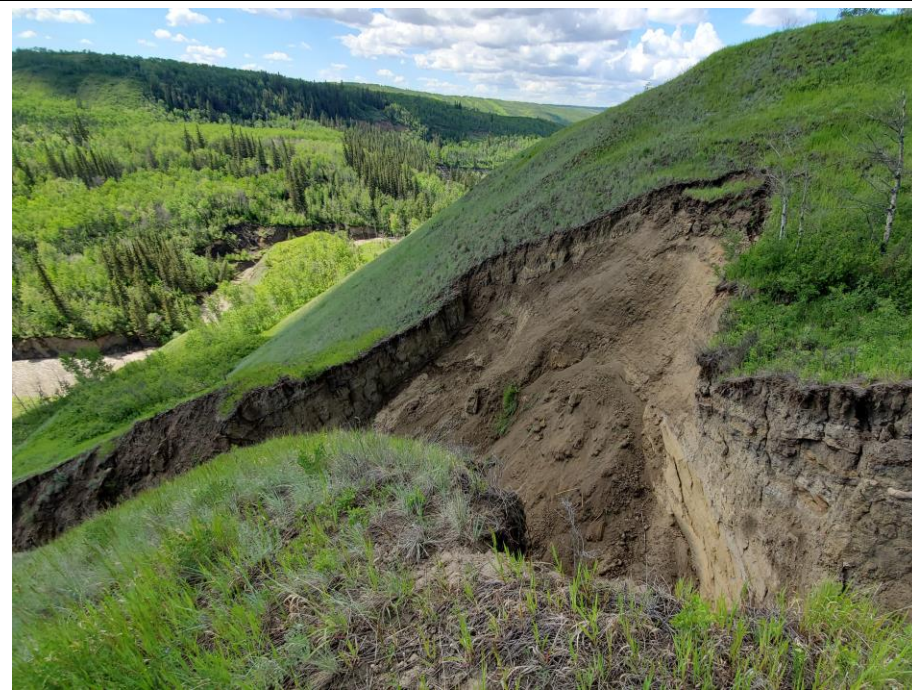
Photo 59-05.
Looking downslope at head of the widest segment of an erosion gully approximately 125 m downslope (south) from the highway (35+450).

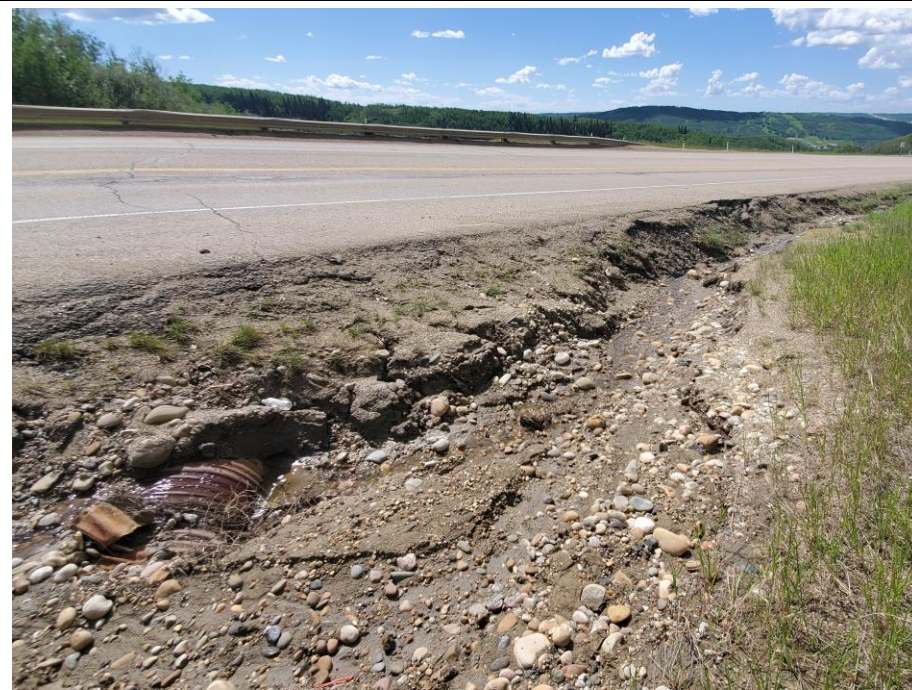
Erosion is very active and deep in the north ditch and within two major gullies south of the highway. Ditch should be regraded and armored. Culvert drainage should be restored. Current gullies do not present an immediate risk to the highway but consideration of adding a trunk drain to this section should be considered to reduce rate of retrogression.

Photo 59-06.
Buried and blocked culvert inlet near 35+475. Significant north ditch erosion upslope and downslope of inlet (up to 1.5 m deep).

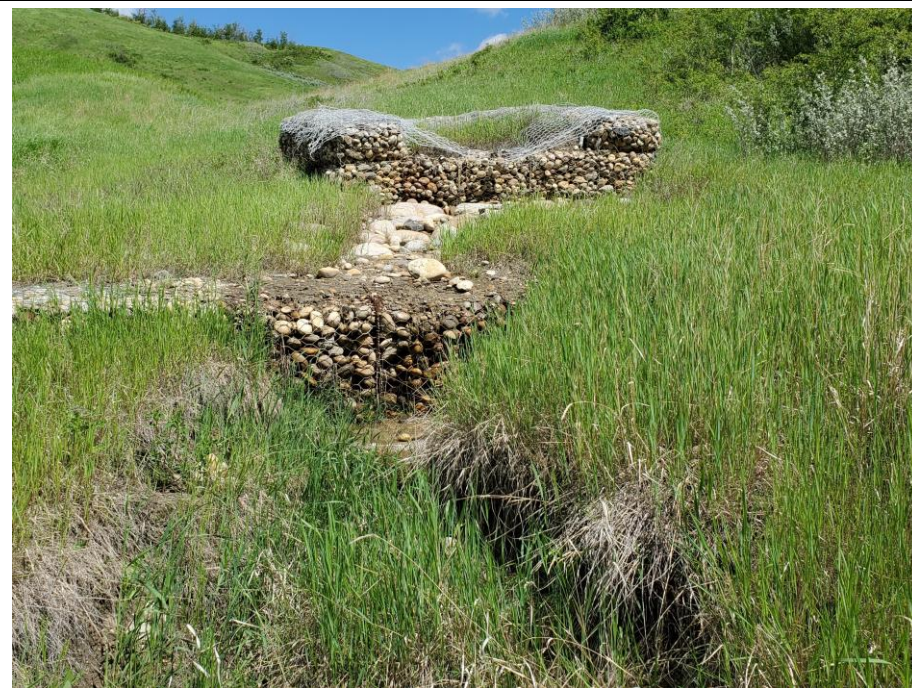
<input checked="" type="checkbox"/> Other	<p>Outlet drain pipe blocked in gabion discharge structure at 35+480. Slumping downslope of discharge structure is ongoing. Structure is in similar condition to previous inspection. (Photo 59-07)</p> <p>The slope above the road between 35+200 and 35+400 was under active construction and was being used as a borrow source area for nearby bridge construction (Photo 59-02).</p>	<input type="checkbox"/>
<p>Instrumentation:</p> <p>SI67 – No discernible movement</p> <p>SI69 – No discernible movement</p> <p>SI75 – No discernible movement</p> <p>SI81 – 1.2 mm/yr over 1.9 m to 6.1 m depth; and 1.9 mm/yr over 6.1 m to 9.2 m depth; consistent with past trends.</p> <p>SI82 – Sheared at 11.7 m below ground surface since Fall 2012 reading.</p> <p>Pneumatic piezometer PN-004 showed a decrease in groundwater level of 0.05 m since Fall</p>

Photo 59-07.
Gabion culvert outlet structure (35+500) appears in similar condition to previous inspections.

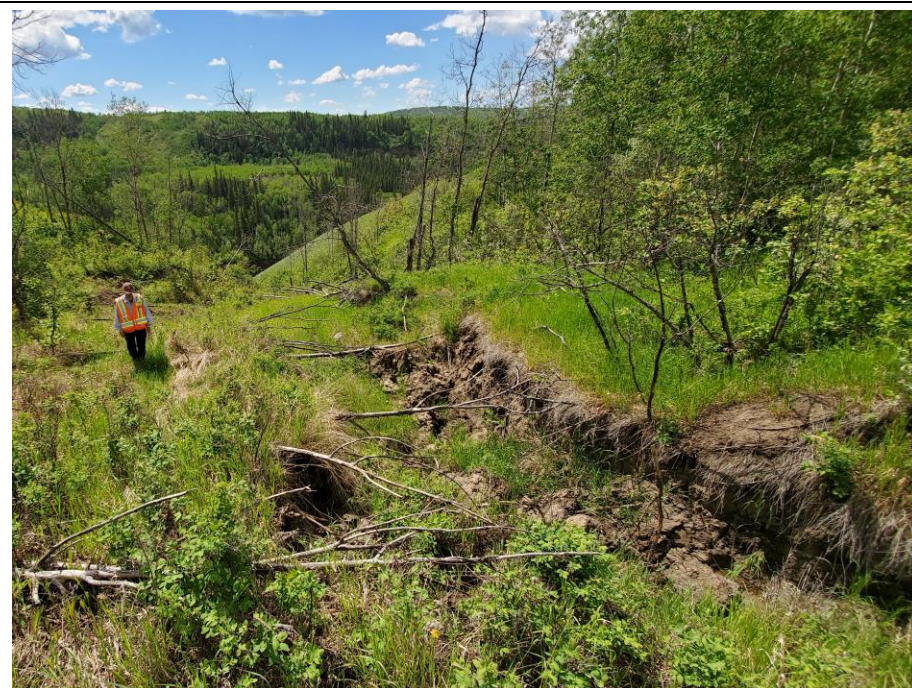
Photo 59-08.
Overgrown erosion gully downstream of gabion culvert outlet near (35+500). Minor ongoing erosion/expansion at the flanks but no major retrogression since previous inspection.

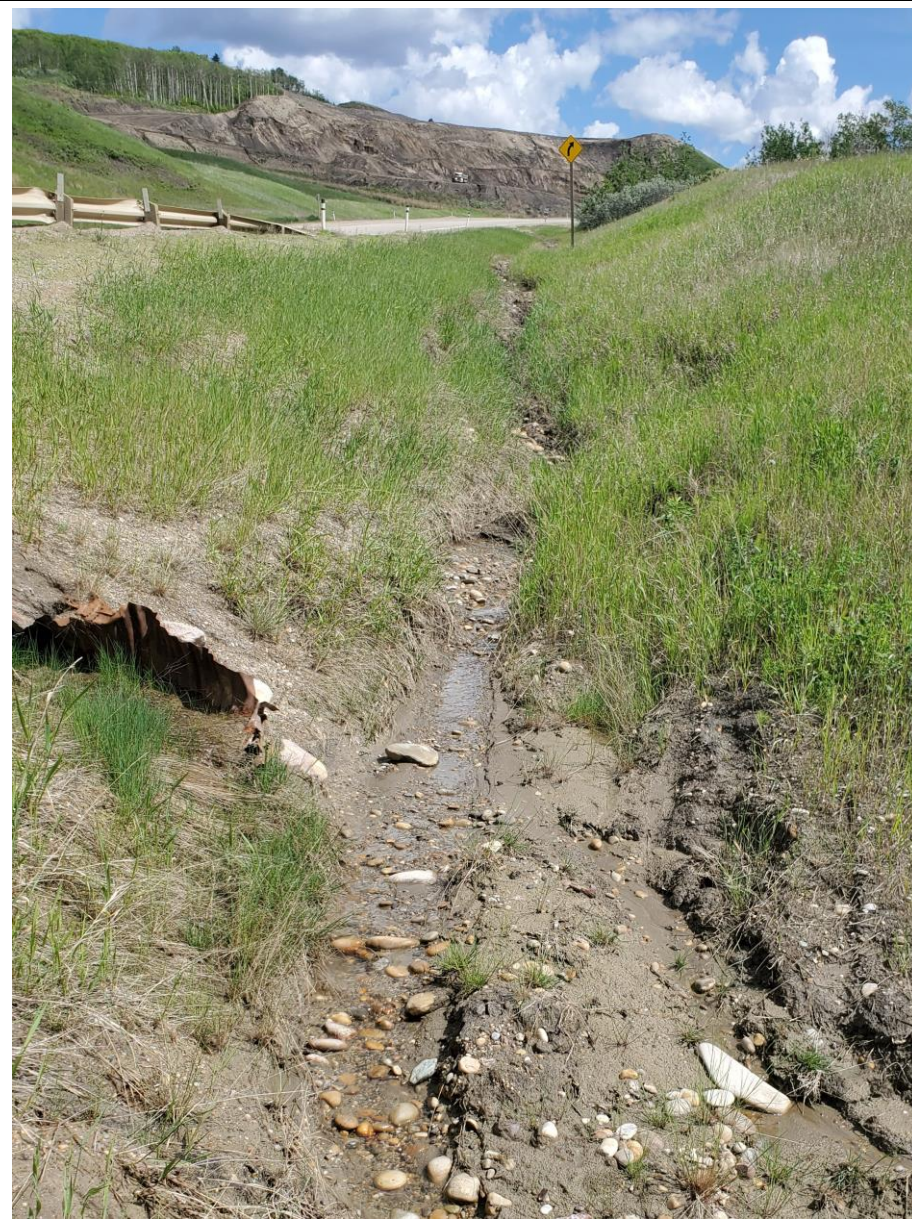
Photo 59-09.
Looking east towards the south ditch erosion upslope from the culvert outlet that drains towards the river (35+500). No significant change from 2019.
