November 16, 2022

File No.: 32121

**ALBERTA TRANSPORTATION GRMP (CON0022164)
PEACE REGION (PEACE RIVER DISTRICT)
INSTRUMENTATION MONITORING RESULTS – FALL 2022**

**SITE PH059: HWY 2:60, PEACE RIVER EAST HILL
(SITE # 2, STATION 34+770 TO 35+680)**

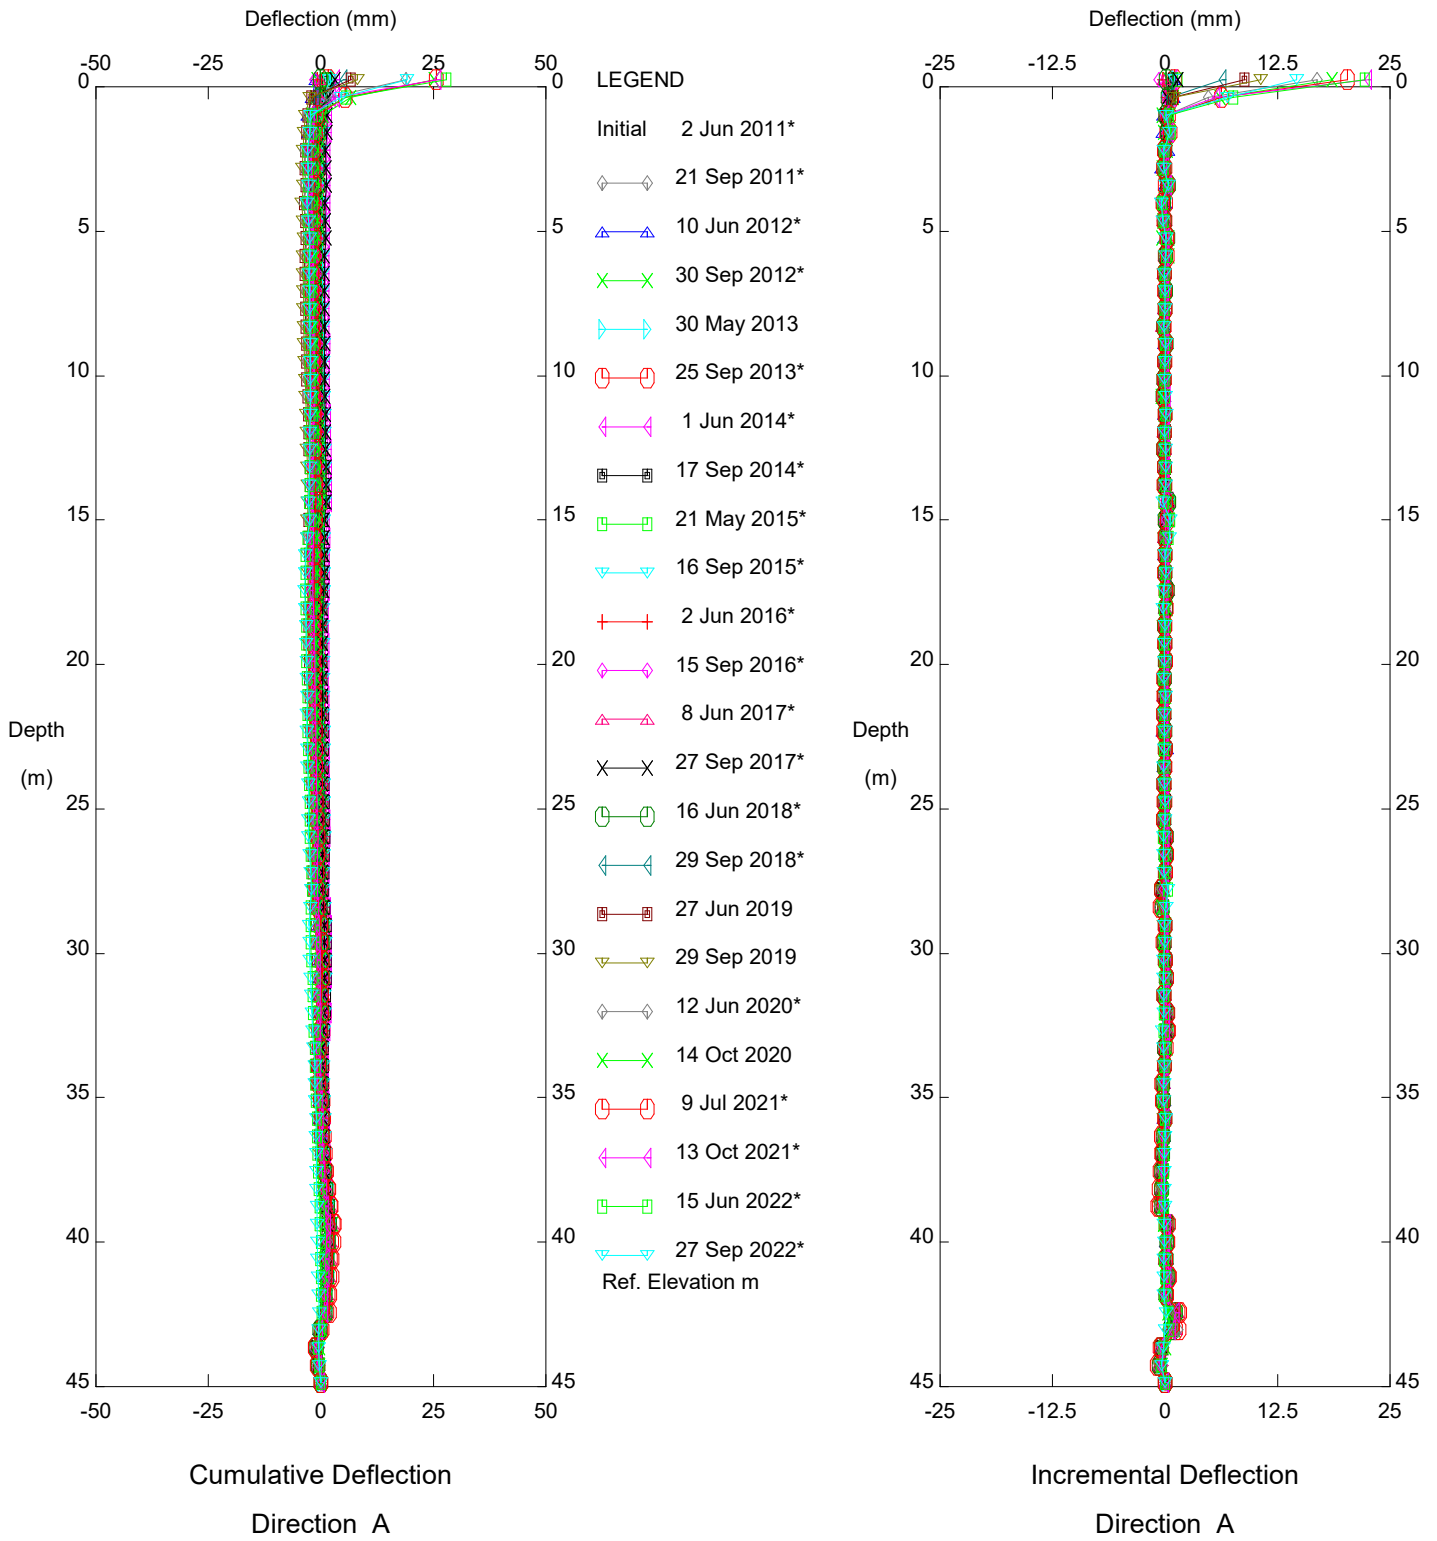
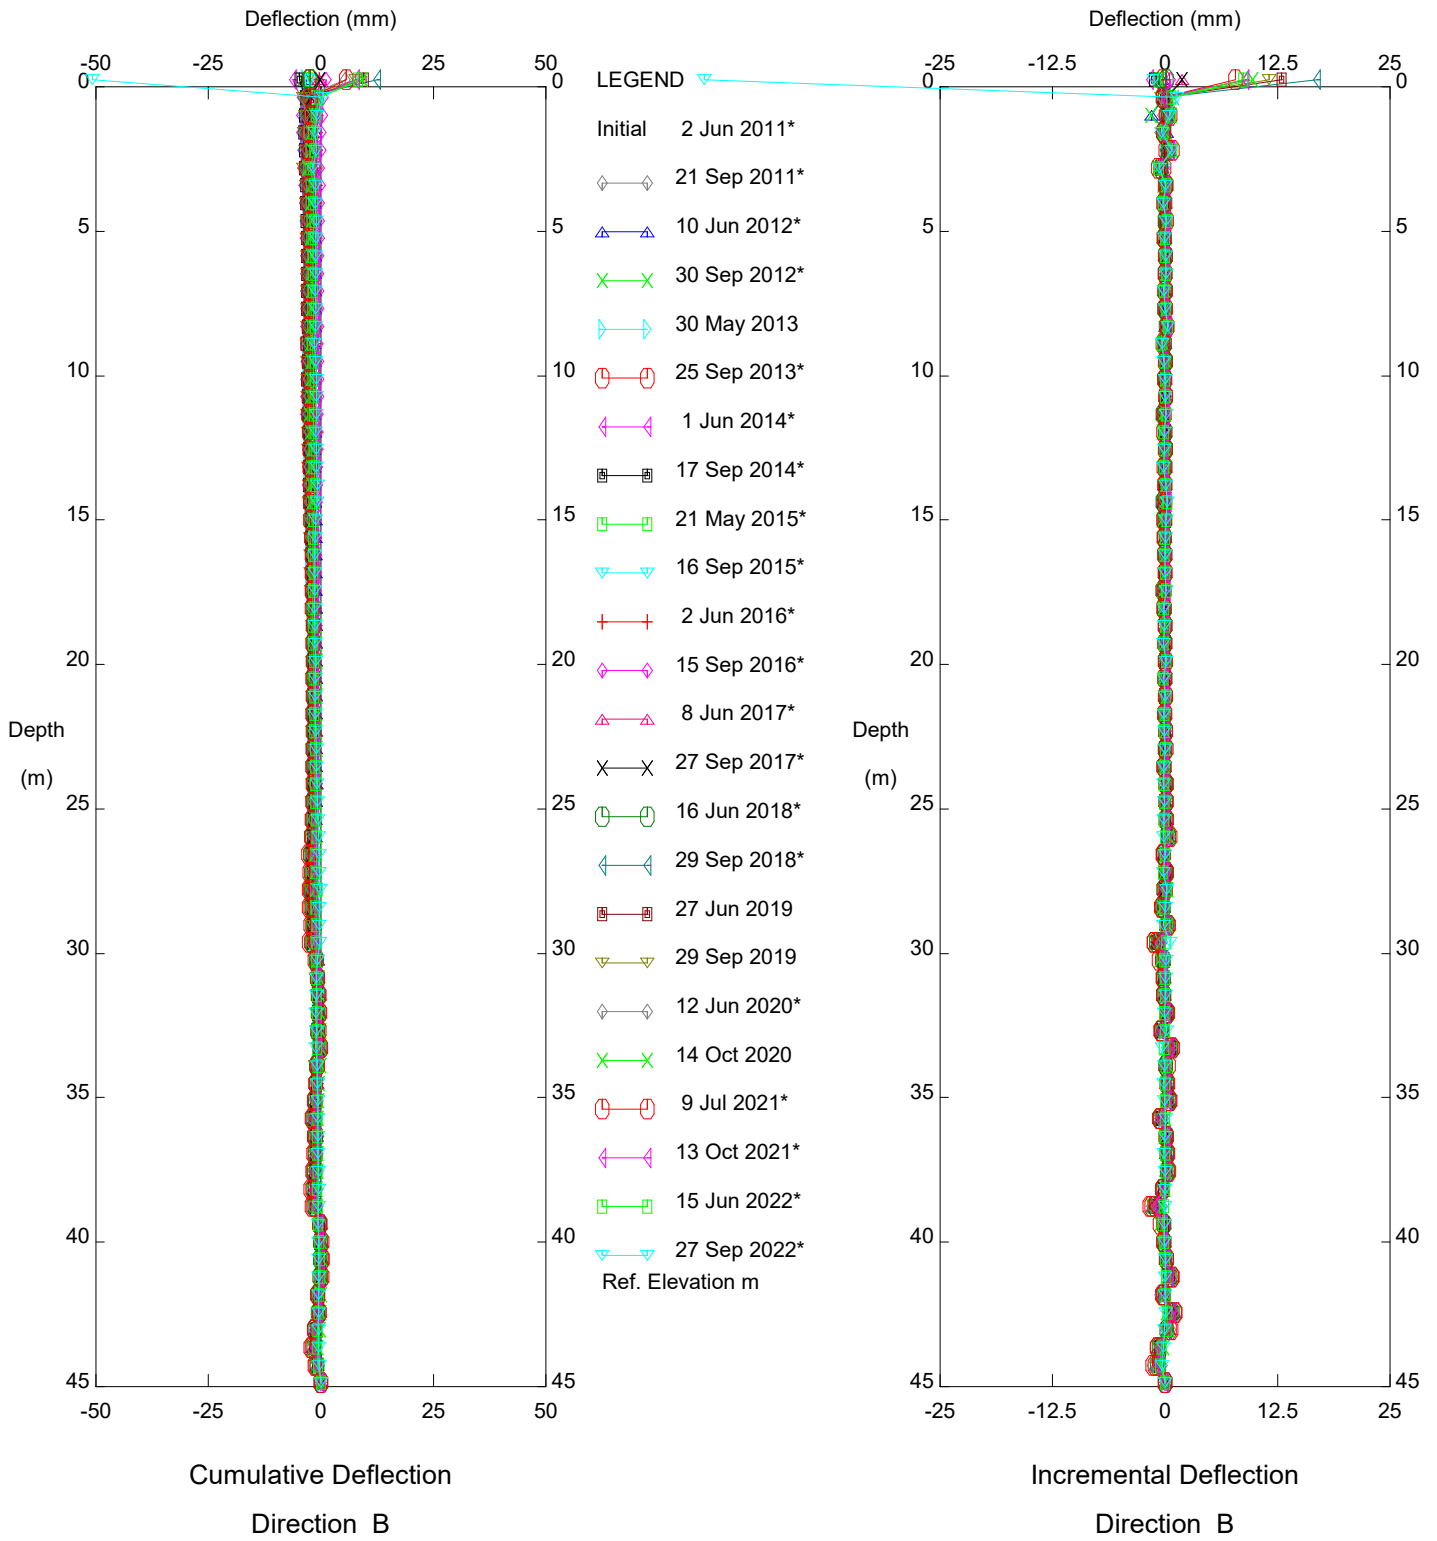
(PH059) PEACE RIVER EAST HILL -SITE 2, Inclinometer SI-67

Slope inclinometers SI-67 and SI-69 continued to show no discernible movement. SI-75 showed a rate of movement of 8.2 mm/yr over 0.0 m to 5.4 m depth since the spring of 2022 readings. SI-81 showed no discernible movement over 1.9 m to 6.1 m depth and a rate of movement of 4.4 mm/yr over 6.1 m to 9.2 m depth since the spring of 2022 readings.

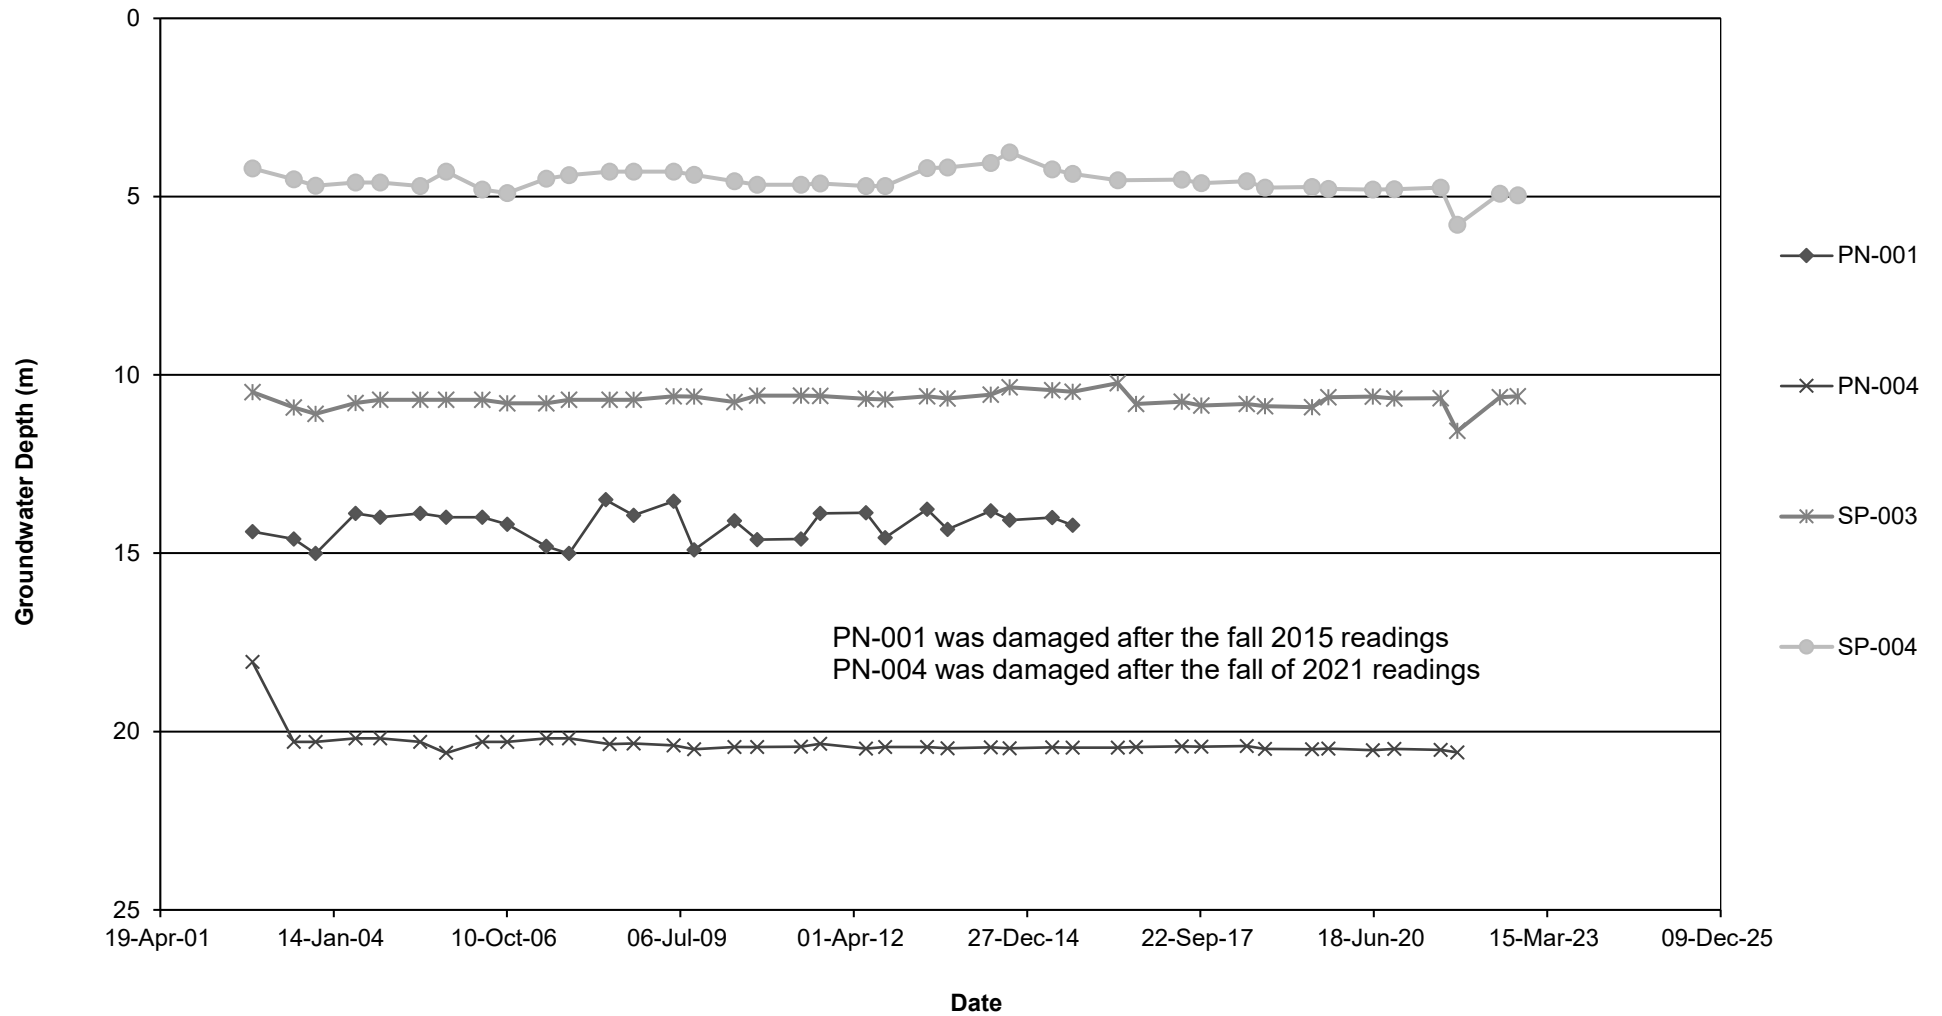
**FIGURE PH059-1
PIEZOMETER DATA: PEACE RIVER EAST HILL SITE #2**

Standpipe piezometers SP-003 showed an increase in water level of 0.03 m since the spring of 2022 readings. SP-004 showed a decrease in groundwater level of 0.04 m since the spring of 2022 readings. The pneumatic and standpipe piezometer readings are summarized in Tables PH059-2 and PH059-3, and are plotted on Figure PH059-1 in Appendix A.
