**ALBERTA TRANSPORTATION
GEOHAZARD ASSESSMENT PROGRAM
PEACE REGION (PEACE RIVER DISTRICT)
2022 INSPECTION**

Site Number	Location	Name	Hwy	km
PH59	East Hill	34+770 to 35+680 Site 2	2:60	35.20
Legal Description		UTM Co-ordinates		
S28-083-21 W5M		11V E 484105	N 6231090

PEACE RIVER EAST HILL
HWY 2:60 (PH059)
KEY MAP

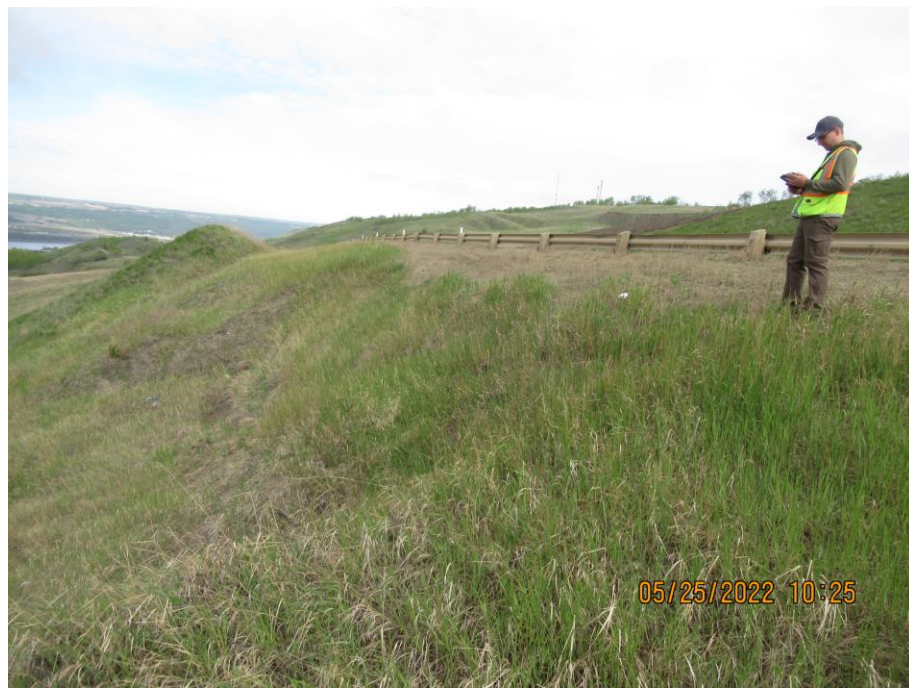
Photo 59-01.
Looking east at headscarp area of shallow landslide on downslope side of roadway. Some downslope movement within displaced slide mass but no major expansion at the main scarp since 2009 (34+850).

Drain pipe outlet needs to be cleared in gabion discharge structure at 35+480. Culvert at 35+480 under the highway needs to be repaired. Regrading of the slope or fill placement at 34+850 may be required in the future if the guardrail becomes undermined due to erosion or movement at the slide scarp. It is understood that this work might already be underway as part of the 2022 pavement overlay project.	\$40,000
--	----------

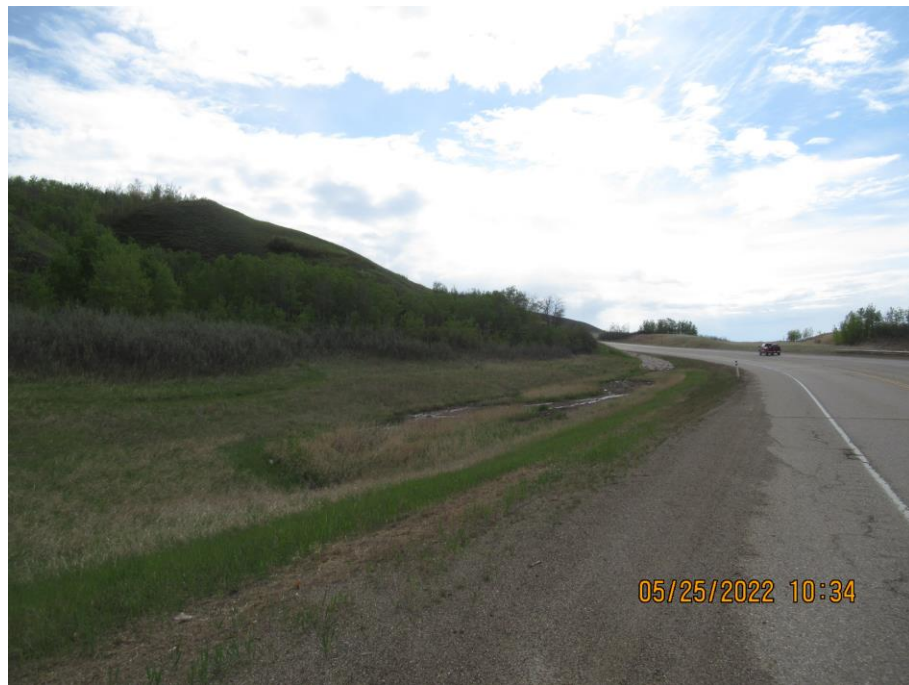
Erosion is very active and deep in the north ditch and within two major gullies south of the highway. Ditch should be regraded and armored. Culvert drainage should be restored. Current gullies do not present an immediate risk to the highway but adding a trunk drain to this section should be considered to reduce rate of retrogression.

Photo 59-02.
Look east at ditch erosion near the west end of the new ditch armoring before the culvert inlet (35+650).

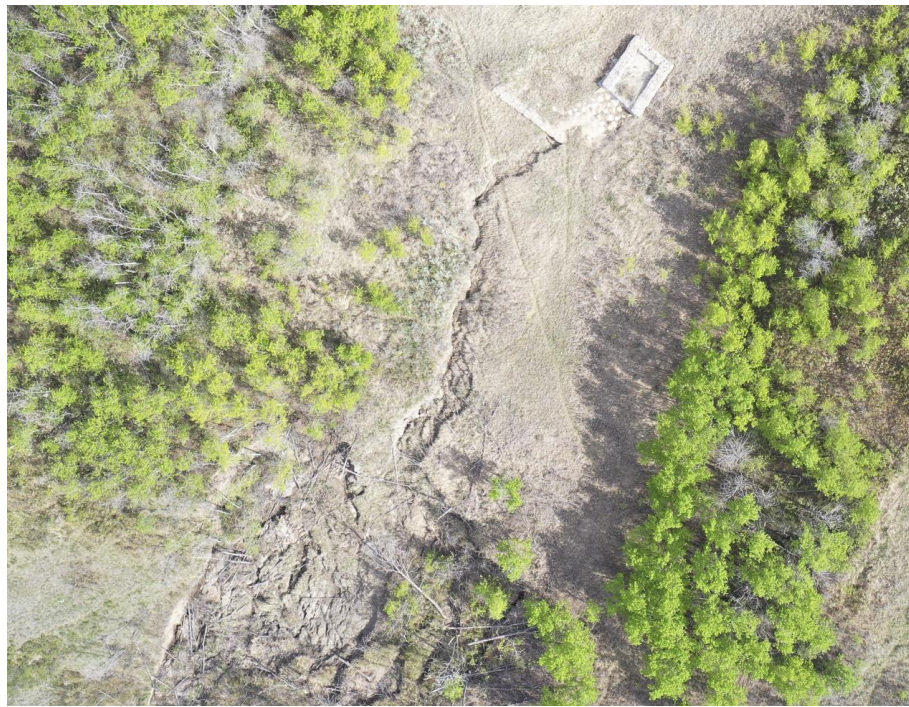
Photo 59-03.
Overhead drone image of erosion and slide damage downslope from the gabion culvert outlet structure (35+500).

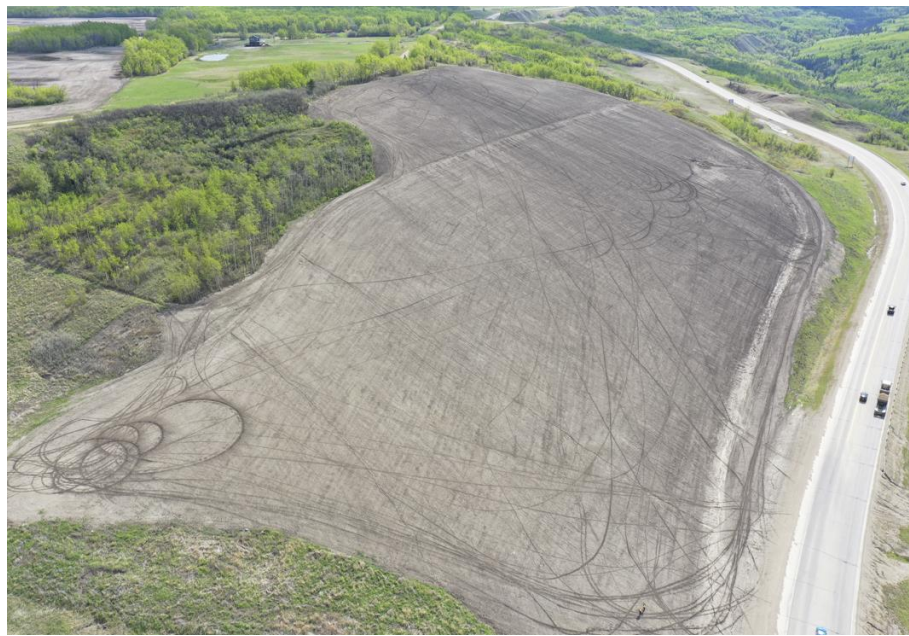
The unloading of the upslope area above the highway between 35+150 to 35+400 is expected to help reduce the potential reactivation of the old landslide plane from the 1980s; however, revegetation of the disturbed soils and managing erosion will be required.

Photo 59-04.
Oblique drone view towards the east of the graded borrow area above the highway (35+200). Minor rill erosion was noted.

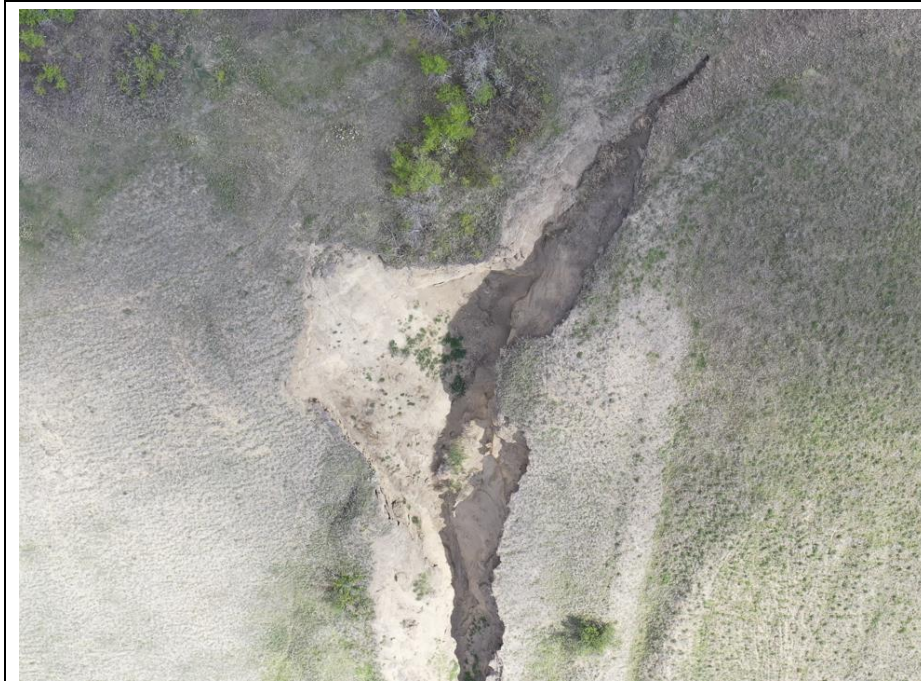
Photo 59-05.
Overhead drone image of an erosion gully approximately 125 m downslope (south) from the highway (35+450). Ongoing erosion and minor expansion relative to the 2020 condition.

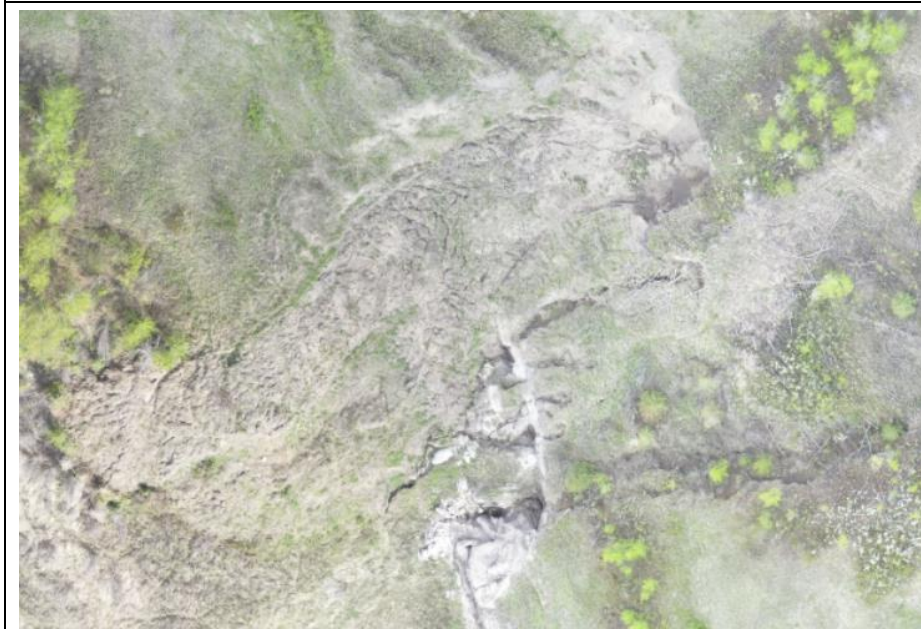
<p>fair to good condition. Flank of scarp near 35+300 has no change from 2019 condition.</p> <p>New active landslide area occurring at the base of the valley below the erosion gully at KM 35+500 (Photo - 59-06) as well as ongoing movements in the slide area further up the valley slope along this erosion feature (Photo 59-03).</p>	
<input checked="" type="checkbox"/> Erosion	<p>Erosion gully is active near 35+450, approximately 125 m downslope from highway (Photo 59-05). Erosion gully downstream of gabion culvert outlet near 35+500 has minor ongoing erosion/expansion at the flanks but no major retrogression since previous inspection (Photo 59-03).</p> <p>North ditch erosion damage between approximately KM 35+350 to 35+575 has been repaired and armored with riprap by the maintenance contractor. Minor erosion damage is occurring outside of the repaired extents.</p> <p>Silt buildup and minor erosion was noted within ditch on the north side of the highway near 35+650 (Photo 59-02).</p>	<input checked="" type="checkbox"/>

Photo 59-06.
Overhead drone image of a recent landslide in the lower valley below the erosion gully at KM 35+500. Offset over 250 m from the highway.
