ALBERTA TRANSPORTATION AND
ECONOMIC CORRIDORS GRMP
PEACE REGION – (PEACE RIVER DISTRICT)
INSTRUMENTATION MONITORING - FALL 2025

Site Number	Location	Name	Hwy	km
PH059	Station 34+770 to 35+680	Peace River East Hill	2:60	Km 34.8 to 35.7
Legal Description:		UTM Co-ordinates		
6-28-83-21 W5		11U E 484136.86	N	6231088.27

Current Monitoring:	25 & 26 September, 2025	Previous Monitoring	9-June-2025
Instruments Read By:	Mr. Niraj Regmi, G.I.T and Mr. Angelo Castillo, of Thurber

**SITE PH059: HWY 2:60, PEACE RIVER EAST HILL
(SITE # 2, STATION 34+770 TO 35+680)**

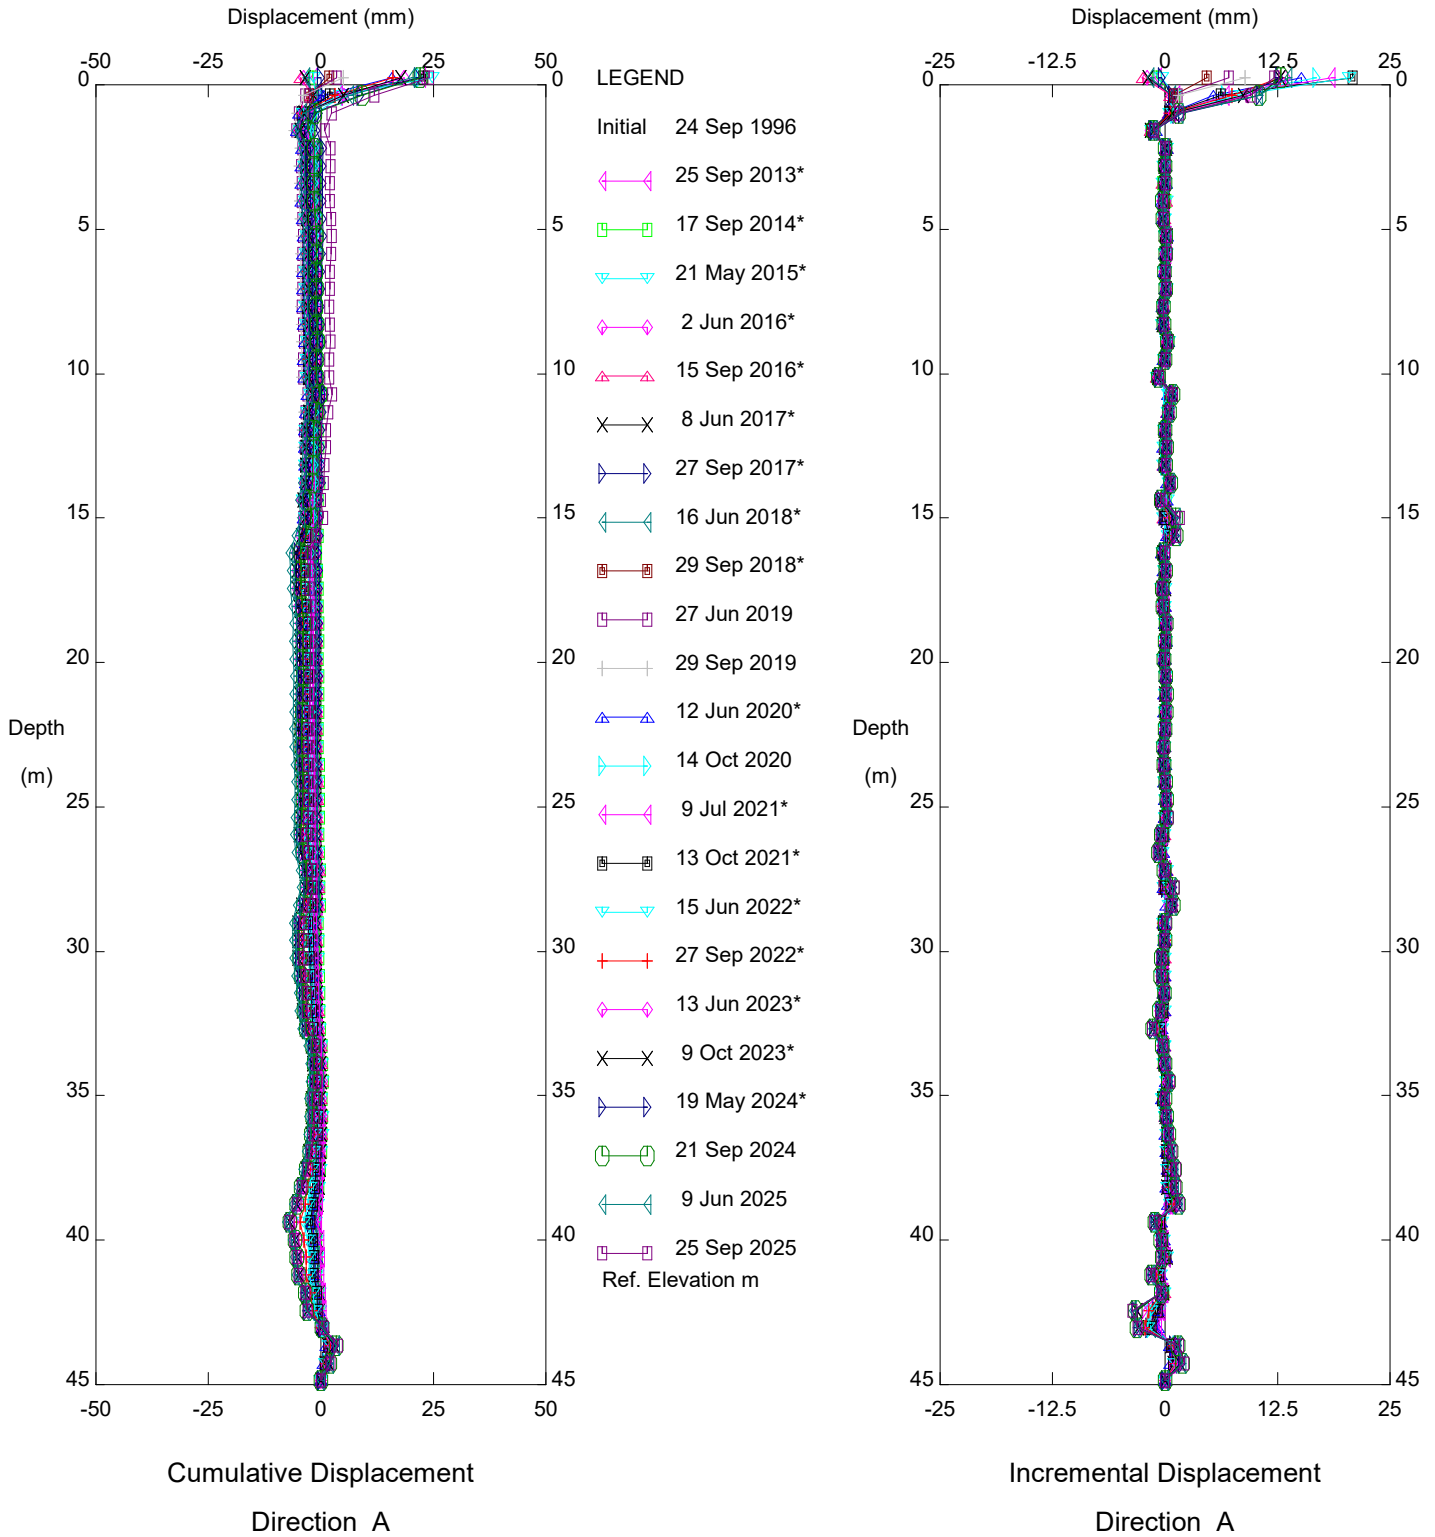
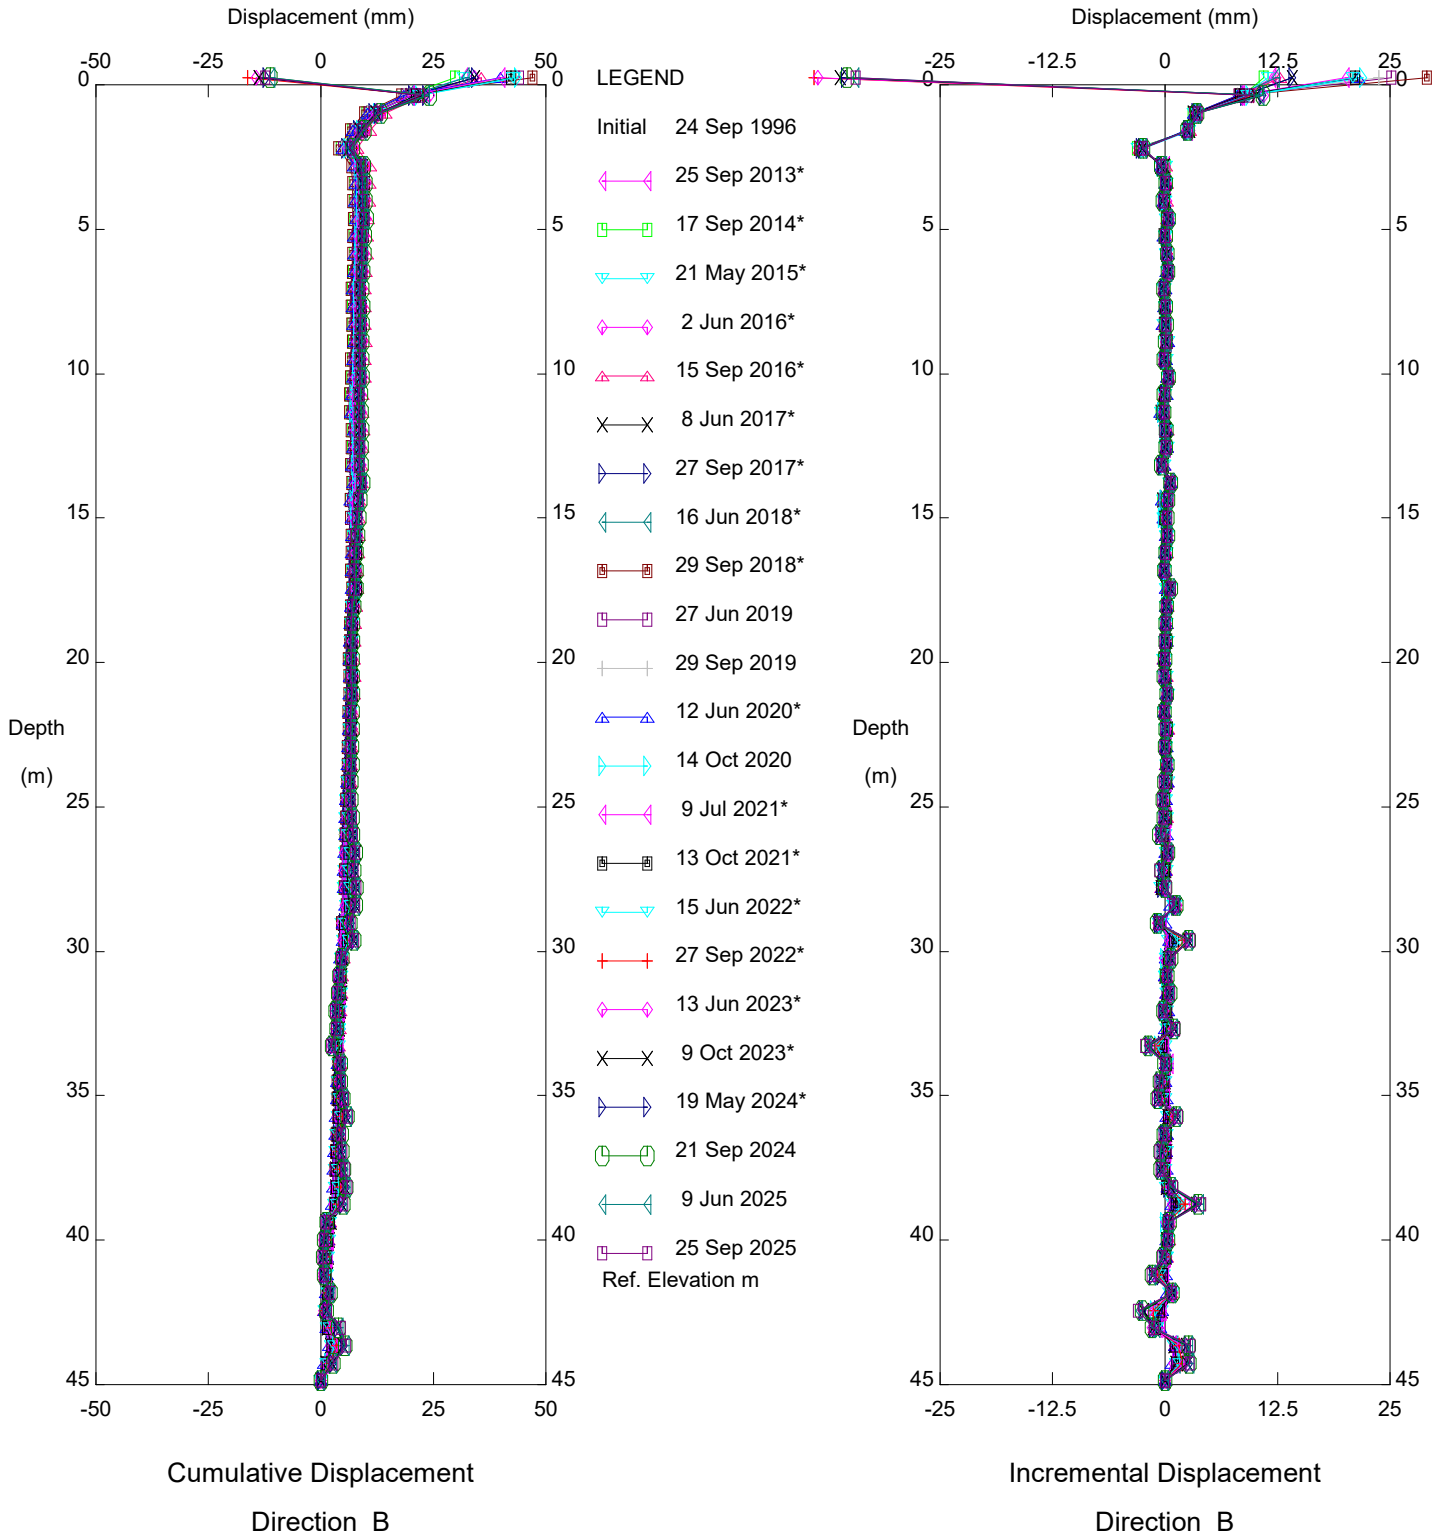
(PH059) PEACE RIVER EAST HILL -SITE 2, Inclinometer SI-67

Discussion	
Zones of New Movement:	None
Interpretation of Monitoring Results:	<p>SI-67 is located upslope of the highway and SI-69, 75 and 81 are all located downslope of the highway.</p> <p>SI-67 and SI-69 showed no discernible movement although there are many zones of very subtle movements within the 45 m depth of these slope indicators.</p> <p>SI-75 showed a rate of movement of 15.4 mm/yr over 0.0 m to 5.4 m depth since the spring of 2025 readings. The rate of movement increased by 15.8 mm per year between the spring of 2025 and the fall of 2025.</p> <p>SI-81 showed no discernable movement over 1.9 m to 6.1 m depth and 3.2 mm/yr over 6.1 m to 9.2 m depth since the spring of 2025 readings. The movement rate over 1.9 m to 6.1 m depth decreased by 6.3 mm/yr and the movement rate over 6.1 m to 9.2 m depth increased by 7.8 mm/yr since the spring of 2025 readings. The movement pattern at SI-75 and SI-81 is consistent with a trendline of accelerated movement since the fall of 2022, relative to the movement trendline between 2010 and 2022. There are also several zones of very subtle movements at greater depth in SI-75 and 81.</p>

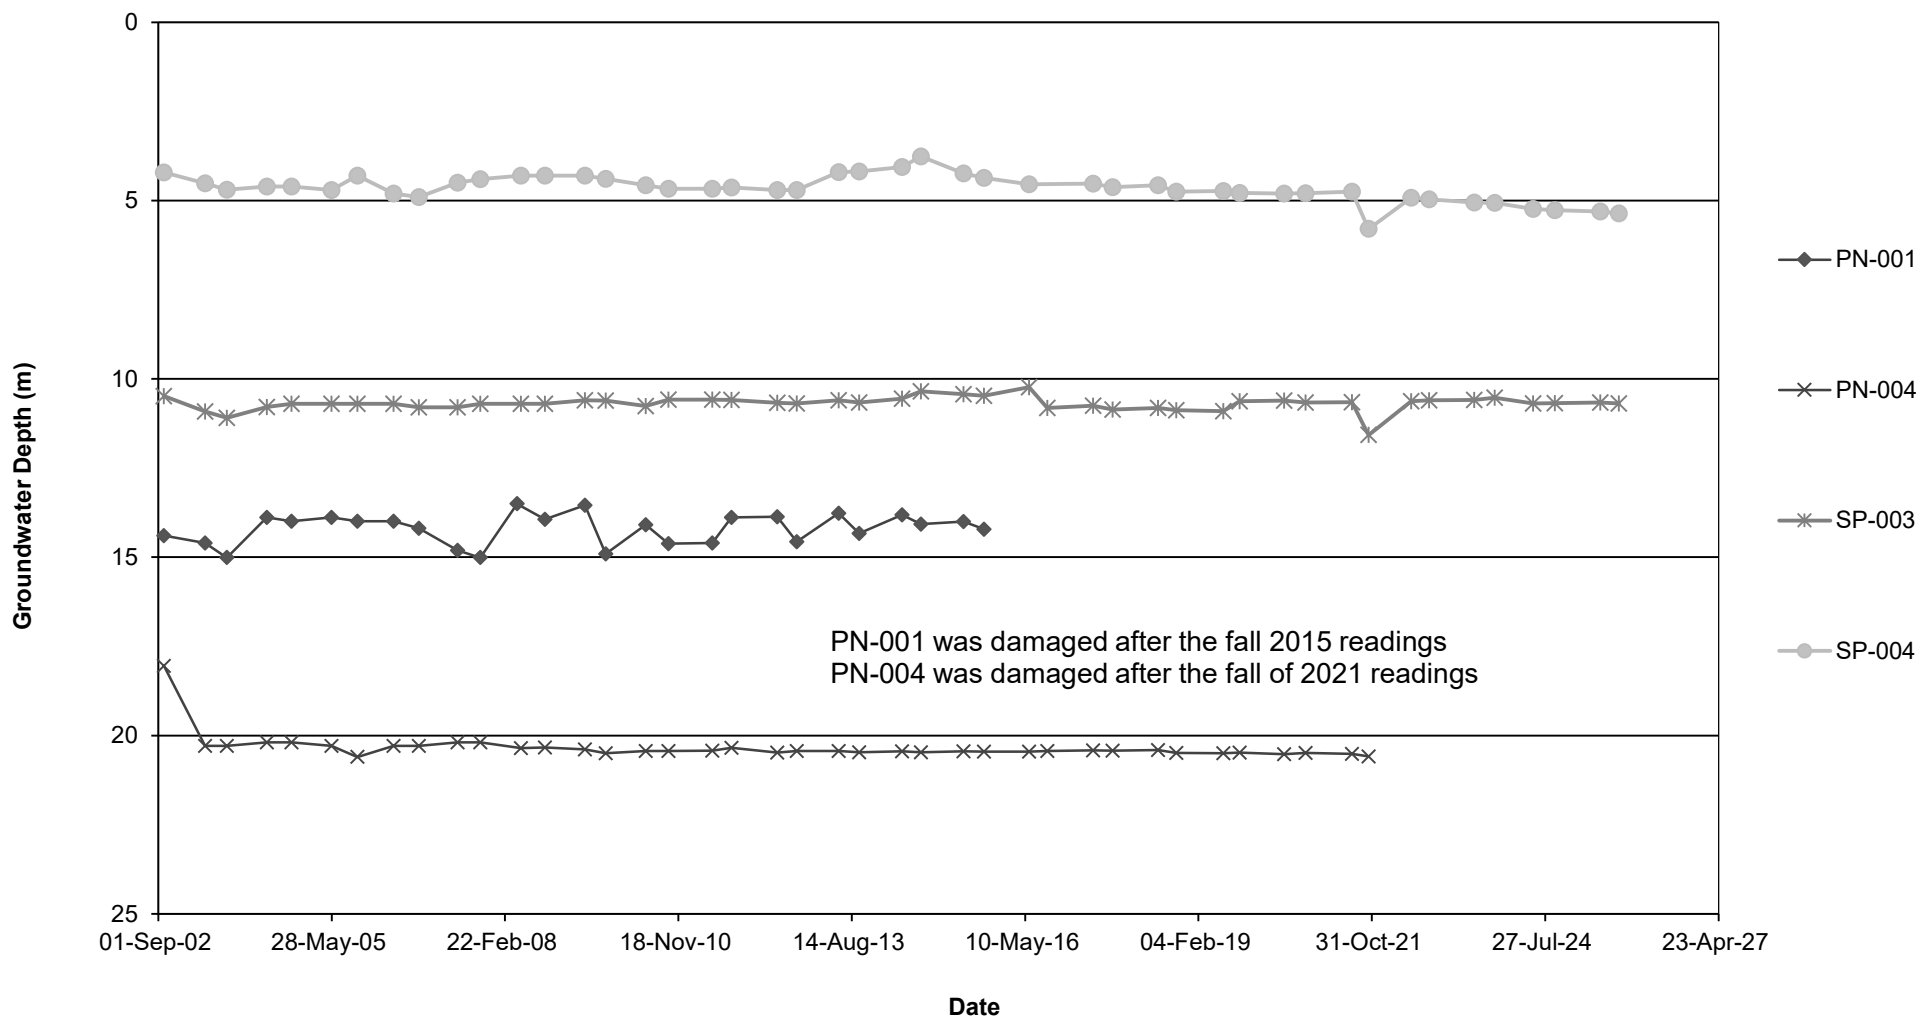
FIGURE PH059-1
PIEZOMETER DATA: PEACE RIVER EAST HILL SITE #2

Standpipe piezometer SP-003 showed a decrease in groundwater level of 0.03 m since the spring of 2025 reading. The groundwater level at SP-003 has been generally steady since 2002. SP-004 showed a decrease in groundwater level of 0.06 m since the spring of 2025 readings. This slow downward trend has persisted at SP-004 since 2014.
Future Work:	The instruments should be read again in the spring of 2026.
Instrumentation Repairs:	No instrument repairs are required currently.
Additional Comments:
