**ALBERTA TRANSPORTATION GEOHAZARD ASSESSMENT PROGRAM
PEACE REGION – PEACE-HIGH LEVEL
2020 INSPECTION**

| PH60 | East Hill | 35+680 to 36+180 Site 3 | 2:60 | 35.95 |

| | Date | PF | CF | Total |
|---|---|---|--|---|
| Current Inspection: | 9-Jun-2020 | 13 | 4 | 52 |

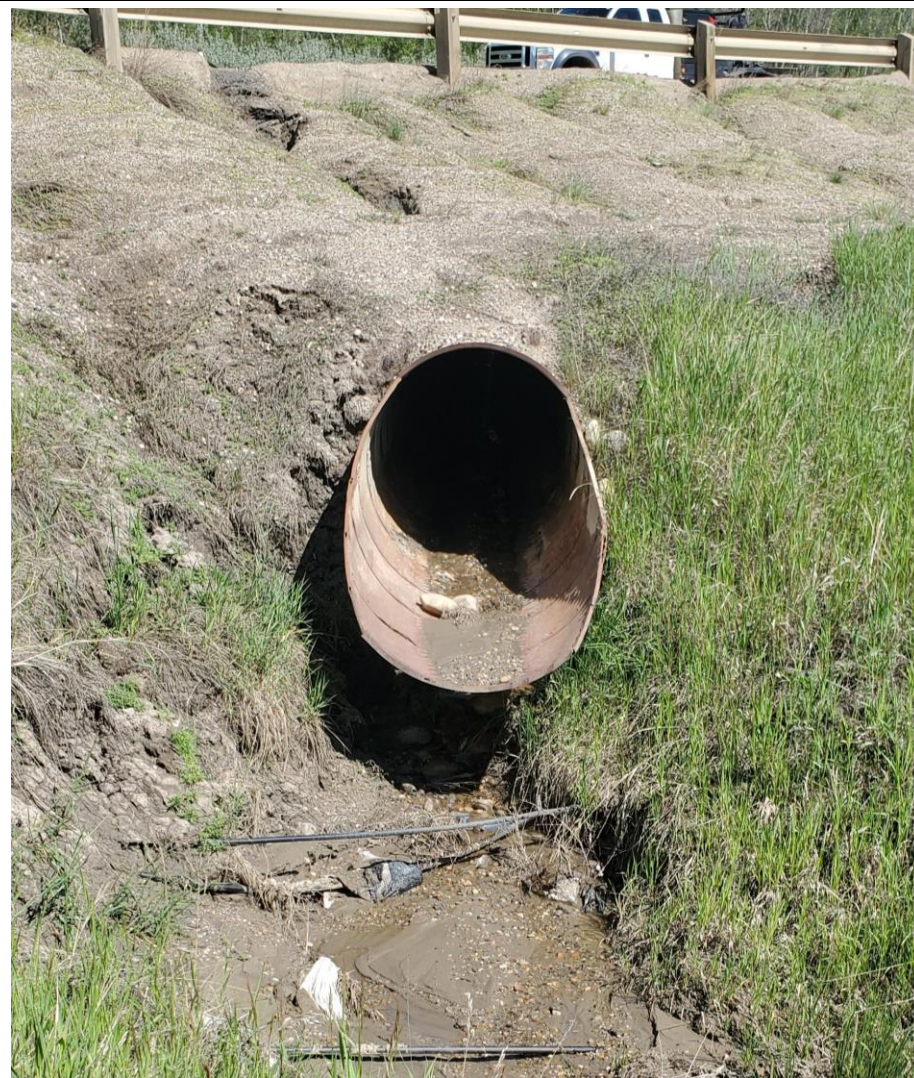
| <input checked="" type="checkbox"/> Bridge/Culvert Distress | Erosion ongoing at culvert outlet at 35+700 which is believed to be at least partially blocked (Photo 60-01). | <input type="checkbox"/> |

Photo 60-01.
Close-up of hanging culvert outlet (35+700). Ongoing erosion below culvert and rilling above. No major change from the 2019 condition.

Consider redirecting surface runoff further downslope of headcutting/gullyng that is occurring at 36+000 and 35+700.

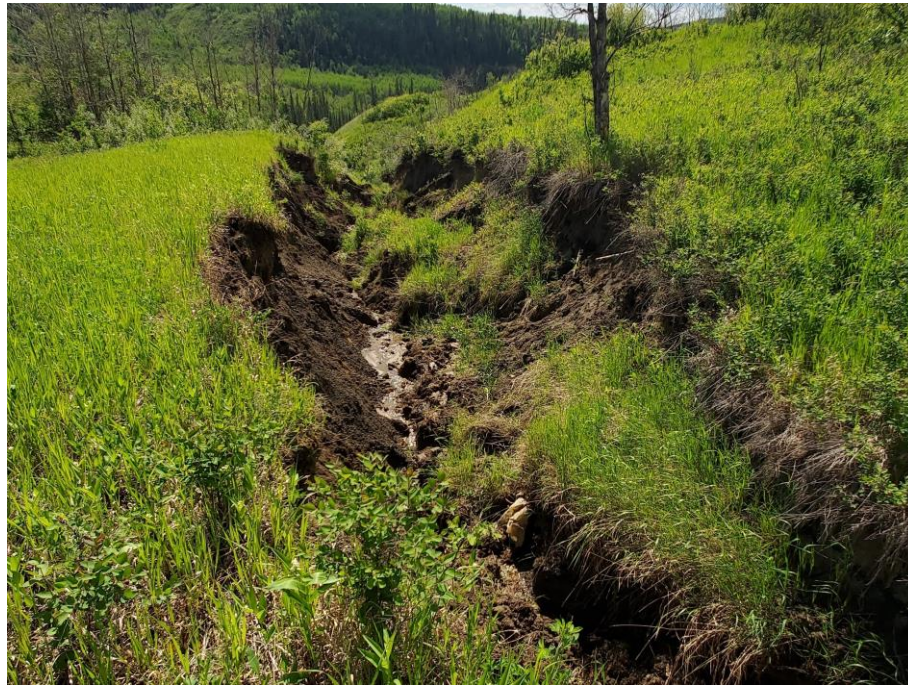
| <input checked="" type="checkbox"/> Erosion | <p>Ongoing erosion at the culvert outlet and gully immediately below roadway at 35+700 where there is active slumping on the gully walls (Photos 60-01 and 60-02). The erosion and gully significantly expands approximately 125 m downslope of the highway where trees and thicker vegetation becomes sparse. Ongoing minor retrogression but no significant expansion since 2019 and gully sidewalls are intermittently stable (Photo 60-03).</p> <p>Minor ditch erosion is ongoing on both sides of the roadway between 35+850 and 36+000.</p> <p>At 36+050, gully erosion is ongoing on the upper portion of the toe berm below the roadway (Photos 60-06).</p> | <input checked="" type="checkbox"/> |

Photo 60-02.
Looking downslope at erosional gulying below culvert shown in Photo 60-01 (35+700). Active slumping on gully walls.

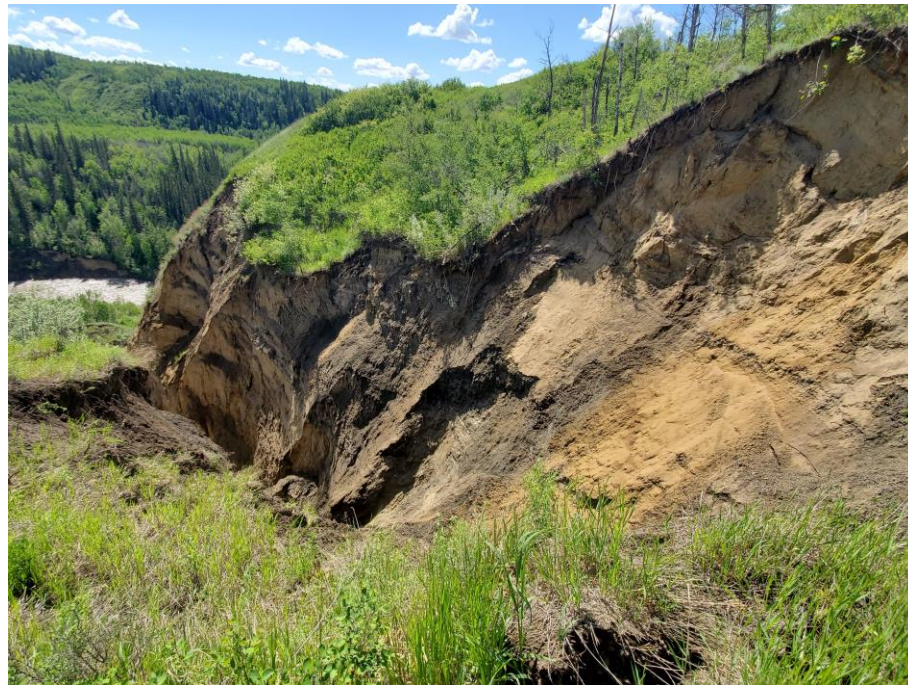
Photo 60-03.
Gully and slide area below the culvert outlet at 35+700, offset approximately 125 m from the highway. Mass movement occurred in 2016, ongoing minor retrogression but no new major retrogressions or movements were noted in 2020. Gully sidewalls are intermittently stable.

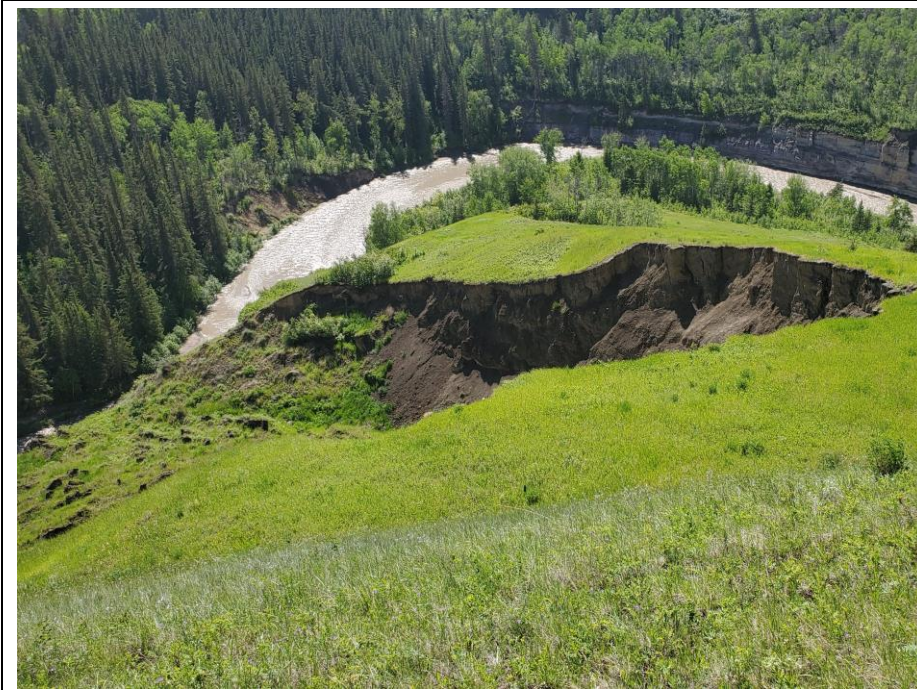
Photo 60-04. View overlooking the main scarp of a major slide/earth flow event that occurred in 2016. Minor retrogression since that time. Slide area is offset approximately 180 m from the highway (35+950).

Consider repairing the shallow slope failures at 35+900 and 35+835. This may include removal of loose soil and backfill using granular fill; and protecting the exposed surface with liner and soil cover to allow vegetation to grow.

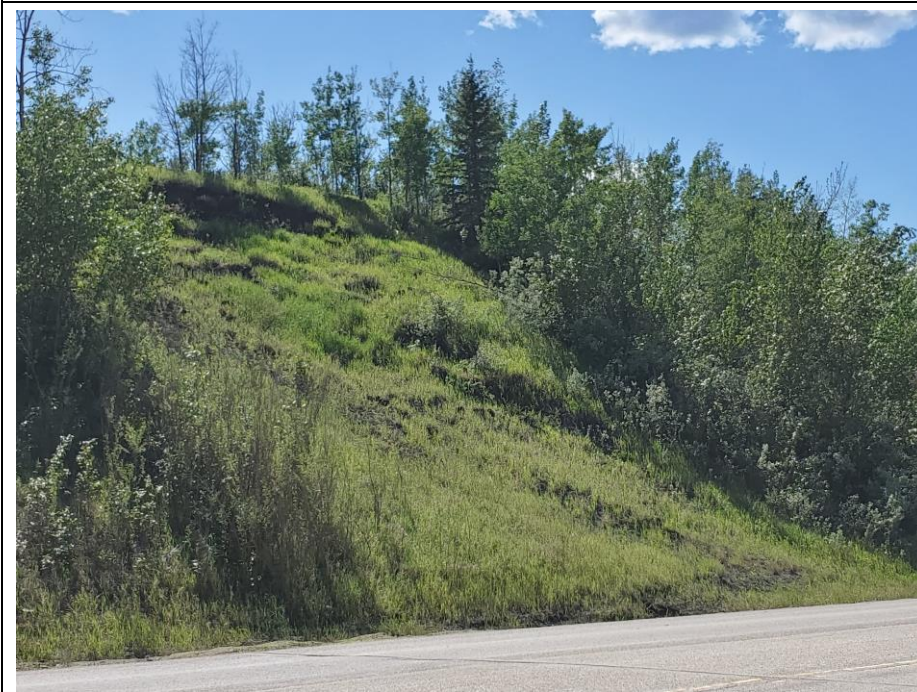
| <input checked="" type="checkbox"/> Slope Movement | <p>Retrogressive slumping along Heart River is actively continuing, which encompasses the lower portions of the large toe berm constructed downslope of the roadway to stabilize the initial landslide in this area. Areas have minor ongoing movement but no significant retrogression/lateral expansion of the main 2016 slide area which is offset approximately 180 m from highway (Photo 60-04).</p> <p>Overgrown scarp near 35+750 shows no sign of recent movement.</p> <p>Shallow slide/flow on the backslope at 35+830 had no further expansion and was not blocking ditch (Photo 60-05).</p> | <input type="checkbox"/> |

Photo 60-05. Shallow slide/flow within through-cut area on the south cut slope (35+830). First observed in 2016, no further expansion or blocking of ditch.

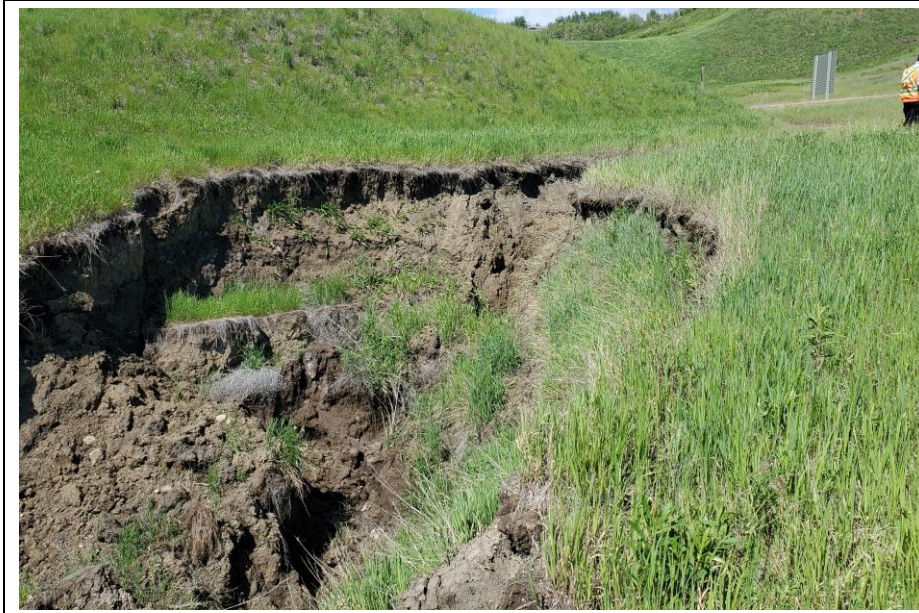
Photo 60-06.
Headcutting and erosional gully
occurring below roadway (36+050).
